**Re: Revised Remediation Work Plan
Mesa 8105 JV-P 013H
Incident Numbers NCH1835547953, NAB1906552791, and NAB1906551740
Lea County, New Mexico**

Ensolum, LLC (Ensolum), on behalf of BTA Oil Producers, LLC (BTA), has prepared the following *Revised Remediation Work Plan (Revised Work Plan)* as a follow up to the original *Remediation Work Plan (Work Plan)* dated September 25, 2019. This *Revised Work Plan* proposes to complete additional delineation activities at the Mesa 8105 JV-P 013H (Site) in response to the denial of the original *Work Plan* by the New Mexico Oil Conservation Division (NMOCD). In the denial, NMOCD indicated that the impacted soil left in place had not been properly delineated. The following *Revised Work Plan* proposes full lateral and vertical delineation of the impacted soil left in place.

BTA Oil Producers, LLC
Revised Remediation Work Plan
Mesa 8105 JV-P 013H

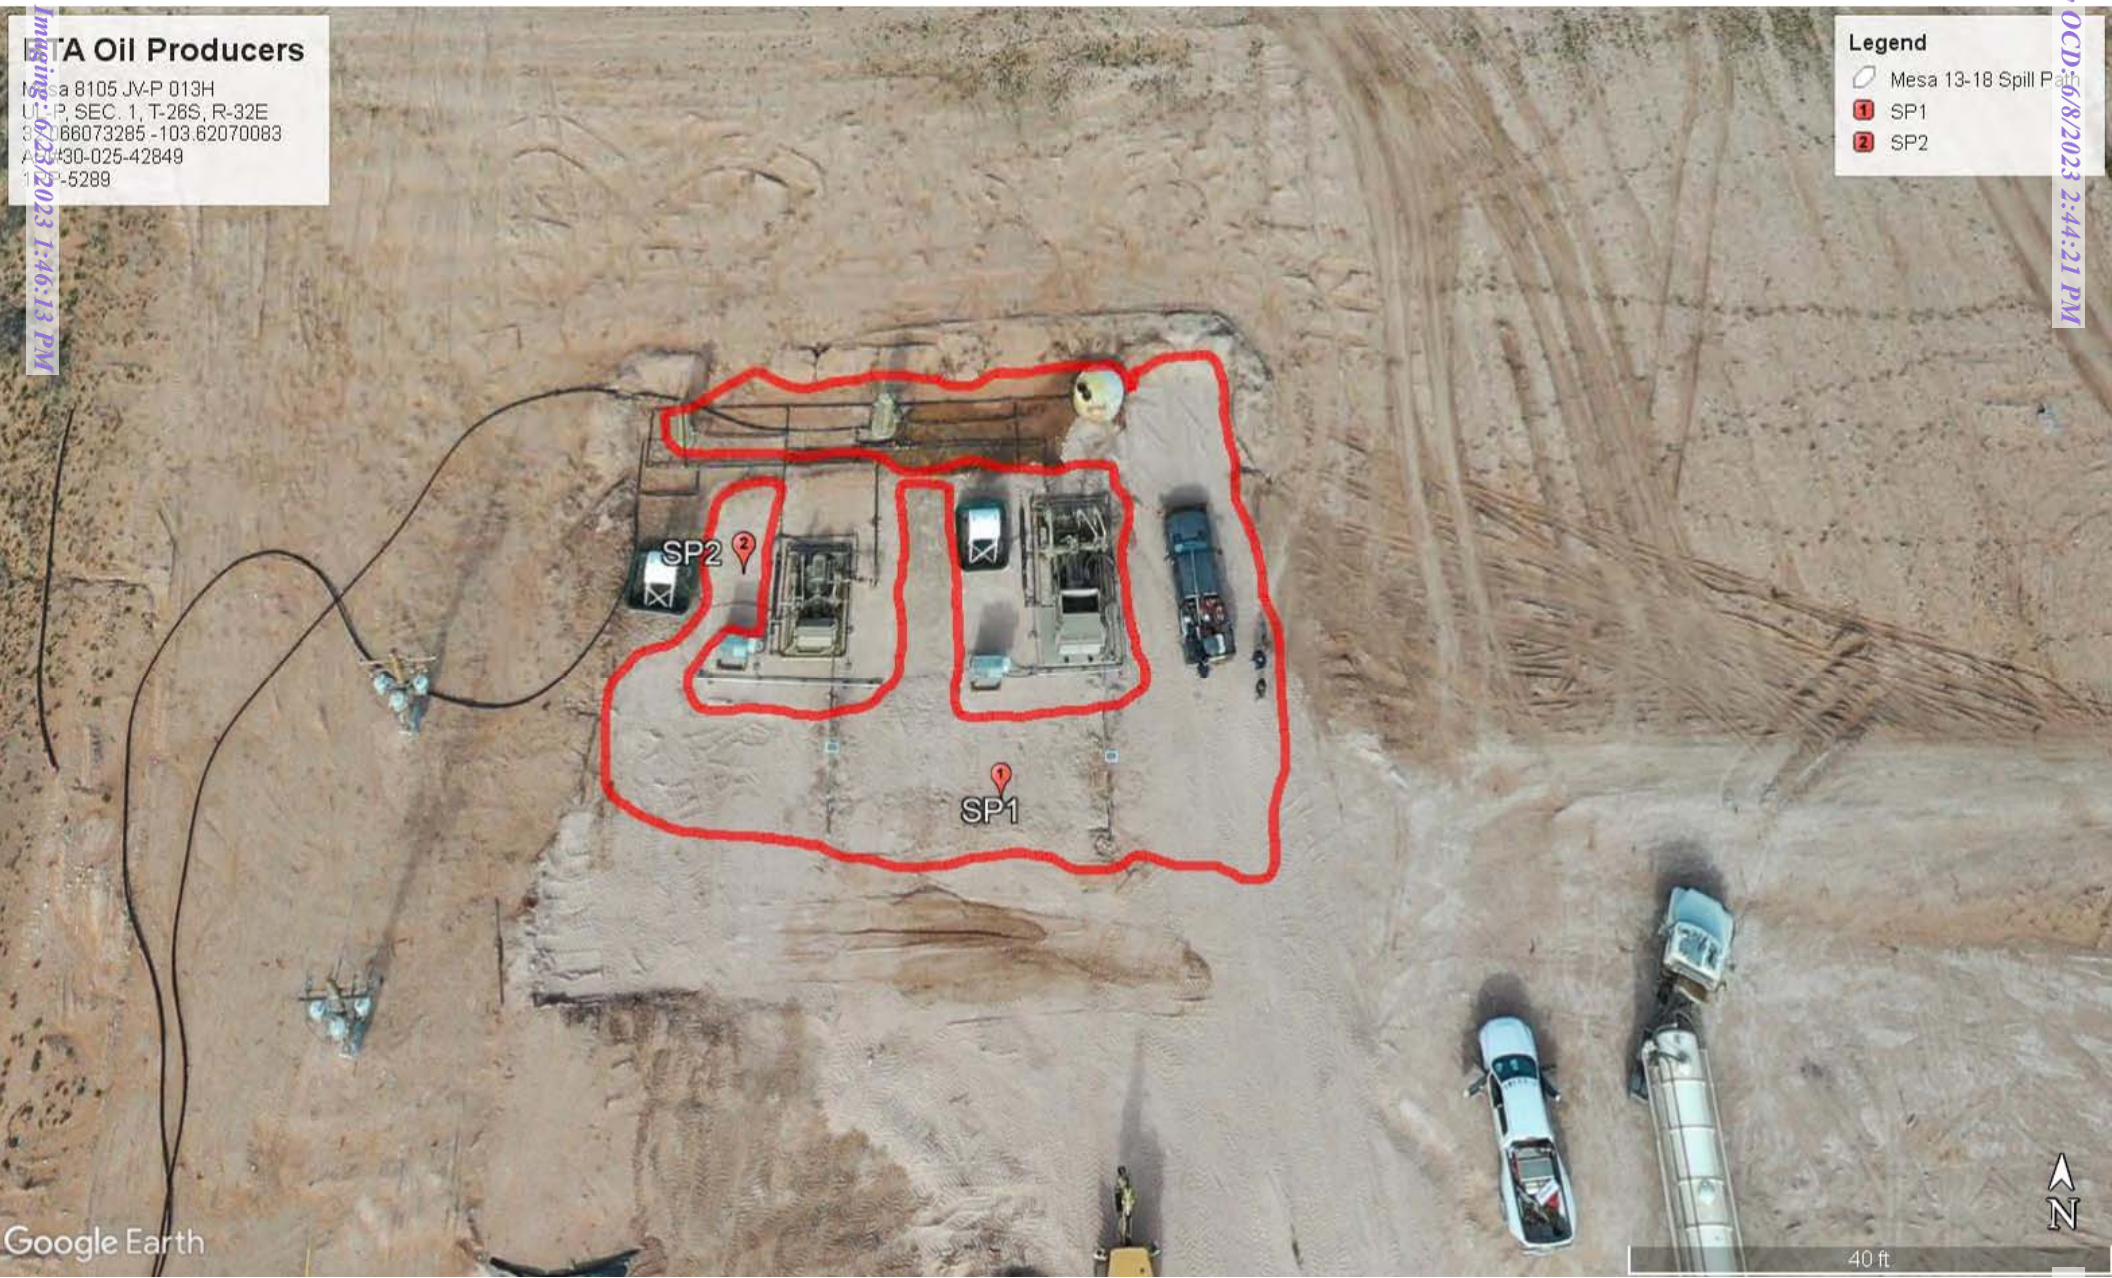
Figure 2 - Excavation Extent and Delineation Soil Sample Locations (2018/2019)

Between November 2018 and August 2019, delineation and excavation activities were conducted at the Site to address the impacted soil resulting from the three slop tank overflow releases into an area of active production equipment. Impacted soil was excavated to a depth of 2 feet bgs around the active compressors and production equipment, and beneath the surface lines. A total of approximately 128 cubic yards of impacted soil were excavated. However, impacted soil was left in place immediately adjacent to and beneath the active compressors and production equipment where remediation would cause a major facility deconstruction. Impacted soil within the release extent was vertically delineated to below the most stringent Table I Closure Criteria. Delineation sample points SP1 and SP2 confirmed that impacted soil did not extend deeper than 4 feet bgs. The excavation extent and delineation soil sample locations are presented on the attached Figure 2. The laboratory analytical results are summarized in the attached Table 1. There was limited area to continue deeper excavation due to two compressors, two vertical separator vessels, hard-piped gas meter runs, high-pressure gas lines, and buried electrical lines within the release area. A *Work Plan* was submitted to NMOCD on September 25, 2019, proposing to defer the impacted soil left in place and install a 20 mil impermeable liner in the base

Upon review of the September 25, 2019, *Work Plan*, it was noted that impacted soil was excavated to a depth of 2 feet bgs not 1-foot bgs as described in the denial language. Additionally, upon review of the 2018/2019 site photographs, it appears that impacted soil was excavated as close as possible to the active compressors and production equipment, including areas beneath surface lines. Additional excavation does not appear to be safely practical. A photographic log of the 2018/2019 excavation activities is provided in Appendix B along with photos from May 2023 showing the backfilled excavation area. BTA agrees that the delineation activities completed in 2019 were not adequate for deferral of the impacted soil left in place. As such, BTA requests approval to complete the following additional remediation activities:

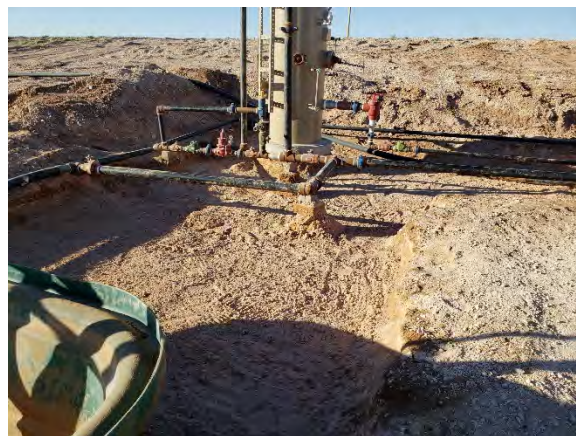
Spill Excavated

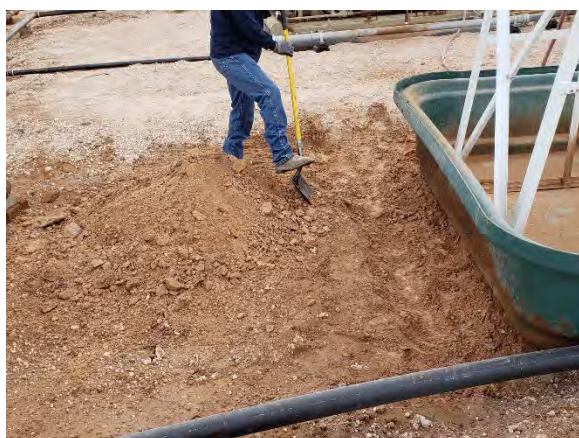
Digging up release

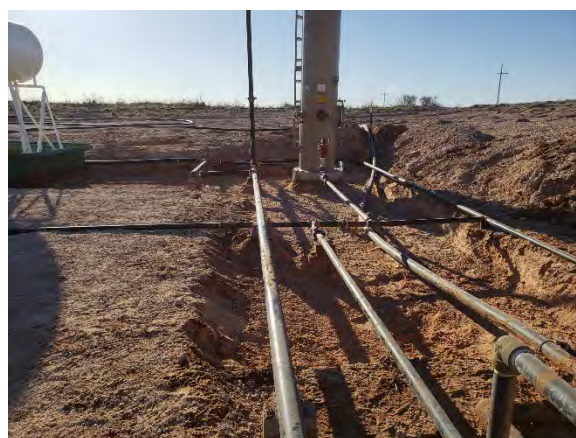
Spill Excavated

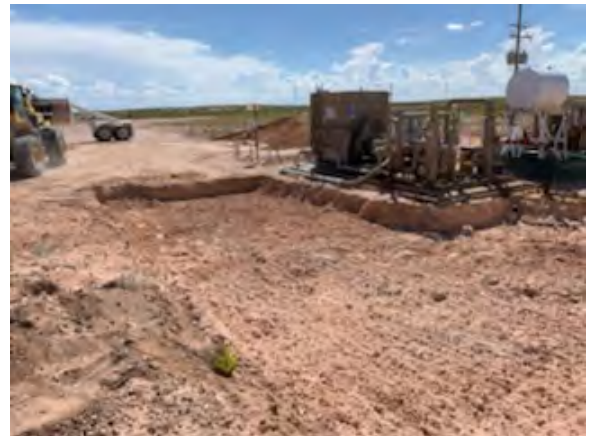
Spill Area Facing South

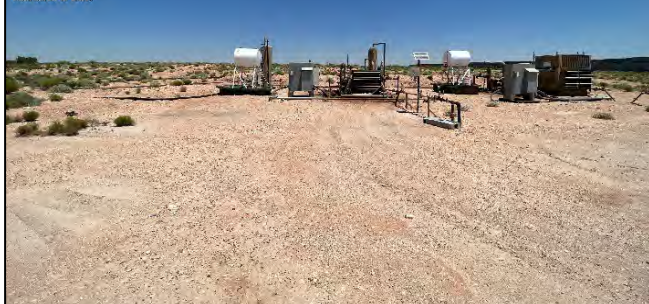
Photograph: 1 Date: 5/30/2023
Description: Historical release area/backfilled excavation
View: North

Date & Time: Tue, May 30, 2023 at 12:04:57 MDT
Position: +032.066180° / -103.624564° (±15.7ft)
Altitude: 3323ft (±10.8ft)
Datum: WGS-84
Azimuth/Bearing: 010° N10E 0178mils True (±11°)
Elevation Angle: -02.4°
Horizon Angle: +00.6°
Zoom: 0.5X
Facing north
Mariana O'Dell

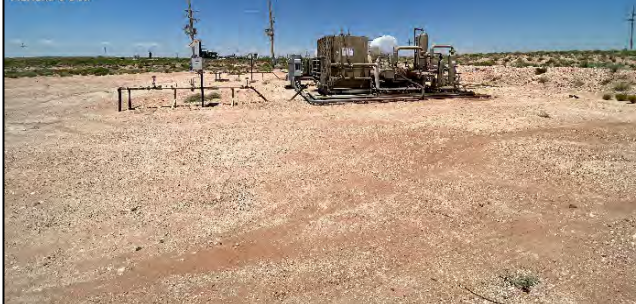
Photograph: 2 Date: 5/30/2023
Description: Historical release area/backfilled excavation
View: West

Date & Time: Tue, May 30, 2023 at 12:05:31 MDT
Position: +032.066279° / -103.624314° (±15.6ft)
Altitude: 3324ft (±11.0ft)
Datum: WGS-84
Azimuth/Bearing: 285° N75W 5067mils True (±12°)
Elevation Angle: -03.4°
Horizon Angle: +00.1°
Zoom: 0.5X
Facing west backfill
Mariana O'Dell

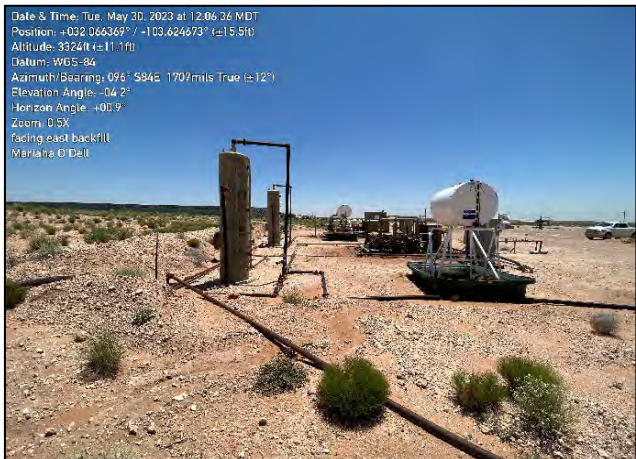
Photograph: 3 Date: 5/30/2023
Description: Historical release area/backfilled excavation
View: East

Date & Time: Tue, May 30, 2023 at 12:06:36 MDT
Position: +032.066369° / -103.624673° (±15.5ft)
Altitude: 3324ft (±11.1ft)
Datum: WGS-84
Azimuth/Bearing: 096° S84E 1797mils True (±12°)
Elevation Angle: -04.2°
Horizon Angle: +00.9°
Zoom: 0.5X
Facing east backfill
Mariana O'Dell

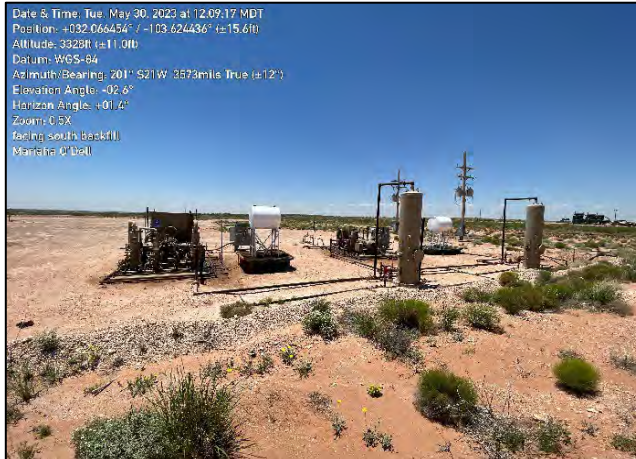
Photograph: 4 Date: 5/30/2023
Description: Historical release area/backfilled excavation
View: South

Date & Time: Tue, May 30, 2023 at 12:09:17 MDT
Position: +032.066454° / -103.624436° (±15.6ft)
Altitude: 3320ft (±11.0ft)
Datum: WGS-84
Azimuth/Bearing: 201° S21W 3573mils True (±12°)
Elevation Angle: -02.6°
Horizon Angle: +00.0°
Zoom: 0.5X
Facing south backfill
Mariana O'Dell
