Release Notification and Corrective Action

Facility Name: Poker Lake Unit #155 Facility Type: Exploration and Production

**Re: Closure Request Addendum
Poker Lake Unit #155
Incident Number nAB1807828569
Eddy County, New Mexico**

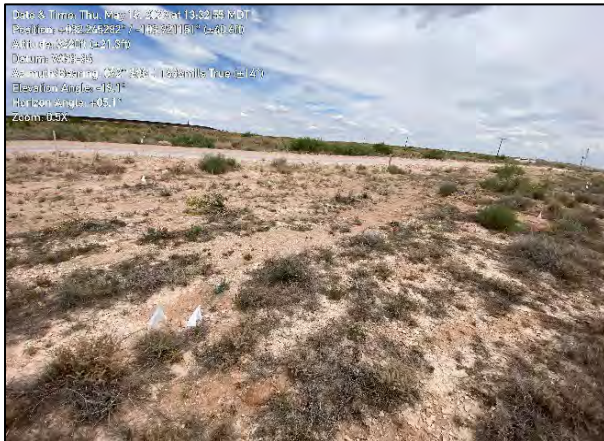
Photograph: 1 Date: 5/18/2023
 Description: View of historical release area.

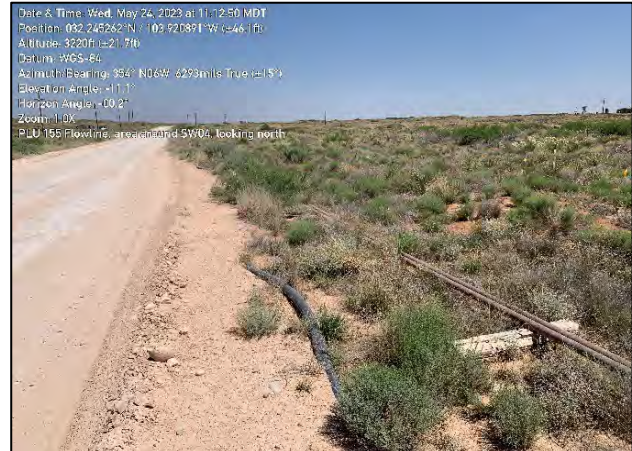
Photograph: 2 Date: 5/24/2023
 Description: View of historical release area.

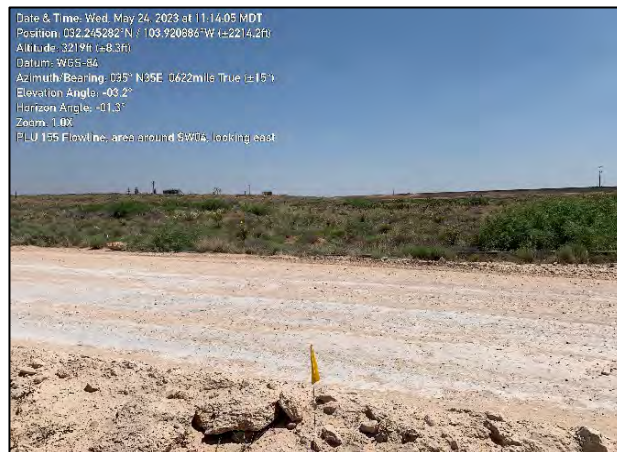
Photograph: 3 Date: 5/24/2023
 Description: View of historical release area.
