**RE: Liner Inspection and Closure Report
Johnson 10 23 27 Fee #401H
API No. 30-015-45044
GPS: Latitude 32.319781 Longitude -104.18779
UL H, Section 9, Township 23S, Range 27E, Eddy County, NM
NMOCD Reference No. NAPP2232025163**

Devon Energy Production Company (Devon) has contracted Pima Environmental Services, LLC (Pima) to perform a liner inspection and prepare this closure report for a produced water release that happened at the Johnson 10 23 27 Fee #401H (Johnson). An initial C-141 was submitted on February 20, 2023, and can be found in Appendix B. This incident was assigned Incident ID NAPP2232025163, by the New Mexico Oil Conservation Division (NMOCD).

JOHNSON 10 23 27 FEE #401H

Liner Inspection

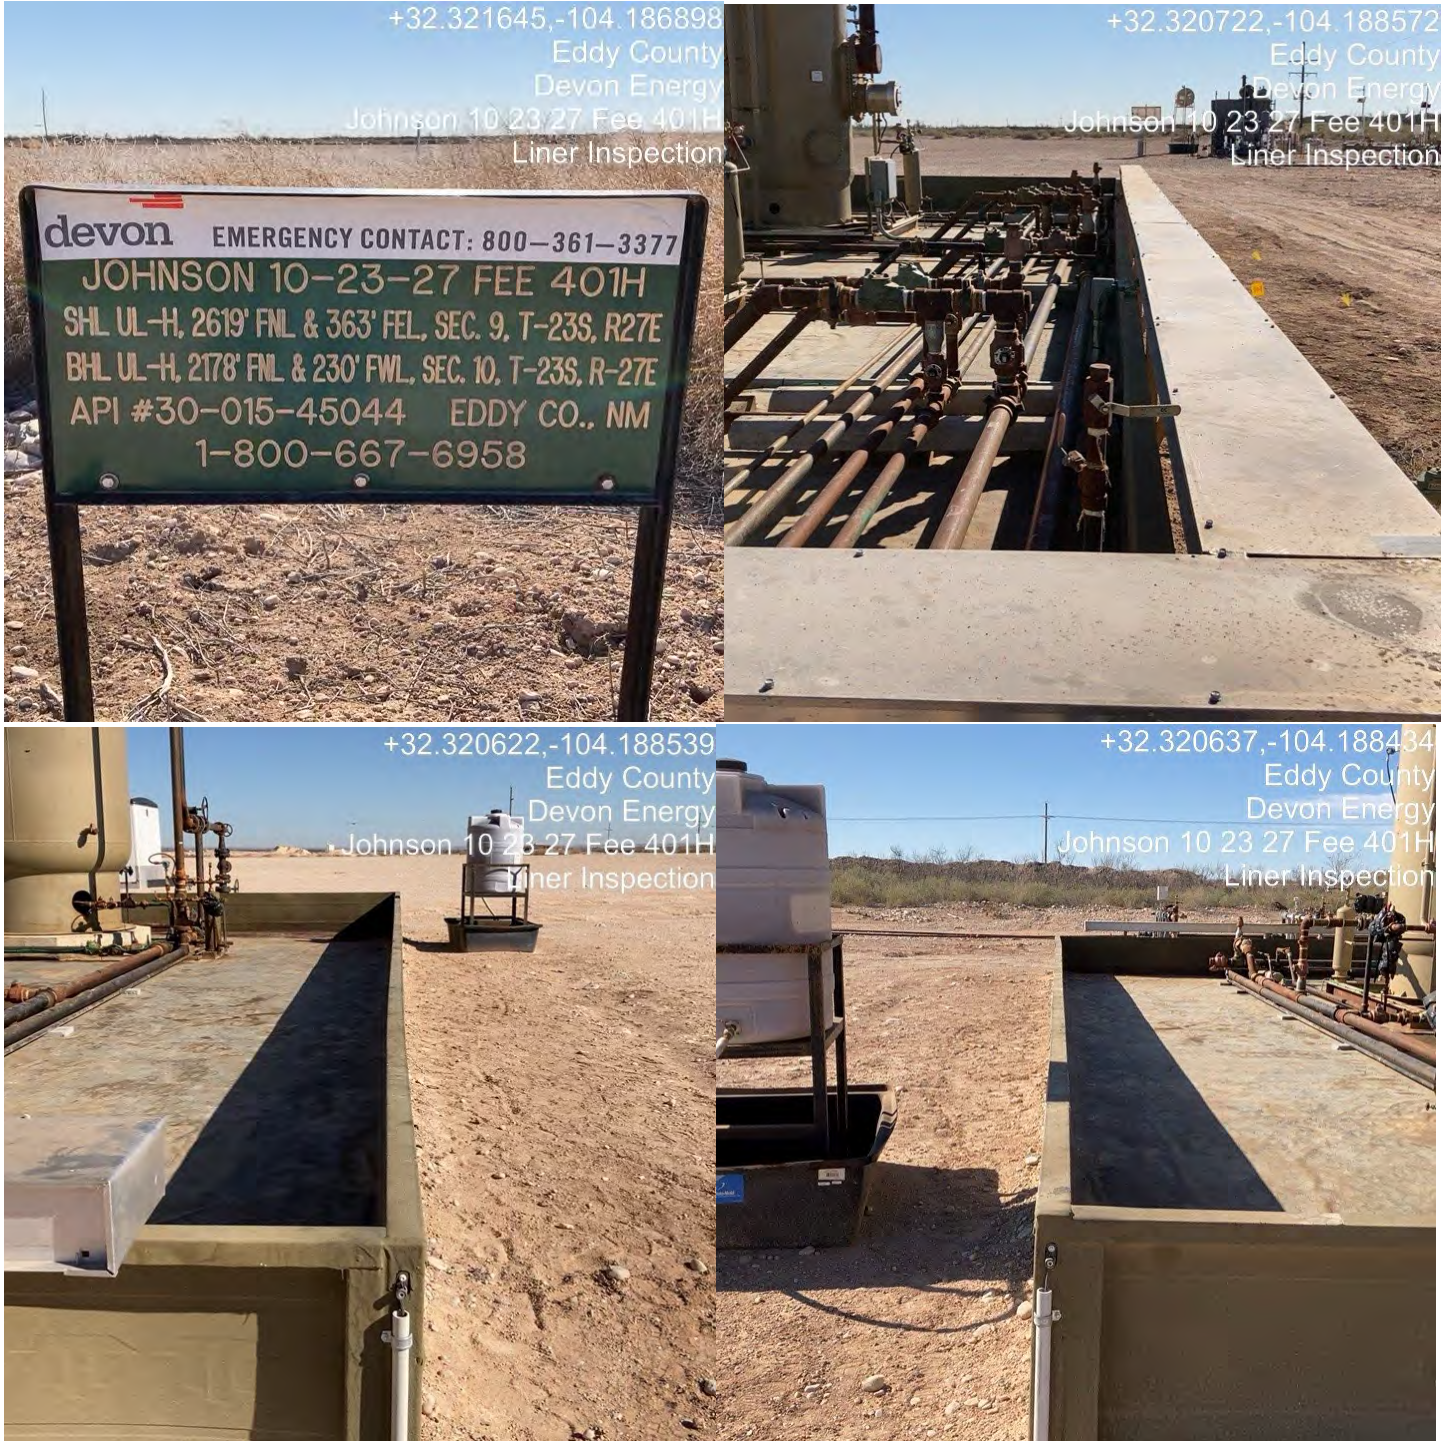
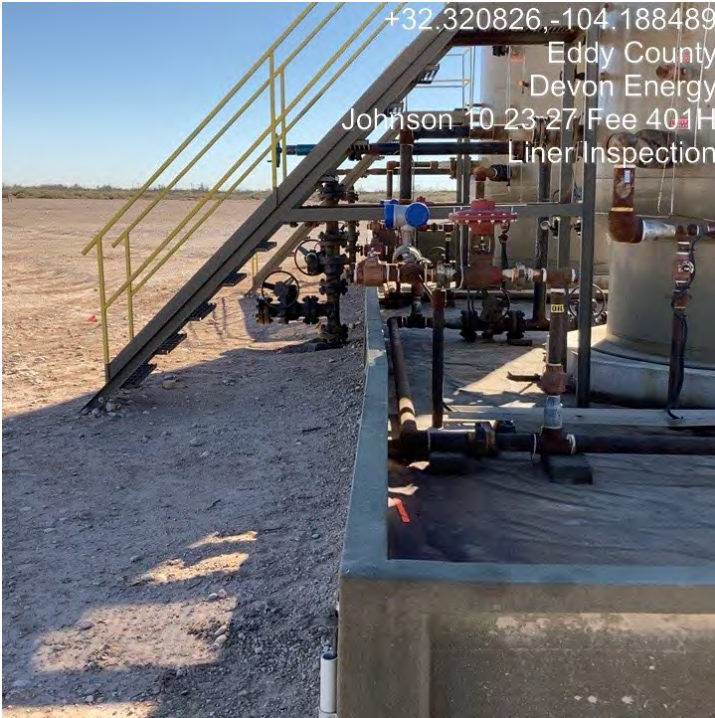
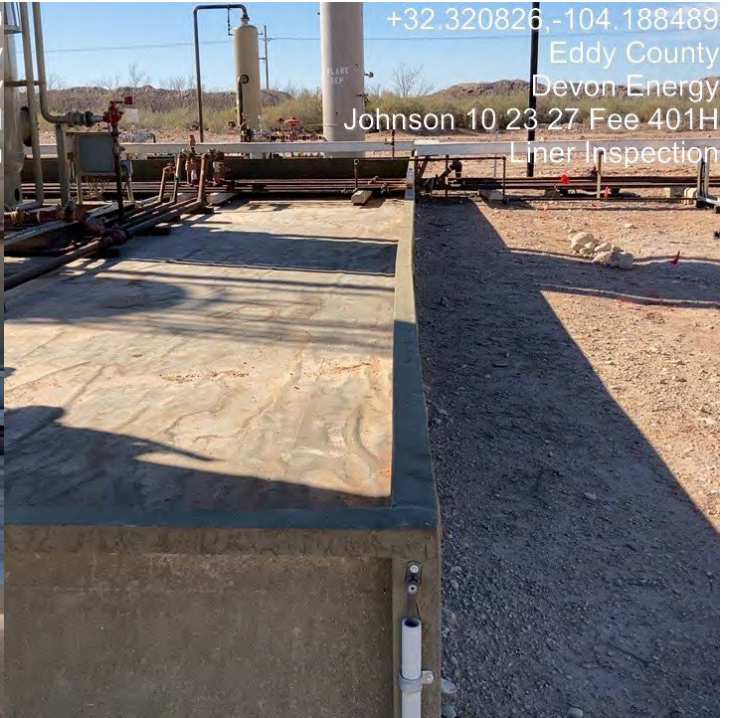
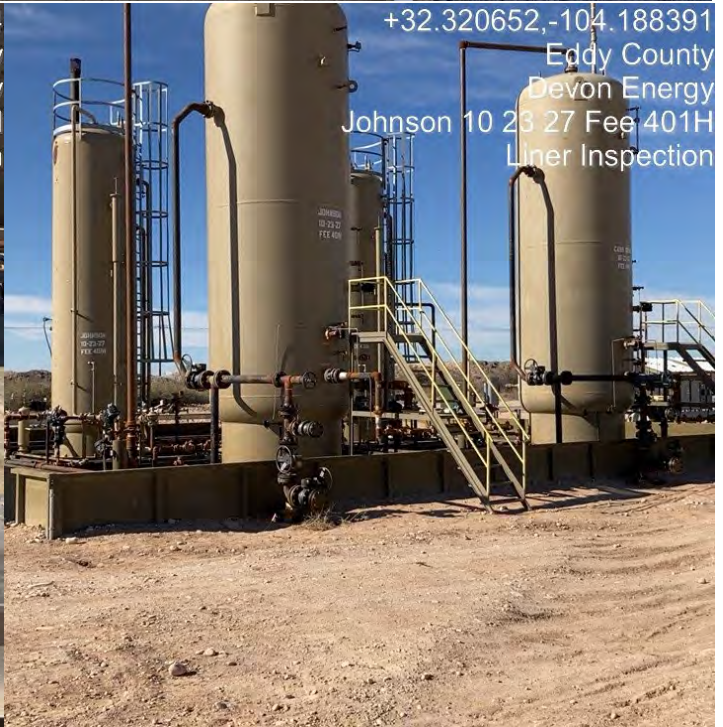
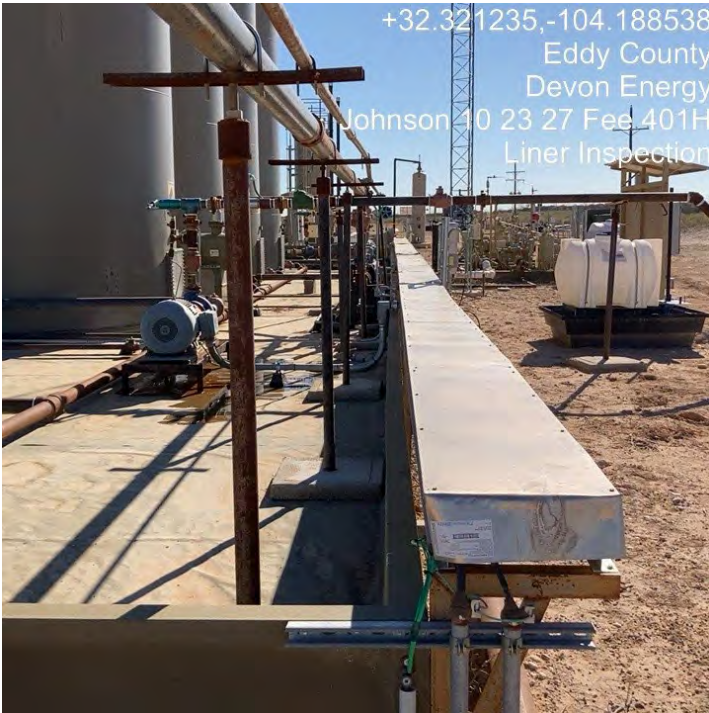
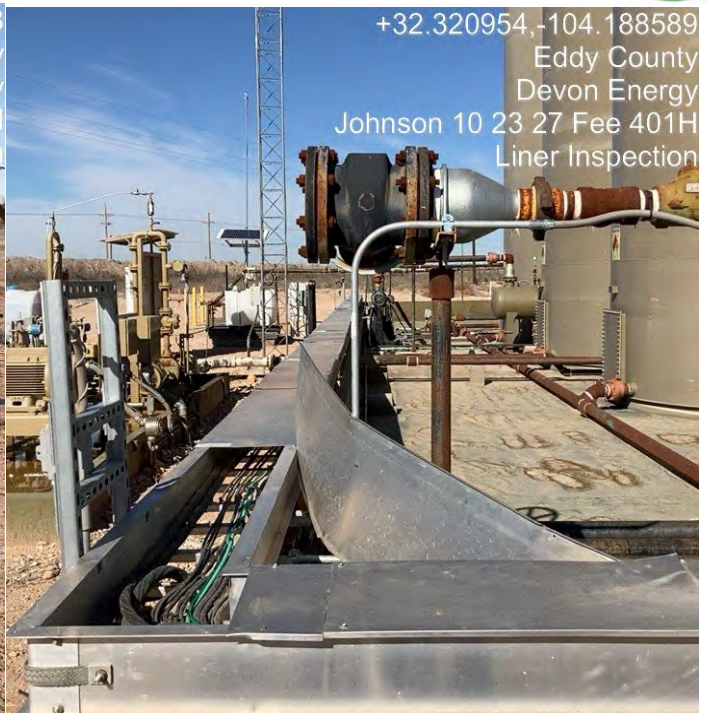
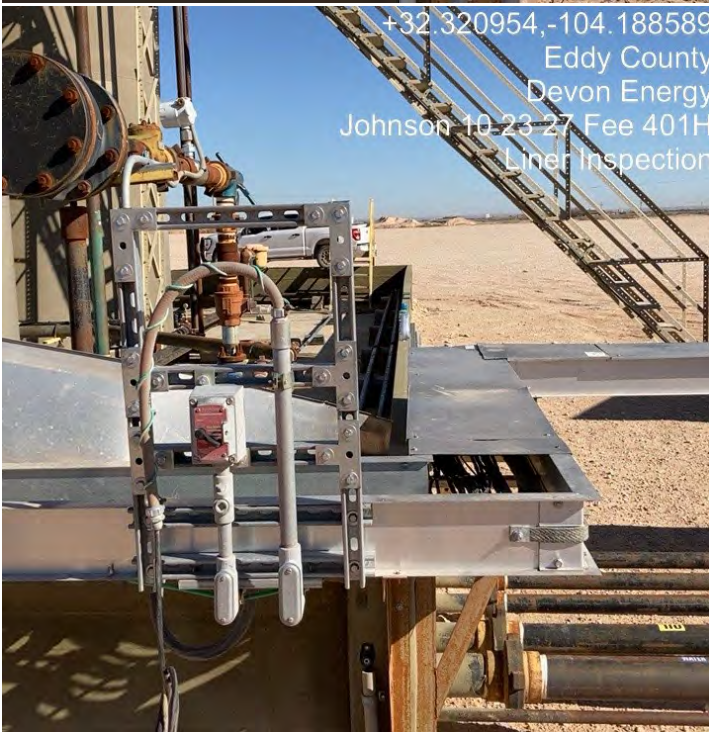
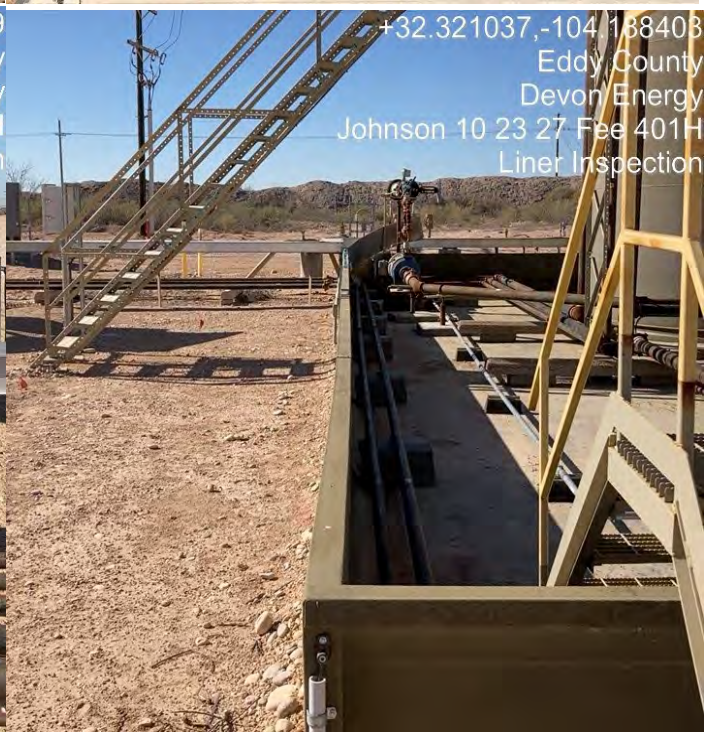
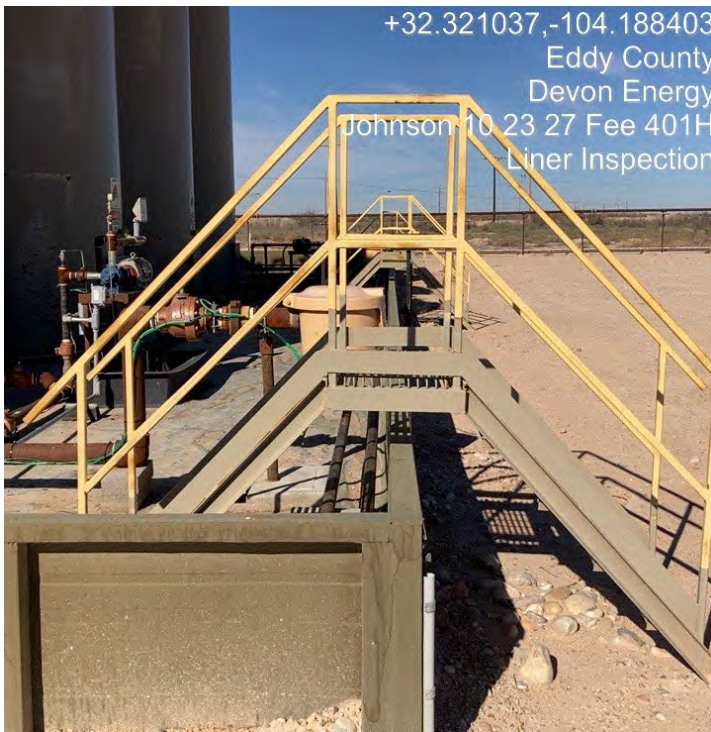
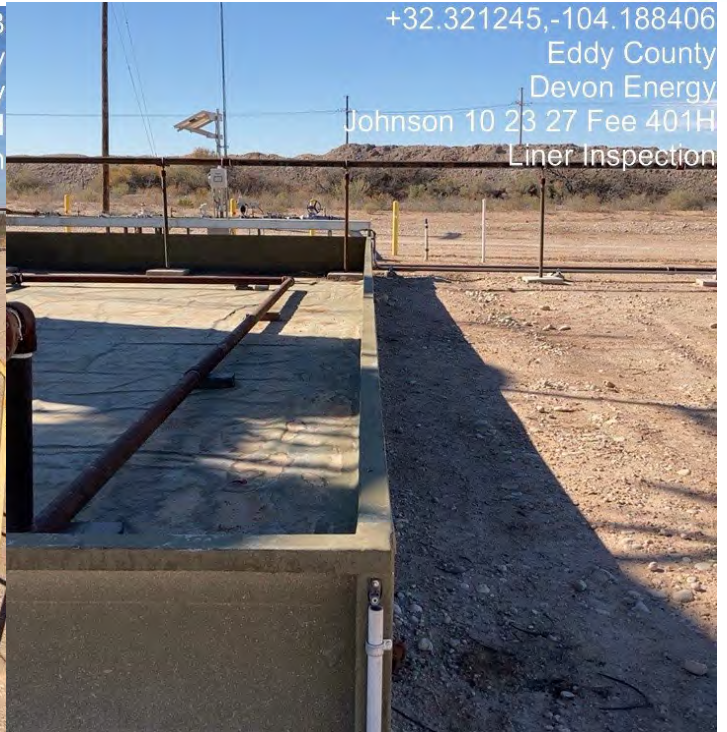
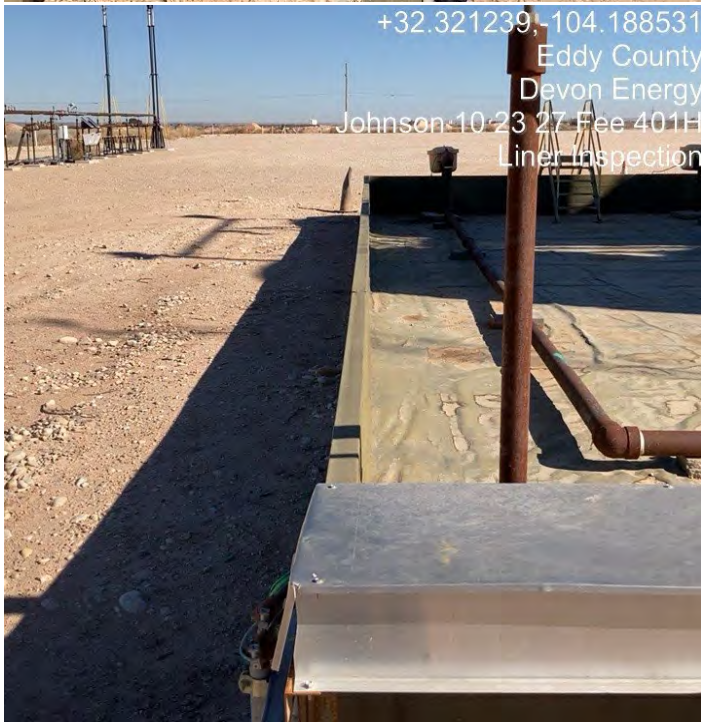
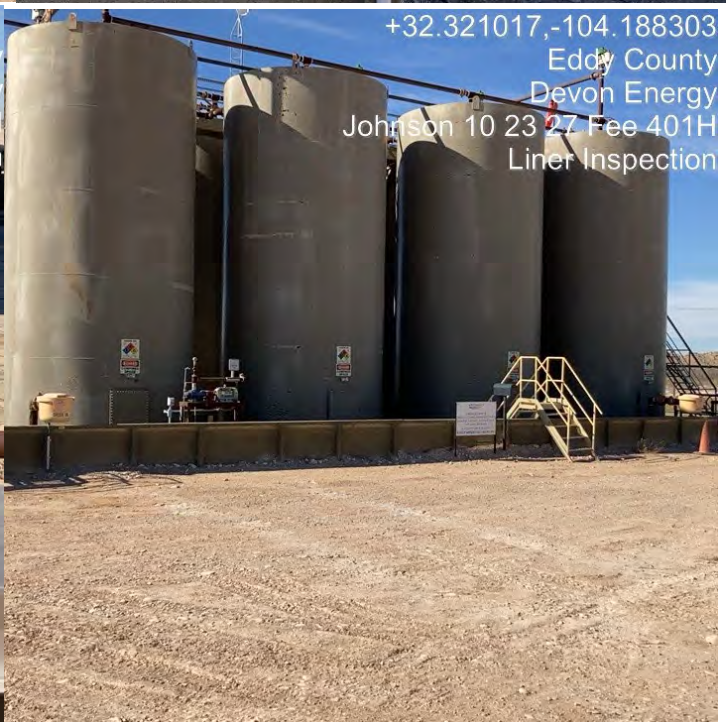
On December 30, 2022, after sending the 48-hour notification email, Pima Environmental conducted a liner inspection at this location. We concluded that this liner and containment maintained its integrity and was able to retain the fluids. The Liner Inspection Form and Photographic Documentation can be found in Appendix C.

Visualization	Yes	No	Comments
Is there a tear in the liner?		X	
Are there holes in the liner?		X	
Is the liner retaining any fluids?		X	
Does the liner have integrity to contain a leak?	X
