**RE: LINER INSPECTION REPORT
SALADO DRAW 6 FEDERAL 1H (NRM2029656359)**

Devon Energy
Salado Draw 6 Federal 1H (NRM2029656359)

Appendix A
LINER INSPECTION FORM, FIELD NOTES & PHOTO LOG

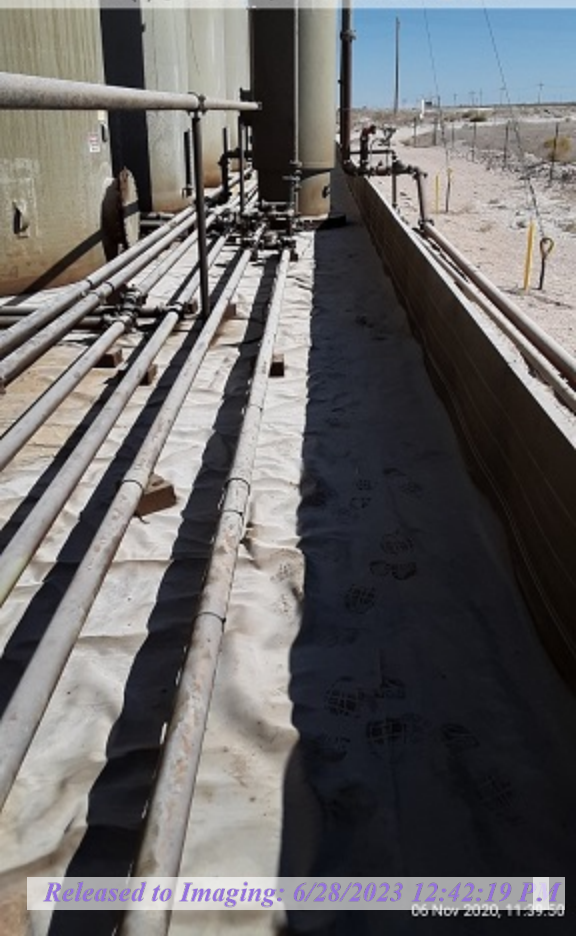
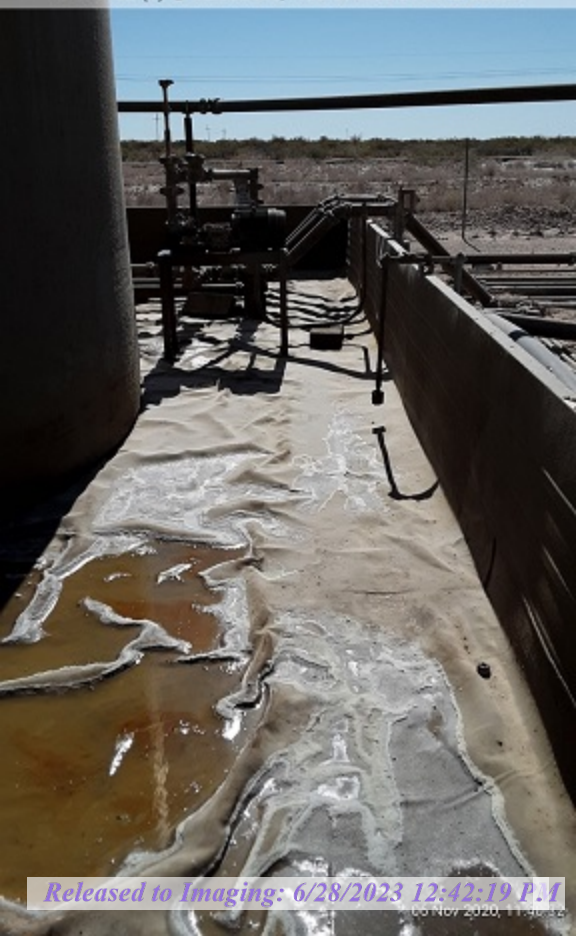
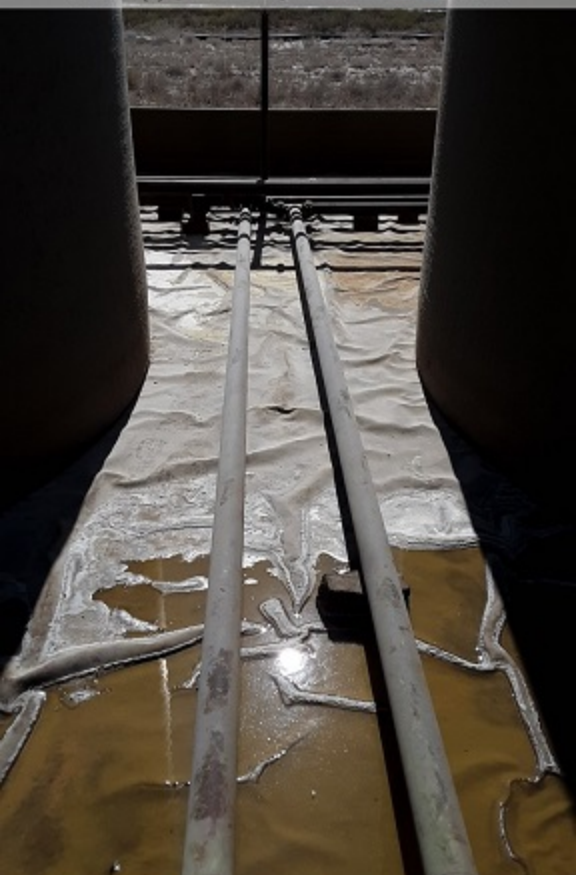
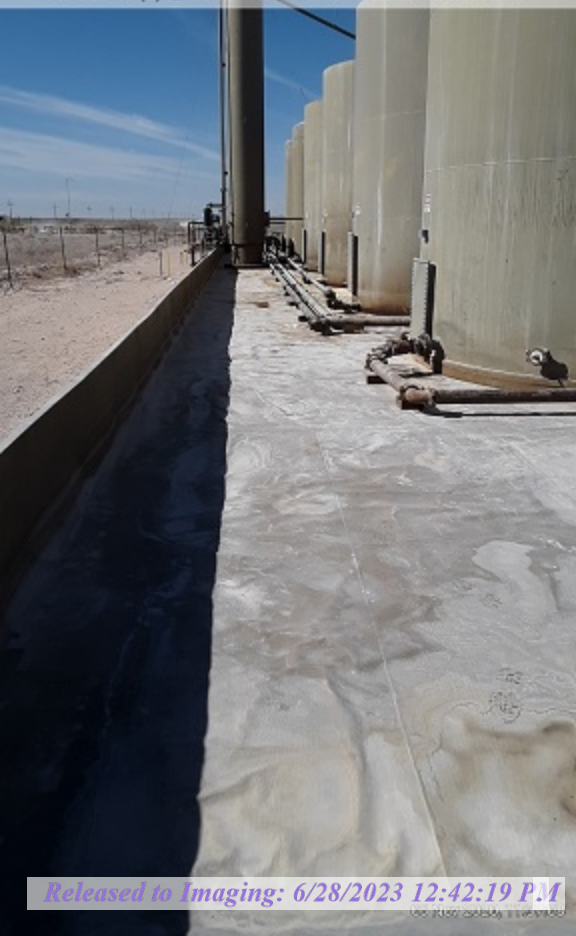
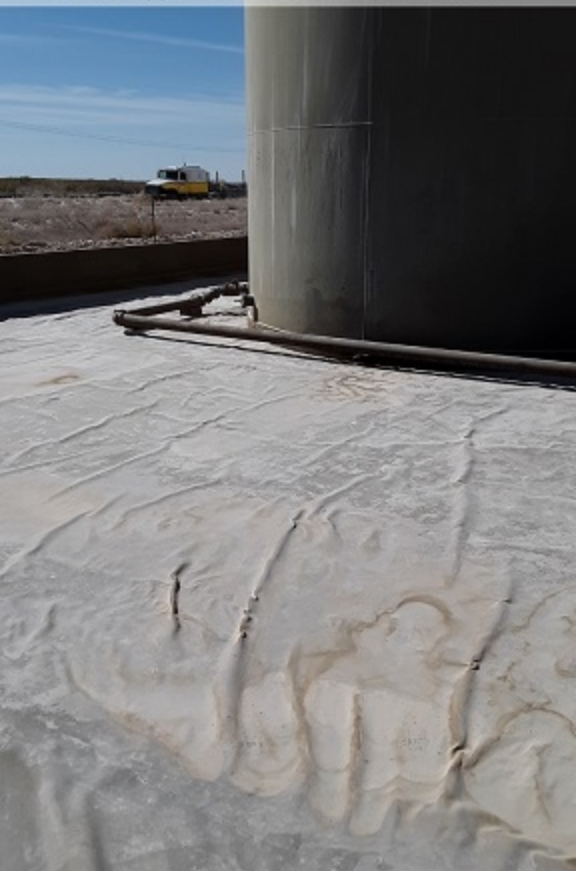
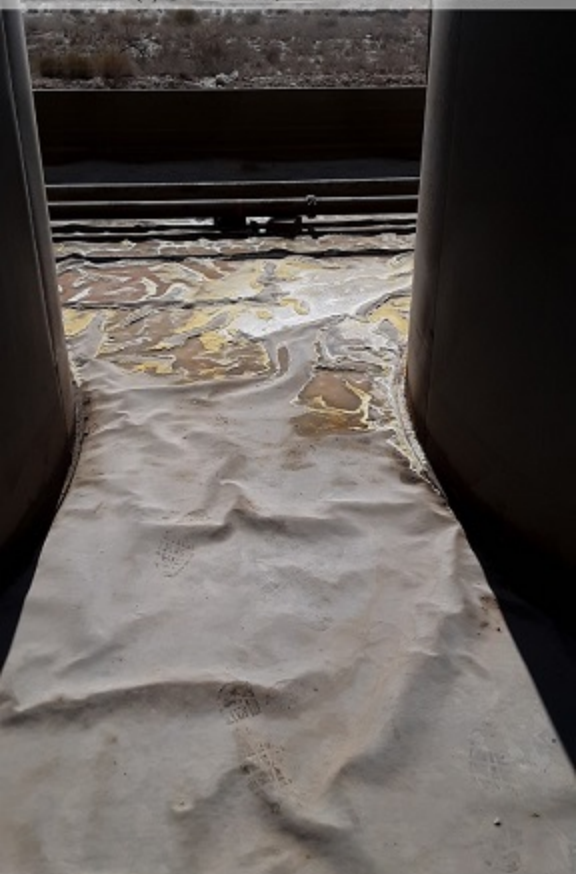
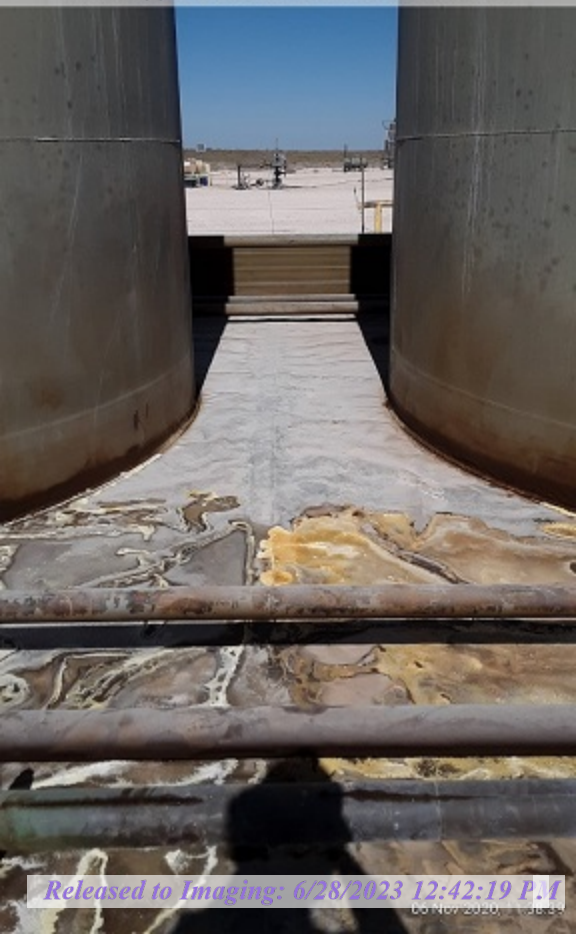
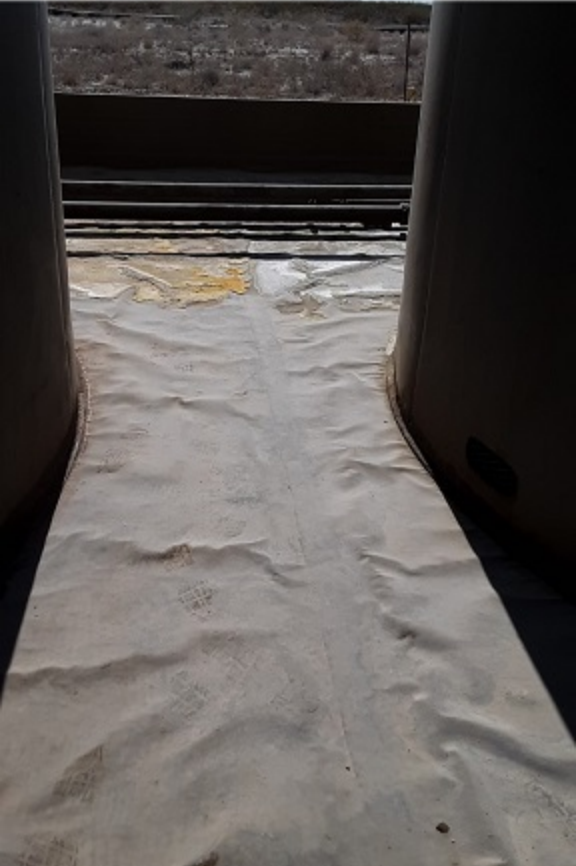
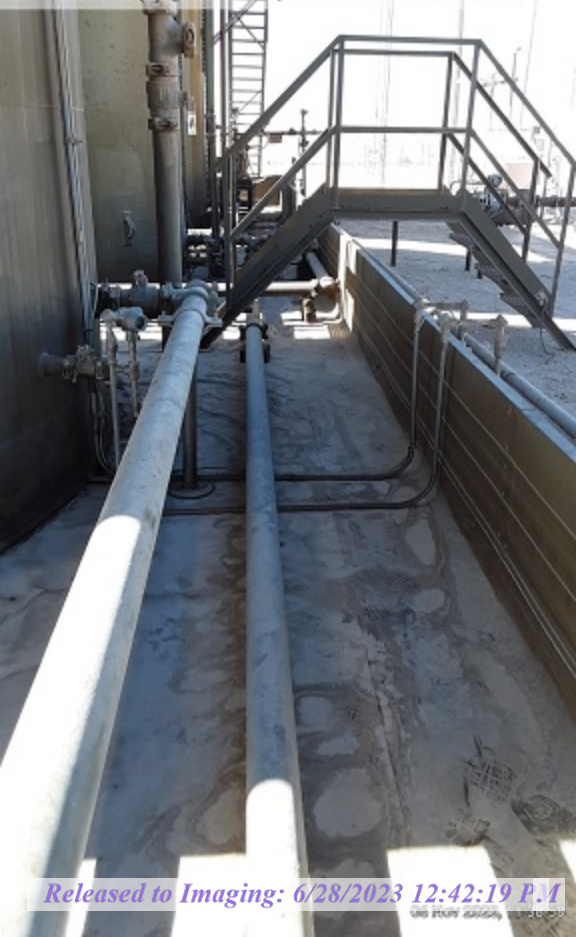
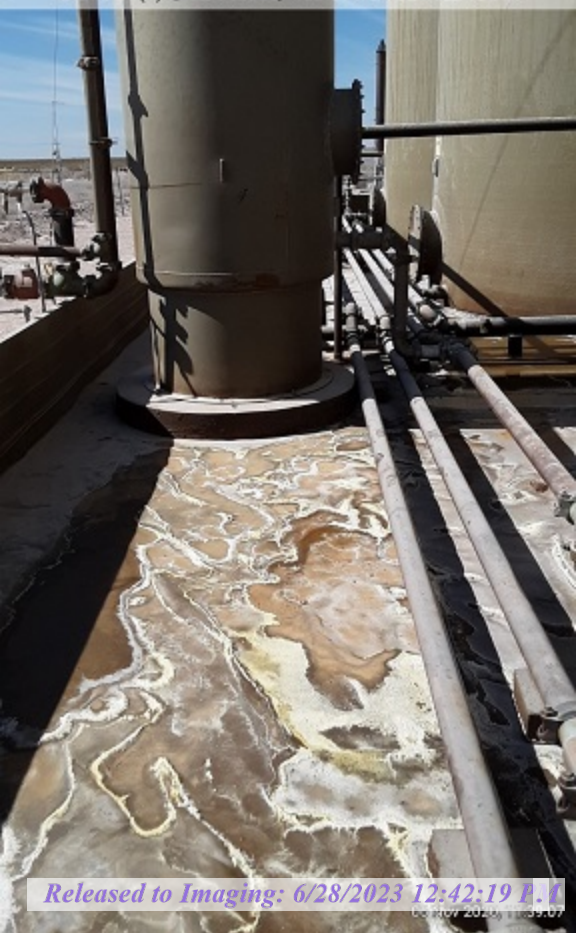
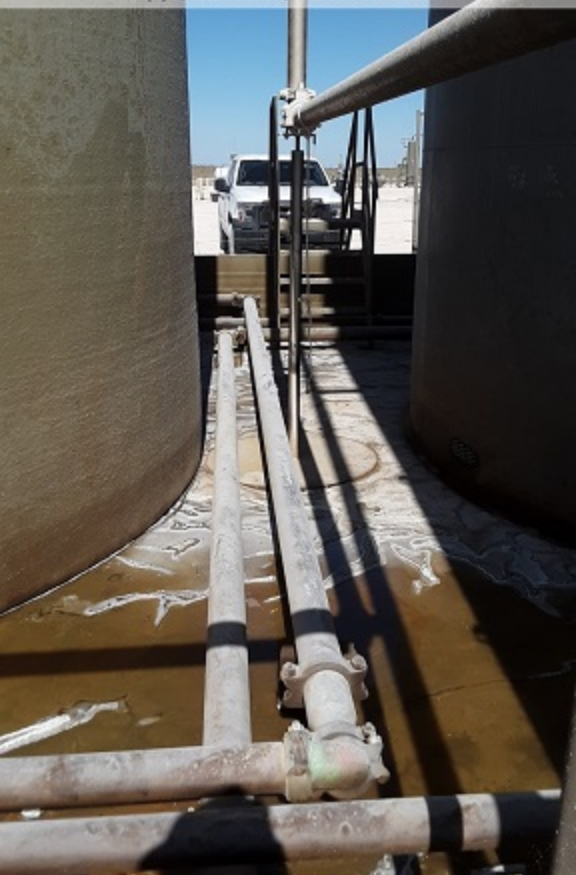
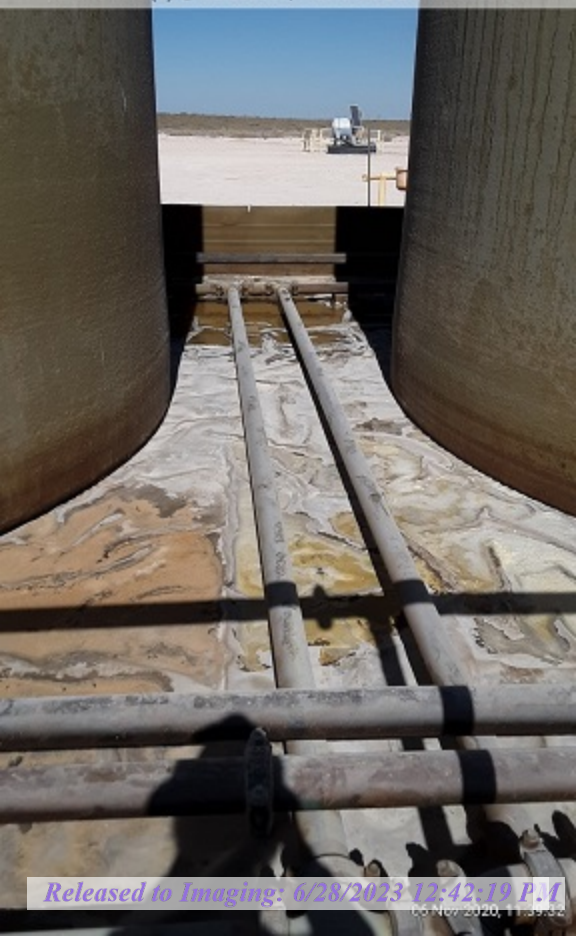
All Damaged Areas Observed Marked in White Paint on Liner
Photos and Field Notes Detailing Failures Attached to This Form

Can Responsible Party Demonstrate:
Liner Integrity Was Maintained (per SMA Inspection) (Y/N): Y
Release Was Contained to Lined Containment Area (Y/N): Y
Liner Was Able to Contain the Leak (Y/N): Y

- Arrived at scheduled time of 11am.
Waited 15 minutes before beginning inspection.
OCD did not arrive, began inspection.
- Initial observations: Facility was stable
and in operation. Notified a Denvon representative
that was ~~on-site~~ on-site that a liner
inspection was to occur.
- Walked to POR on the west side of
the liner to examine if release was
fully contained. Release did stay in
Secondary Containment.
- Searched for tears and other potential
compromises throughout containment.
 - No failures
 - Liner remained intact
 - Verified that the outside perimeter
of Containment was not compromised
- Took several photos of containment area
from different areas throughout liner.
- Mapped containment and Photograph locations.

SMA recommends no further action for this release and requests the closure of NRM2029656359.
