Report Type: Closure Report 1RP-5324

Site:	Hound Condor Tie-in					
Company:	EOG Resources					
Section, Township and Range	Unit L	Sec 30	T 25S	R 34E		
County:	Lea County					
GPS:	32.09950			-103.51690		
Surface Owner:	Federal					
Directions:	From the intersection of Pipeline Rd & Battle Axe Rd in rural Lea County, travel northeast on Battle Axe Rd for 2.75 mi, turn northwest onto lease road for 0.60 mi, turn east onto lease road for 0.93 mi and arrive at location.

Re: Closure Report for the EOG Resources, Hound/Condor Tie-in, Unit L, Section 30, Township 25 South, Range 34 East, Lea County, New Mexico. 1RP-5324

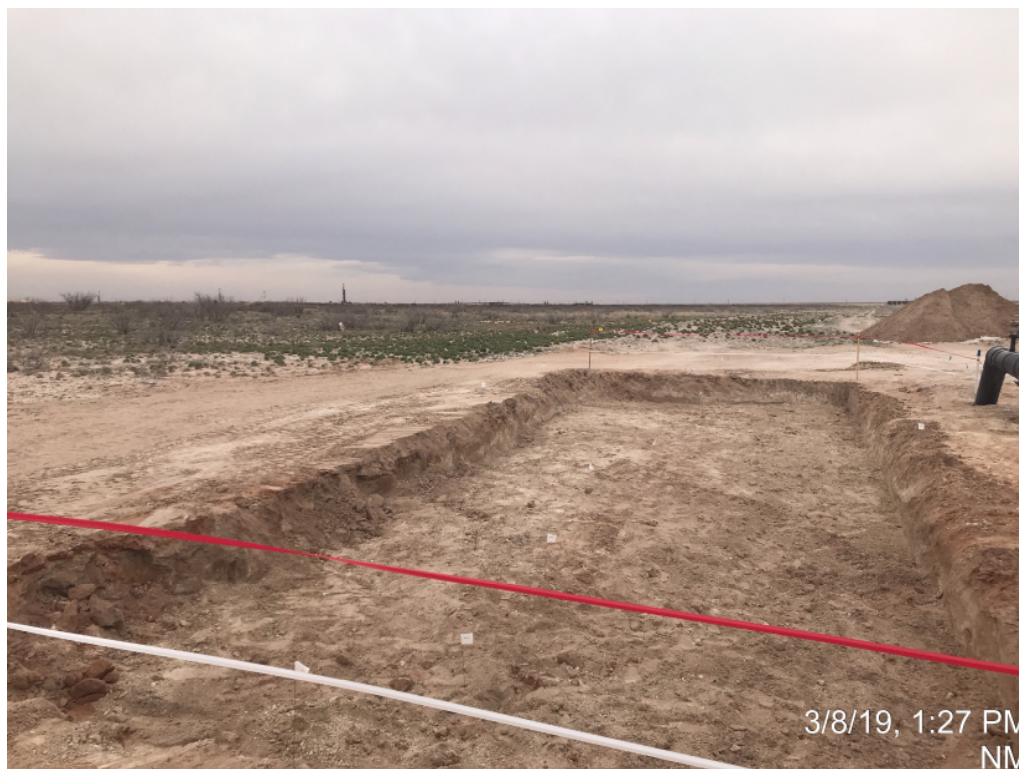
View North – Area of Bottom Hole 1 to Bottom Hole 6

Tetra Tech personnel were onsite from March 8 through March 18, 2019 to supervise the remediation activities. Three (3) areas were excavated to total depths between 1.5' to 2.0' below surface. Sixteen (16) bottom hole composite samples (Bottom Hole 1 to Bottom Hole 16) and eleven (11) sidewall composite samples (North Sidewalls 1, 2, and 3, South Sidewalls 1 and 2, East Sidewalls 1, 2, and 3, and West Sidewalls 1, 2, and 3) were collected every 200 square feet to ensure proper removal of the impacted soils. The samples were submitted to the laboratory to be analyzed for TPH method 8015 extended, BTEX method 8021B, and Chloride by EPA Method 300.0. The sampling results are summarized in Table 1. The excavation depths and sample locations are shown in Figure 4.

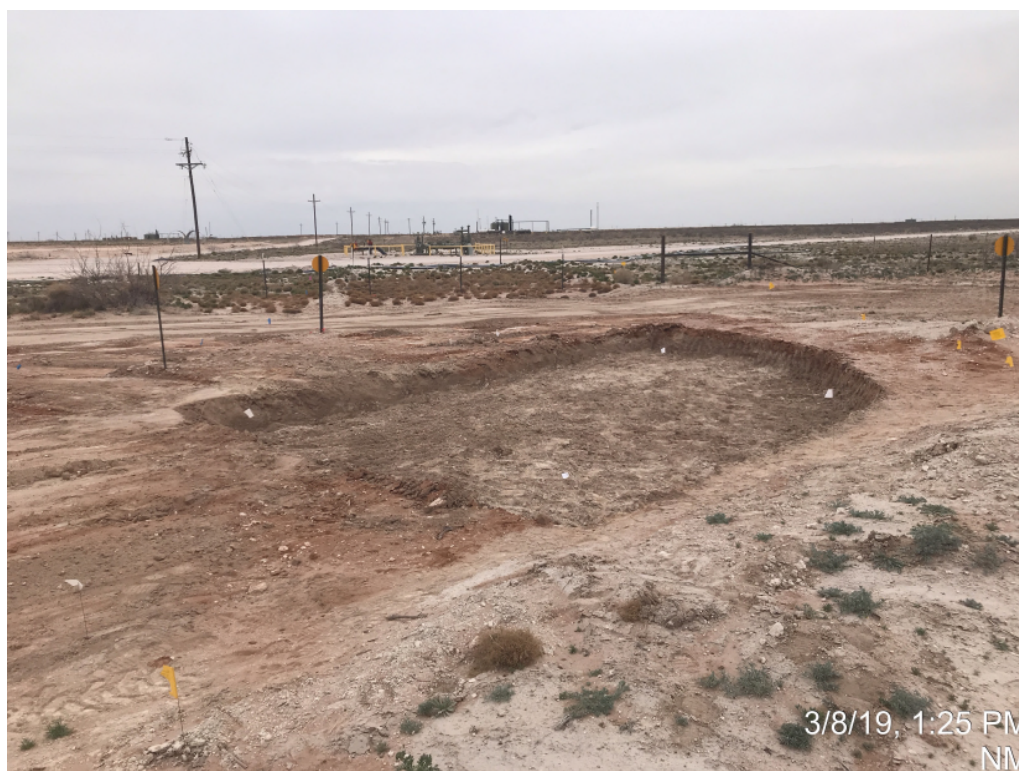
View Southeast – Area of Bottom Hole 7 & 8

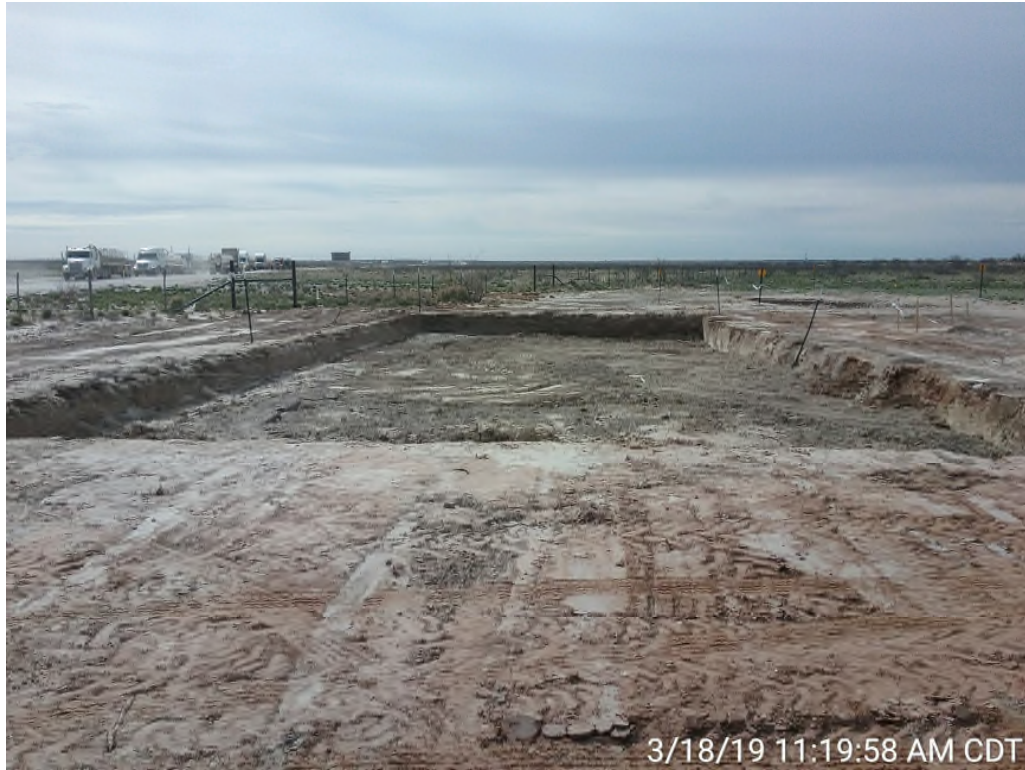
View South – Area of Bottom Hole 9 to Bottom Hole 16
