## Closure Report

Antelope Ridge 24 SWD #001  
Lea County, New Mexico  
API ID # 30-025-26547  
**Incident #** NOY1816657191

Subject: **Closure Report**  
Antelope Ridge 24 SWD #001  
Lea County, New Mexico  
API ID # 30-025-26547  
Incident # NOY1816657191

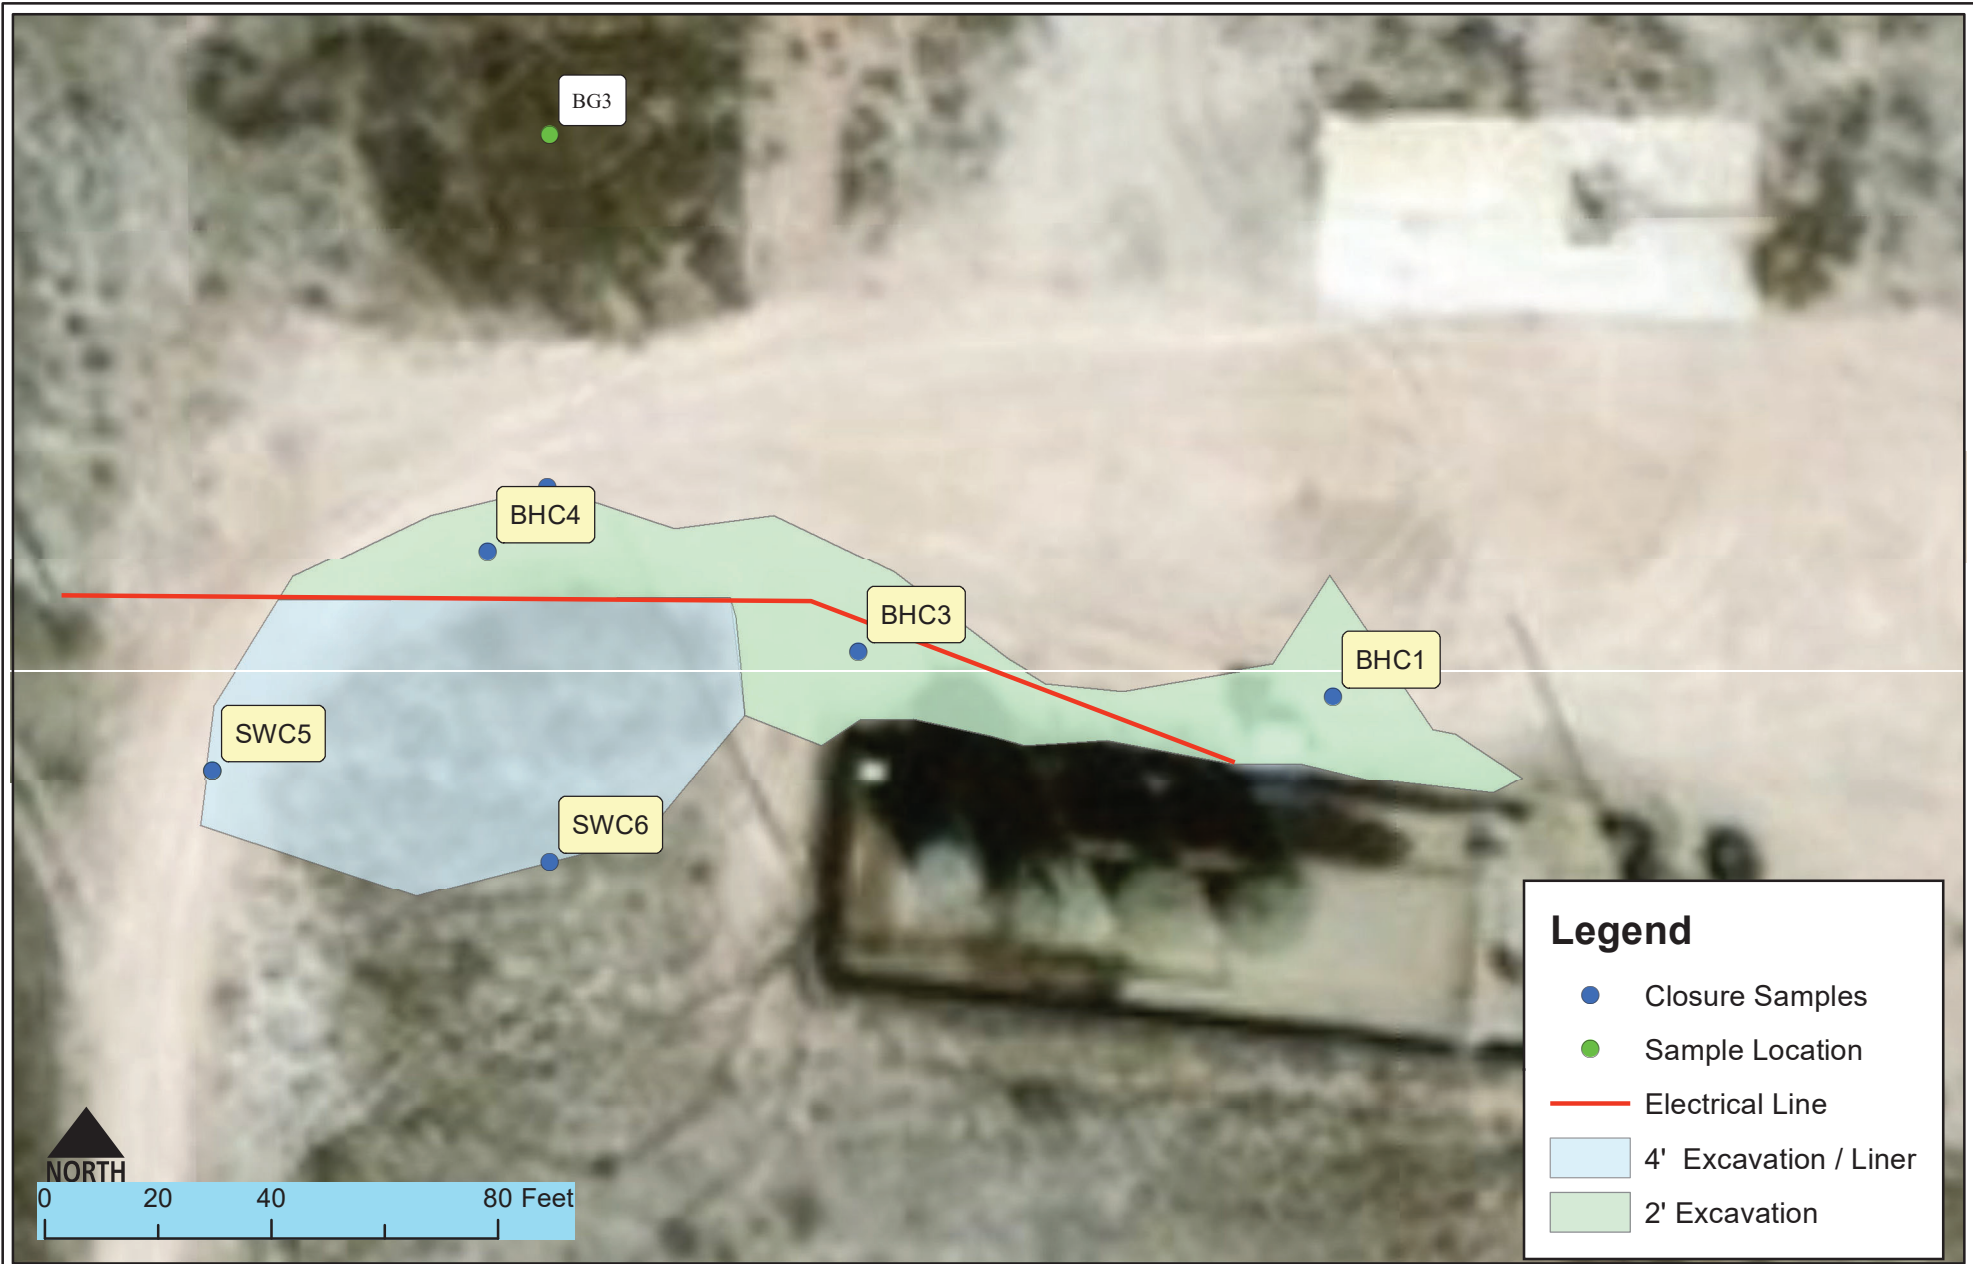
Figure 1

Site and Sample Location Map  
ANTELOPE RIDGE 24 SWD #001 - Matador Resources  
S: 24 T23S R34E, Lea County New Mexico

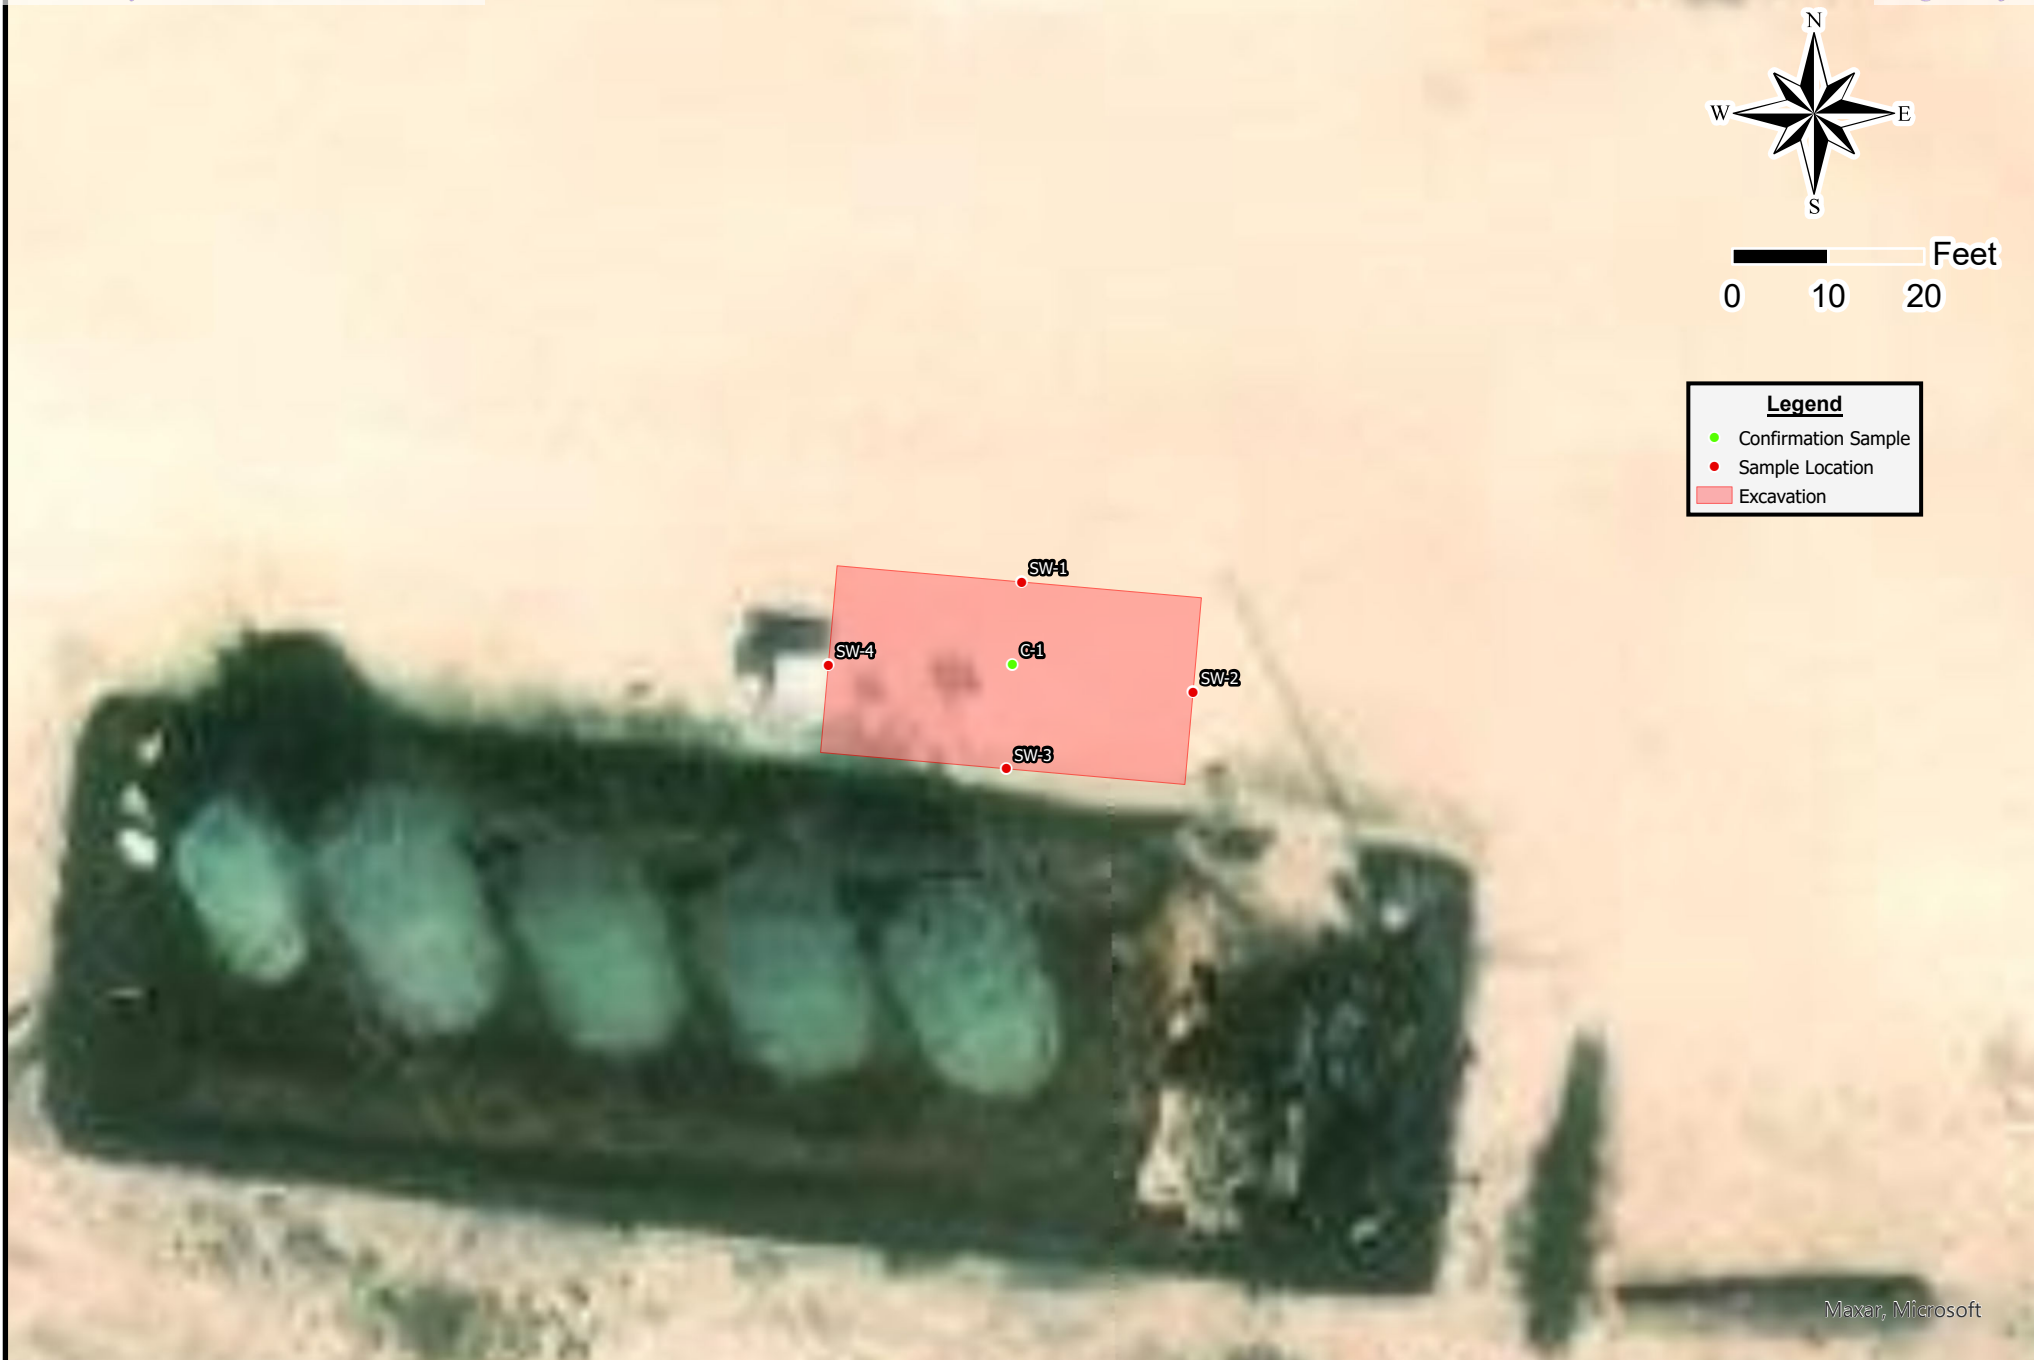
Matador Resources  
Antelope Ridge 24 SWS #001  
Lea County, New Mexico  
Figure 2

The soil sample results from the laboratory analytical are summarized below. Sample locations are illustrated on Figure 2 in [Appendix I](#) and complete laboratory analytical reports are presented in [Appendix V](#).

- The impacted areas on location were excavated to depths of 4 feet bgs. Talon field titrated soil samples for total chlorides to guide the vertical and horizontal extents of the excavation process.
- Pursuant to NMOCD guidance, confirmation soil samples were collected at 200 square foot intervals and analyzed for TPH, BTEX and Total Chlorides to insure all areas had reached NMOCD closure criteria.
- The excavated areas on the well pad were backfilled with new caliche, machine compacted, and contoured to match the surrounding location.
- Photographic documentation is provided in [Appendix IV](#).
- Copies of the Final C-141s are presented in [Appendix III](#).

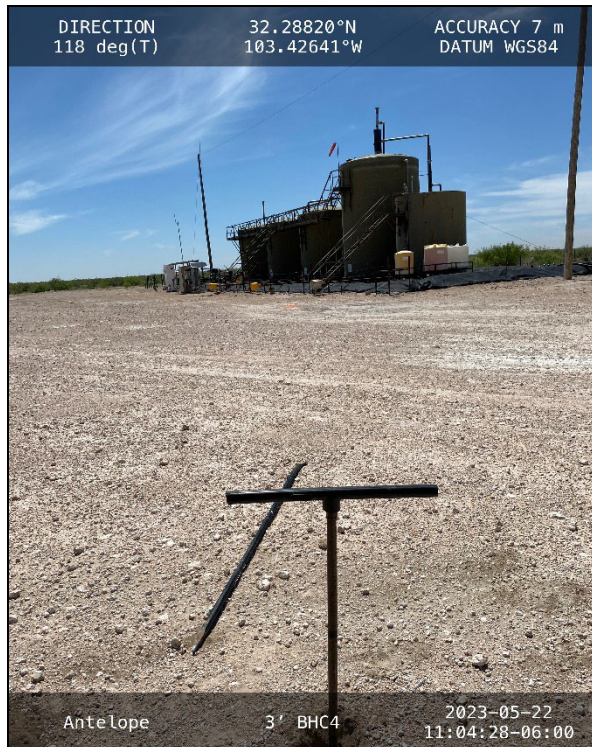
**Photograph No.1 Description:**

BHC4 Sample Point @ 3'

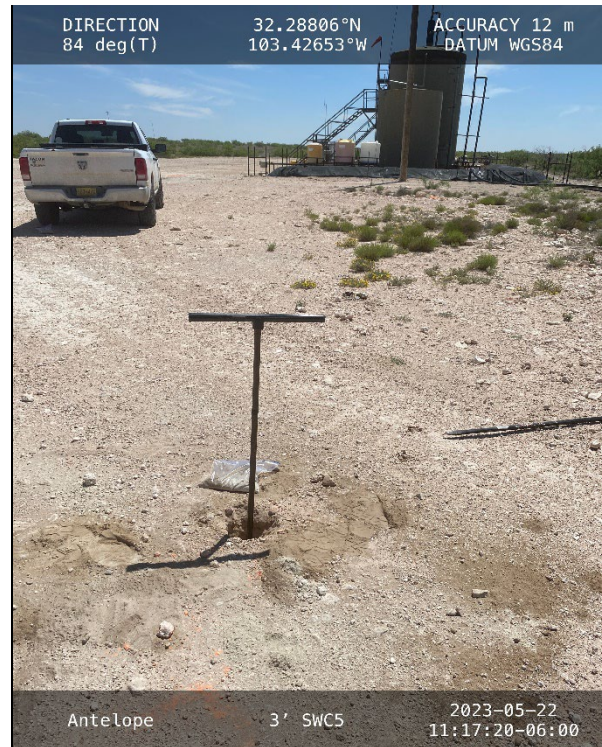
**Photograph No.2 Description:**

SWC5 Sample Point @ 3'

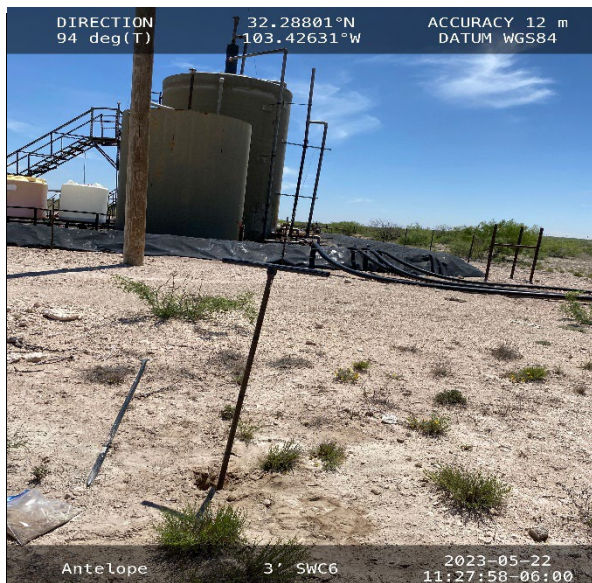
**Photograph No.3 Description:**

SWC6 Sample Point @ 3'

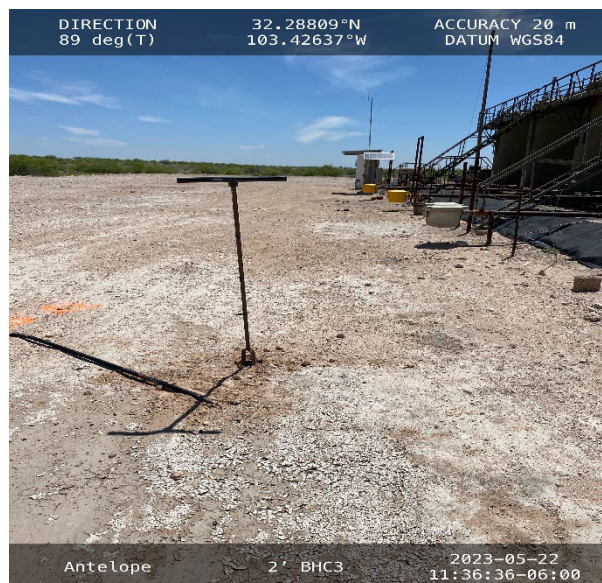
**Photograph No.4 Description:**

BHC3 Sample Point @ 2'

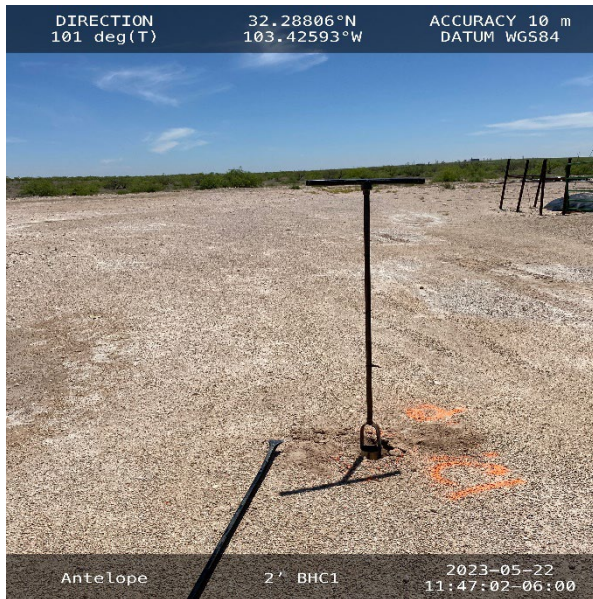
**Photograph No.5 Description:**

BHC1 Sample Point @ 2'

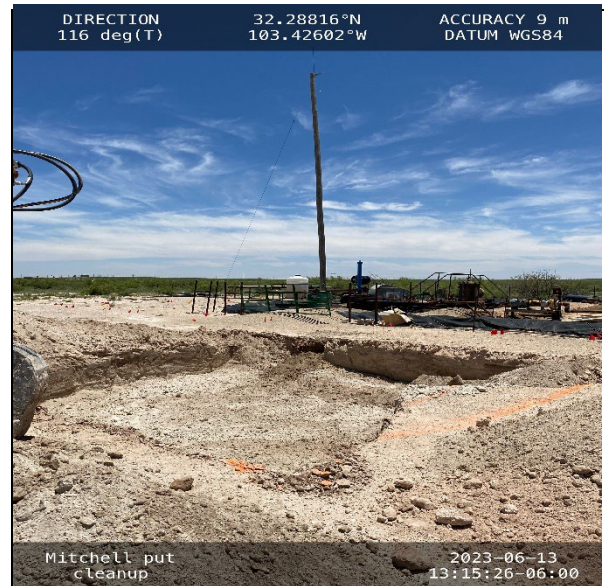
**Photograph No.6 Description:**

BHC1 Excavation to remove contaminated soils.

On June 14, 2023, Talon Returned to location and removed impacted soils located at C1 (BHC-1). The samples were transported with the chain of custody to Cardinal Laboratories, for analysis of Total Chlorides (SM4500CI-B), Total Petroleum Hydrocarbons (TPH, EPA Method 8015M) and Volatile Organics (BTEX, EPA Method 8021B).
