### Release Notification and Corrective Action

LT Environmental, Inc. (LTE), on behalf of XTO Energy, Inc. (XTO), presents the following Closure Request report detailing site assessment, soil sampling, and excavation activities at the Poker Lake Unit 184 Battery (Delaware C) (Site) in Unit G, Section 6, Township 24 South, Range 30 East, in Eddy County, New Mexico (Figure 1). The purpose of the site assessment, soil sampling, and excavation activities was to address impacts to soil following three separate events that caused the release of produced water and crude oil at the Site. Based on the excavation activities and results of the soil sampling events, XTO is submitting this Closure Request, describing remediation that has occurred and requesting no further action for the release events.

**FIGURE 6**  
**DELINEATION SOIL SAMPLE LOCATIONS**  
**POKER LAKE UNIT 184 BATTERY (DELAWARE C)**  
**UNIT G SEC 6 T24S R30E**  
**EDDY COUNTY, NEW MEXICO**  
**XTO ENERGY, INC.**

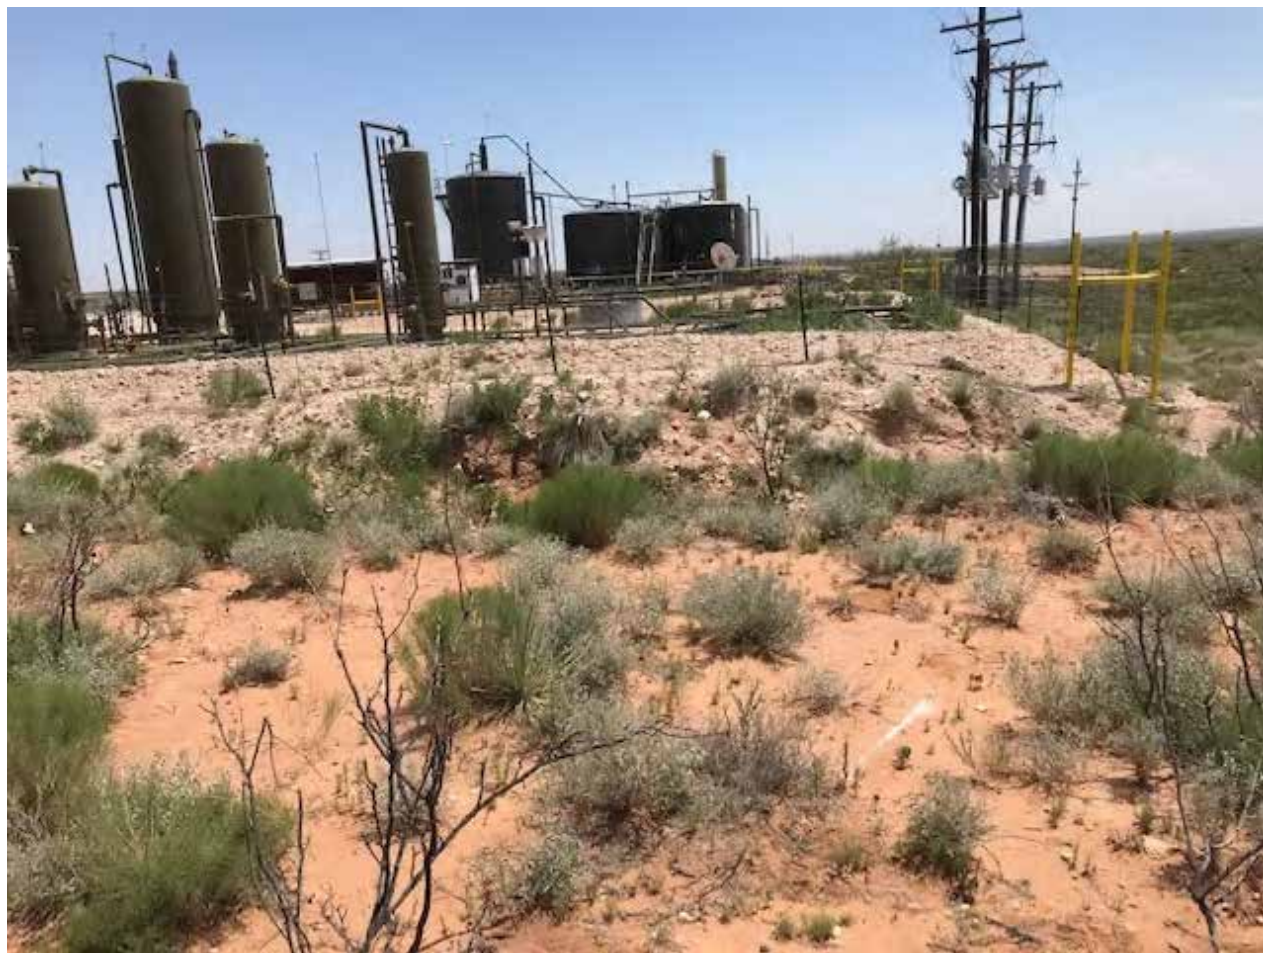
South facing view of release/assessment area (2RP-4396, 2RP-4397).
