**Re: Closure Request
Livingston Ridge #2 SWD Water Line
2RP-2044
EOG Resources, Inc.
Site Location: Sec. 1, T 22-S, R 31-E
(Lat 32.41751°, Long -103.73427°)
Eddy County, New Mexico**

GHD Services Inc. (GHD), on behalf of EOG Resources (EOG) is requesting that no further action (NFA) status be granted for the Livingston Ridge SWD water line release (hereafter referred to as the "Site"). The Site is located within Section 1, Township 22 South, Range 31 East, in Eddy County, New Mexico (**Figure 1**).

**Re: Assessment Summary Report
Livingston Ridge SWD Water Line
2RP-2044
EOG Resources, Inc.
Site Location: Sec. 1, T 22-S, R 31-E
(Lat 32.41751°, Long -103.73427°)
Eddy County, New Mexico**

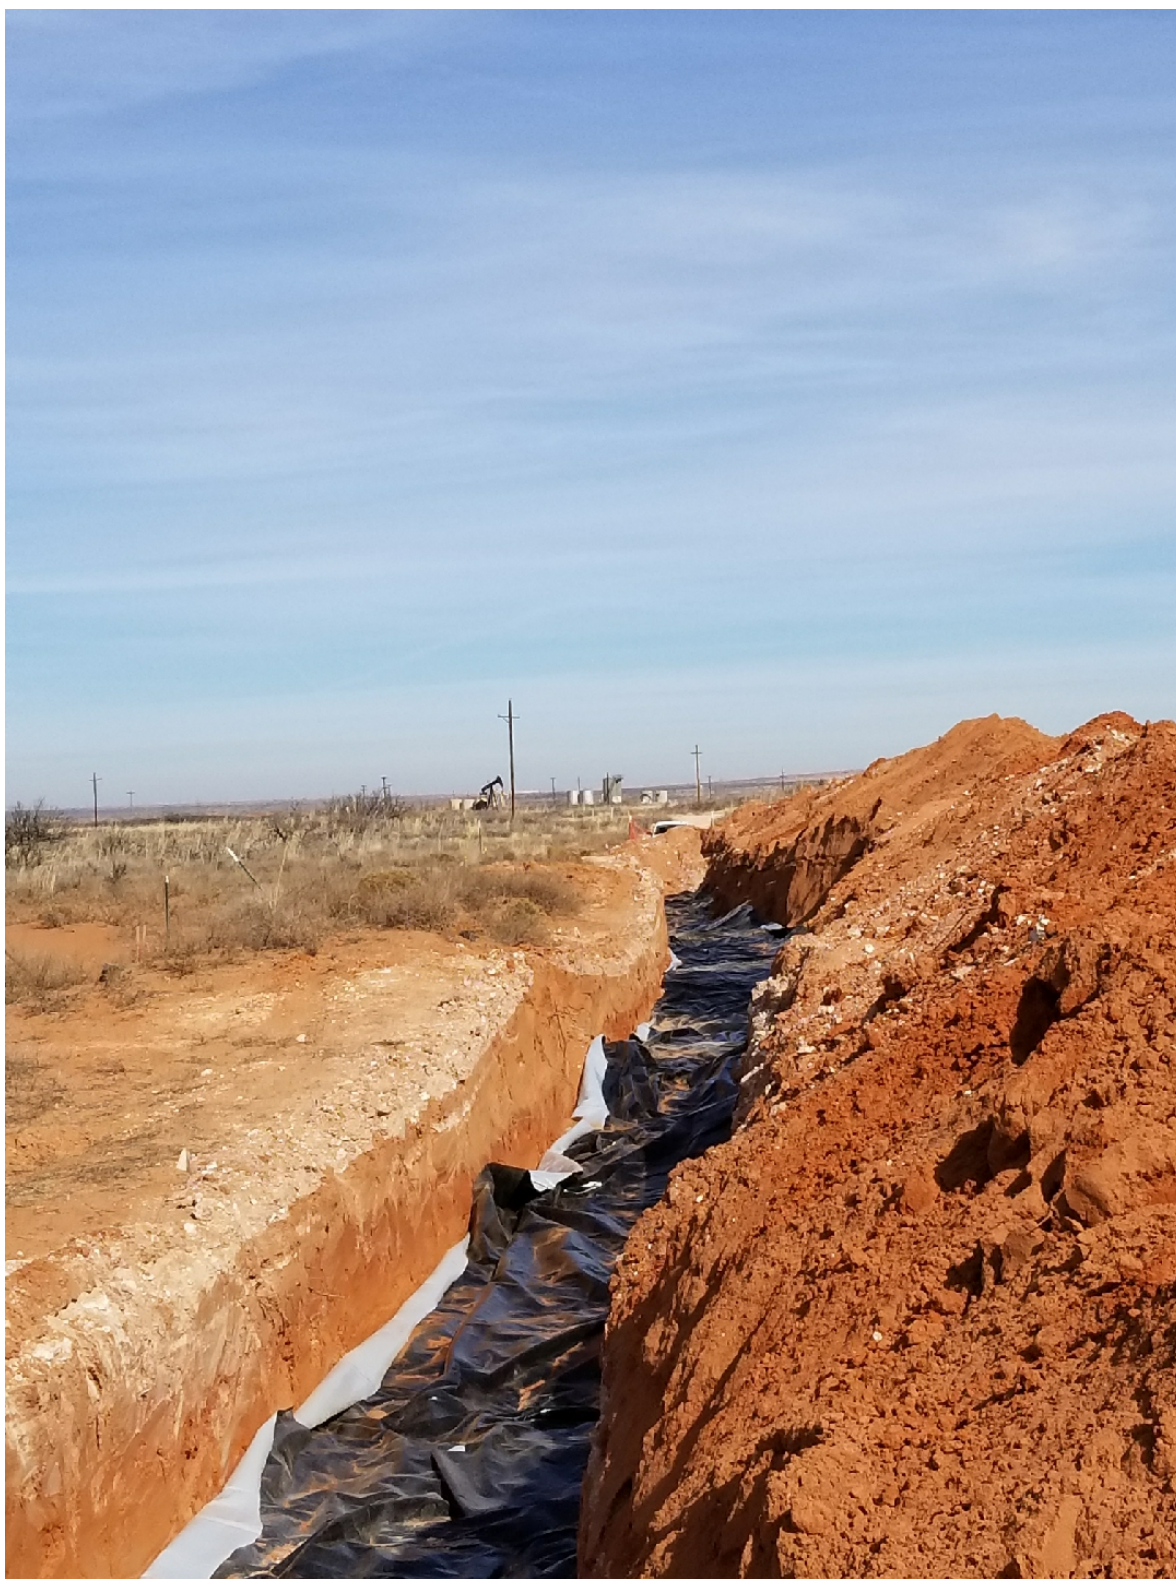
Photo 1 - Liner Placement

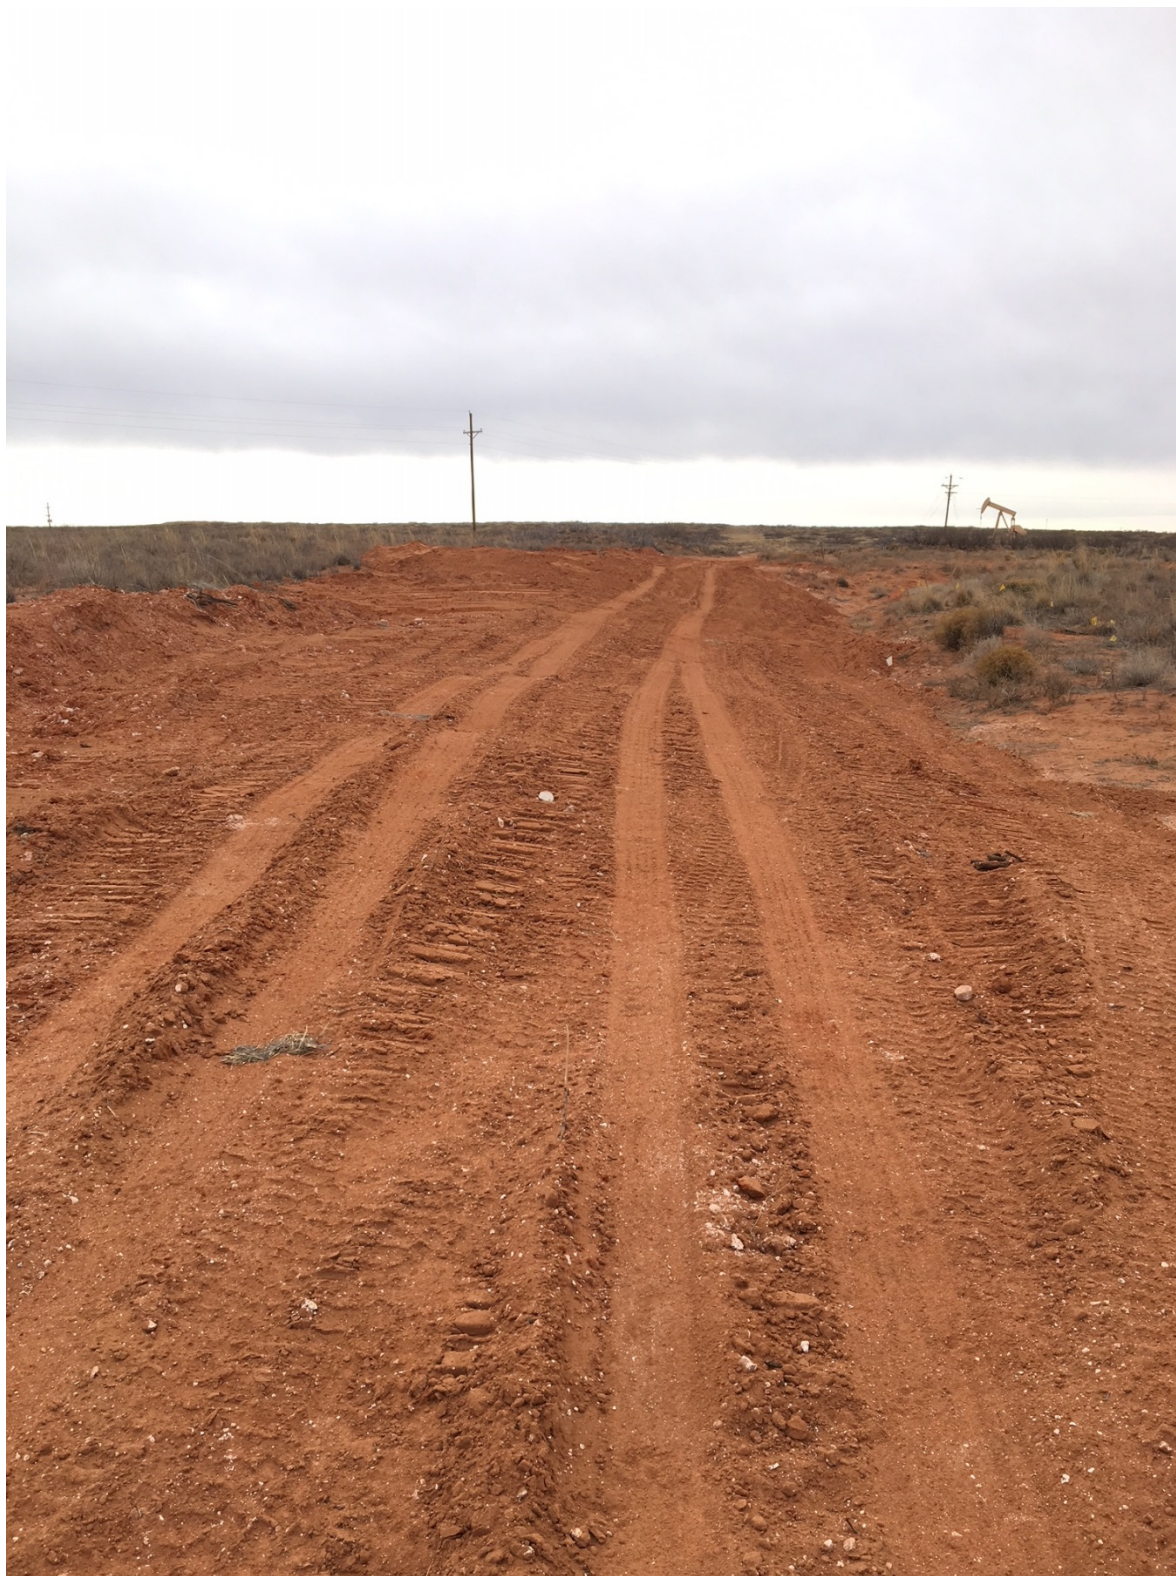
Photo 2 - Backfilled area
