CHALUPA #4 SWD – SOUTH RELEASE AREA

Remediation Summary and Closure Request

NMOCD Incident No. nOY1706630747
UL "M", Sec. 13, T14S, R33E
33.0982437°, -103.5753937°
Lea County, New Mexico

June 2, 2023

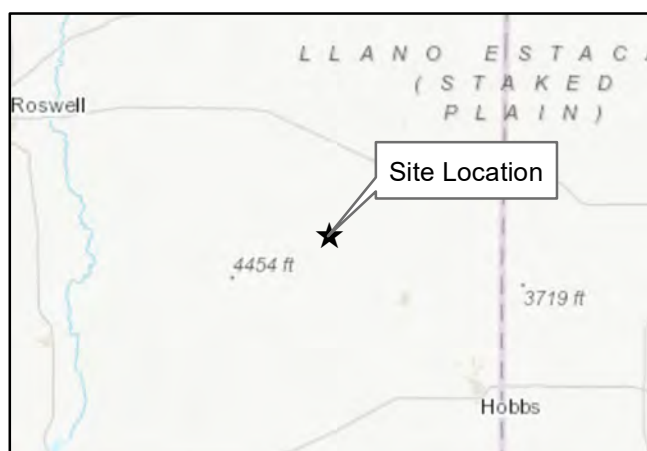
Figure 1

The Site is located in Lea County, New Mexico in Unit Letter "M", Township 14 South, Range 33 East and the approximate coordinates are 33.0982437, -103.5753937 (Figure 1). The Site is located approximately 0.3 miles south of State Highway 108 (Anderson Road) in a rural area on New Mexico State Trust Lands administered by the New Mexico State Land Office (NMSLO) and leased to Norman and Elwanda Hahn Ranches, LTD for agriculture use. The nearest town of Lovington, New Mexico is located approximately 16 miles southeast of the Site.
