# CHALUPA #4 SWD – NORTH RELEASE AREA

## Remediation Summary & Closure Report

NMOCD Incident No. nOY1706631442  
UL "L", Sec. 13, T14S, R33E  
33.103422°, -103.576112°  
Lea County, New Mexico

June 5, 2023

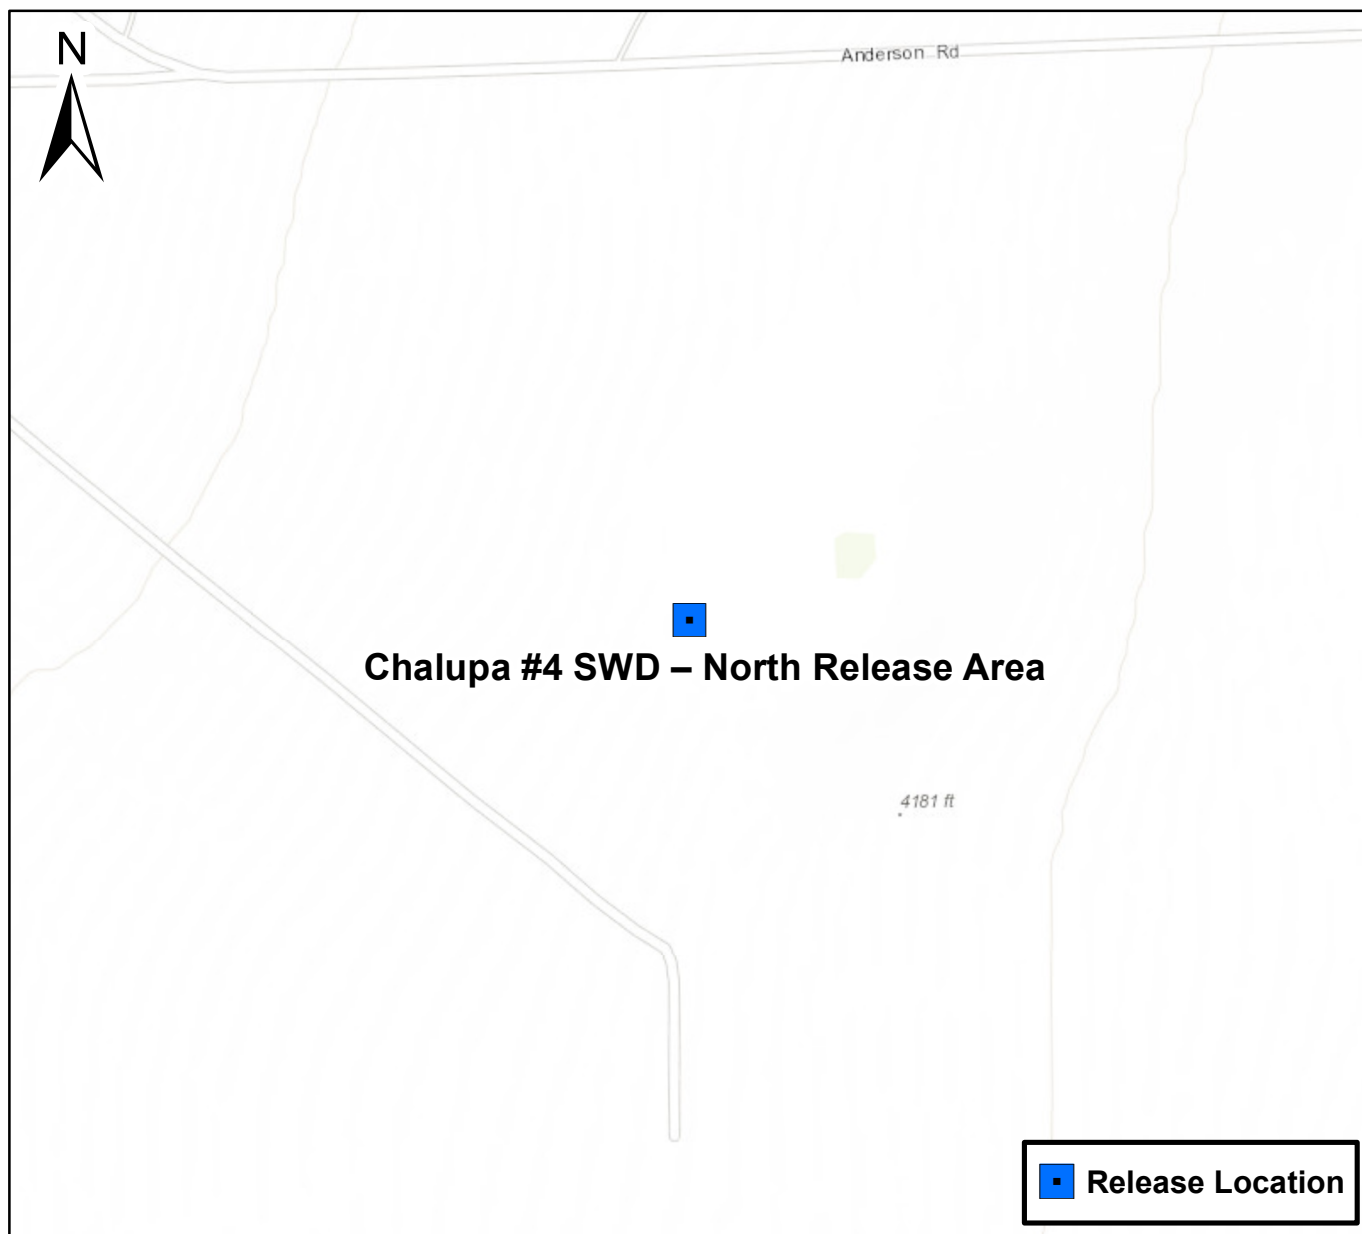
## Figure 1

The site is located in Unit Letter “L” of Section 13, Township 14 South, Range 33 East in Lea County, New Mexico. The Site is located approximately 0.3 miles south of State Highway 108 (Anderson Road) in a rural area on New Mexico State Trust Lands administered by the New Mexico State Land Office (NMSLO) and leased to Norman and Elwanda Hahn Ranches, LTD for agriculture use. The nearest town of Lovington, New Mexico is located approximately 16 miles southeast of the Site. A Site Location Map is included as Figure 1.
