Report Type: Closure Report 2RP-3993

Site:	Ross Gulch 8-3 SWD					
Company:	EOG Resources, Inc.					
Section, Township and Range	Unit K	Sec. 8	T 26S	R 31E		
Lease Number:	API No. 30-015-39736					
County:	Eddy County					
GPS:	32.05680° N			103.80110° W		
Surface Owner:	Private					
Mineral Owner:						
Directions:	From the intersection of HWY 285 and Longhorn Rd in rural Eddy County, travel EAST on Longhorn Rd for approximately 4.30 mi, turn EAST onto Pipeline Rd for approximately 11.5 miles, turn SOUTH onto lease road for approximately 0.5 mi, turn EAST onto lease road for approximatey 0.10 mi to location.

**Re: Closure Report for the EOG Resources, Inc., Ross Gulch 8-3 SWD, Unit K, Section 8, Township 26 South, Range 31 East, Eddy County, New Mexico. 2RP-3993**

Excavation Areas &amp; Depths Map

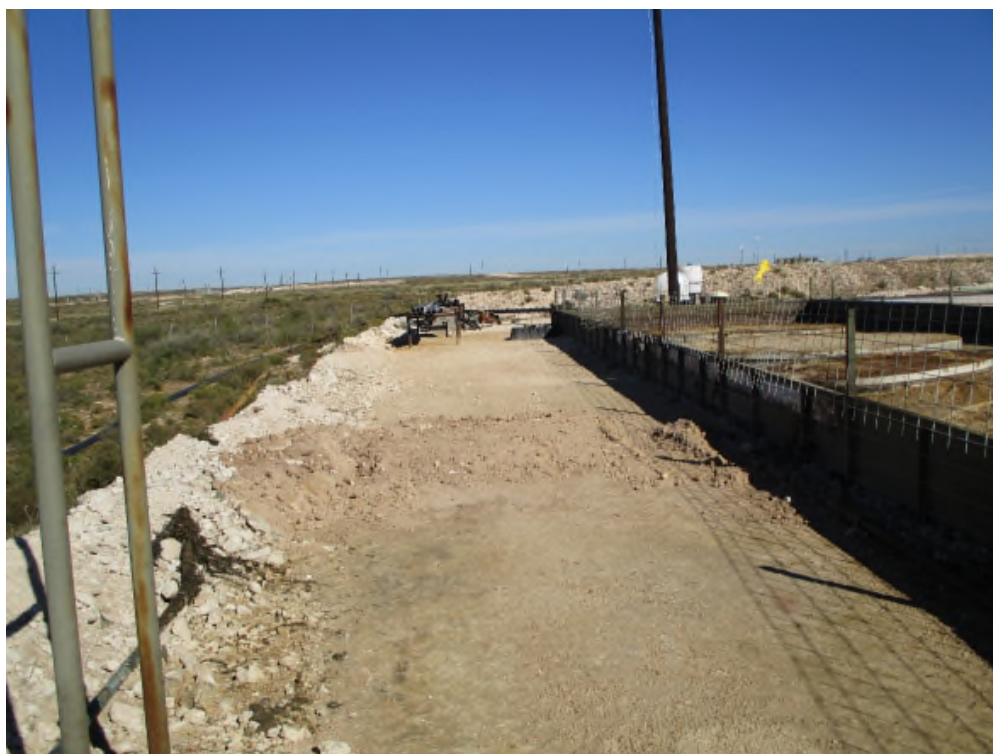
View North – Area of T-1

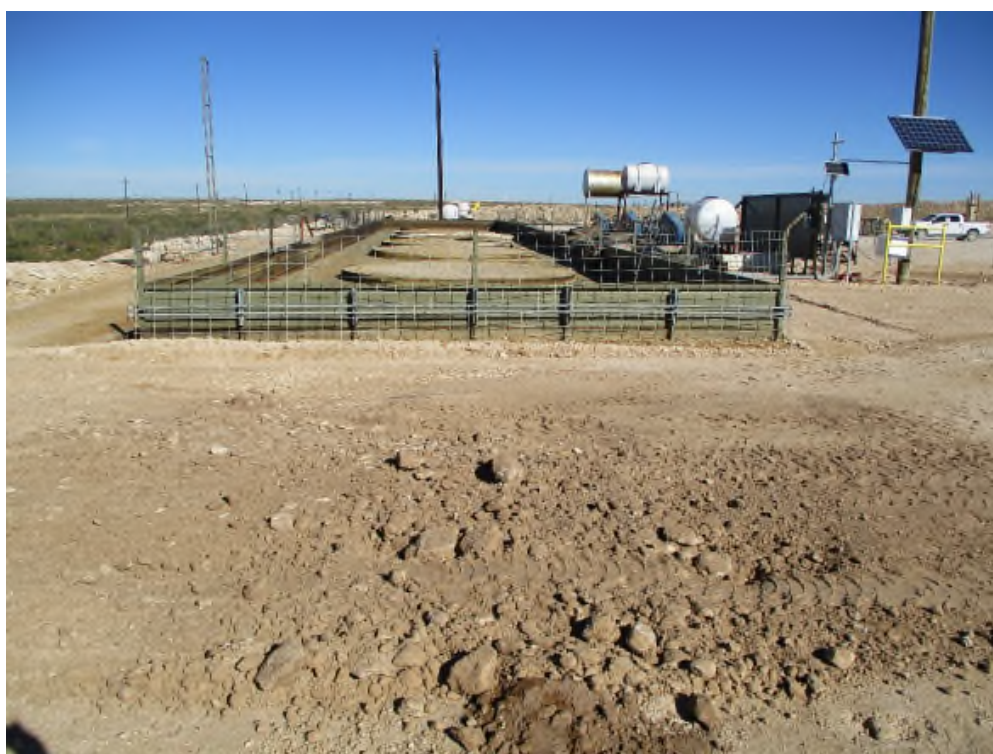
View North – Area of T-2

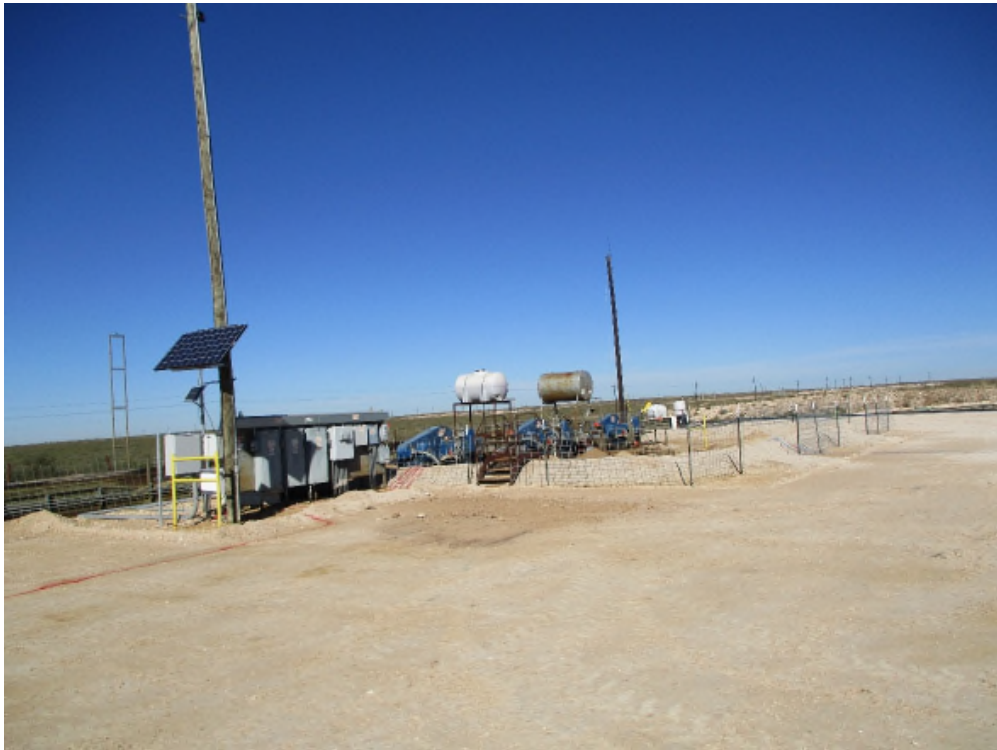
View North – Area of T-3

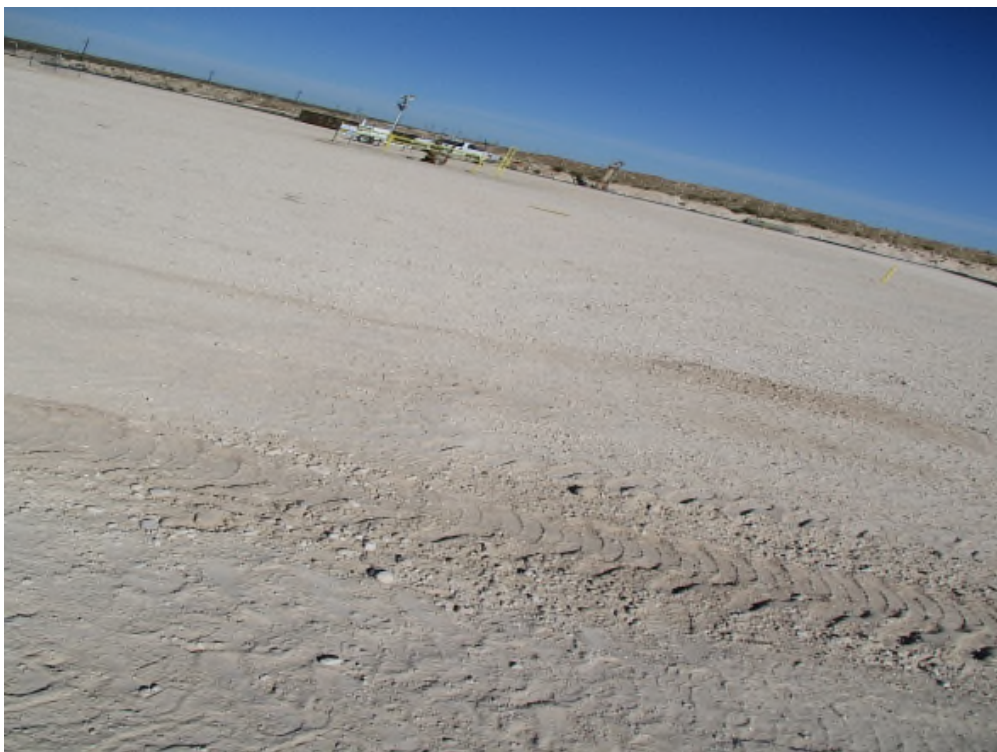
View North – Area of T-4 Background

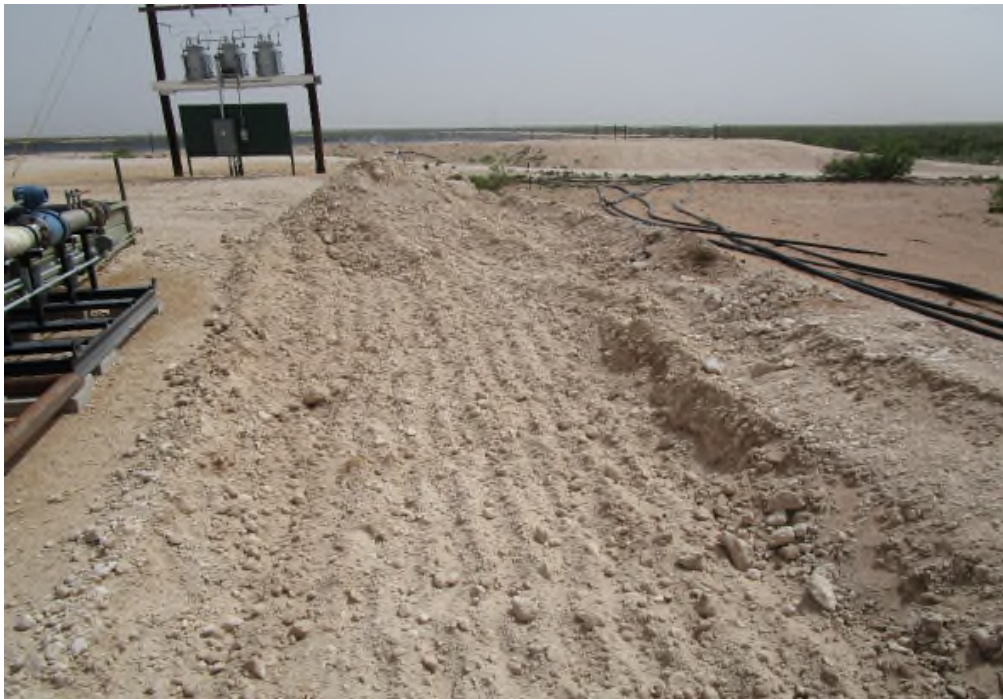
View South – Area of T-1 excavated

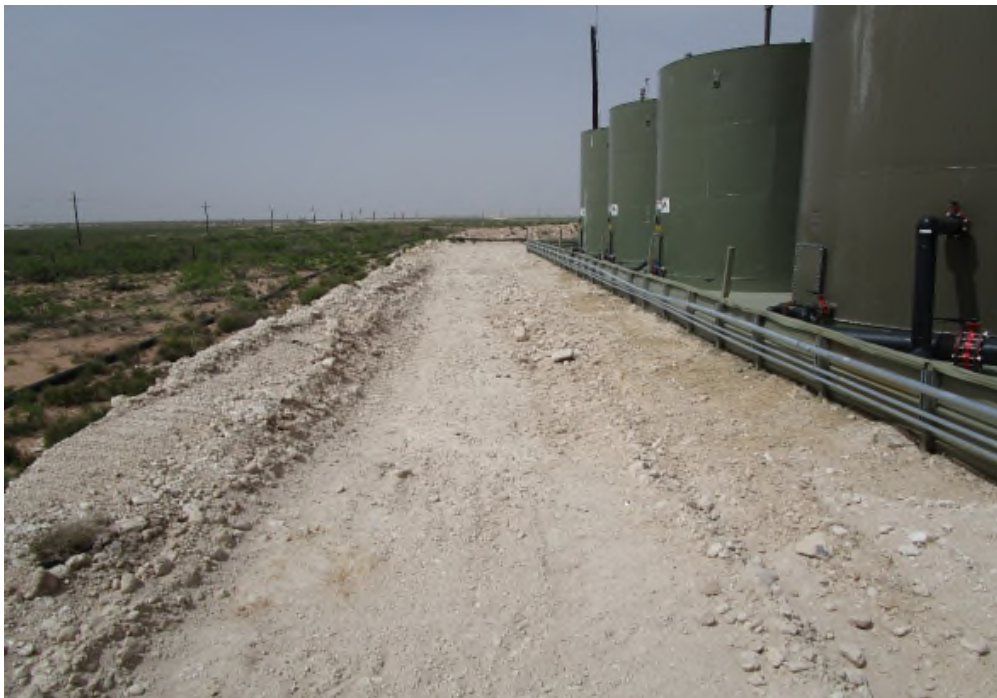
View North – Area of T-1 Backfilled

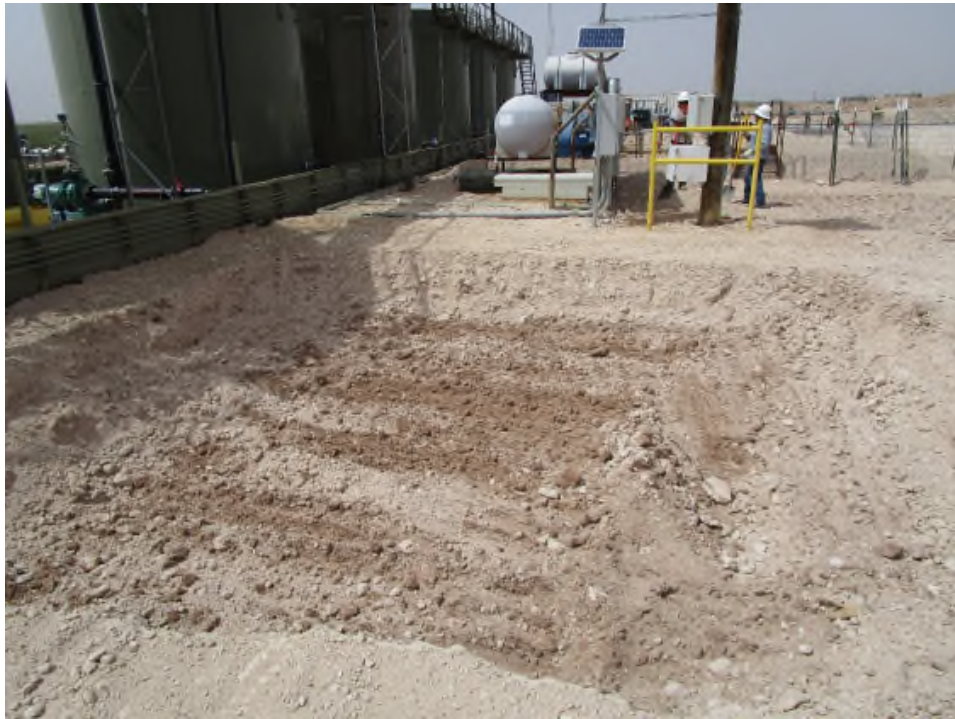
View North – Area of T-3 excavated

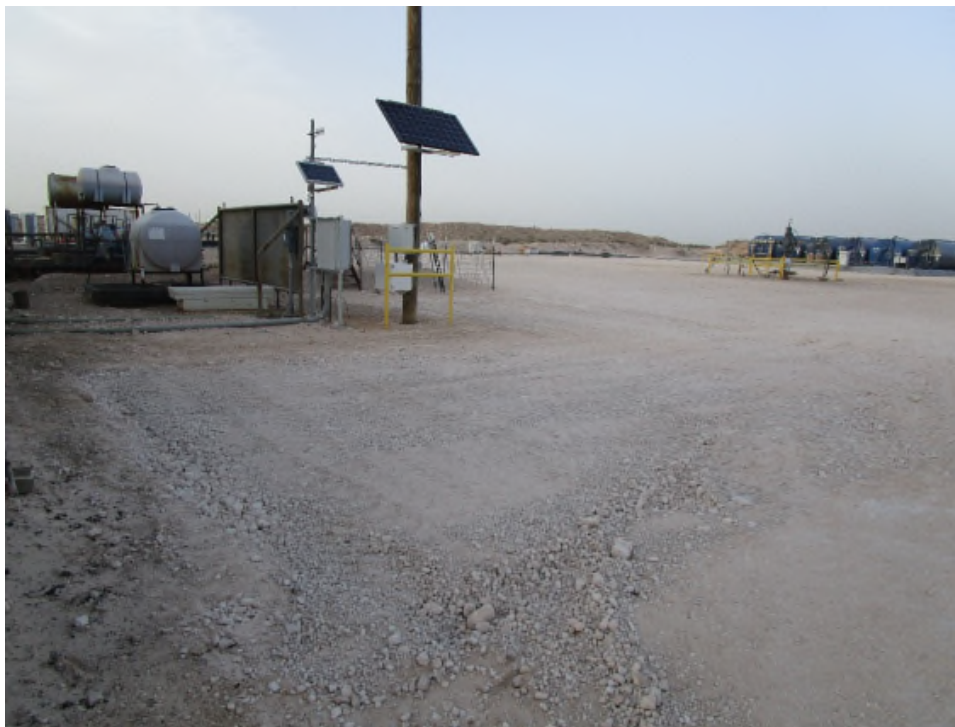
View North East – Area of T-3 Backfilled
