Site Assessment/Characterization

Date: April 18, 2023
Subject: Soil Remediation Work Plan/Variance Request
Old Indian Draw Gathering Line Southern Area
Incident# NCLB0525654437
Eddy County, New Mexico

MCBU
 OLD INDIAN DRAW ~ GATHERING LINE SOUTH
 INCIDENT NUMBER: NCLB0525654437
 EDDY COUNTY, NEW MEXICO

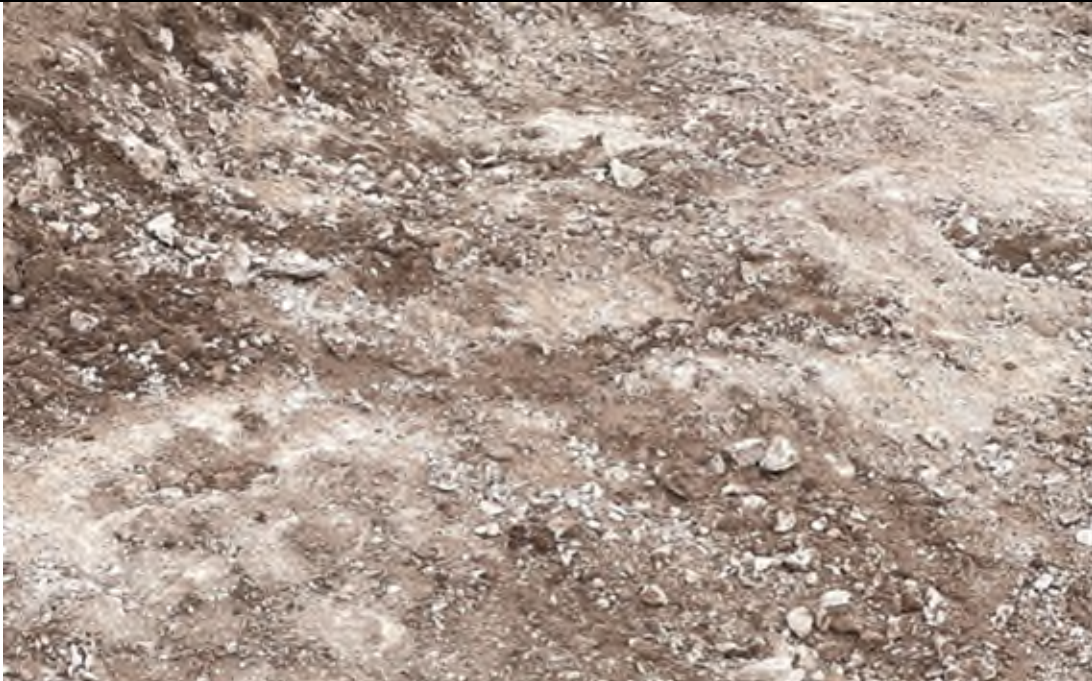
PHOTOGRAPHIC LOG	
Property Name: Old Indian Draw Gathering Line Southern Area		Location: Eddy County, NM	Case No. NCLB0525654437
Photo No. 1	Date: 02/24/2023

Direction Photo Taken: Facing NW			
Description: View of calcrete rock layer in release area at 1 feet bgs.

On March 8, 2023, Arcadis began excavation activities within the southern impacted area assuming the most stringent NMAC closure criteria for soil. A resilient calcrete rock layer was encountered across the release area at depths of approximately 1-foot bgs to 2.5 feet bgs. Repeated attempts to break through the resilient calcrete rock layer utilizing an excavator equipped with a trenching bucket and "rock teeth" yielded limited results.

Repeated attempts to break through the resilient calcrete rock layer utilizing an excavator equipped with a trenching bucket and “rock teeth” yielded limited results. Continued excavation activities are believed not practicable based on the site’s geologic conditions. Analytical data collected during assessment activities confirm the release area has been horizontally and vertically defined. As such, Arcadis is requesting approval of the following Variance:

- Due to the resilient calcrete rock layer encountered at shallow depths across the release area, Arcadis is requesting a variance to limit excavation activities to include only removing impacted soil affected above the NMOCD Reclamation Standards present within the release area to the maximum extent practicable (to the surface of the calcrete layer).

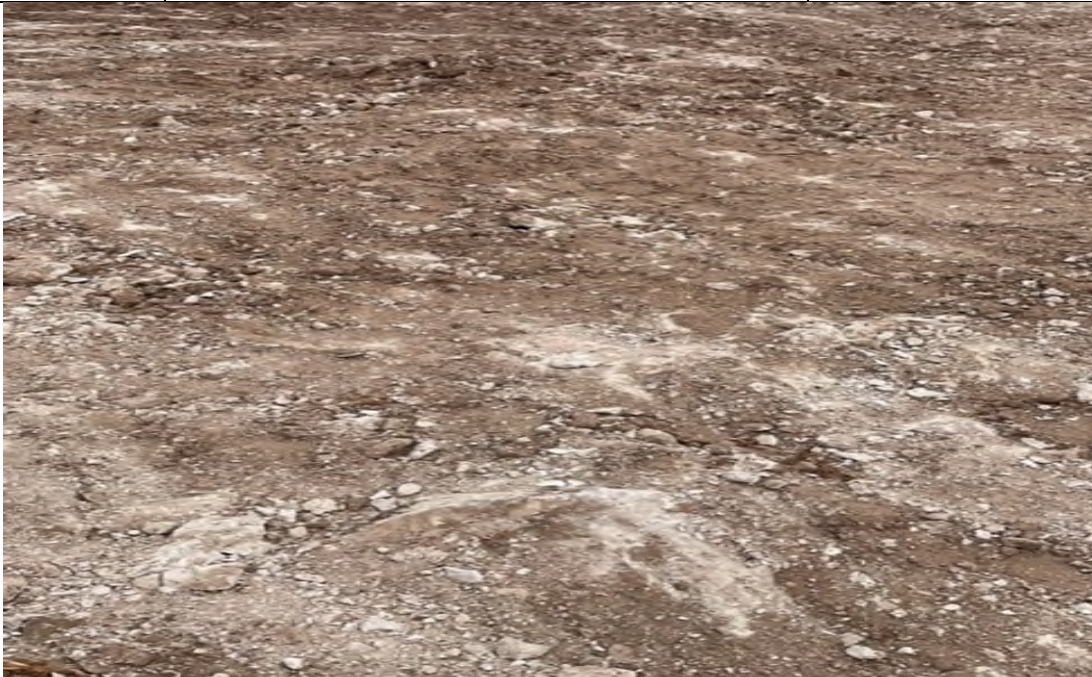
PHOTOGRAPHIC LOG	
Property Name: Old Indian Draw Gathering Line Southern Area		Location: Eddy County, NM	Case No. NCLB0525654437
Photo No. 2	Date: 02/24/2023

Direction Photo Taken: Facing N			
Description: Additional view of calcrete rock layer in release area around 1 feet bgs.
