MCBU OLD INDIAN DRAW ~ GATHERING LINE SOUTH INCIDENT NUMBER: NCLB0525654437 EDDY COUNTY, NEW MEXICO	
<b>EXCAVATION SIDEWALL          SOIL SAMPLE LOCATIONS</b>

MCBU  
 OLD INDIAN DRAW ~ GATHERING LINE SOUTH  
 INCIDENT NUMBER: NCLB0525654437  
 EDDY COUNTY, NEW MEXICO

Incident #'s NKMW1105550129 (2RP-611), NMLB1226438559 (2RP-1297),  
 NJMW1334440905 (2RP-2104), and NAB1433953640 (2RP-2644)

MCBU OLD INDIAN DRAW ~ UNIT #001 EDDY COUNTY, NEW MEXICO	
<b>SITE DETAILS MAP</b>	
	FIGURE <b>2</b>

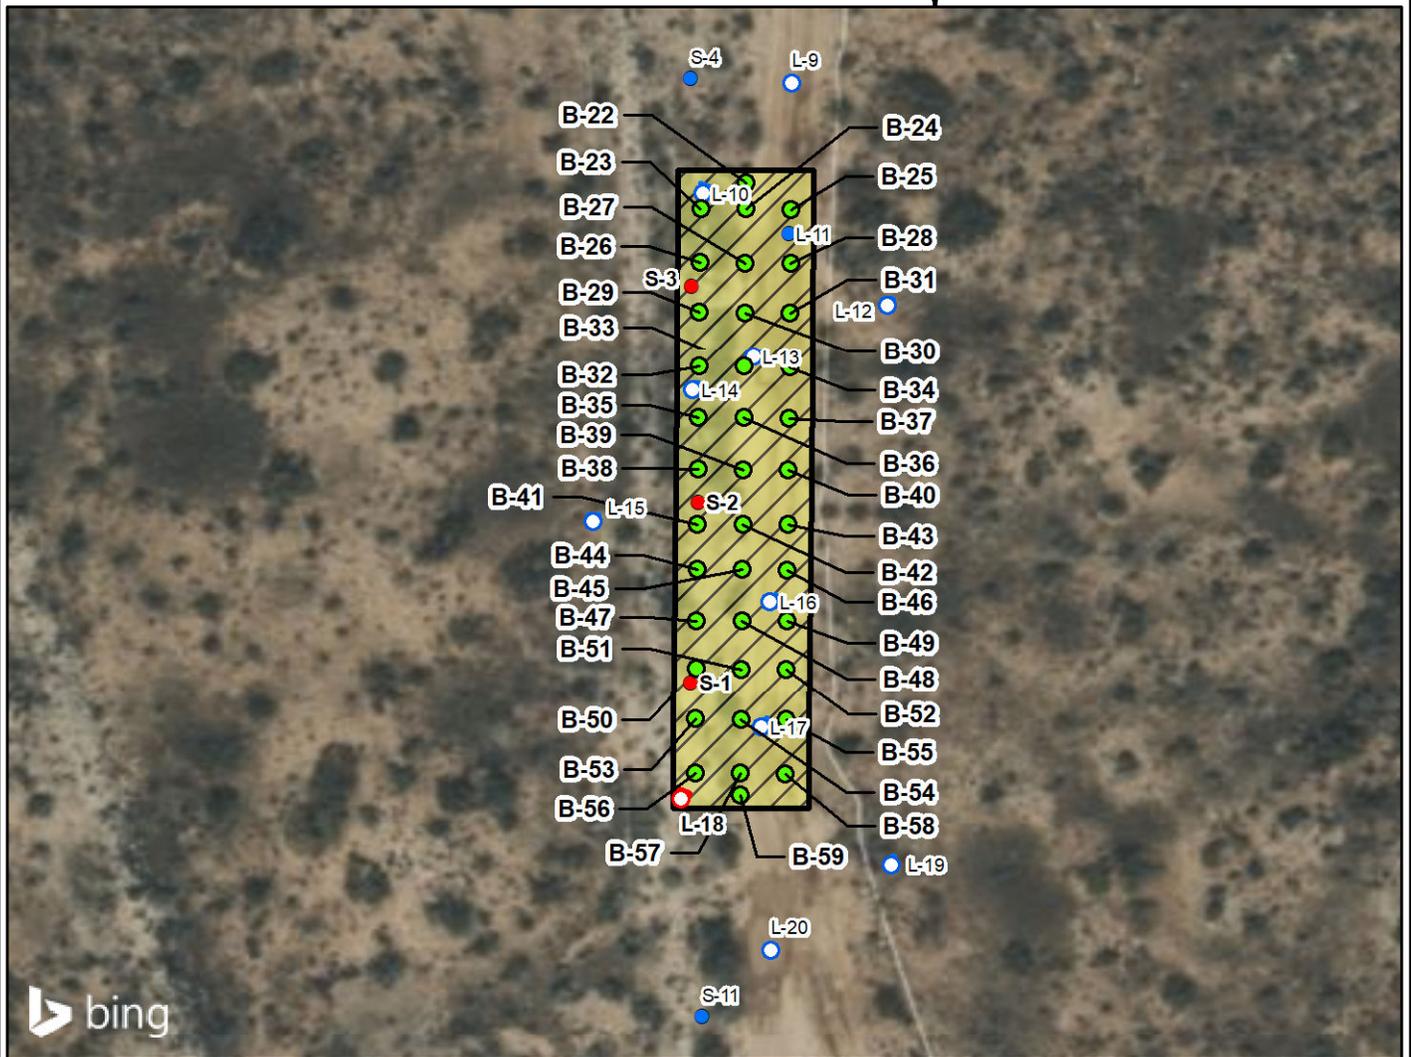
### EXCAVATION BASE SOIL SAMPLE LOCATIONS

Five-point composite sidewall sample locations are depicted on **Figure 2**, and the composite base sample locations are depicted on **Figure 3**. Current site conditions and the resilient rock layer encountered are documented in the attached **Photographic Log**. Impacted soil excavated to date have been transported to a NMOCD approved disposal facility. Waste manifests are available upon request.

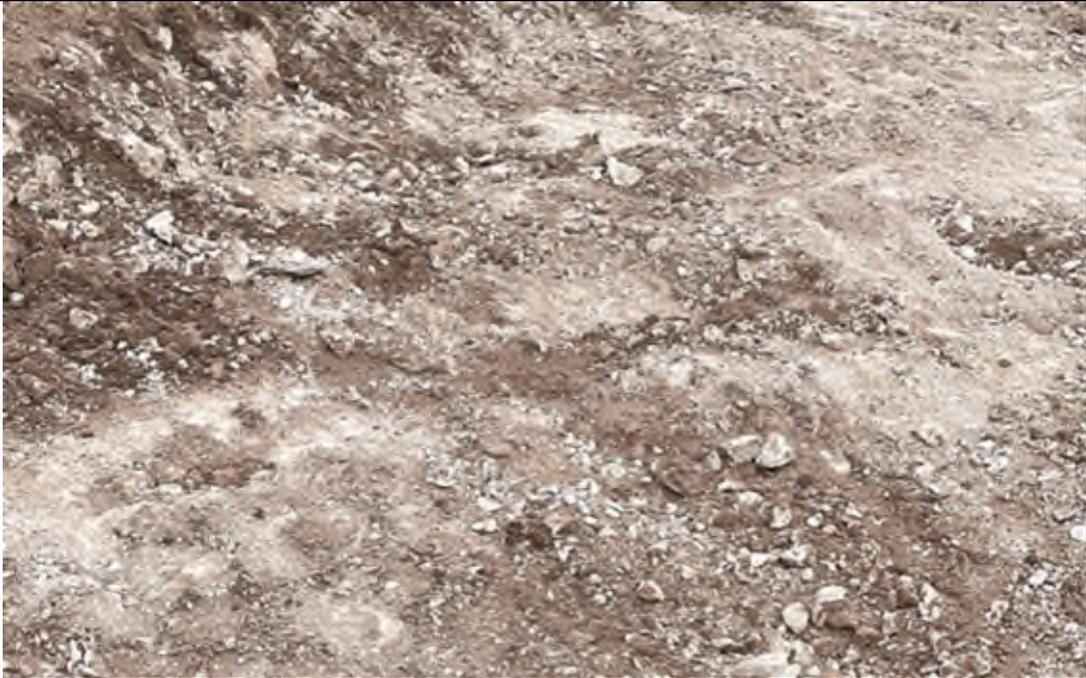
<b>PHOTOGRAPHIC LOG</b>	
<b>Property Name:</b> Old Indian Draw Gathering Line Southern Area		<b>Location:</b> Eddy County, NM	<b>Case No.</b> NCLB0525654437
<b>Photo No.</b> 1	<b>Date:</b> 02/24/2023

<b>Direction Photo Taken:</b> Facing NW			
<b>Description:</b> View of calcrete rock layer in release area at 1 feet bgs.

Repeated attempts to break through the resilient calcrete rock layer utilizing an excavator equipped with a trenching bucket and “rock teeth” yielded limited results. Continued excavation activities are believed not practicable based on the site’s geologic conditions. Analytical data collected during assessment activities confirm the release area has been horizontally and vertically defined. As such, Arcadis is requesting approval of the following Variance:

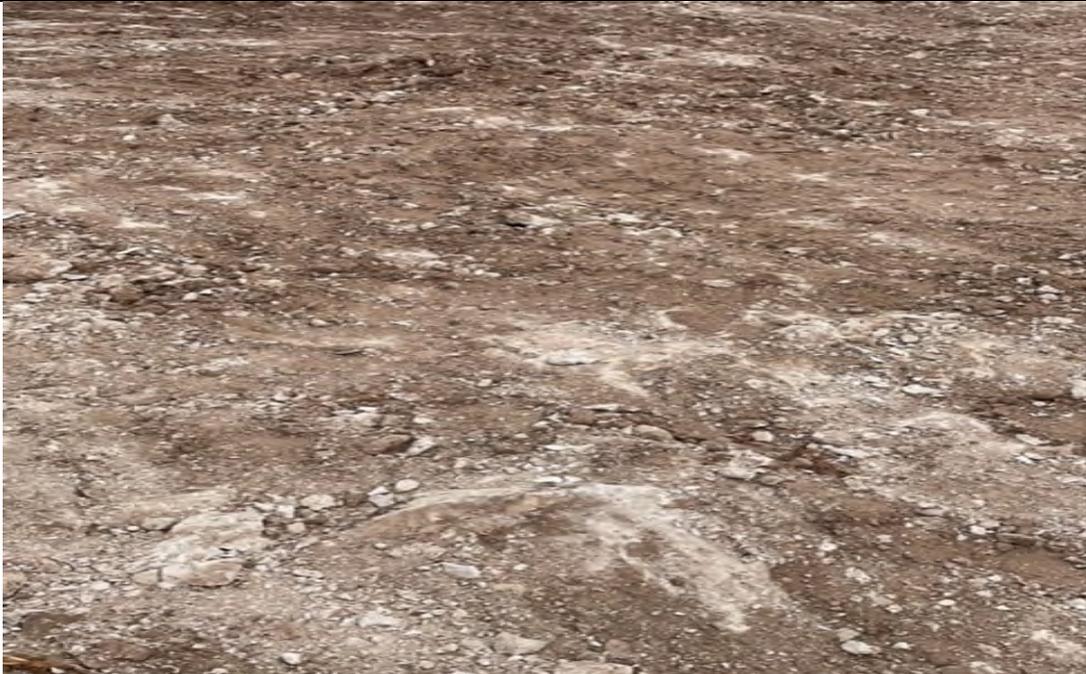
<b>PHOTOGRAPHIC LOG</b>	
<b>Property Name:</b> Old Indian Draw Gathering Line Southern Area		<b>Location:</b> Eddy County, NM	<b>Case No.</b> NCLB0525654437
<b>Photo No.</b> 2	<b>Date:</b> 02/24/2023

<b>Direction Photo Taken:</b> Facing N			
<b>Description:</b> Additional view of calcrete rock layer in release area around 1 feet bgs.

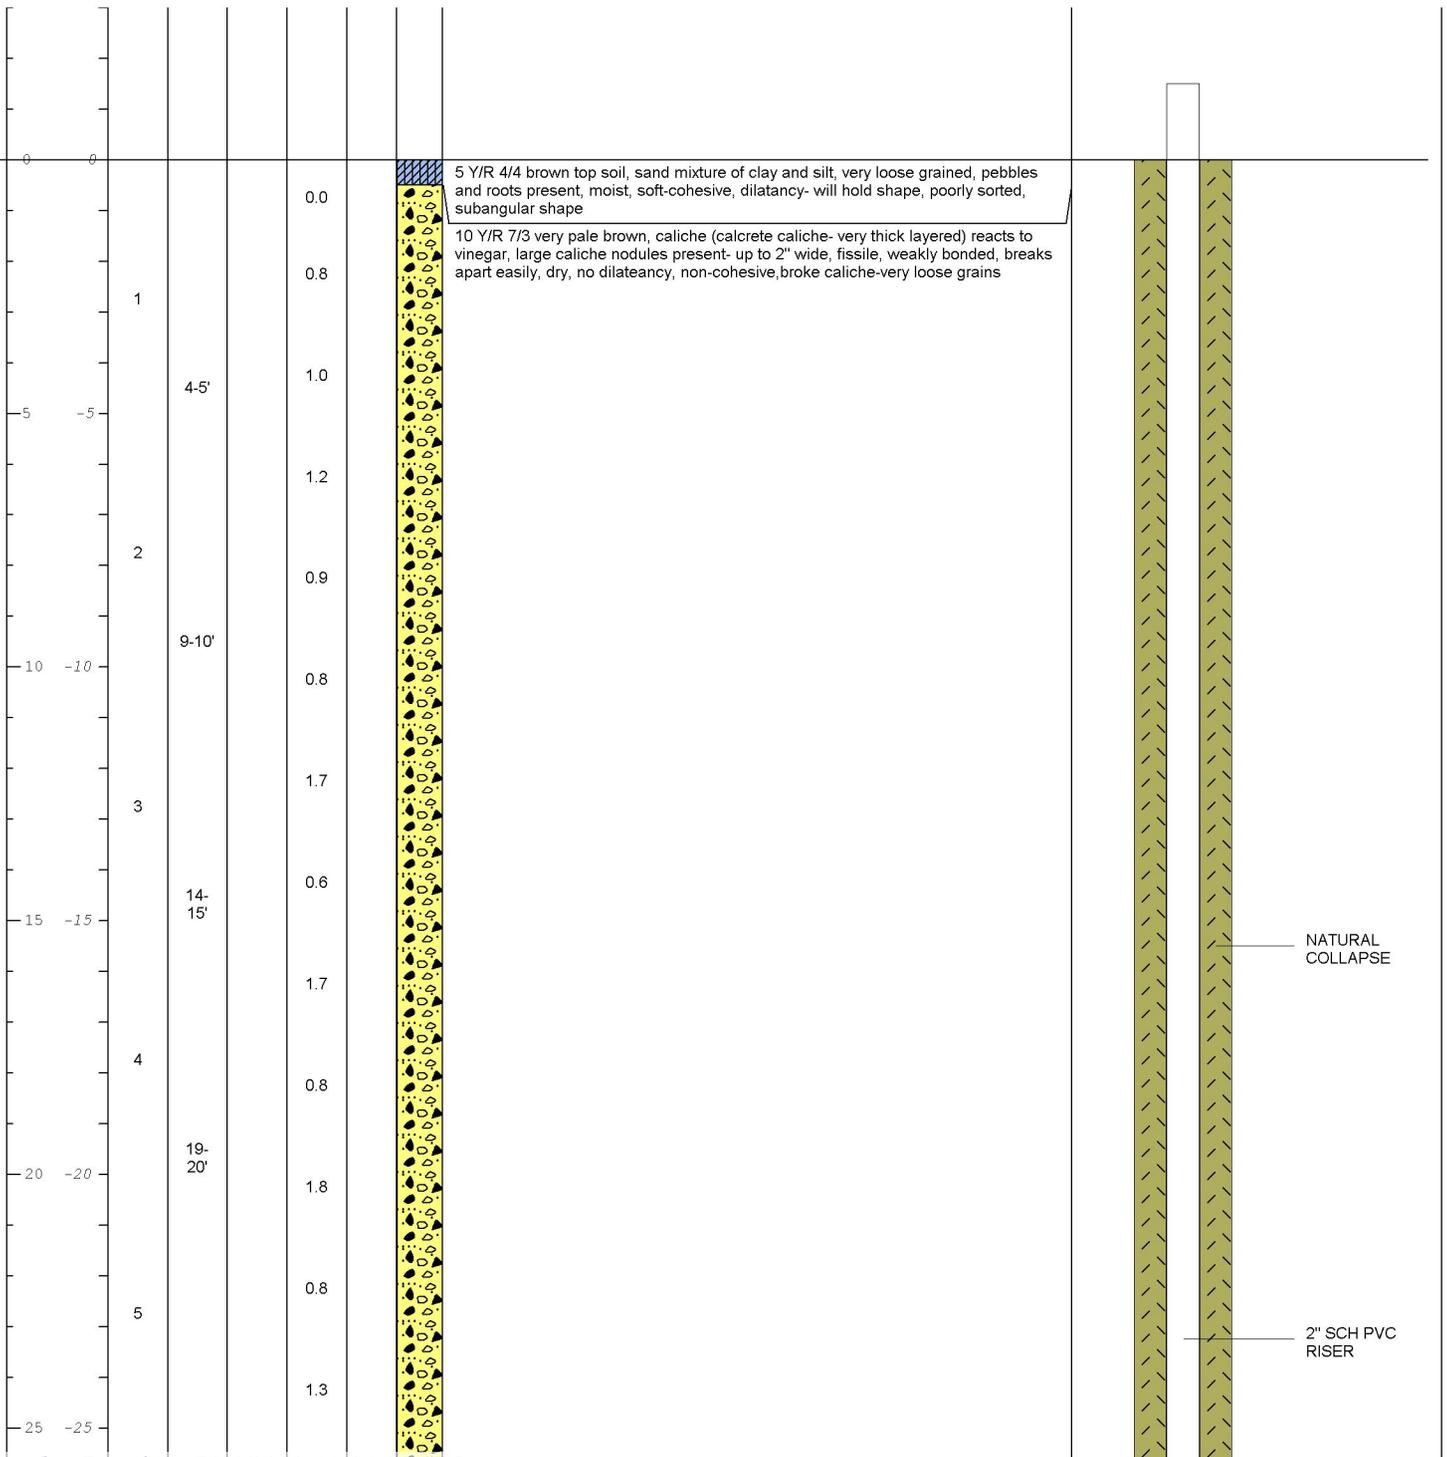
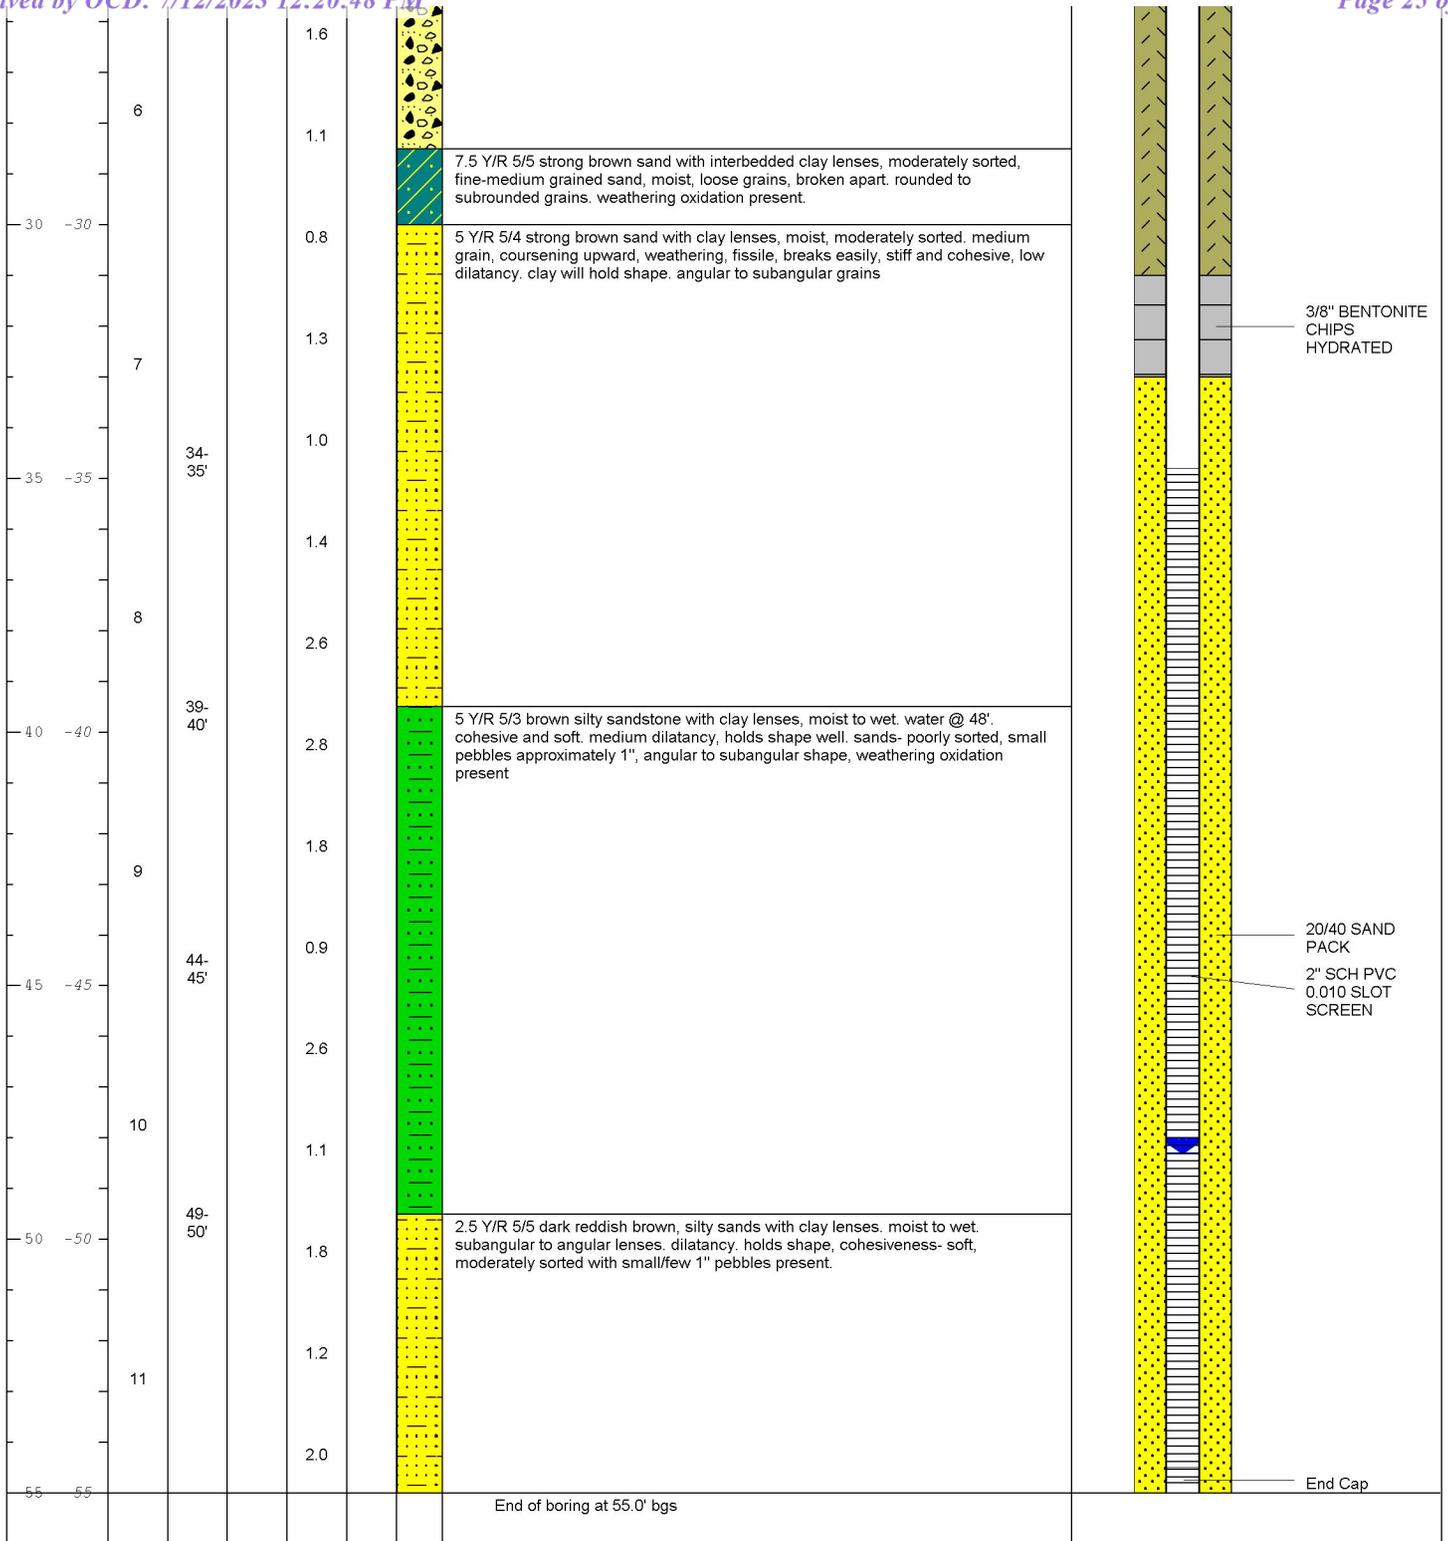
<b>Date Start/Finish:</b> 2/13/2023 <b>Drilling Company:</b> White Drilling Company, Inc. <b>Driller's Name:</b> Bo Atkins <b>Drilling Method:</b> Air Rotary/ Split Spoon <b>Sampling Method:</b> Grab	<b>Latitude:</b> 32.392848 <b>Longitude:</b> -104.124242 <b>Casing Elevation:</b> NS  <b>Borehole Depth:</b> 55' <b>Surface Elevation:</b> NS  <b>Descriptions By:</b> Heather Dudley	<b>Well/Boring ID:</b> TW-2  <b>Client:</b> Chevron-MCBU  <b>Location:</b> Old Indian Draw Unit #001 Carlsbad, New Mexico
---	--	---

DEPTH	Sample Run Number	Sample/Int/Type	Recovery (feet)	PID	USCS Code	Geologic Column	Stratigraphic Description	Well/Boring Construction
-------	-------------------	-----------------	-----------------	-----	-----------	-----------------	---------------------------	--------------------------

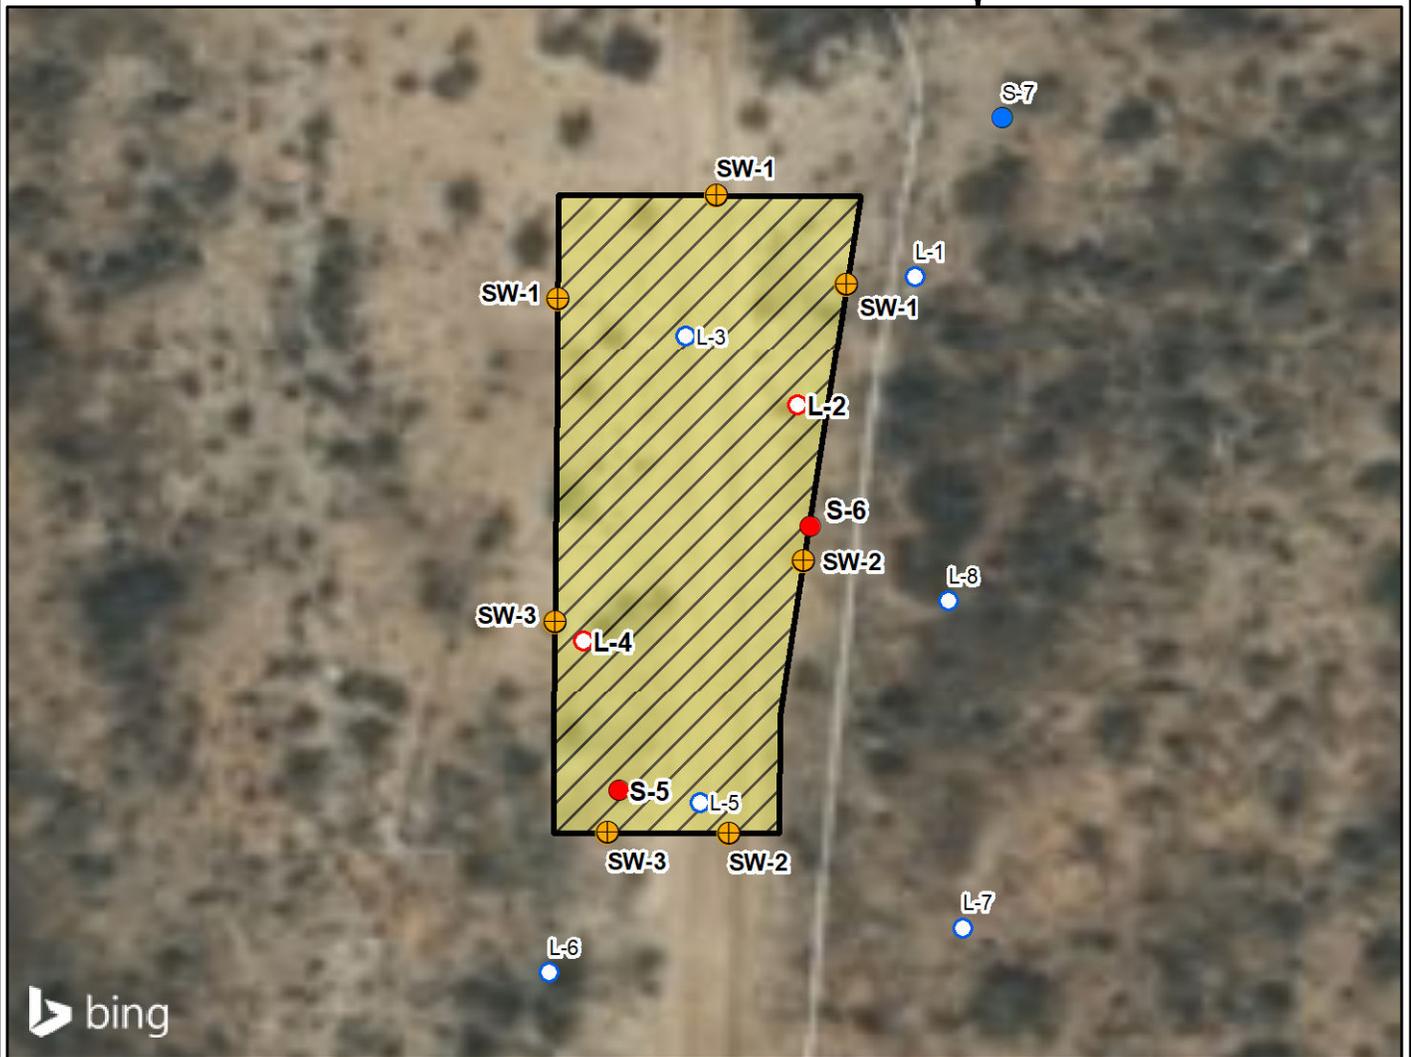
MCBU  
 OLD INDIAN DRAW ~ GATHERING LINE NORTH  
 INCIDENT NUMBER: NCLB052565219  
 EDDY COUNTY, NEW MEXICO

### EXCAVATION SIDEWALL SOIL SAMPLE LOCATIONS

Five-point composite sidewall sample locations are depicted on **Figure 2**, and the five-point composite base sample locations are depicted on **Figure 3**. Current site conditions and the resilient rock layer encountered are documented in the attached **Photographic Log**. Impacted soil excavated to date has been transported to a NMOCD approved disposal facility. Waste manifests are available upon request.

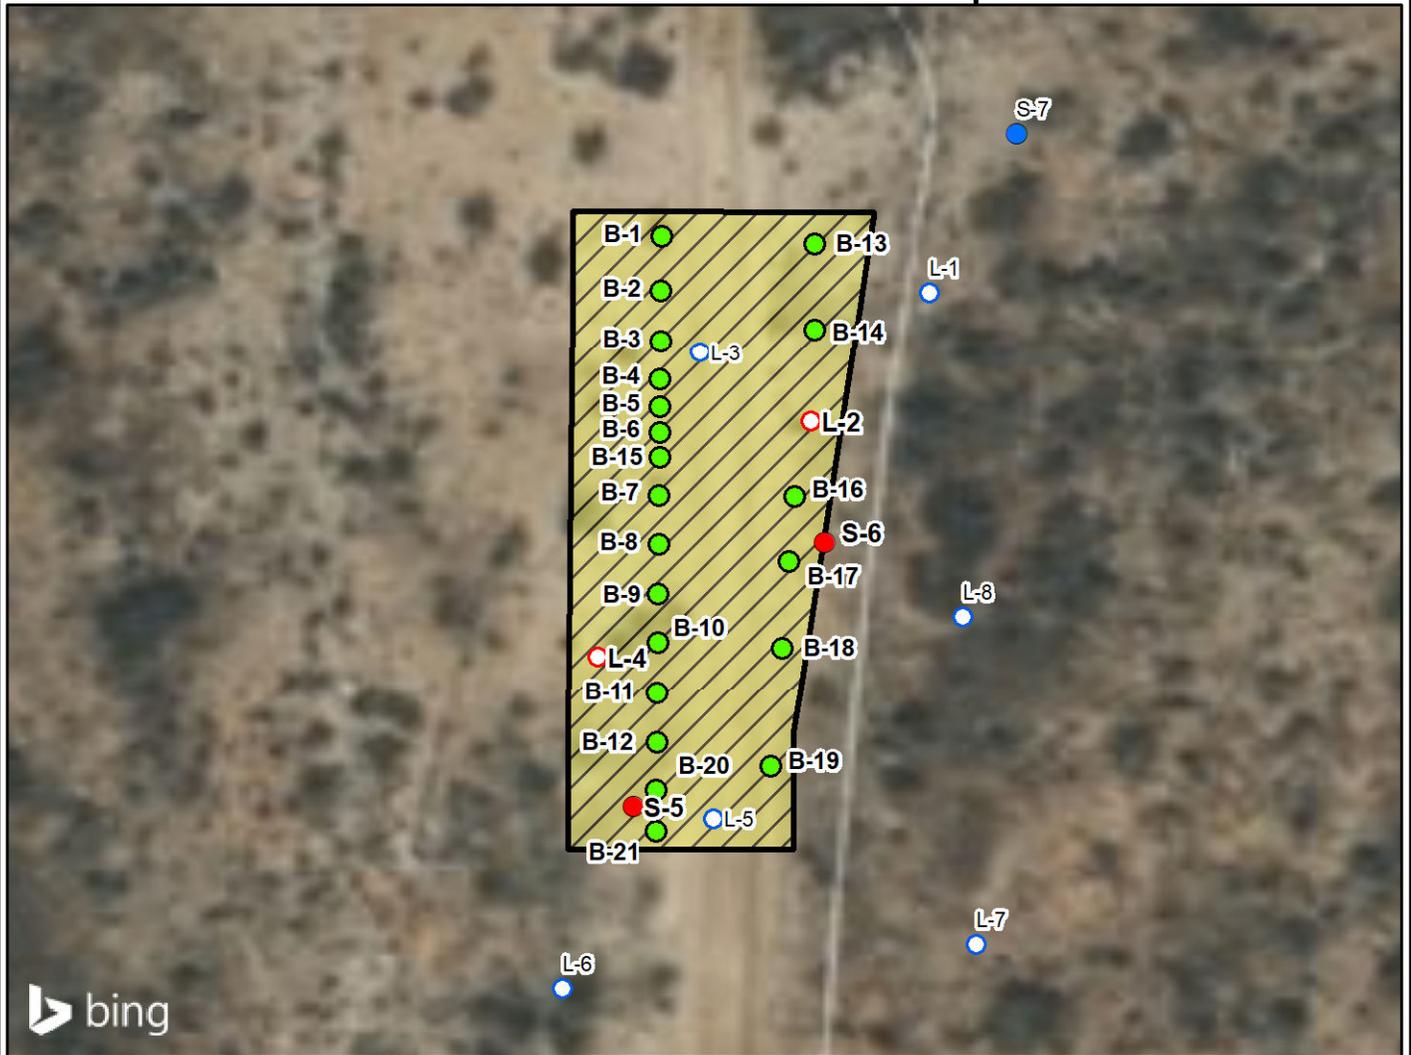
MCBU OLD INDIAN DRAW ~ GATHERING LINE NORTH INCIDENT NUMBER: NCLB0525655219 EDDY COUNTY, NEW MEXICO	
<b>EXCAVATION BASE          SOIL SAMPLE LOCATIONS</b>	
	<b>FIGURE 3</b>

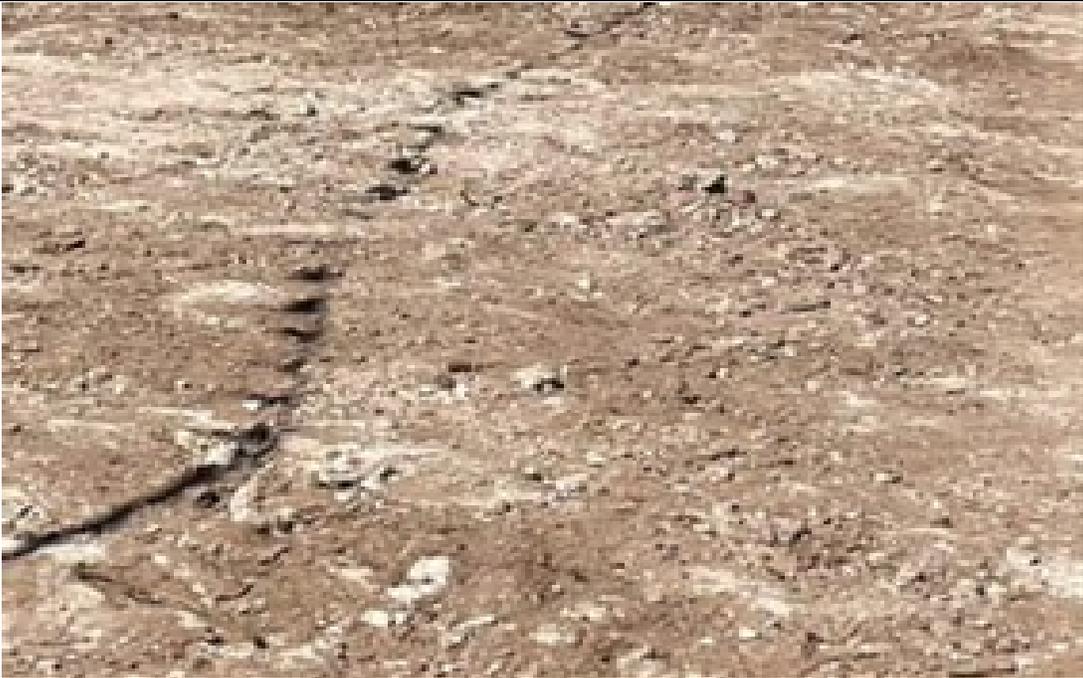
<b>PHOTOGRAPHIC LOG</b>	
<b>Property Name:</b> Old Indian Draw Gathering Line Northern Area		<b>Location:</b> Eddy County, NM	<b>Case No.</b> NCLB0525655219
<b>Photo No.</b> 1	<b>Date:</b> 02/23/2023

<b>Direction Photo Taken:</b> Facing N			
<b>Description:</b> View calcrete rock layer within the release area.

Repeated attempts to break through the resilient calcrete rock layer utilizing an excavator equipped with a trenching bucket and “rock teeth” yielded limited results. Continued excavation activities are believed not practicable based on the site’s geologic conditions. Analytical data collected during assessment activities confirm the release area has been horizontally and vertically defined. As such, Arcadis is requesting approval of the following Variance:

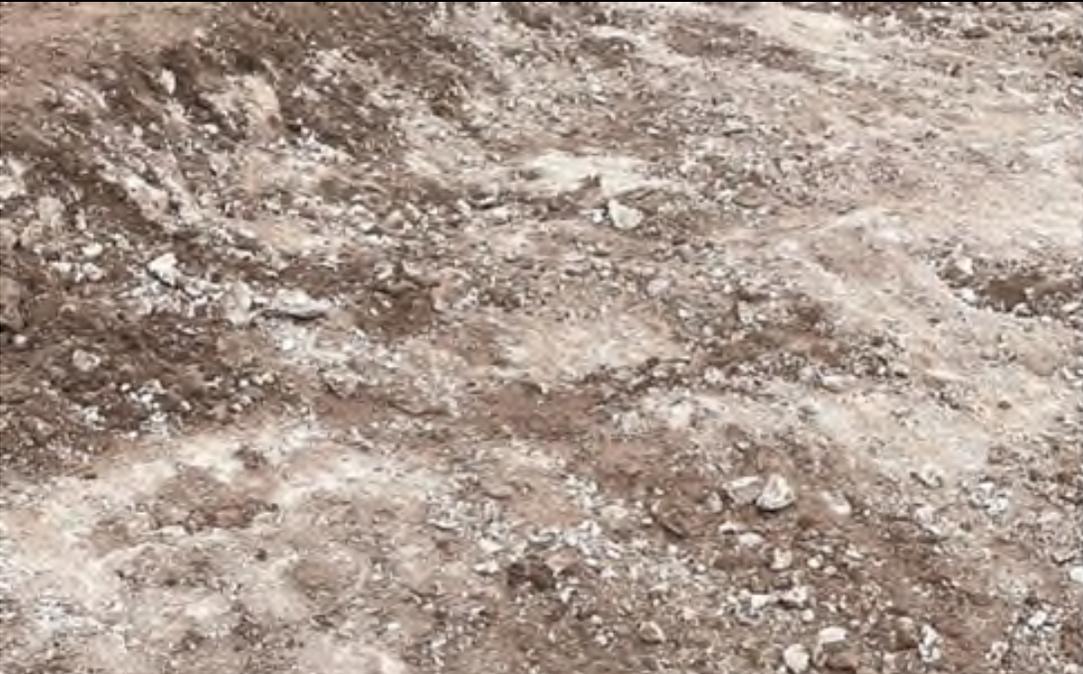
<b>PHOTOGRAPHIC LOG</b>	
<b>Property Name:</b> Old Indian Draw Gathering Line Northern Area		<b>Location:</b> Eddy County, NM	<b>Case No.</b> NCLB0525655219
<b>Photo No.</b> 2	<b>Date:</b> 02/23/2023

<b>Direction Photo Taken:</b> Facing NW			
<b>Description:</b> Additional view of calcrete rock layer.

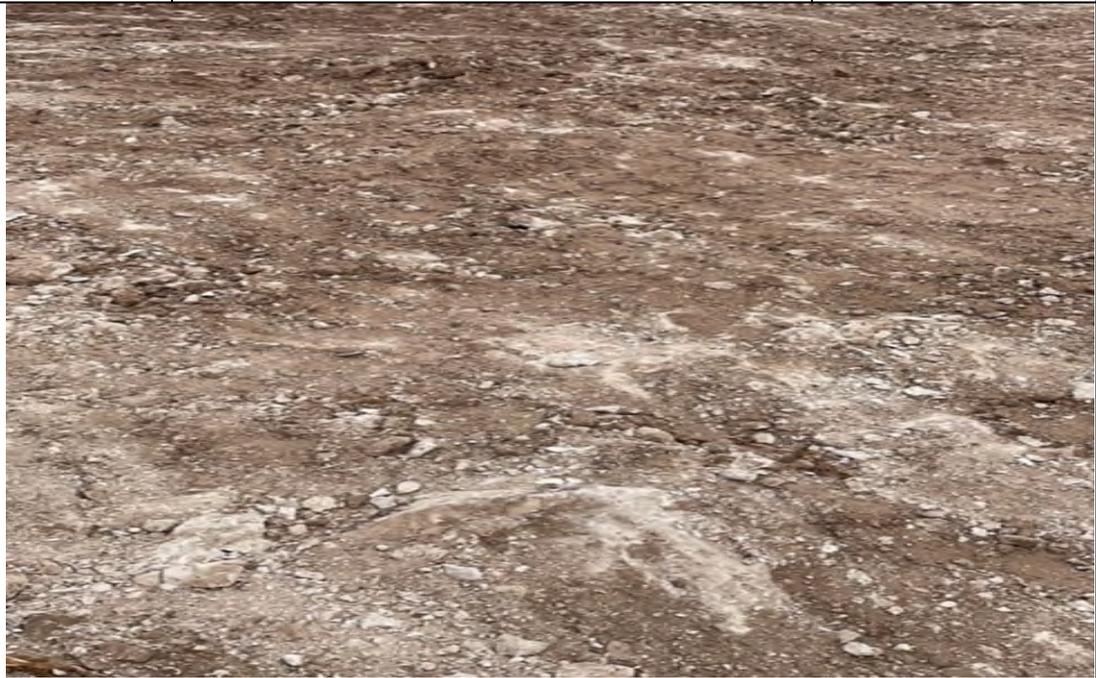
<b>Description:</b>  Solid rock layer in release area around 1 feet bgs.
--

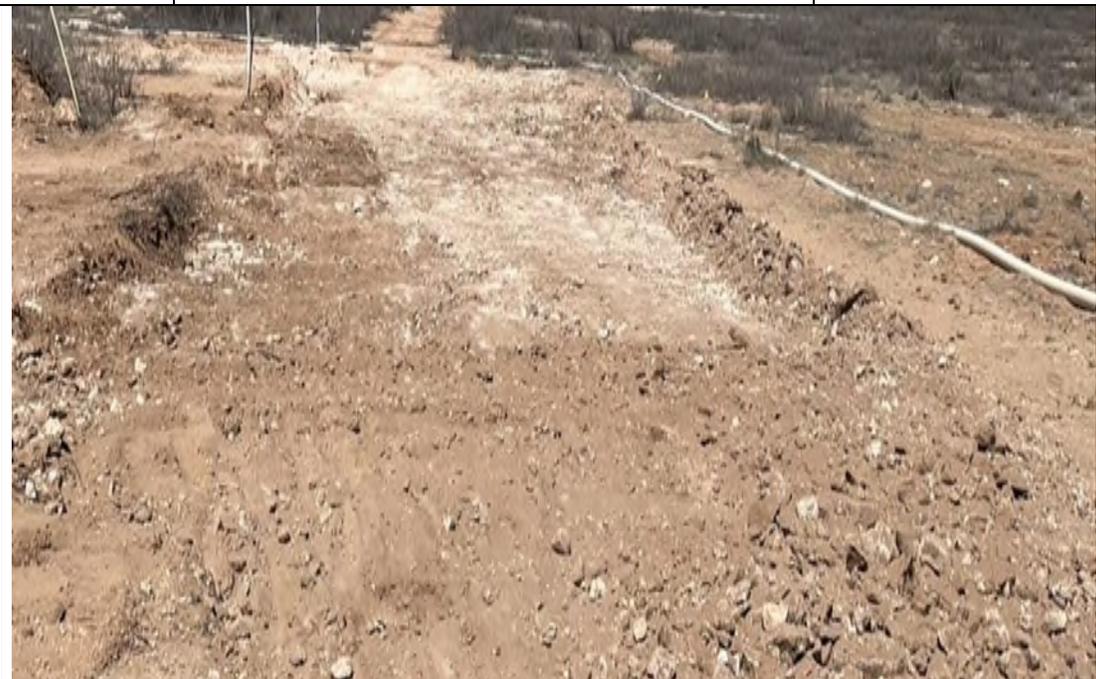
<b>Description:</b>  Area excavated to solid rock layer at 1 to 2 feet bgs.
---

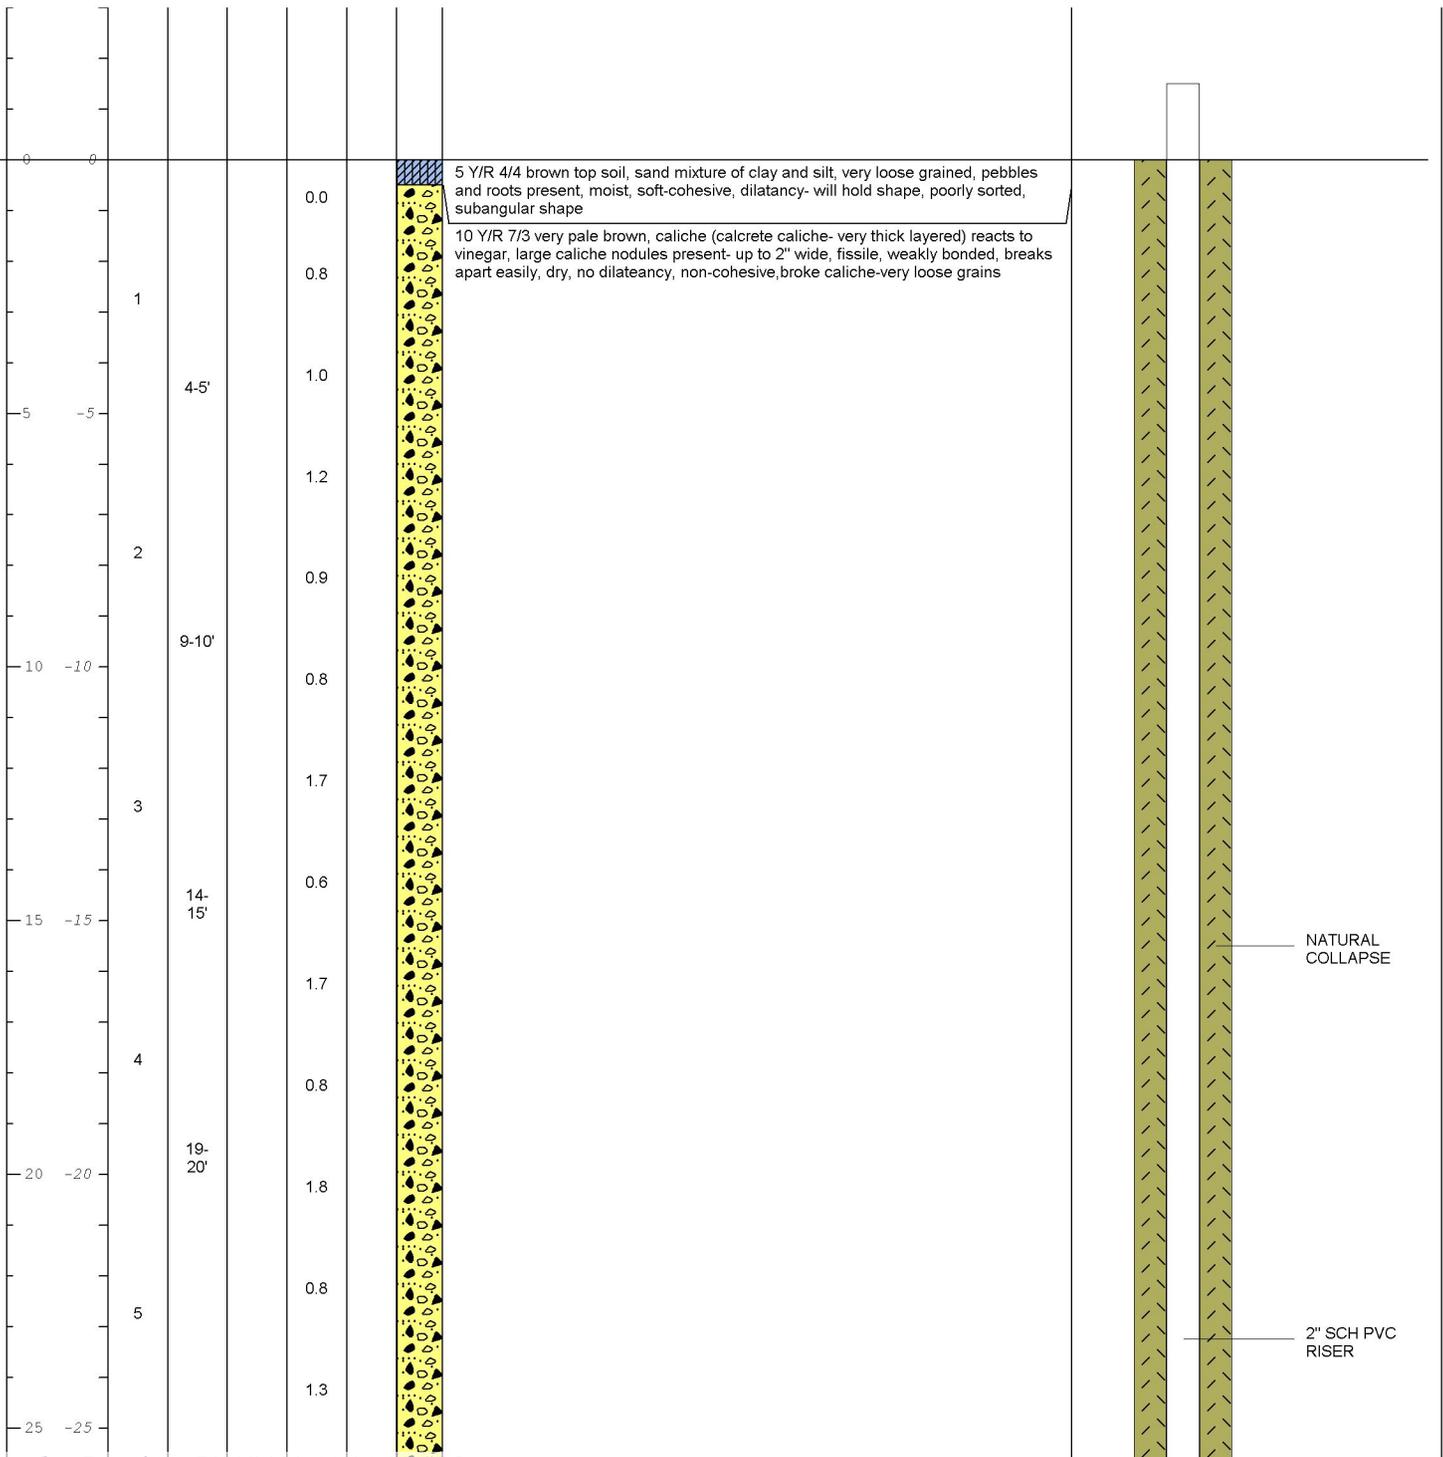
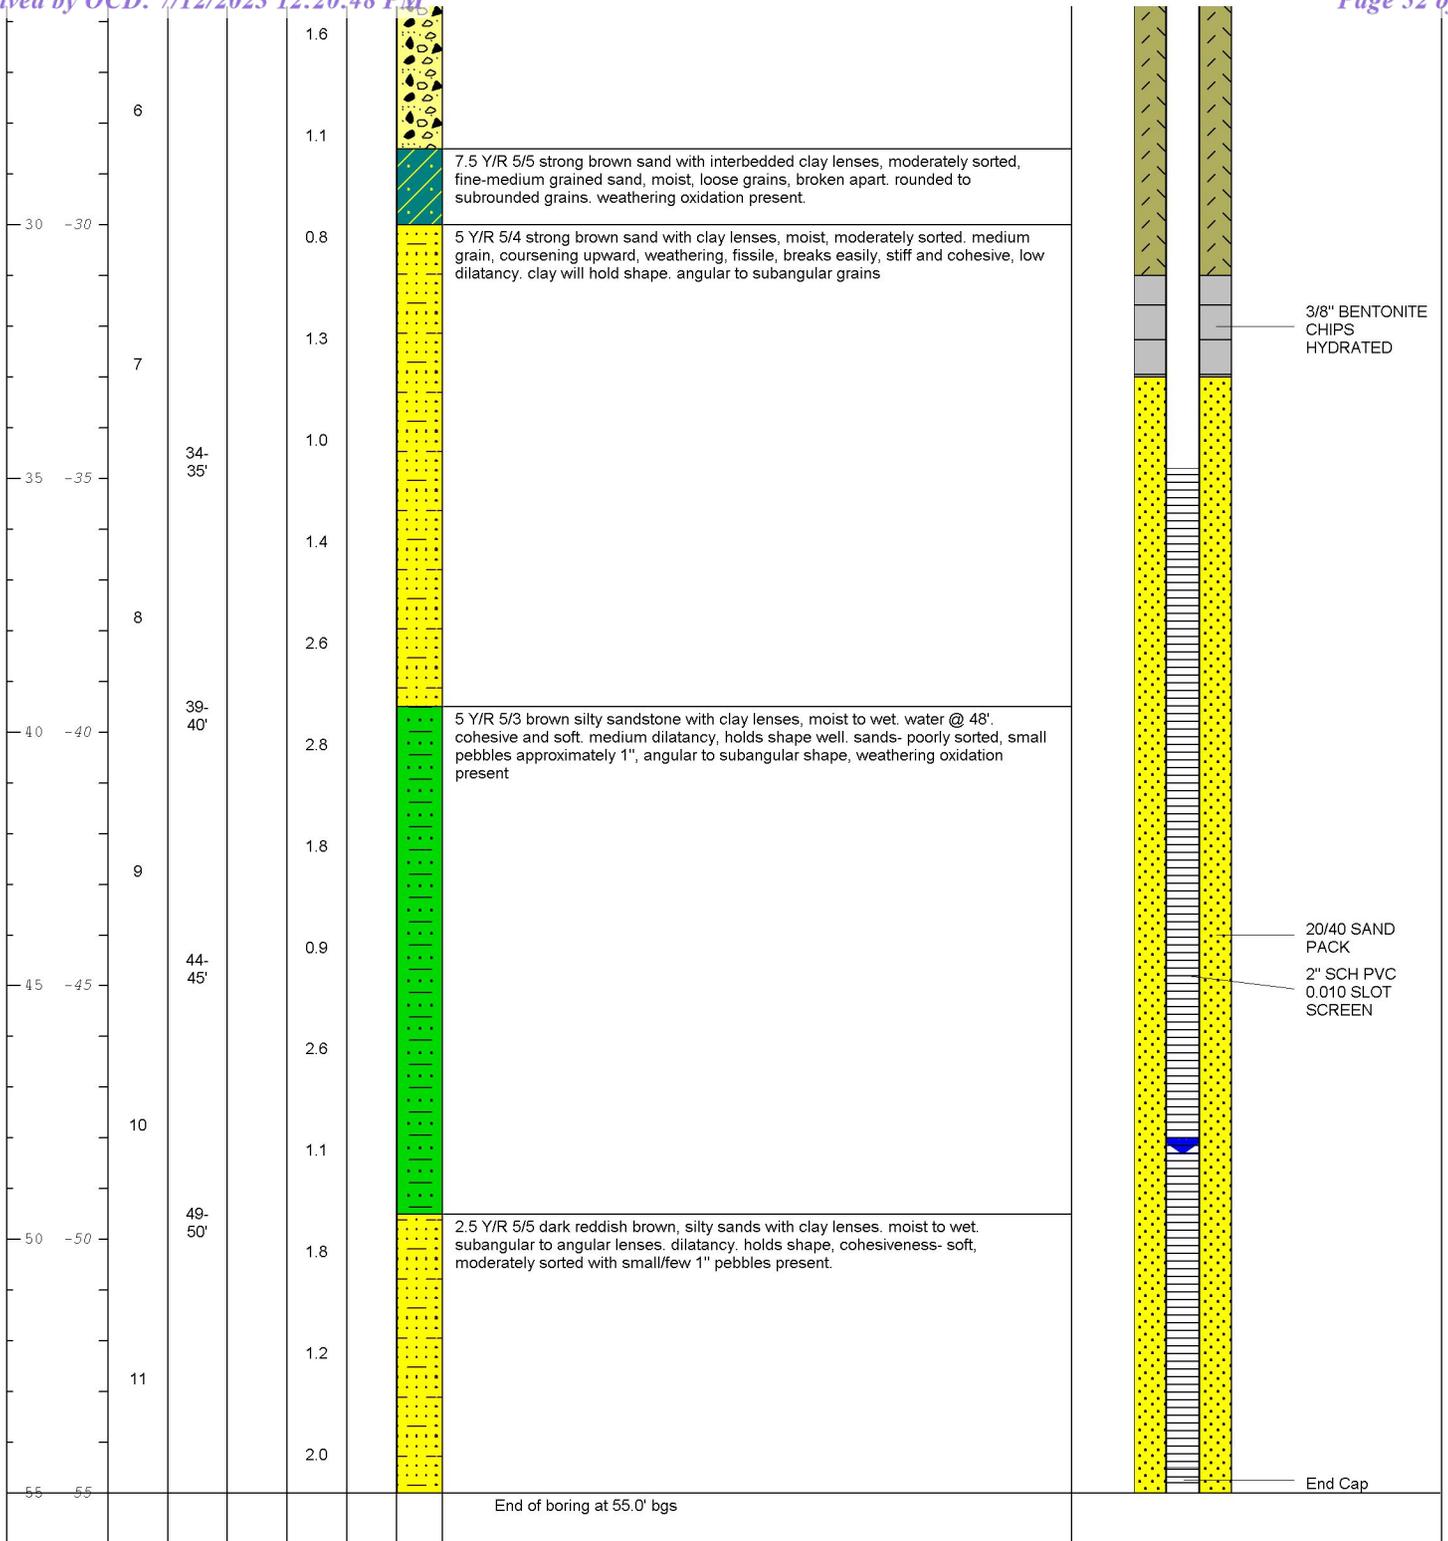
<b>Date Start/Finish:</b> 2/13/2023 <b>Drilling Company:</b> White Drilling Company, Inc. <b>Driller's Name:</b> Bo Atkins <b>Drilling Method:</b> Air Rotary/ Split Spoon <b>Sampling Method:</b> Grab	<b>Latitude:</b> 32.392848 <b>Longitude:</b> -104.124242 <b>Casing Elevation:</b> NS  <b>Borehole Depth:</b> 55' <b>Surface Elevation:</b> NS  <b>Descriptions By:</b> Heather Dudley	<b>Well/Boring ID:</b> TW-2  <b>Client:</b> Chevron-MCBU  <b>Location:</b> Old Indian Draw Unit #001 Carlsbad, New Mexico
---	--	---

DEPTH	Sample Run Number	Sample/Int/Type	Recovery (feet)	PID	USCS Code	Geologic Column	Stratigraphic Description	Well/Boring Construction
-------	-------------------	-----------------	-----------------	-----	-----------	-----------------	---------------------------	--------------------------

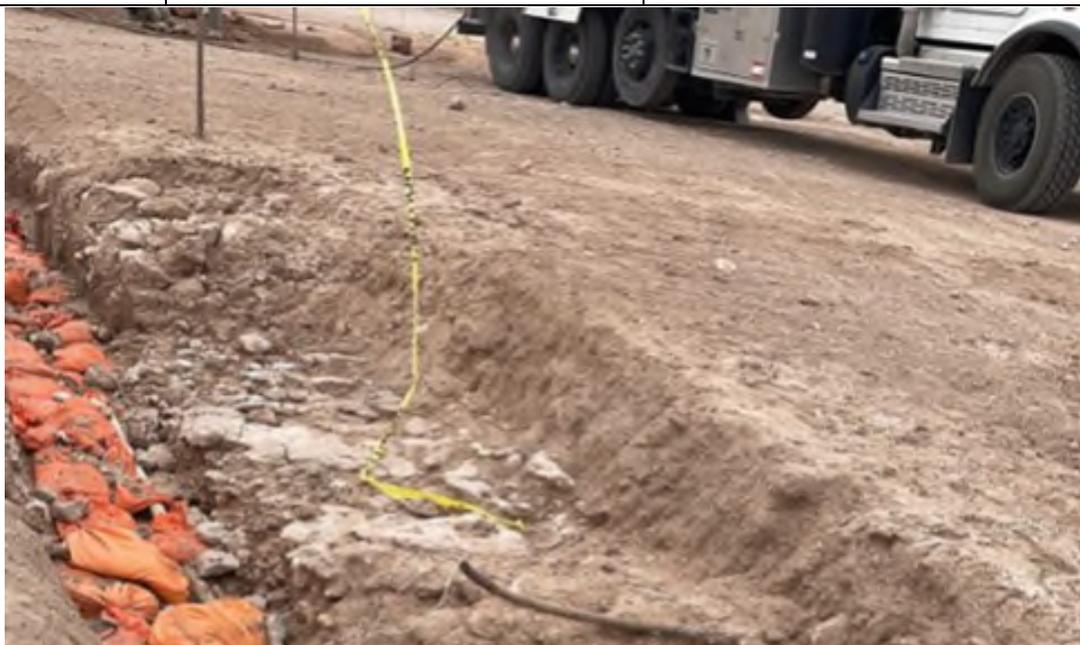
<b>Photo No.</b> 1	<b>Date:</b> 03/20/2023
<b>Direction Photo Taken:</b> Facing NW

**Description:**  
View of hydro-excavated area proximate to the northern header area on pad within the release area. Depth to calcrete rock layer ranging from 1 to 1.5 feet bgs.

Continued excavation activities below the calcrete rock layer are believed not practicable based on the Site's geologic conditions and the associated high-risk potential to damage subsurface utilities which has the potential to cause harm to human health and the environment.

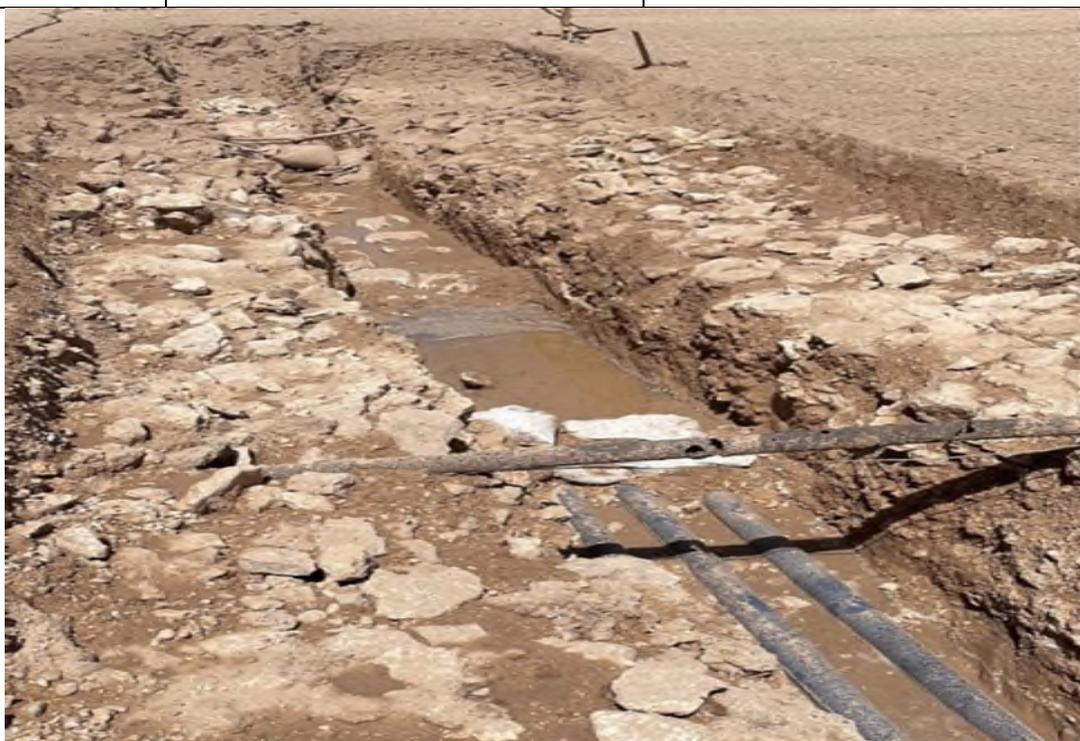
**Description:**  
View of active polylines and crossing abandoned steel line. Depth to calcrete rock layer ranging from 1 to 1.5 feet bgs.

Risks of potential unanticipated/undetected damage to active underground fiberglass production lines by yellow iron type excavation activities within base rock material proximate to the fiberglass production lines are also a significant concern for continued operations within the well field.

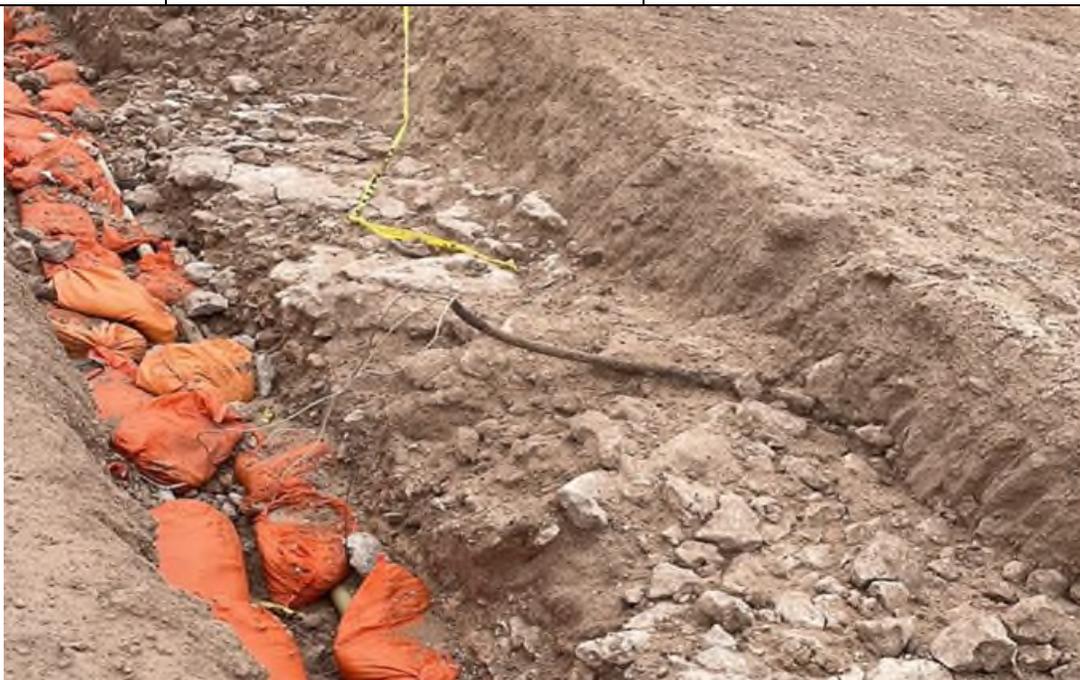
View of active fiberglass lines, abandoned electrical, and calcrete rock layer at depths ranging from 1 to 1.5 feet bgs.
