MCBU OLD INDIAN DRAW ~ GATHERING LINE SOUTH INCIDENT NUMBER: NCLB0525654437 EDDY COUNTY, NEW MEXICO	
<b>EXCAVATION SIDEWALL          SOIL SAMPLE LOCATIONS</b>

MCBU  
 OLD INDIAN DRAW ~ GATHERING LINE SOUTH  
 INCIDENT NUMBER: NCLB0525654437  
 EDDY COUNTY, NEW MEXICO

Incident #'s NKMW1105550129 (2RP-611), NMLB1226438559 (2RP-1297),  
 NJMW1334440905 (2RP-2104), and NAB1433953640 (2RP-2644)

MCBU OLD INDIAN DRAW ~ UNIT #001 EDDY COUNTY, NEW MEXICO	
<b>SITE DETAILS MAP</b>	
	FIGURE <b>2</b>

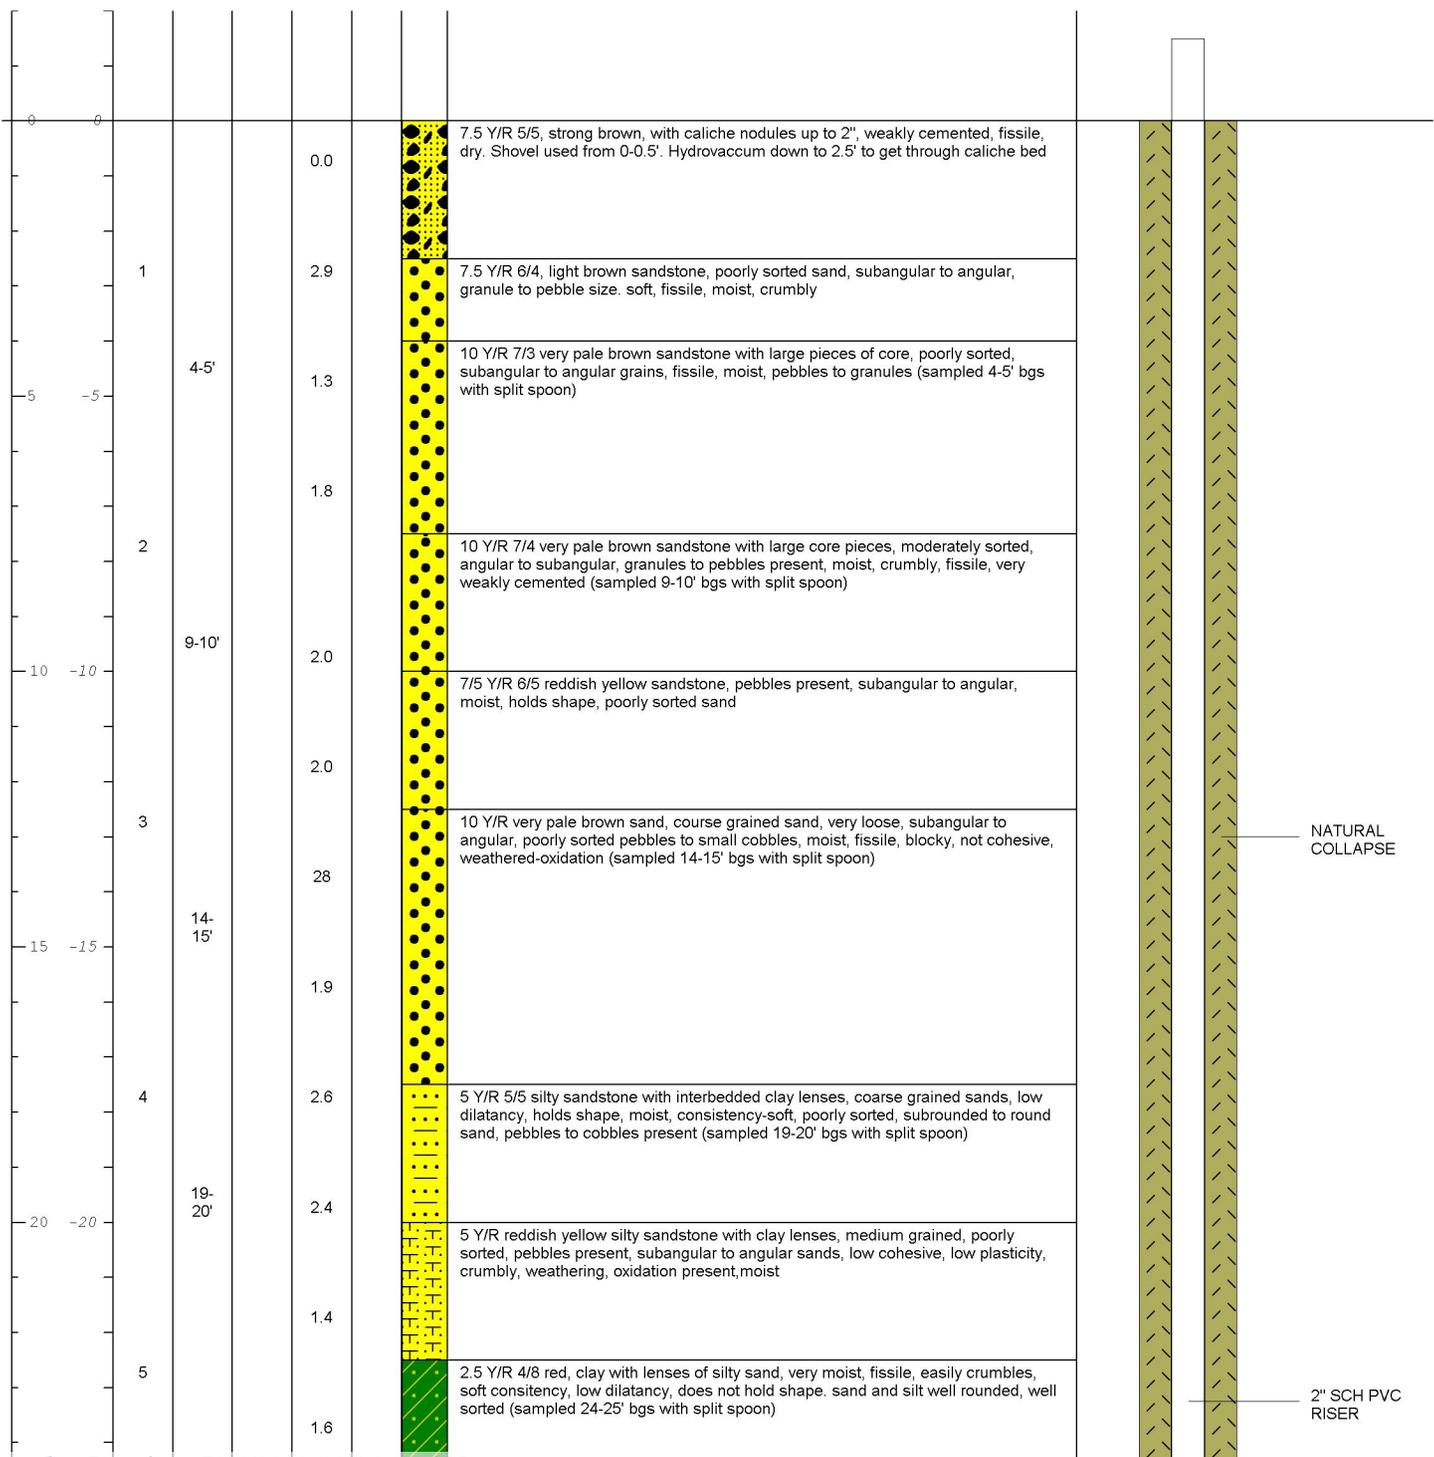
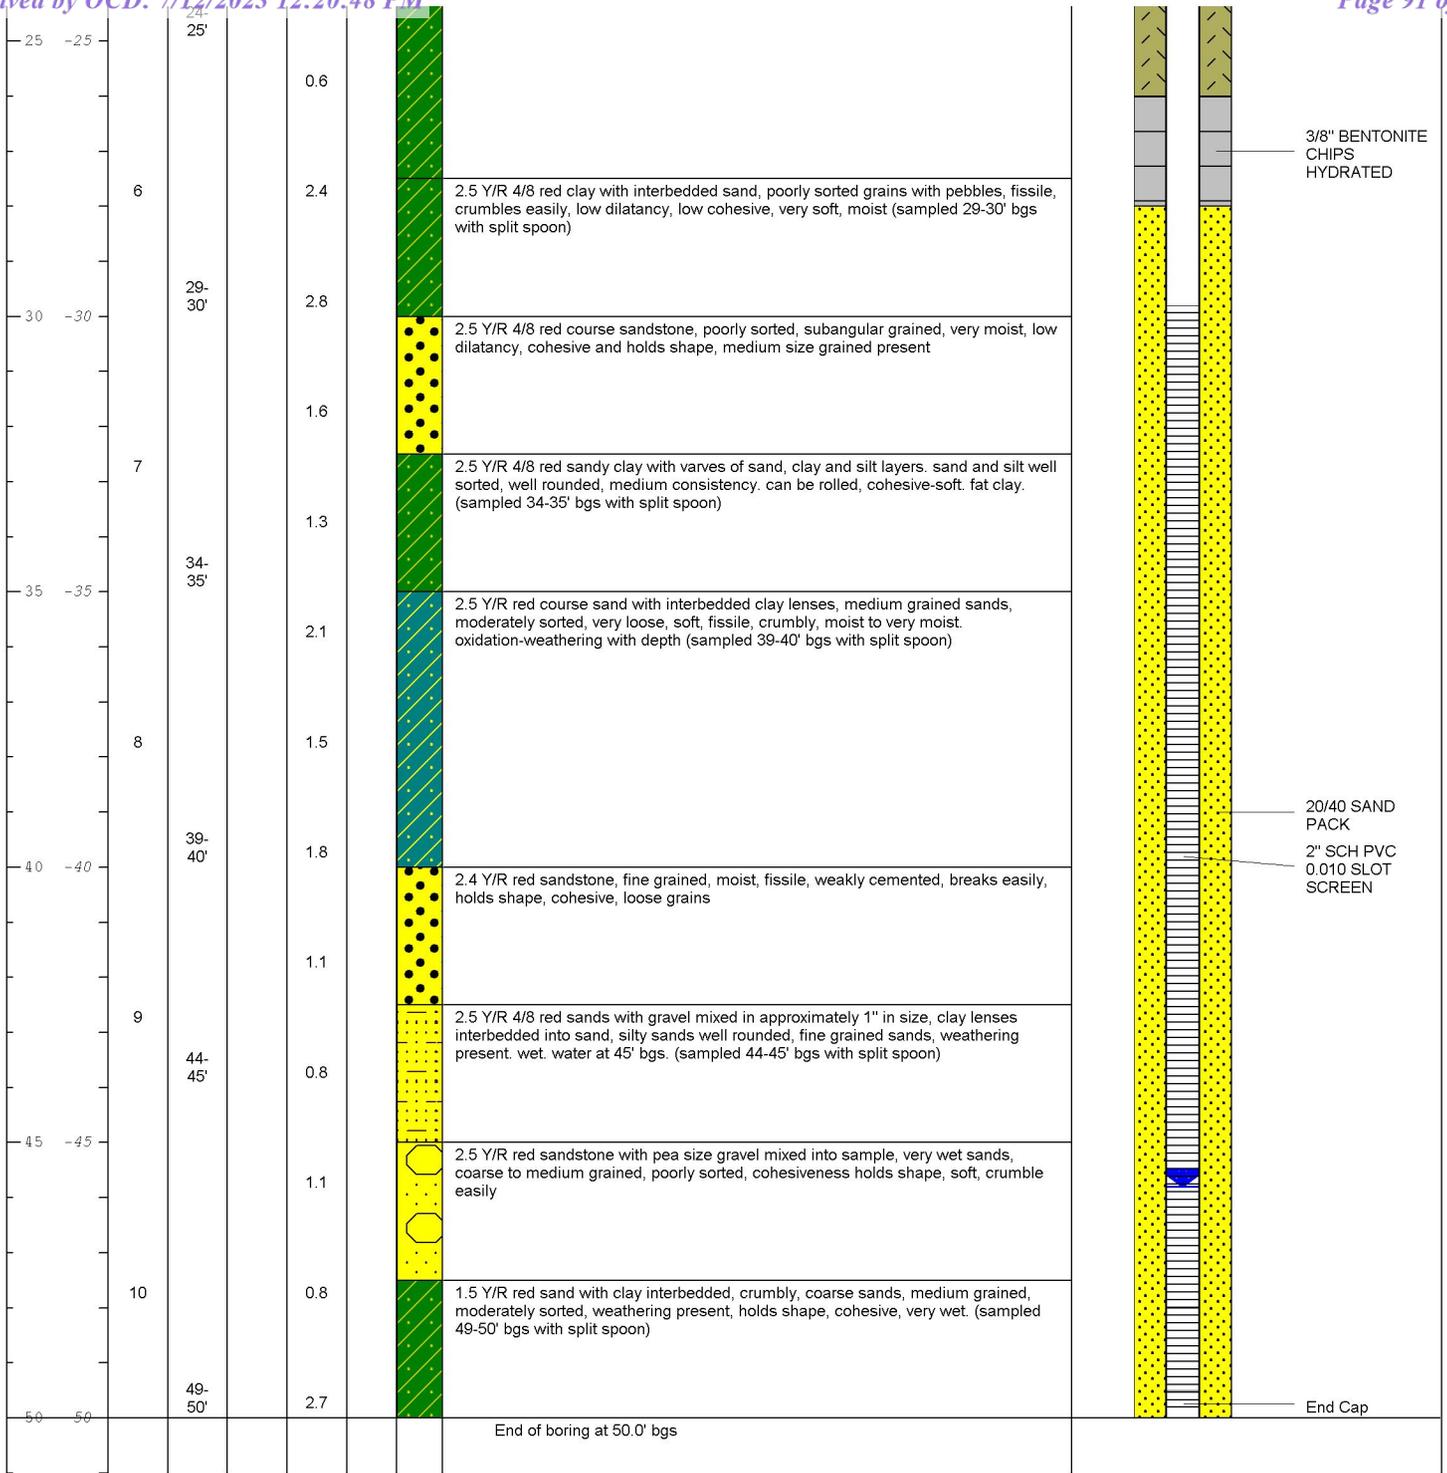
<b>Date Start/Finish:</b> 2/13/2023 <b>Drilling Company:</b> White Drilling Company, Inc. <b>Driller's Name:</b> Bo Atkins <b>Drilling Method:</b> Air Rotary/ Split Spoon <b>Sampling Method:</b> Grab	<b>Latitude:</b> 32.390881 <b>Longitude:</b> -104.12482 <b>Casing Elevation:</b> NS  <b>Borehole Depth:</b> 50' <b>Surface Elevation:</b> NS  <b>Descriptions By:</b> Heather Dudley	<b>Well/Boring ID:</b> TW-1  <b>Client:</b> Chevron-MCBU  <b>Location:</b> Old Indian Draw Unit #001 Carlsbad, New Mexico
---	---	---

DEPTH	Sample Run Number	Sample/Int/Type	Recovery (feet)	PID	USCS Code	Geologic Column	Stratigraphic Description	Well/Boring Construction
-------	-------------------	-----------------	-----------------	-----	-----------	-----------------	---------------------------	--------------------------
