**Re: Closure Request
Mesa Dolphin - Poly Line Weld Leak
Incident Number nAPP2303736433
Lea County, New Mexico**

BTA Oil Producers, LLC
Closure Request
Mesa Dolphin - Poly Line Weld Leak

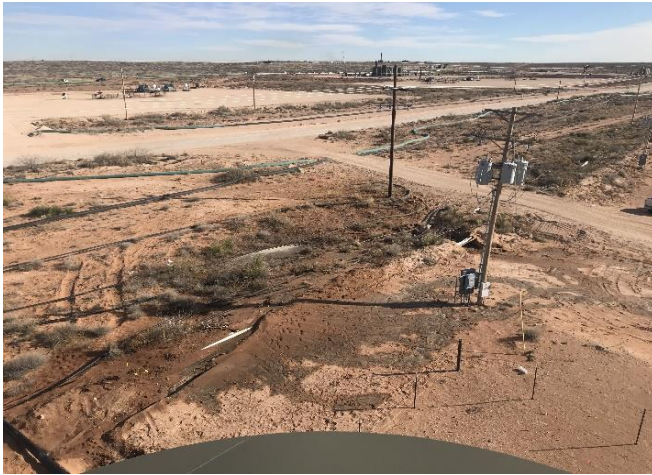
Photograph: 1 (client provided photo) Date: 1/30/2023
Description: Soil staining in release footprint
View: Northeast

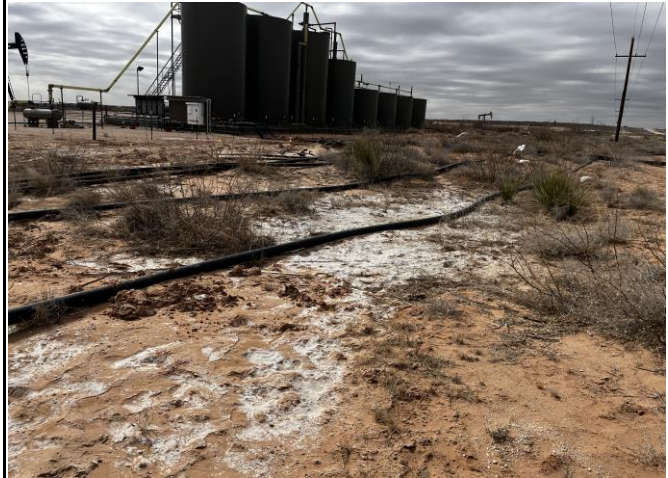
Photograph: 2 Date: 3/3/2023
Description: Initial assessment activities
View: Southwest

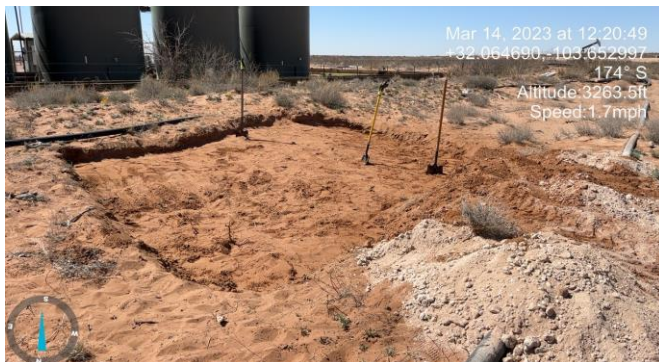
Photograph: 3 Date: 3/14/2023
Description: Excavation activities
View: South

On March 14, 2023, Ensolum personnel were at the Site to oversee excavation activities based on visible staining and laboratory analytical results for soil samples SS01 and SS02. Excavation activities were performed utilizing hand shovels. To direct excavation activities, soil was screened for VOCs and chloride. The excavation was completed to a depth of 1-foot bgs. Photographic documentation of the excavation activities is included in Appendix C.

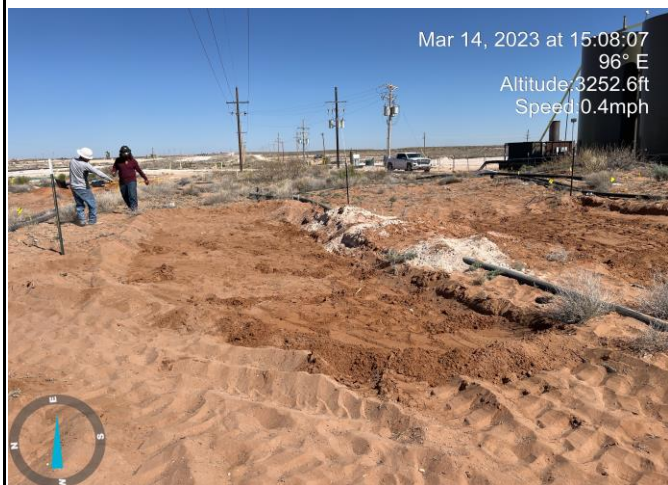
Photograph: 4 Date: 3/14/2023
Description: Excavation activities
View: East
