**RE: Site Assessment, Remediation, and Variance Request
Chimayo 16 State #003
API No. 30-015-38105
GPS: Latitude 32.1329002 Longitude -103.9933624
UL "F", Section 16, Township 25S, Range 29E,
Eddy County, NM
NMOCD Reference No. NAB1532742191**

Raybaw Operating, LLC (Raybaw) has contracted Pima Environmental Services, LLC (Pima) to perform a site assessment, remediation, and prepare this variance request for a produced water release that happened at the Chimayo 16 State #003 (Chimayo). An initial C-141 was submitted on November 20, 2015, and can be found in Appendix C. This incident was assigned Incident ID NAB1532742191, by the New Mexico Oil Conservation Division (NMOCD).

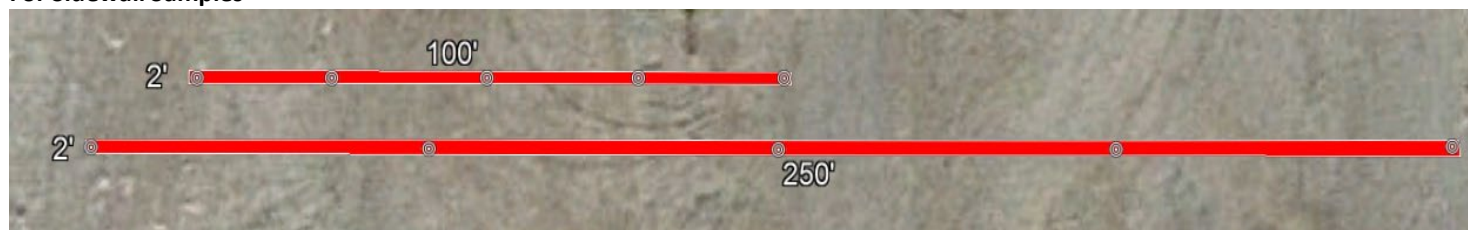
For Sidewall Samples

Top Line = 200 Square Foot

Bottom Line = 500 Square Foot

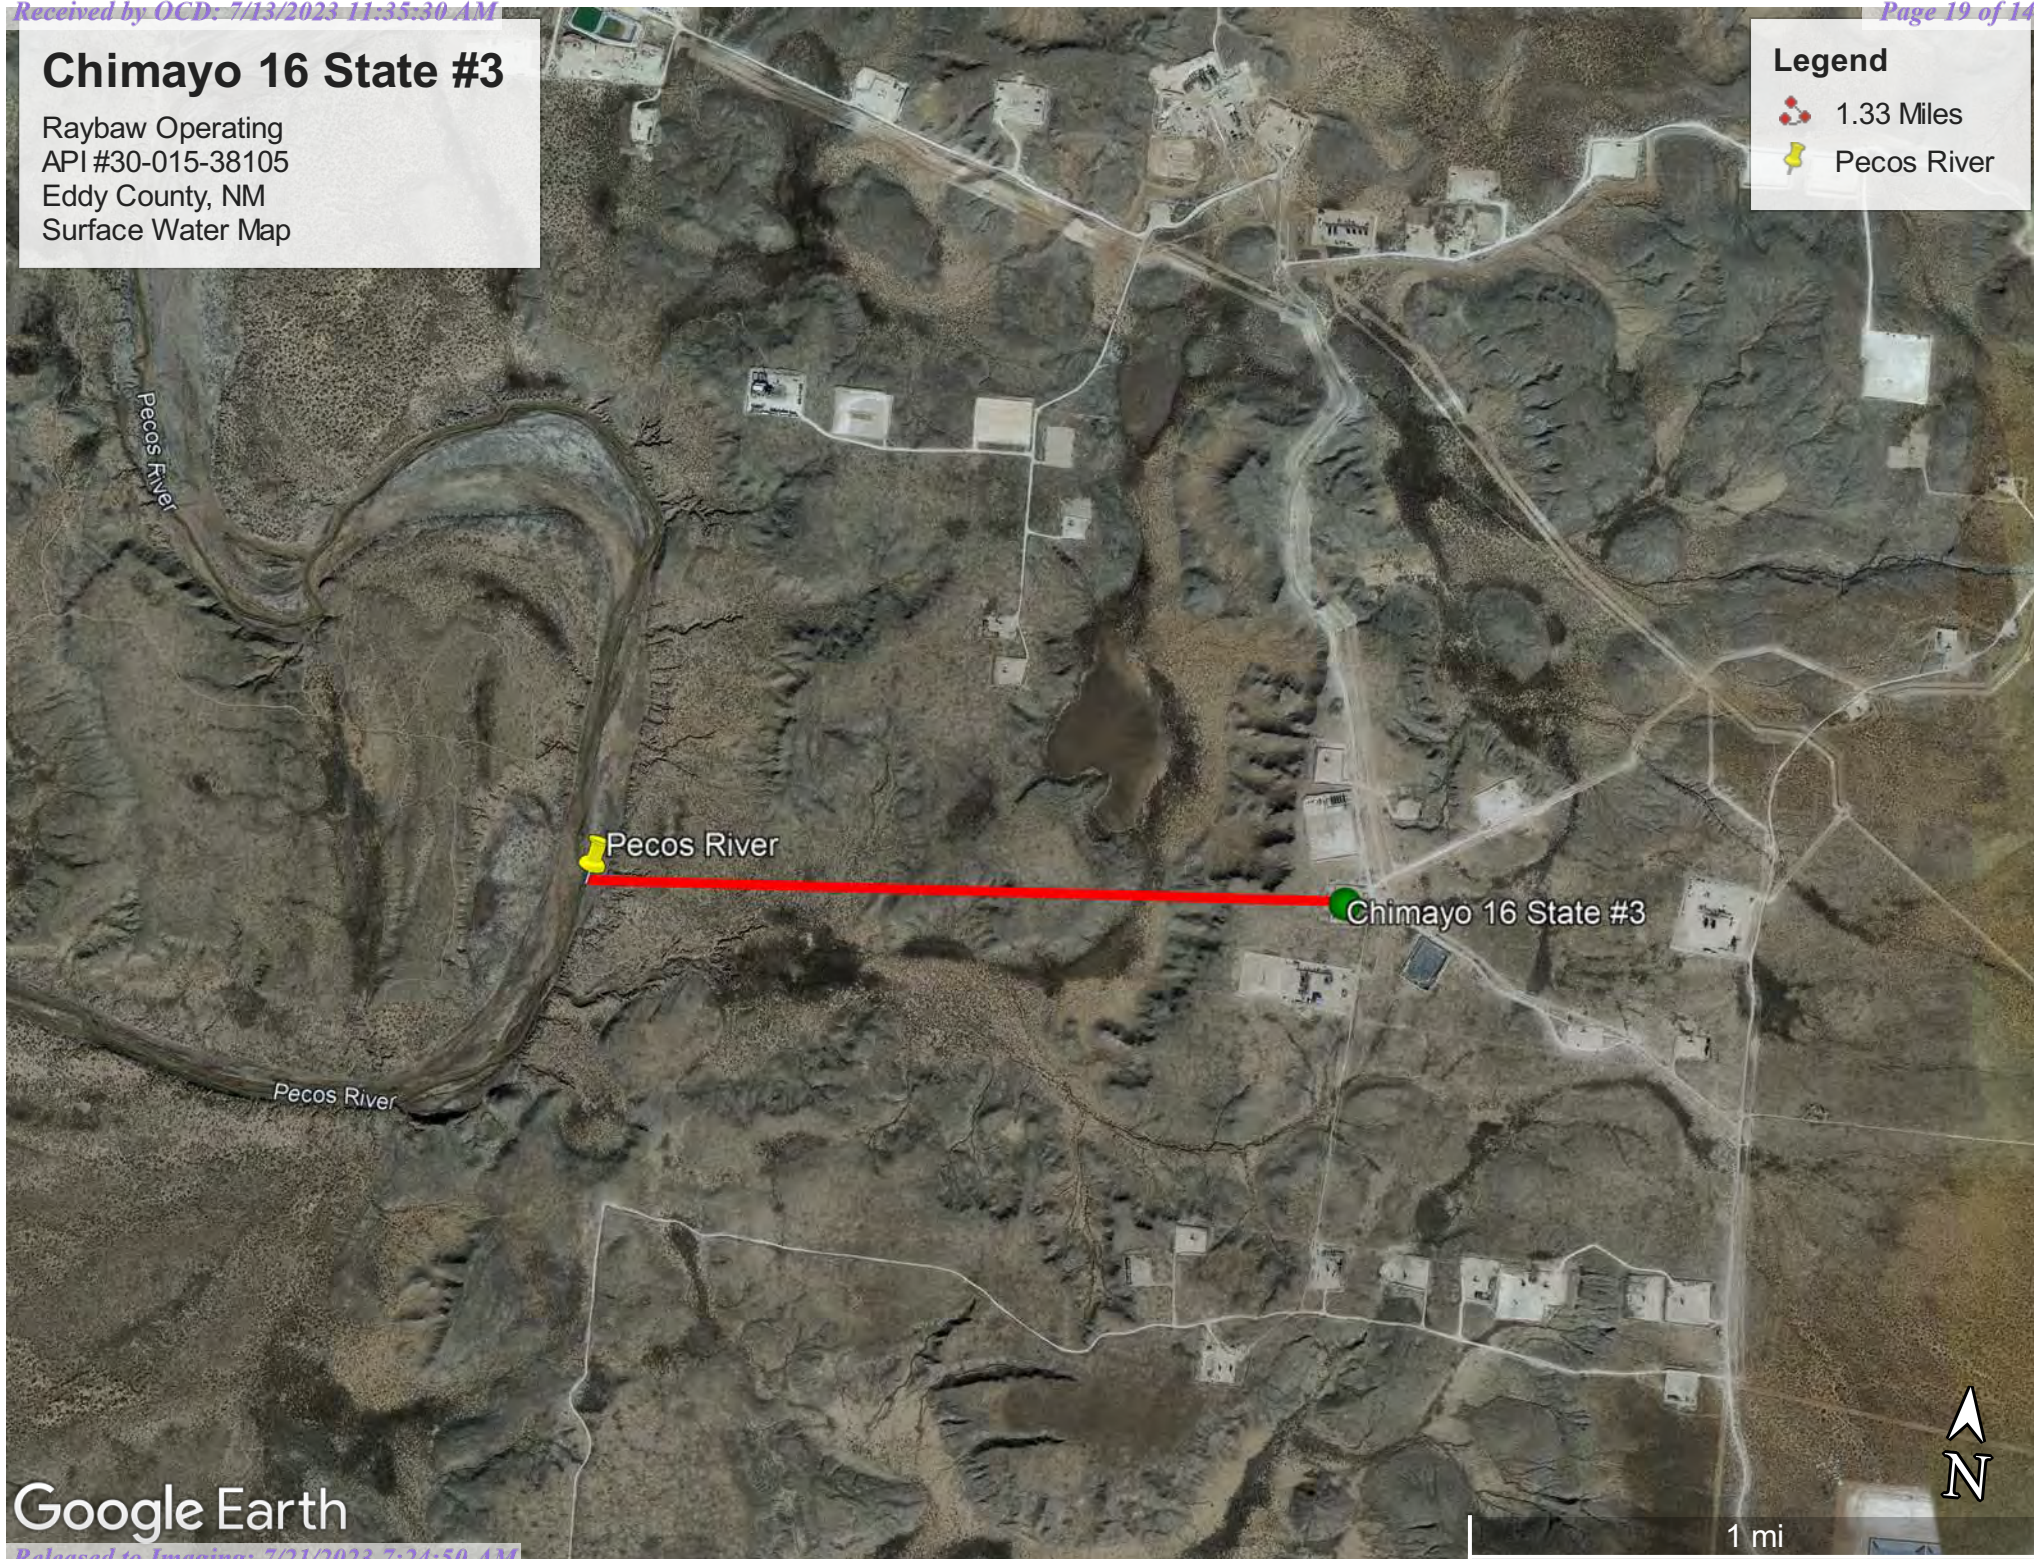
- 1.33 Miles
- Pecos River

2. The nearest surface water feature to this site is the Pecos River and is approximately 1.33 miles to the west (Appendix A).
3. According to FEMA, this site is in a minimal flood hazard area (Appendix B).

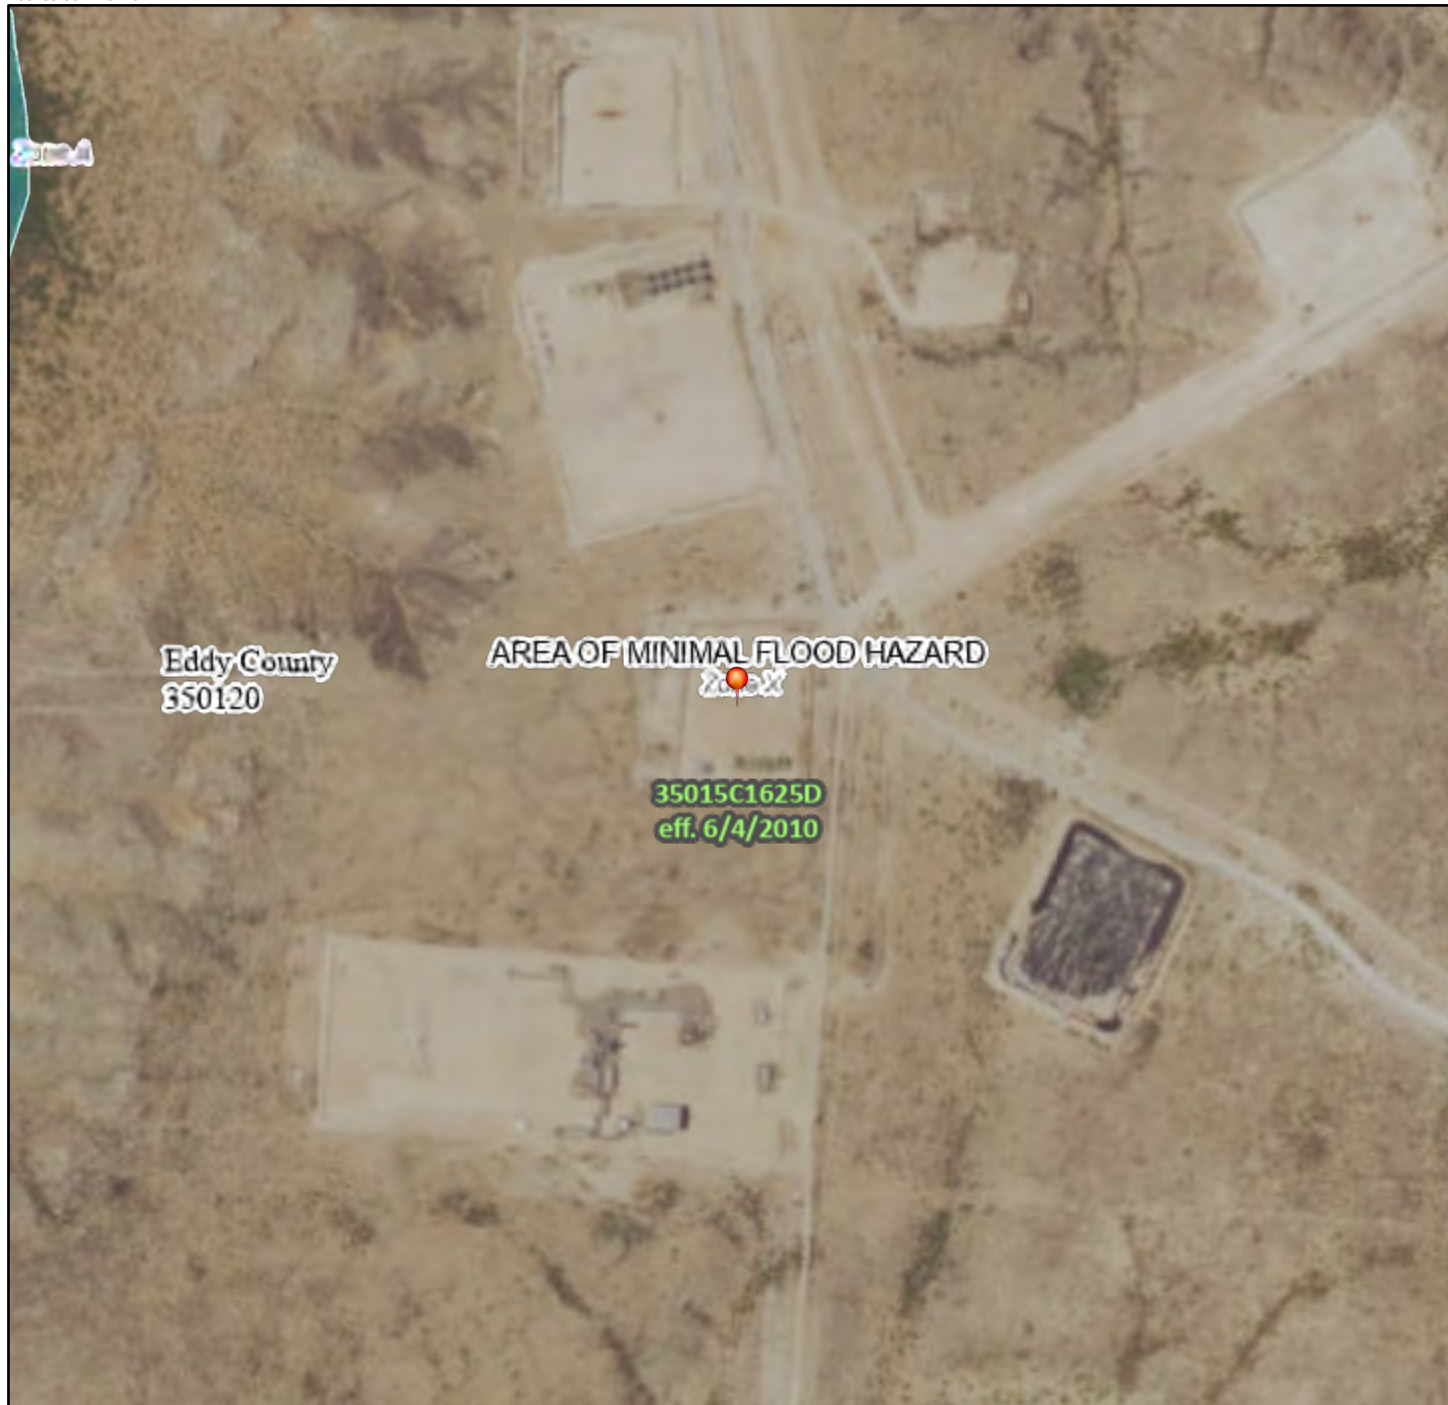
National Flood Hazard Layer FIRMette

NO SCREEN Area of Minimal Flood Hazard Zone X
