Site Assessment/Characterization

Closure

Re: Site Assessment, Remediation, and Closure Report
Cotton Draw Unit #292H
API No. 30-015-43261
GPS: Latitude 32.171190 Longitude -103.733350
UL -- K, Sec. 36, T24S, R31E
Eddy County, NM
NMOCD Ref. No. NAB1602526481

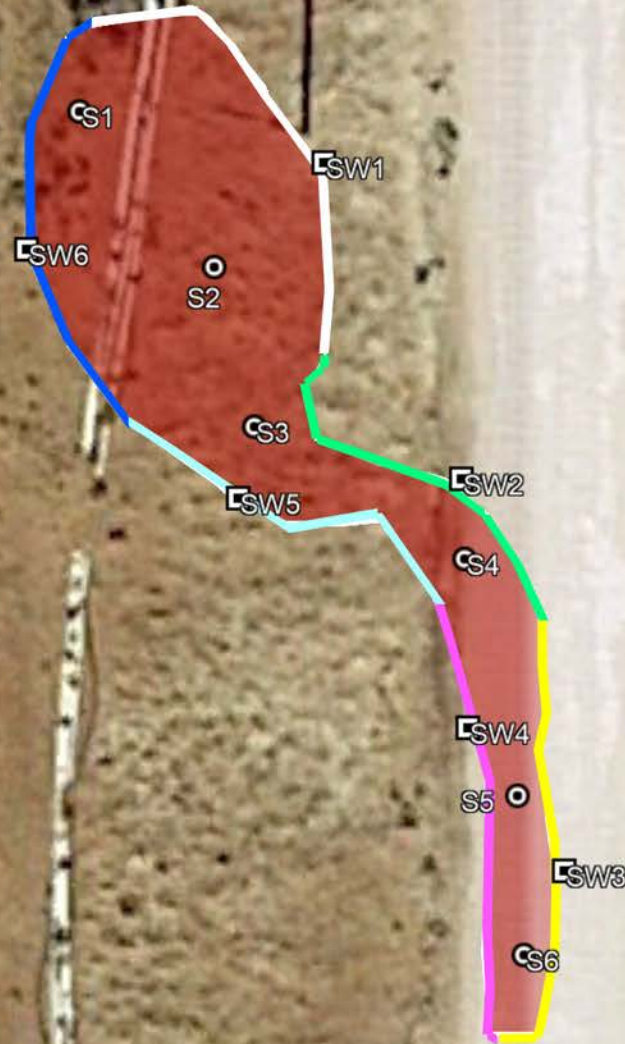
Devon Energy
NAB1602526481
Eddy County, NM
30-015-43261
Site Map

On July 7th, 2023, Pima Environmental mobilized personnel to assess the impacted area. Pima collected a total of twenty-four soil samples for laboratory analysis. Six bottom samples (S1-S6) were collected at various depths to determine vertical delineation. Additionally, side wall samples (SW1-SW6) were collected at a depth of 6 inches to determine horizontal delineation. An initial site map can be found in Figure 4.

- Bottom Sample
- Release Area
- Side Wall Sample
- SW1
- SW2
- SW3
- SW4
- SW5
- SW6

Based on the sample results, the bottoms and sidewalls are below NMOCD Closure Criteria 19.15.29 NMAC. See Appendix D for Photographic Documentation.
