**RE: Closure Report  
ConocoPhillips  
Heritage Concho  
SRO State Com #46H  
Unit Letter D, Section 05, Township 26 South, Range 28 East  
Eddy County, New Mexico  
Incident ID: nAB1803638110**

Closure Report  
July 21, 2023

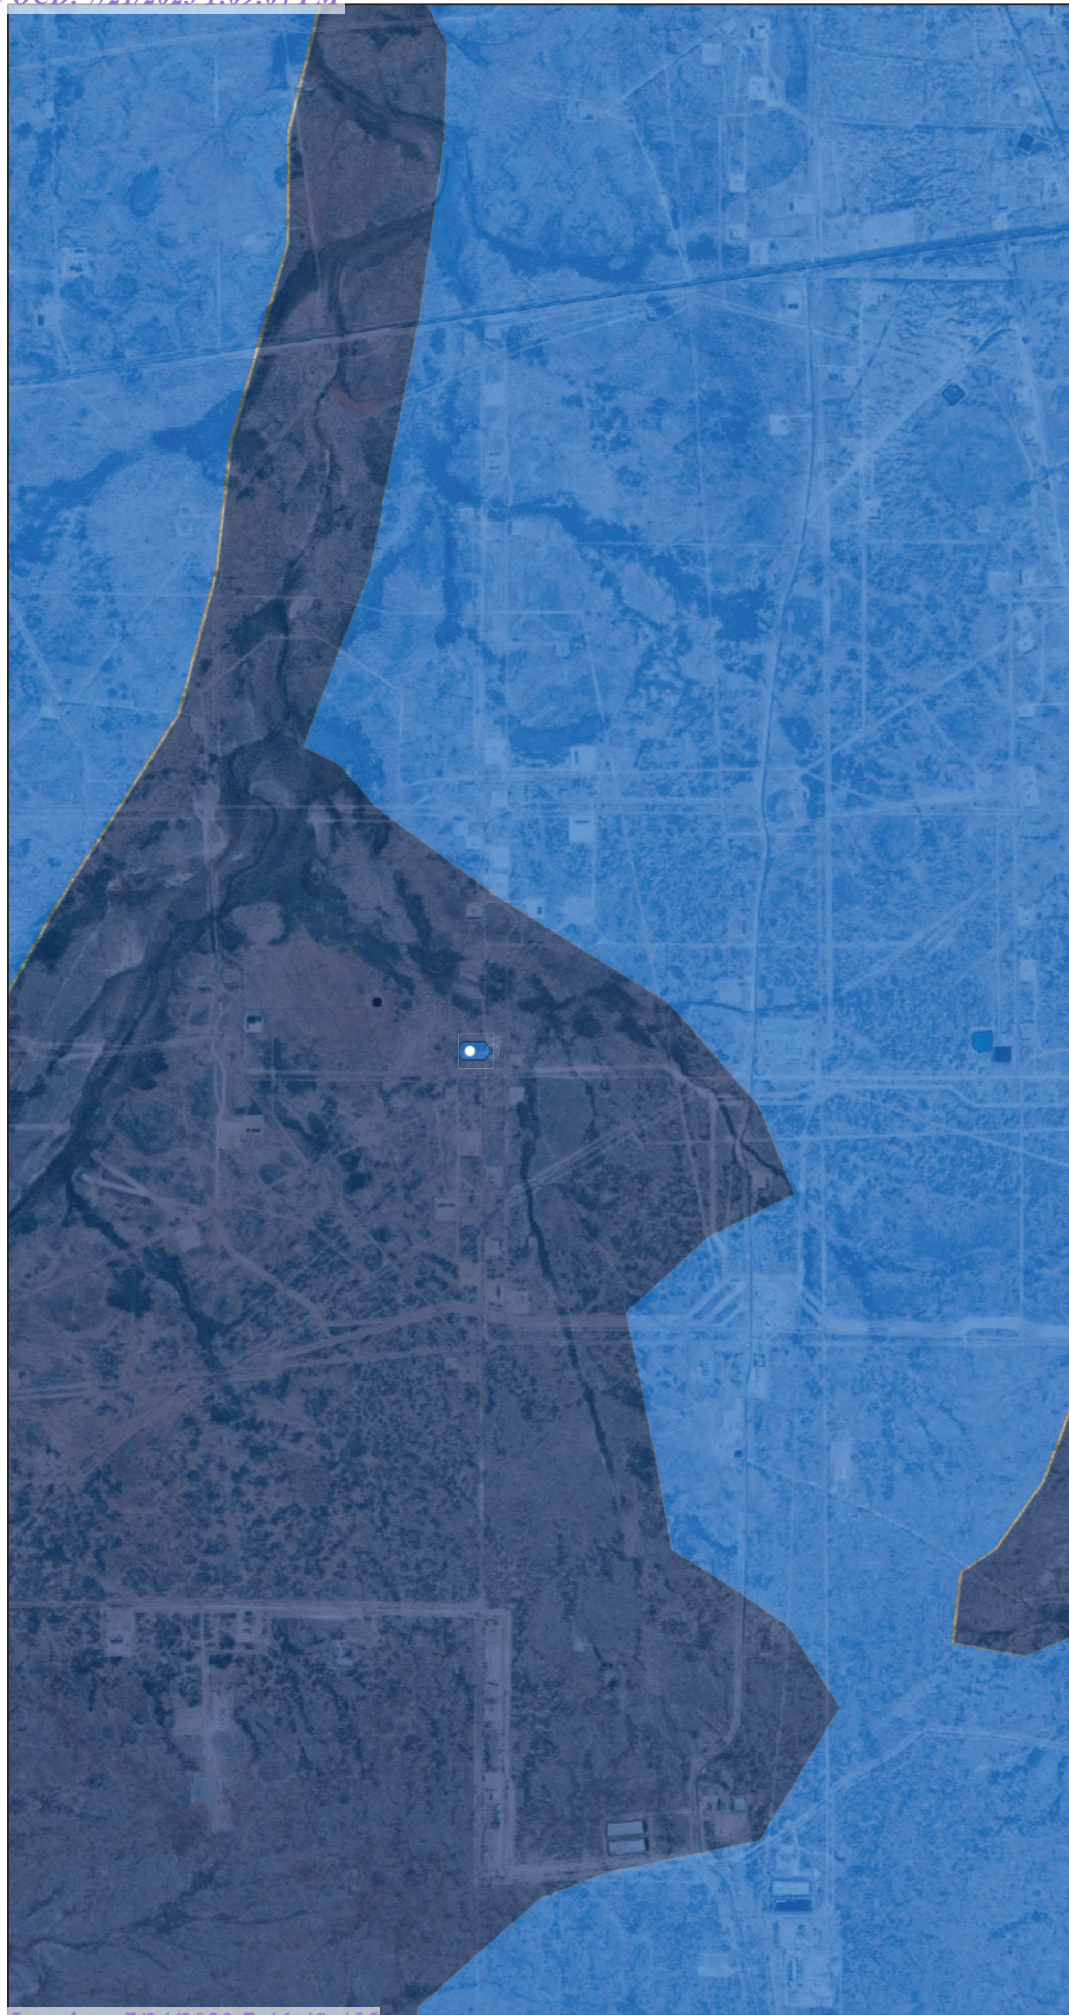
# OCD Potential Karst Locations

A site characterization was performed and no sinkholes, residences, schools, hospitals, institutions, churches, springs, private domestic water wells, stream bodies, wetlands, incorporated municipal boundaries, subsurface mines, or floodplains are located within the distances specified in 19.15.29 New Mexico Administrative Code (NMAC). There are two mapped water bodies approximately 0.25 miles east of the release site. The Site is in an area of high karst potential.

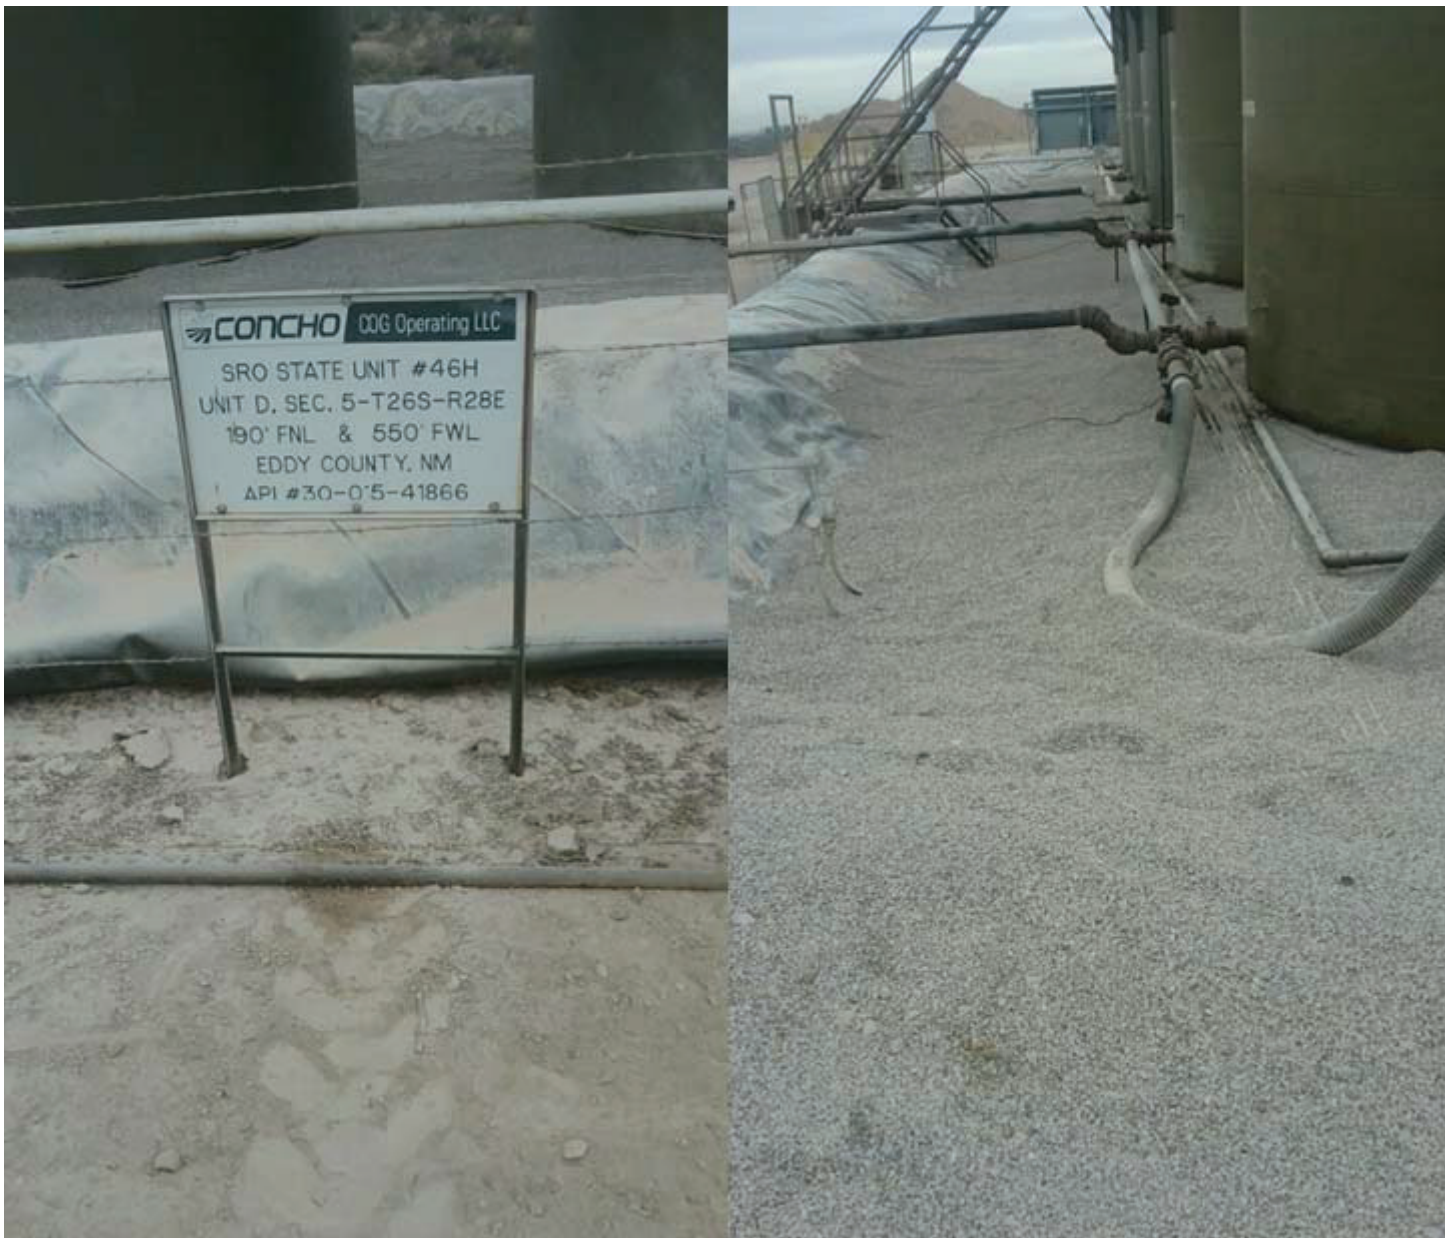
A final inspection has been conducted regarding the clean-up efforts made at the above mentioned lined facility. Free fluids were removed and if present the impacted gravel was removed from the liner and taken to a NMOCD approved disposal facility. The liner was inspected for damage and found to have liner integrity to contain free fluids. Please see the attached Final C-141 and picture taken during the final inspection conducted by a COG HSE representative.

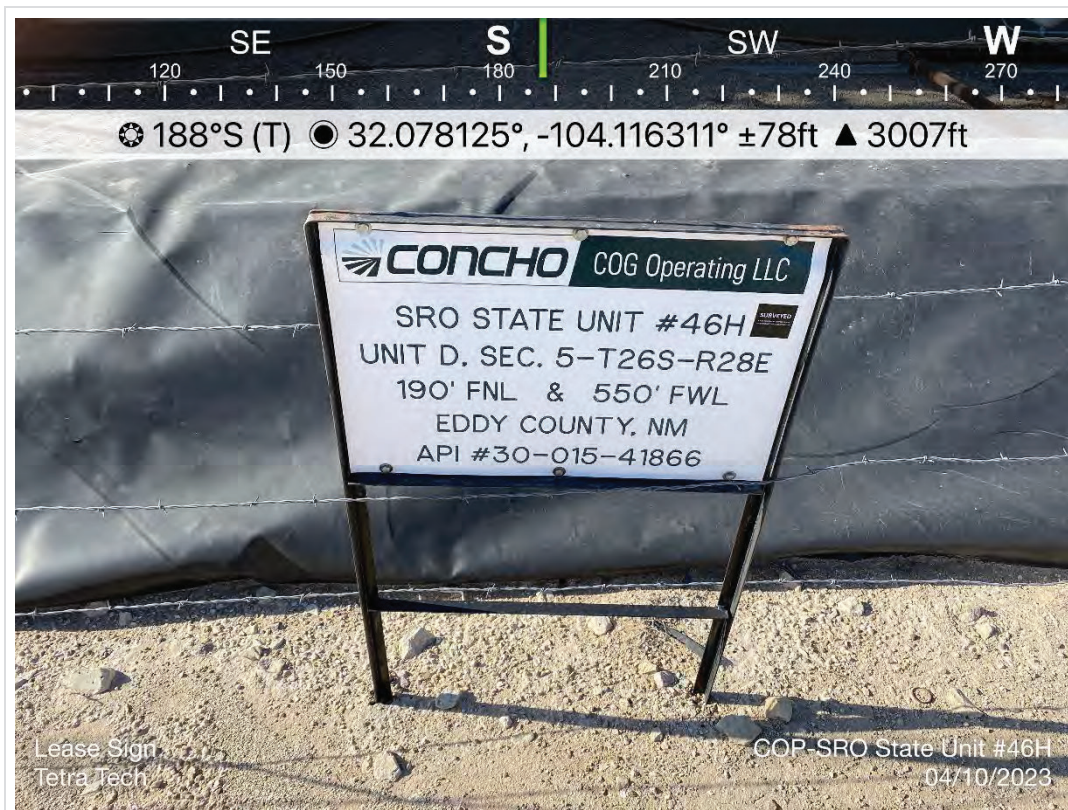
TETRA TECH, INC. PROJECT NO. 212C-MD-03032	DESCRIPTION	View south of Site signage.	1
	SITE NAME	SRO State Com #46H	4/10/2023

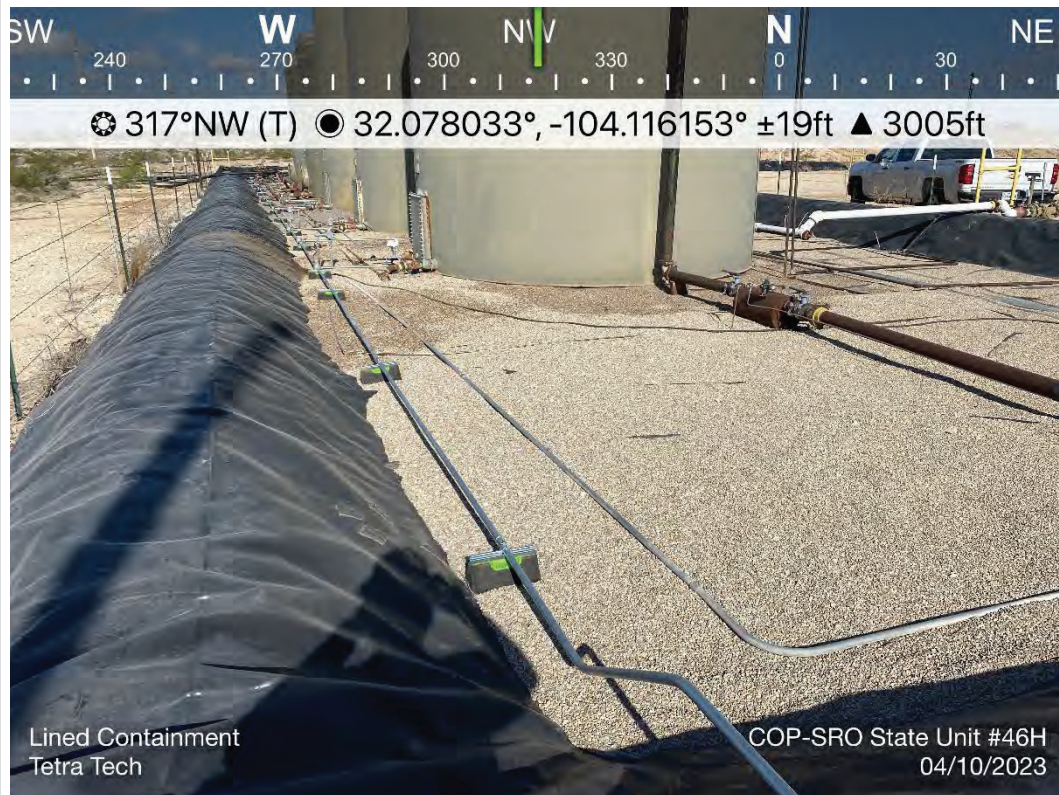
TETRA TECH, INC. PROJECT NO. 212C-MD-03032	DESCRIPTION	View northwest. View of tank batteries inside containment liner. Staining shown around tank batteries.	2
	SITE NAME	SRO State Com #46H	4/10/2023

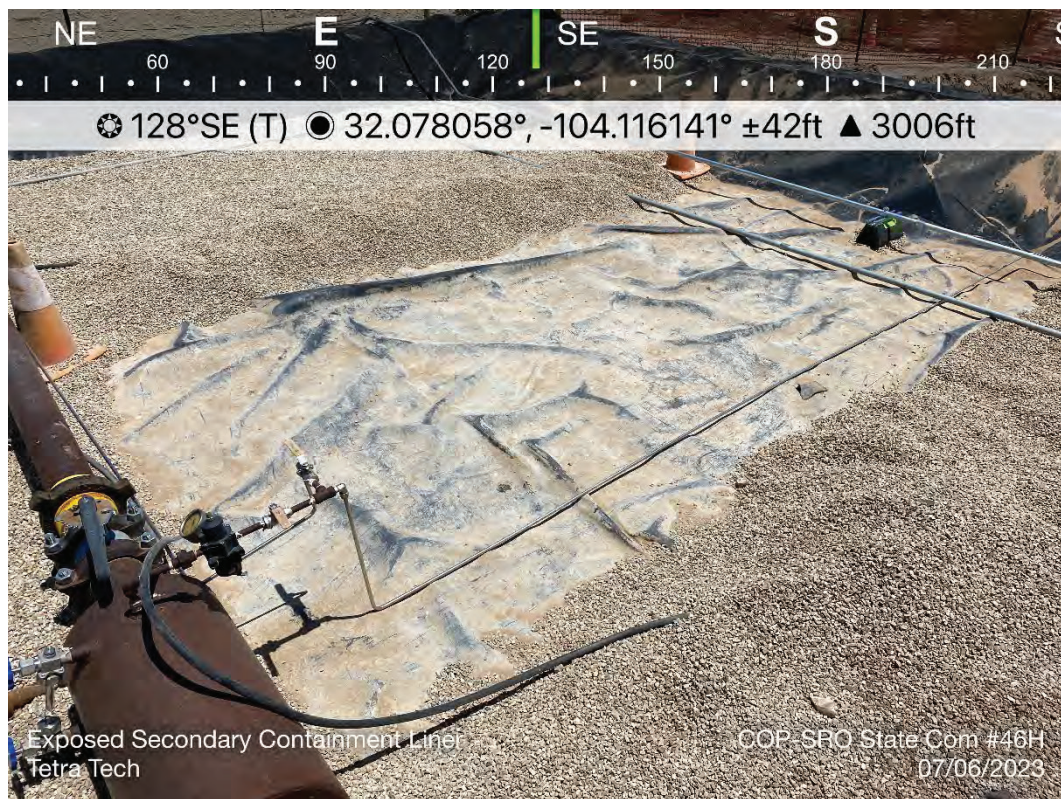
TETRA TECH, INC. PROJECT NO. 212C-MD-03032	DESCRIPTION	View southeast View of exposed liner in the approximate release area. Liner integrity intact.	4
	SITE NAME	SRO State Com #46H	4/10/2023

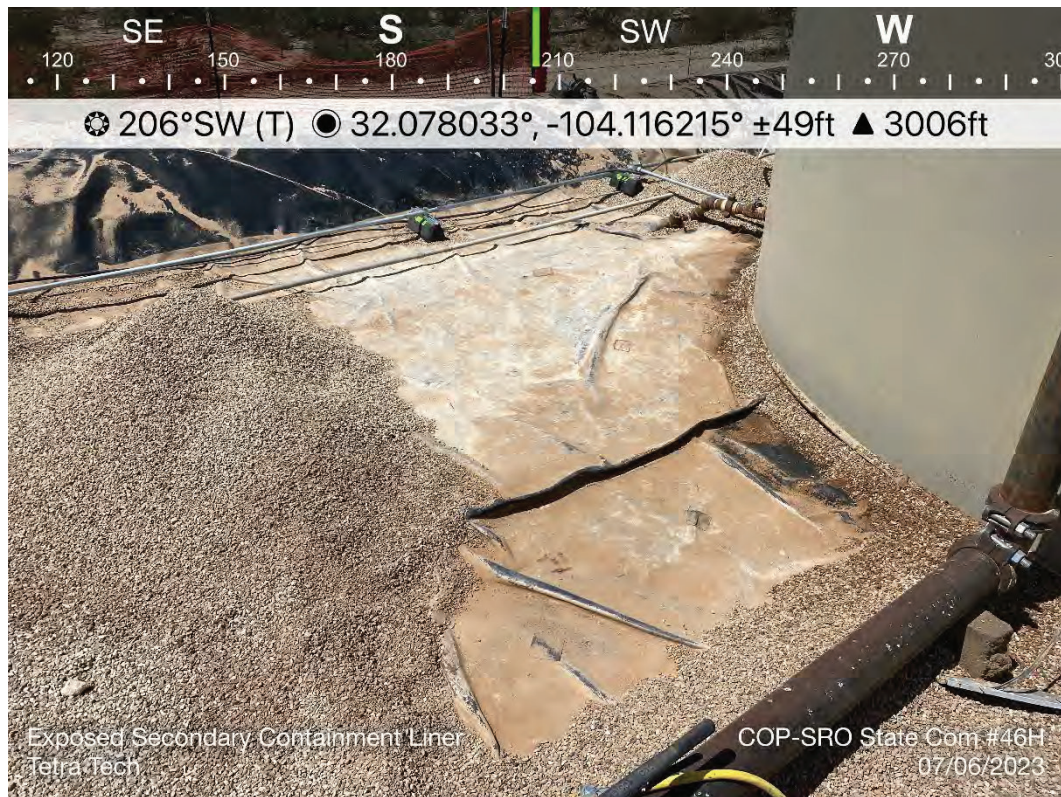
TETRA TECH, INC. PROJECT NO. 212C-MD-03032	DESCRIPTION	View south. View of exposed liner in the approximate release point. Liner integrity intact.	6
	SITE NAME	SRO State Com #46H	7/6/2023

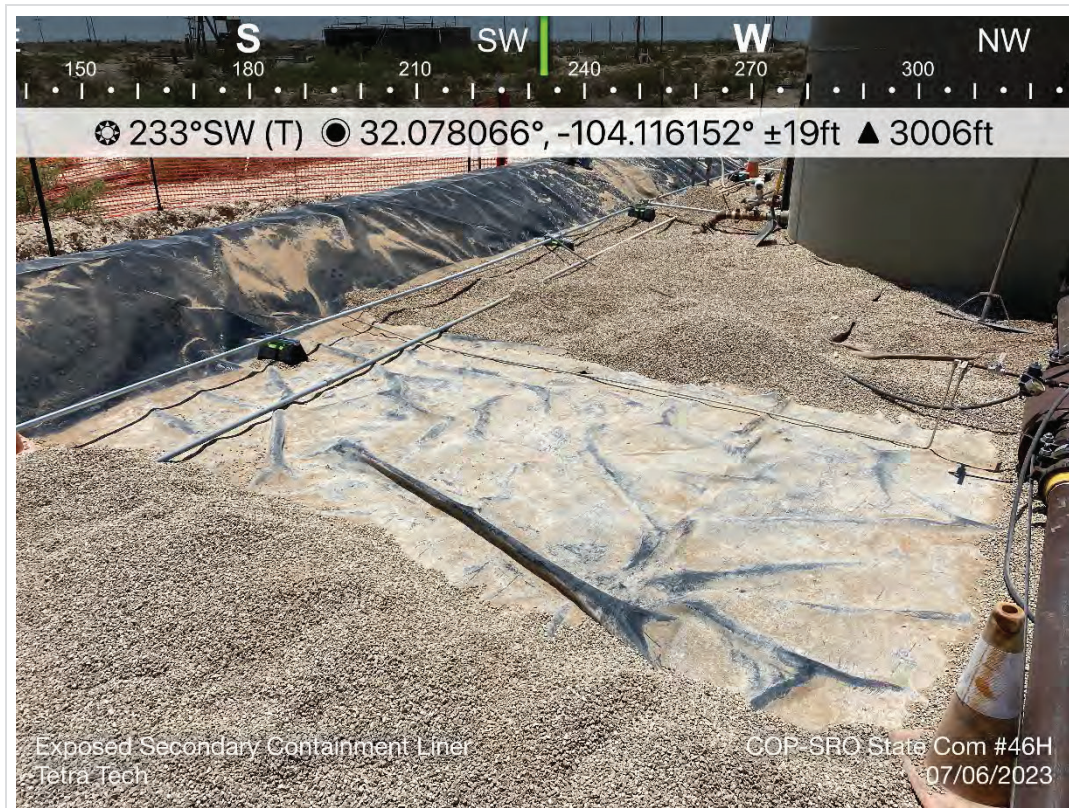
TETRA TECH, INC. PROJECT NO. 212C-MD-03032	DESCRIPTION	View southeast. View of exposed liner in the approximate release area. Liner integrity intact.	7
	SITE NAME	SRO State Com #46H	7/6/2023

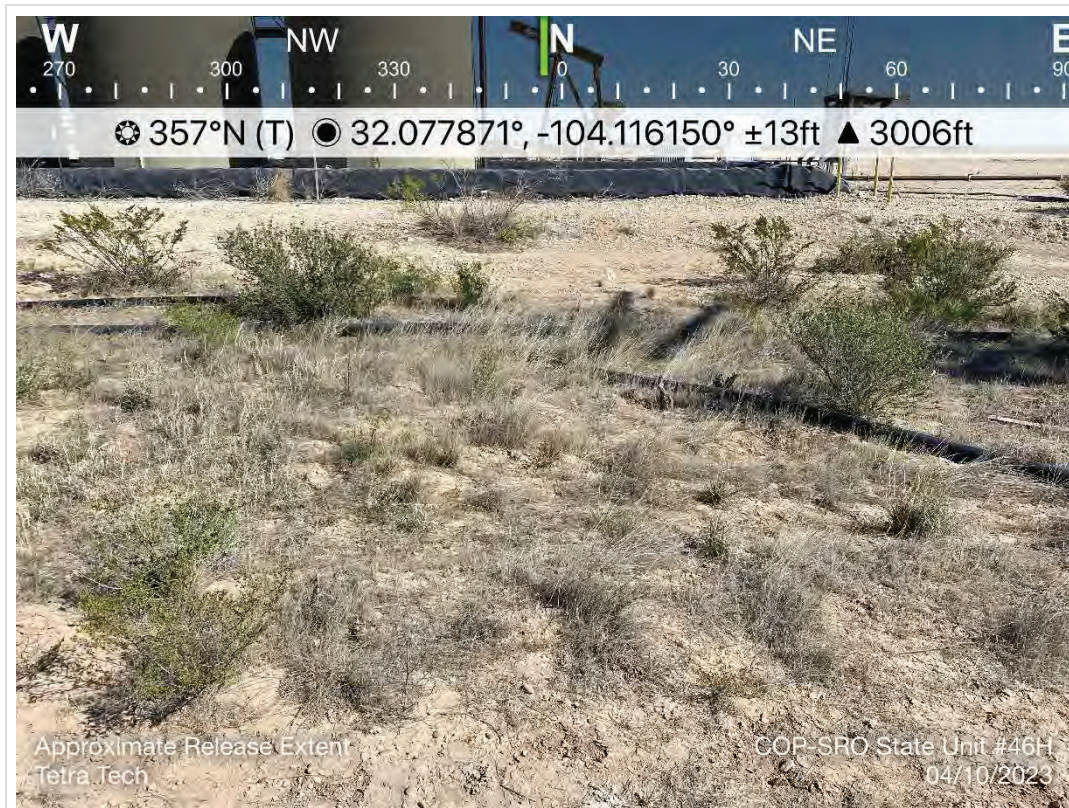
TETRA TECH, INC. PROJECT NO. 212C-MD-03032	DESCRIPTION	View north. View of approximate release extent outside lined containment.	9
	SITE NAME	SRO State Com #46H	4/10/2023

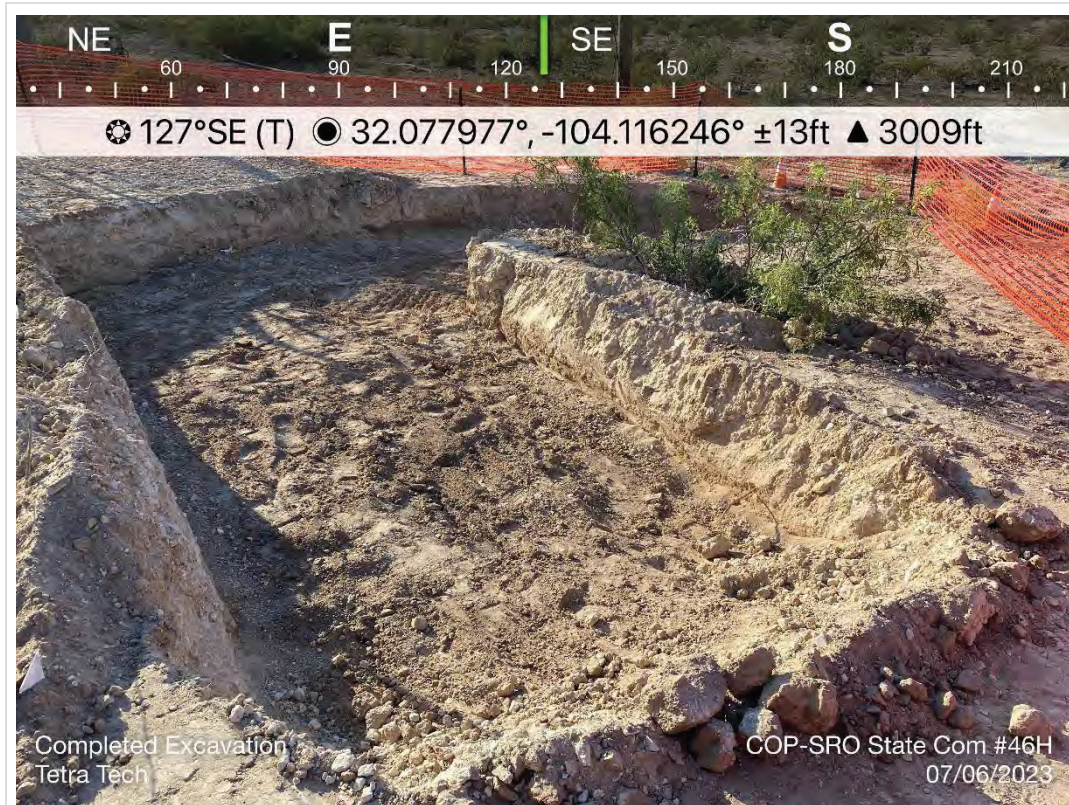
TETRA TECH, INC. PROJECT NO. 212C-MD-03032	DESCRIPTION	View southeast. View of excavation in the release extent outside lined containment.	10
	SITE NAME	SRO State Com #46H	7/6/2023

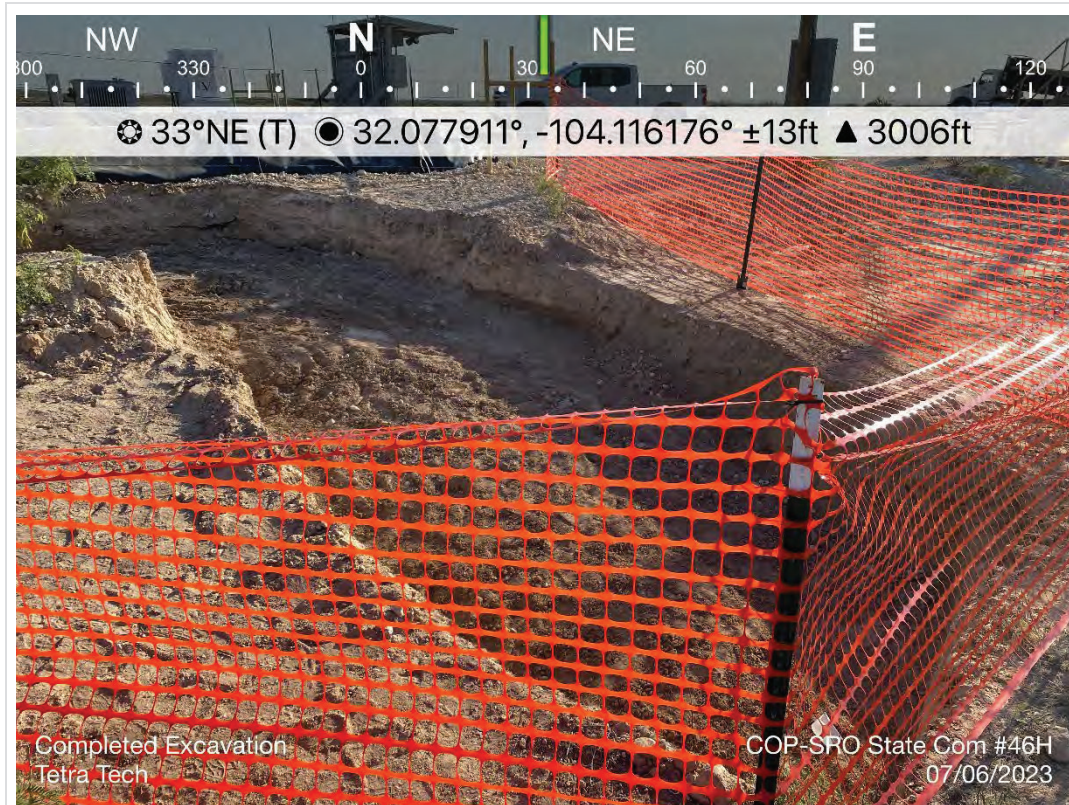
TETRA TECH, INC. PROJECT NO. 212C-MD-03032	DESCRIPTION	View northeast. View of excavation in the release extent outside lined containment.	12
	SITE NAME	SRO State Com #46H	7/6/2023
