Closure Report

Mallon 27 Federal Com #001H
Lea County, New Mexico
Incident # nAPP2210340949
P-27-19S-34E

Matador Production Company
One Lincoln Center
Dallas, TX 75240

May 19, 2022

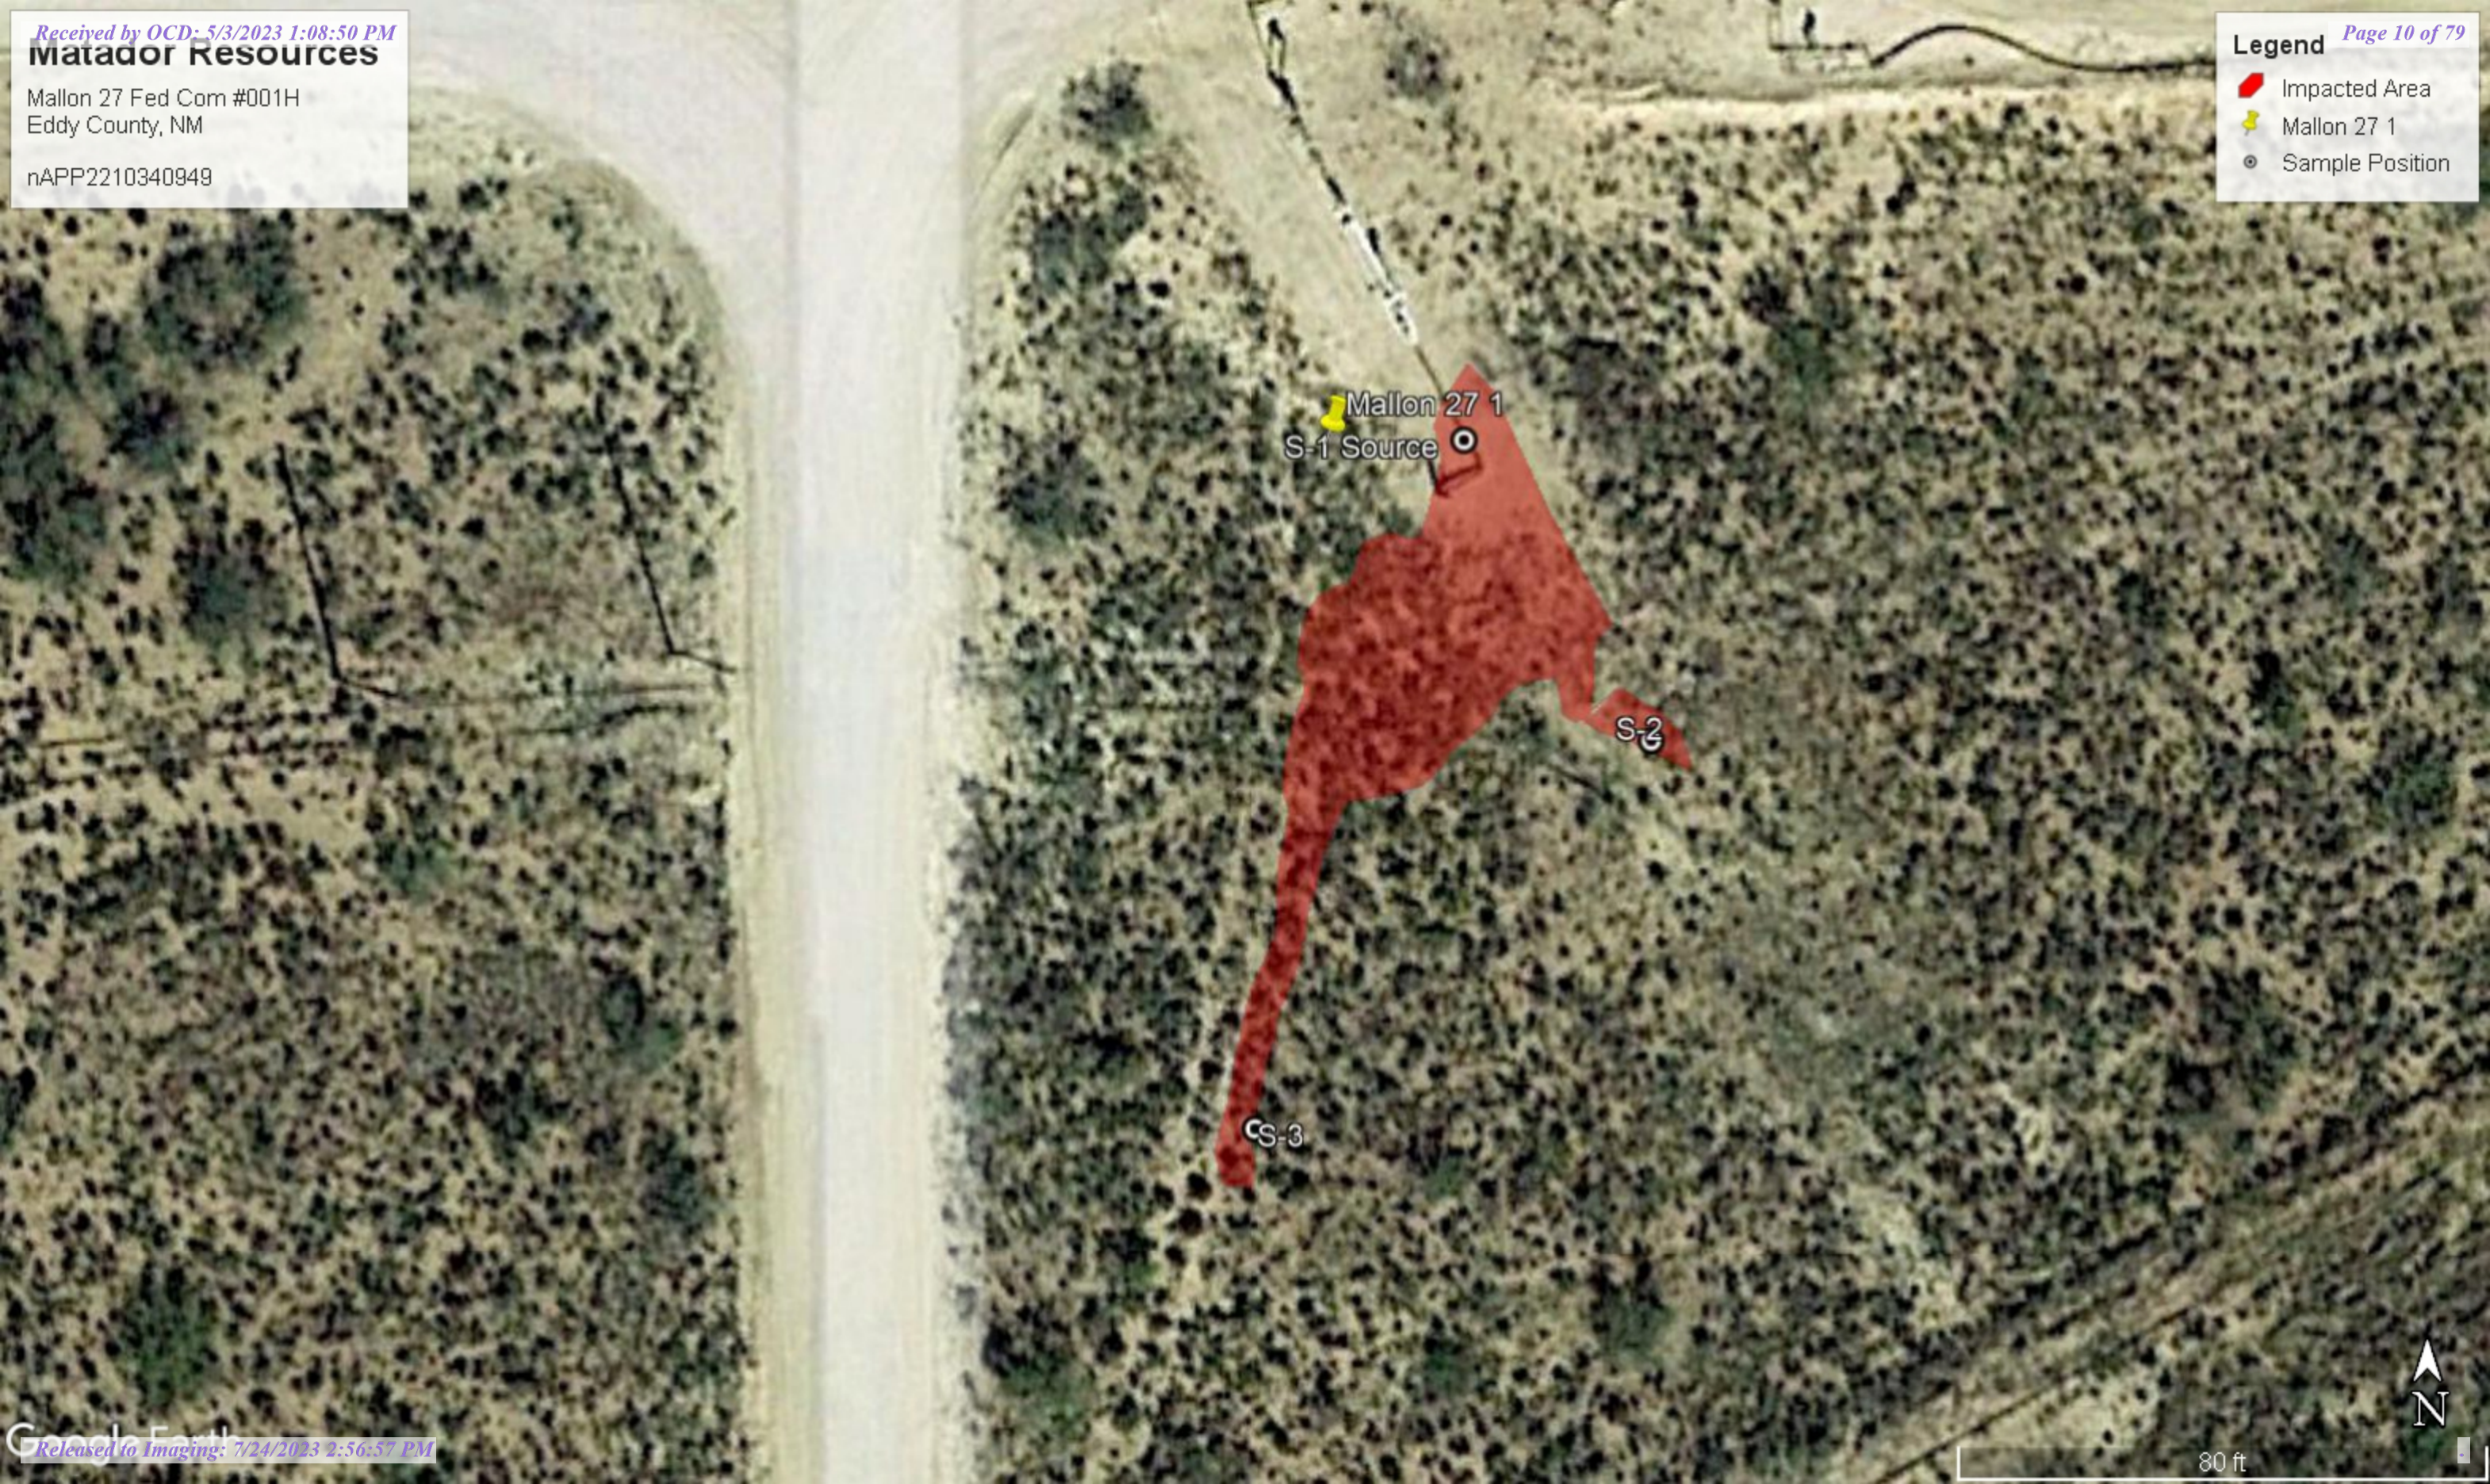
Mallon 27 1

Sample Position

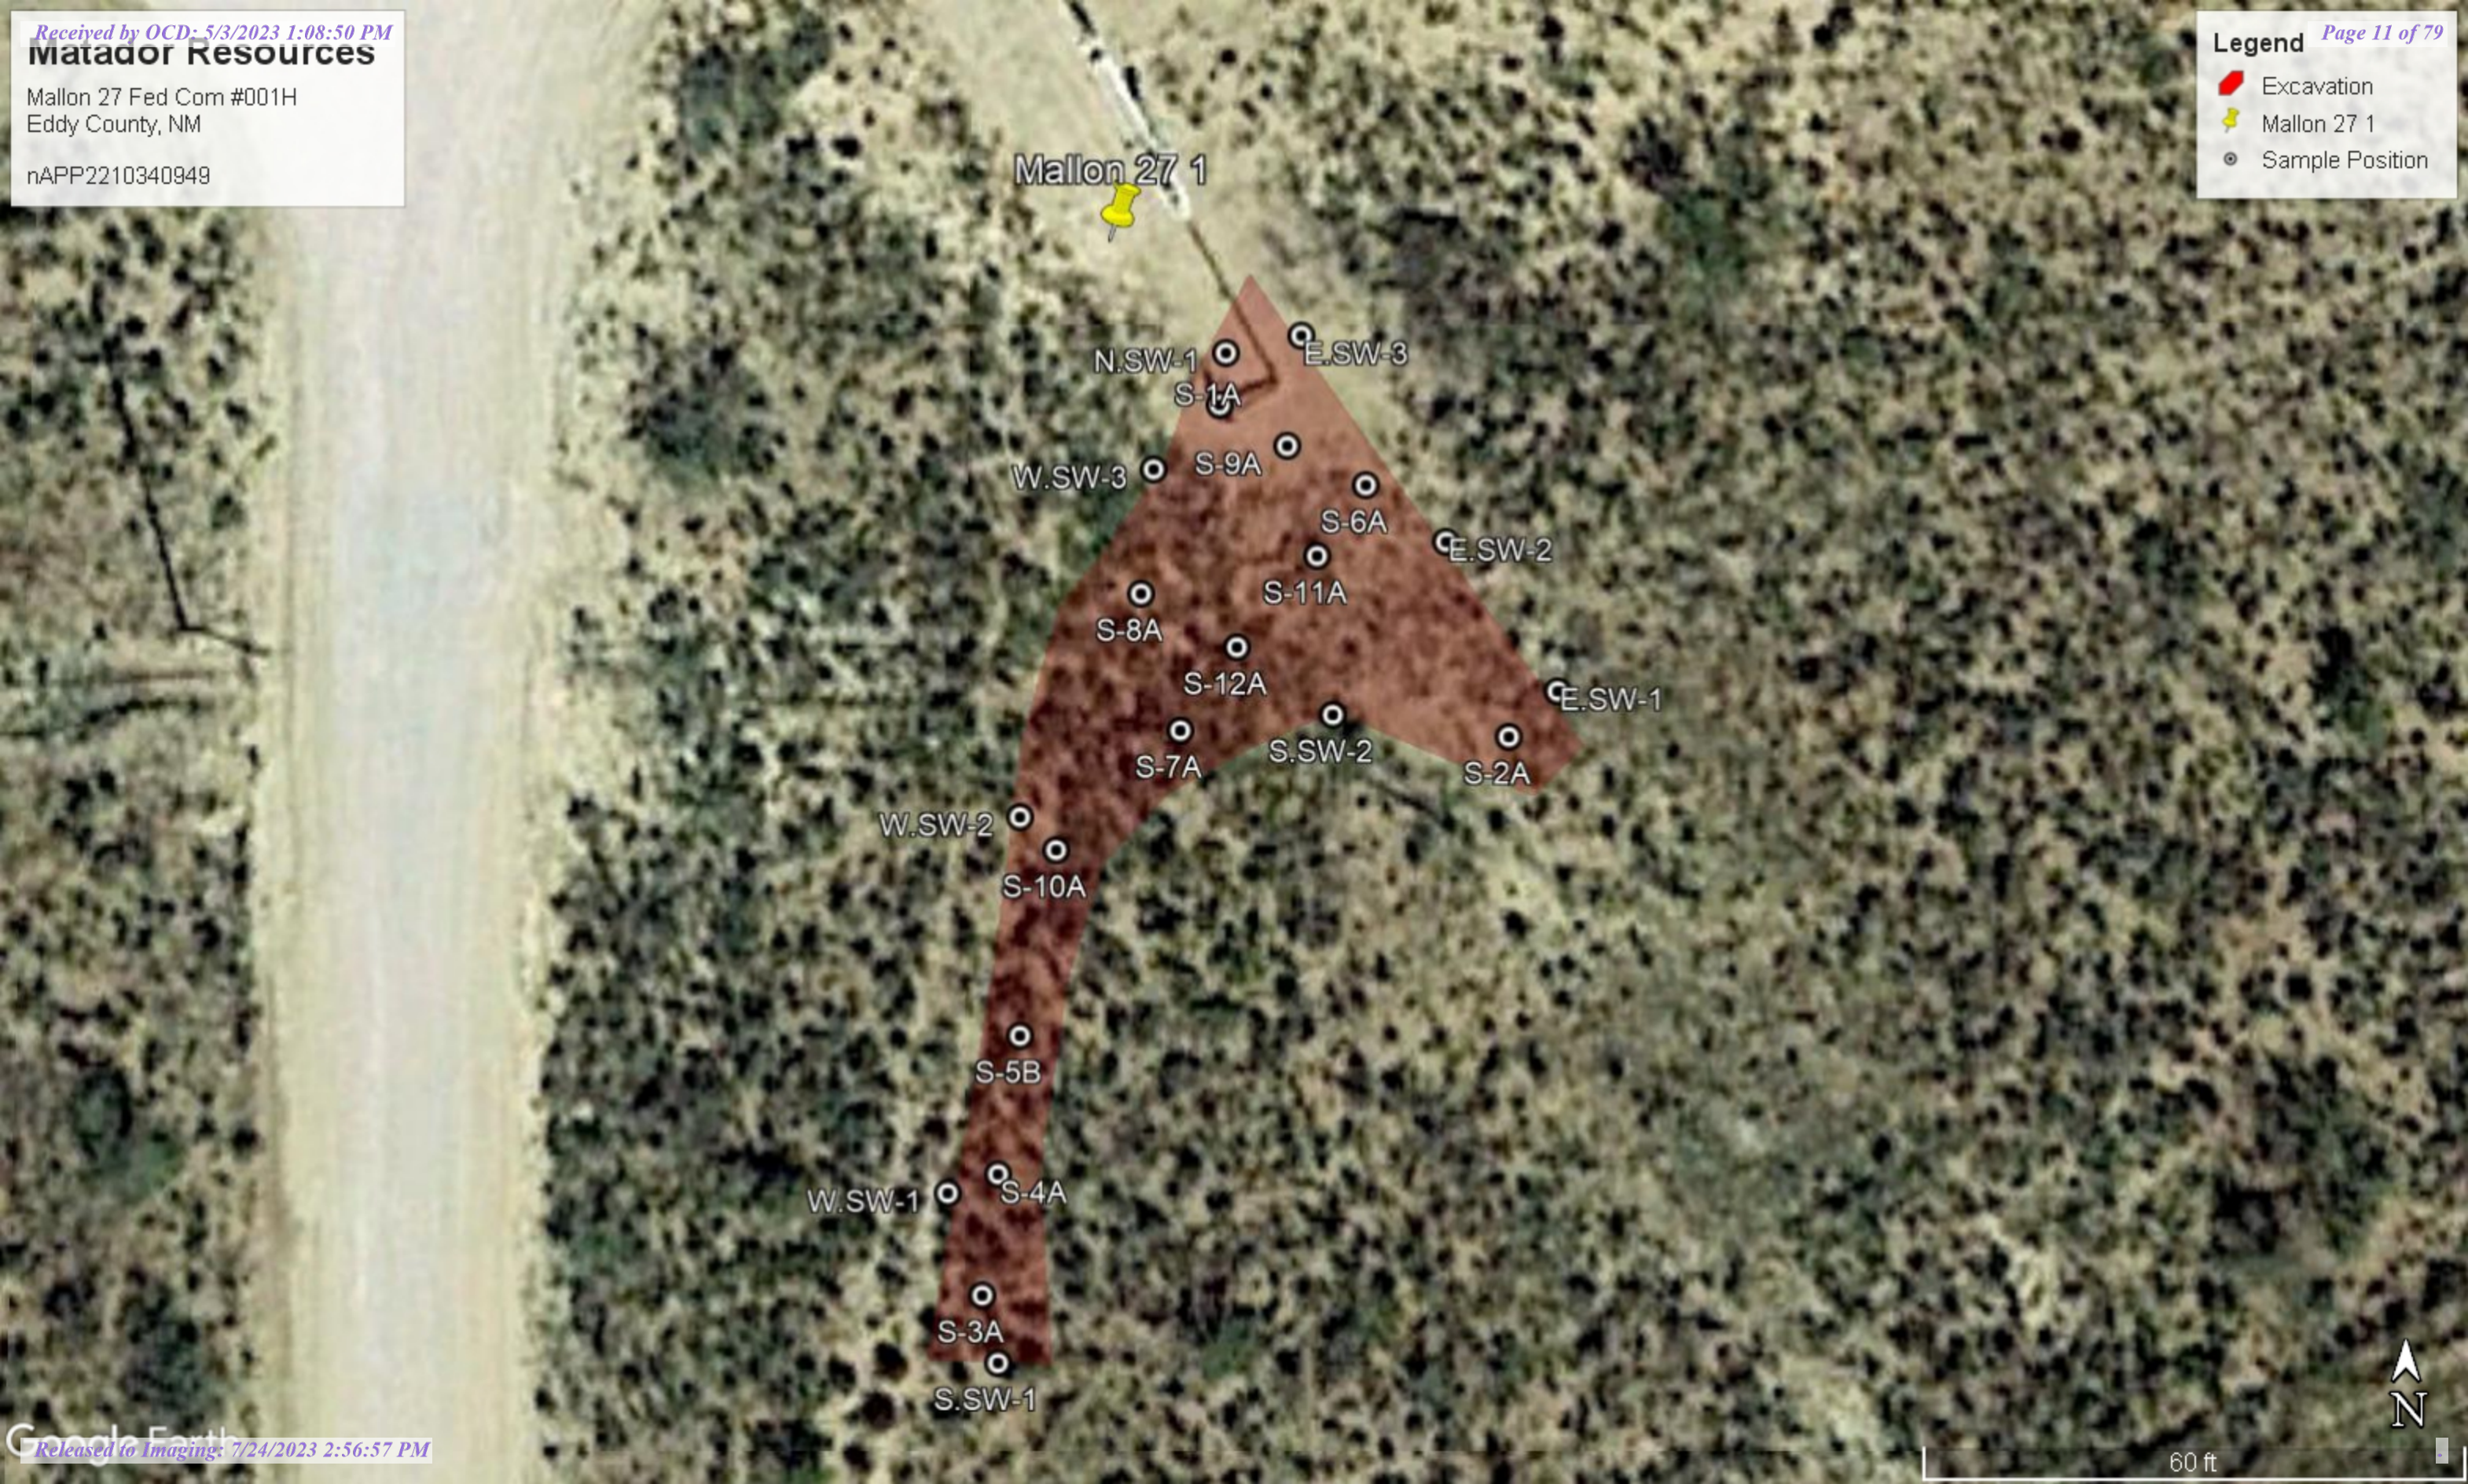
Mallon 27 1

Sample Position

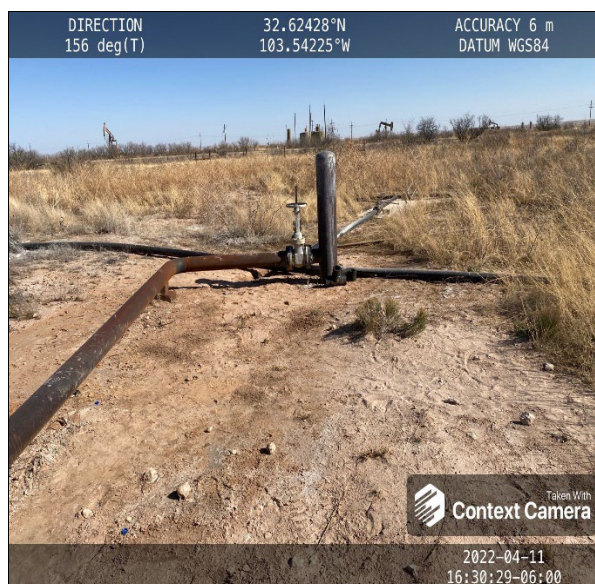
**Photograph No.1 Description:**

Source

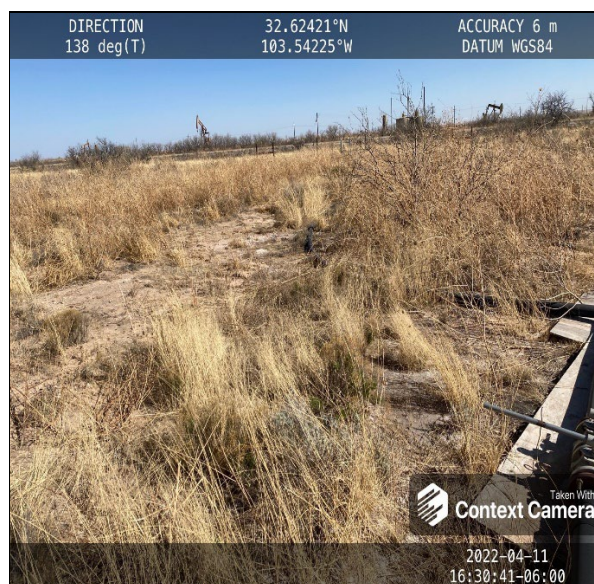
**Photograph No.2 Description:**

Pasture Impact

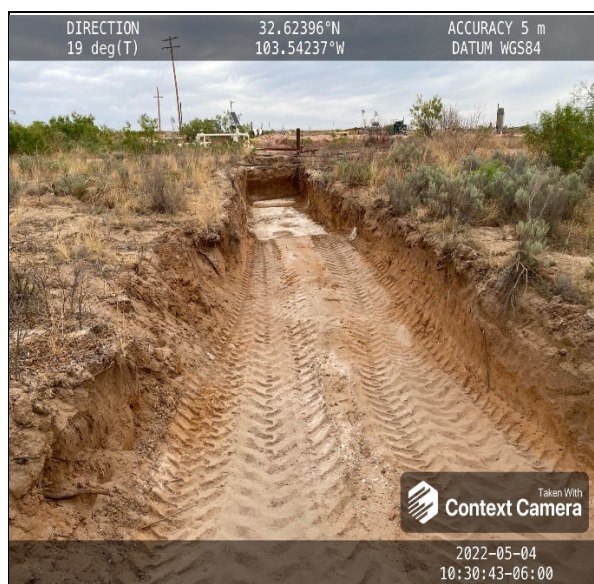
**Photograph No.4 Description:**

Pasture Excavation

- The impacted area in the vicinity of the riser at the source was excavated to depths of 4 feet bgs.
- The spill run traversed a two track for approximately 78 feet to the south. This area was vertically excavated to depths of 5 feet and to the horizontal extent that NMOCD Table 1 soil remediation standards were met or exceeded. Repairs were made to the collar and poly line.
- All contaminated soil was transported to Lea Landfill, a NMOCD approved solid waste disposal facility.
- The excavated area was backfilled with clean sand native to the area, restored to dunal feature and seeded in accordance with BLM guidelines.

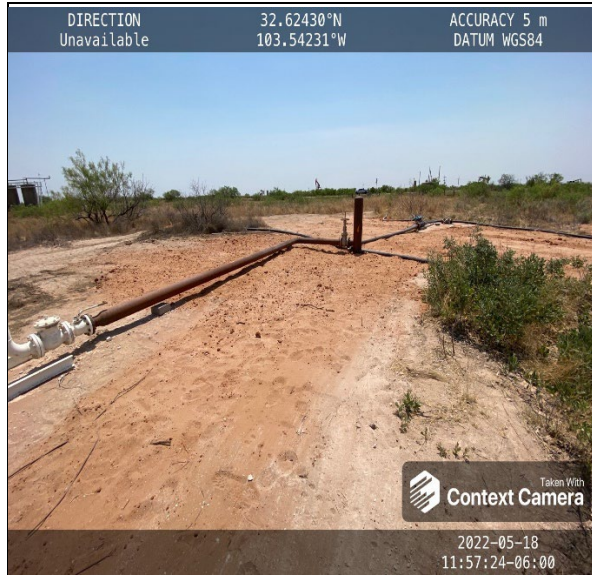
**Photograph No.5 Description:**

Backfill at source

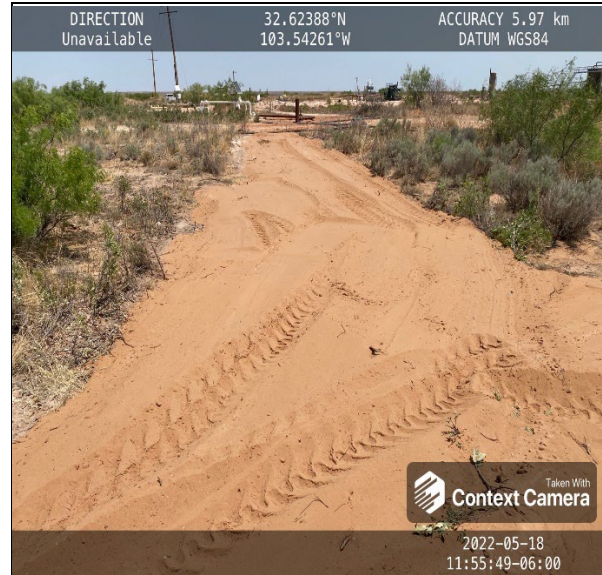
**Photograph No.6 Description:**

Backfilled Pasture
