Release Notification

Cause of Release 2" Flowline corroded and released produced water and crude oil into pasture.

Characterization and Remediation Workplan
South Justis Unit D24 Flowline Failure
Produced Water and Crude Oil Release
Lea County, New Mexico
nAPP2308648014

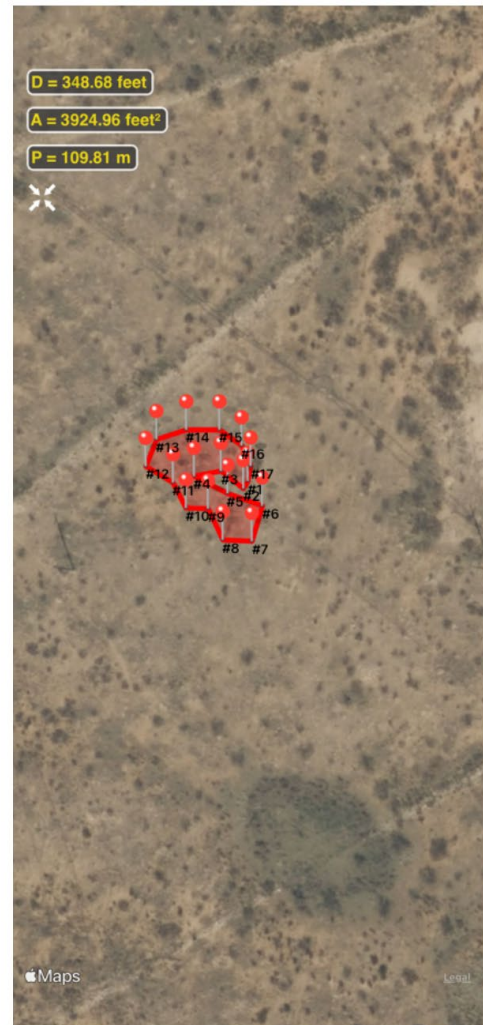
Planimeter Measurement Report

Project Description:
Steel Flowline Leak

Distance : 348.68 feet
Area : 3924.96 feet²
Perimeter : 109.81 m
Number of points : 17
Location : 32.103799, -103.122691
