Terracon Consultants, Inc. (Terracon) is pleased to submit our Release Investigation, Request, and Closure Report for the site referenced above. The scope of services was developed in accordance with the New Mexico Oil Conservation Division (NMOCD) regulations concerning clean-up actions required for releases of crude oil and produced water. The investigative response actions resulted from a natural gas release from a corroded 4-inch lateral line. The below sections detail Terracon's assessment and remediation actions in response to the noted release.

Required Information	Site and Release information	
Responsible party	The pipeline is operated by Frontier Field Services LLC.	
Local contact	Contact: Ms. Amber Groves	P: (575)-703-7992 E: agroves@durangomidstream.com
NMOCD Notification	Notice of the release was provided to the NMOCD District 2 Artesia Office by Mr. Chad Frost/Amber Groves. NMOCD Reference ID: nAPP2231250350 NMOCD Reference ID: nAPP2304838742	
Facility Description	The Mucho Luck site is located in Eddy County, New Mexico within Unit P, Section 27, Township 16 South, Range 27 East. The site is approximately 8.9 miles northeast of Artesia, New Mexico, and is located in

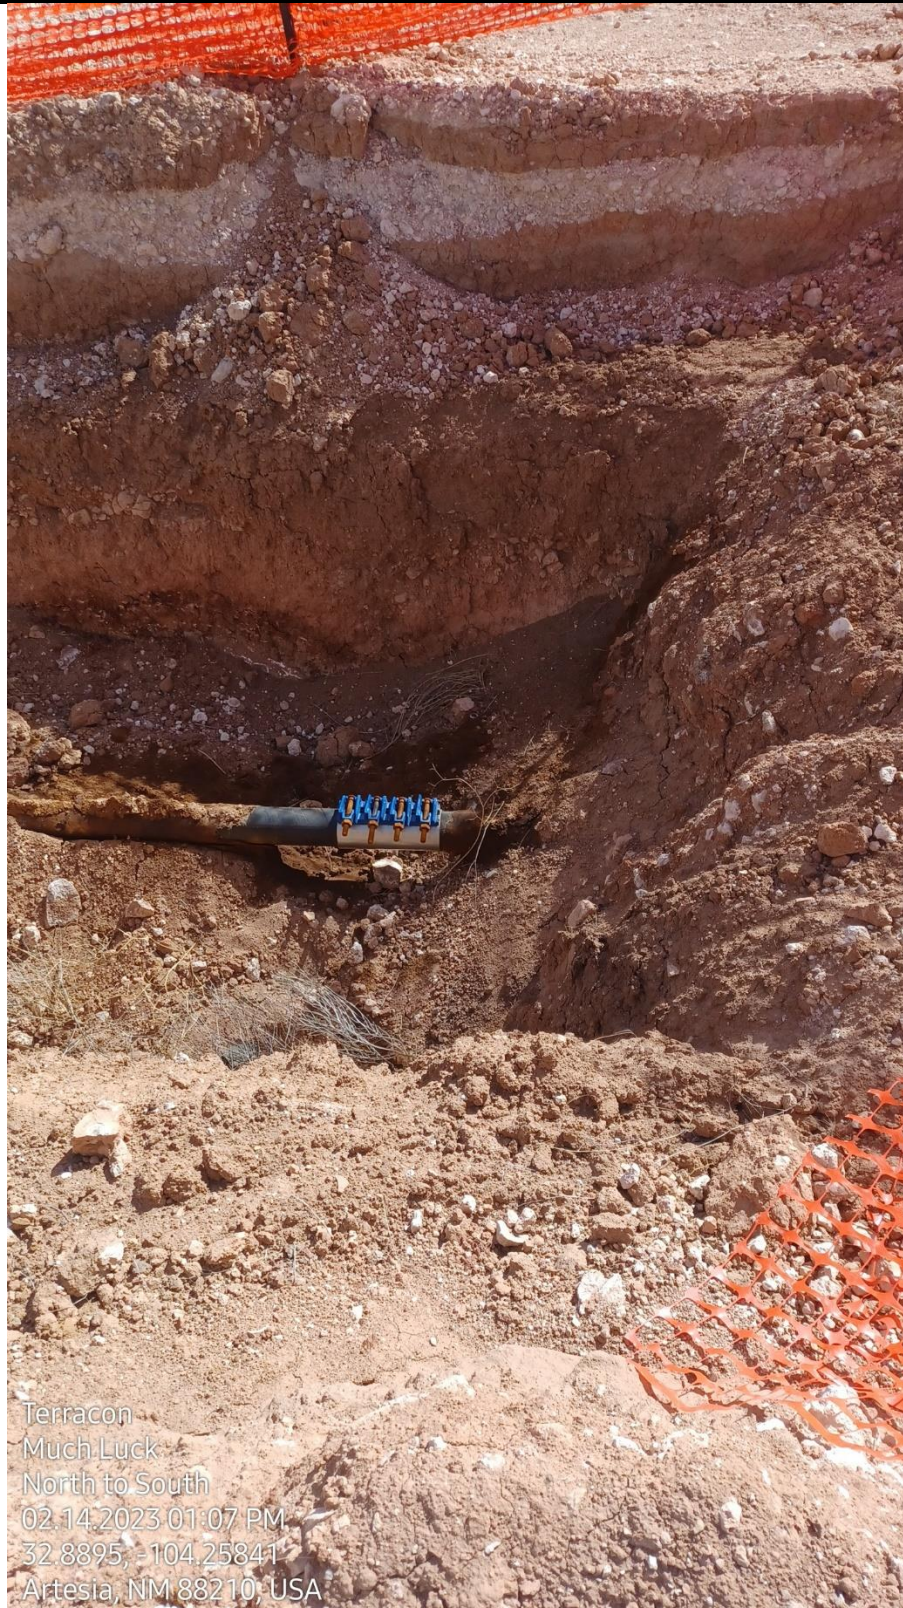
Terracon
Much Luck
North to South
02.14.2023 01:07 PM
32.8895, -104.25841
Artesia, NM 88210 USA

PHOTO 1: View of area prior to excavation

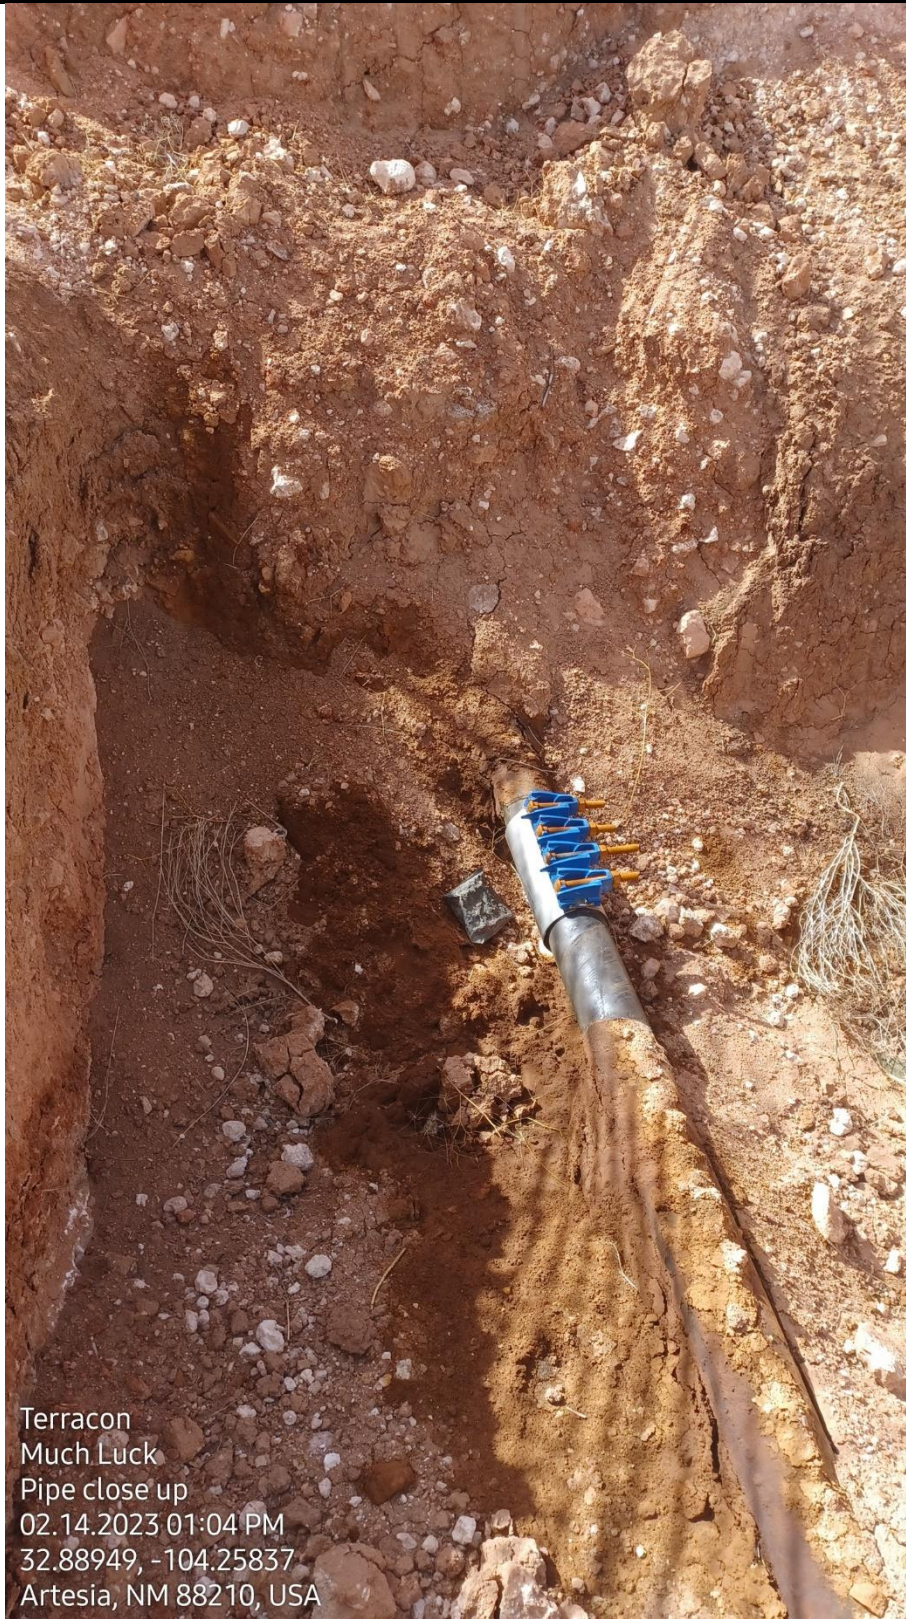
Terracon
Much Luck
Pipe close up
02.14.2023 01:04 PM
32.88949, -104.25837
Artesia, NM 88210, USA

PHOTO 2: View of area prior to excavation

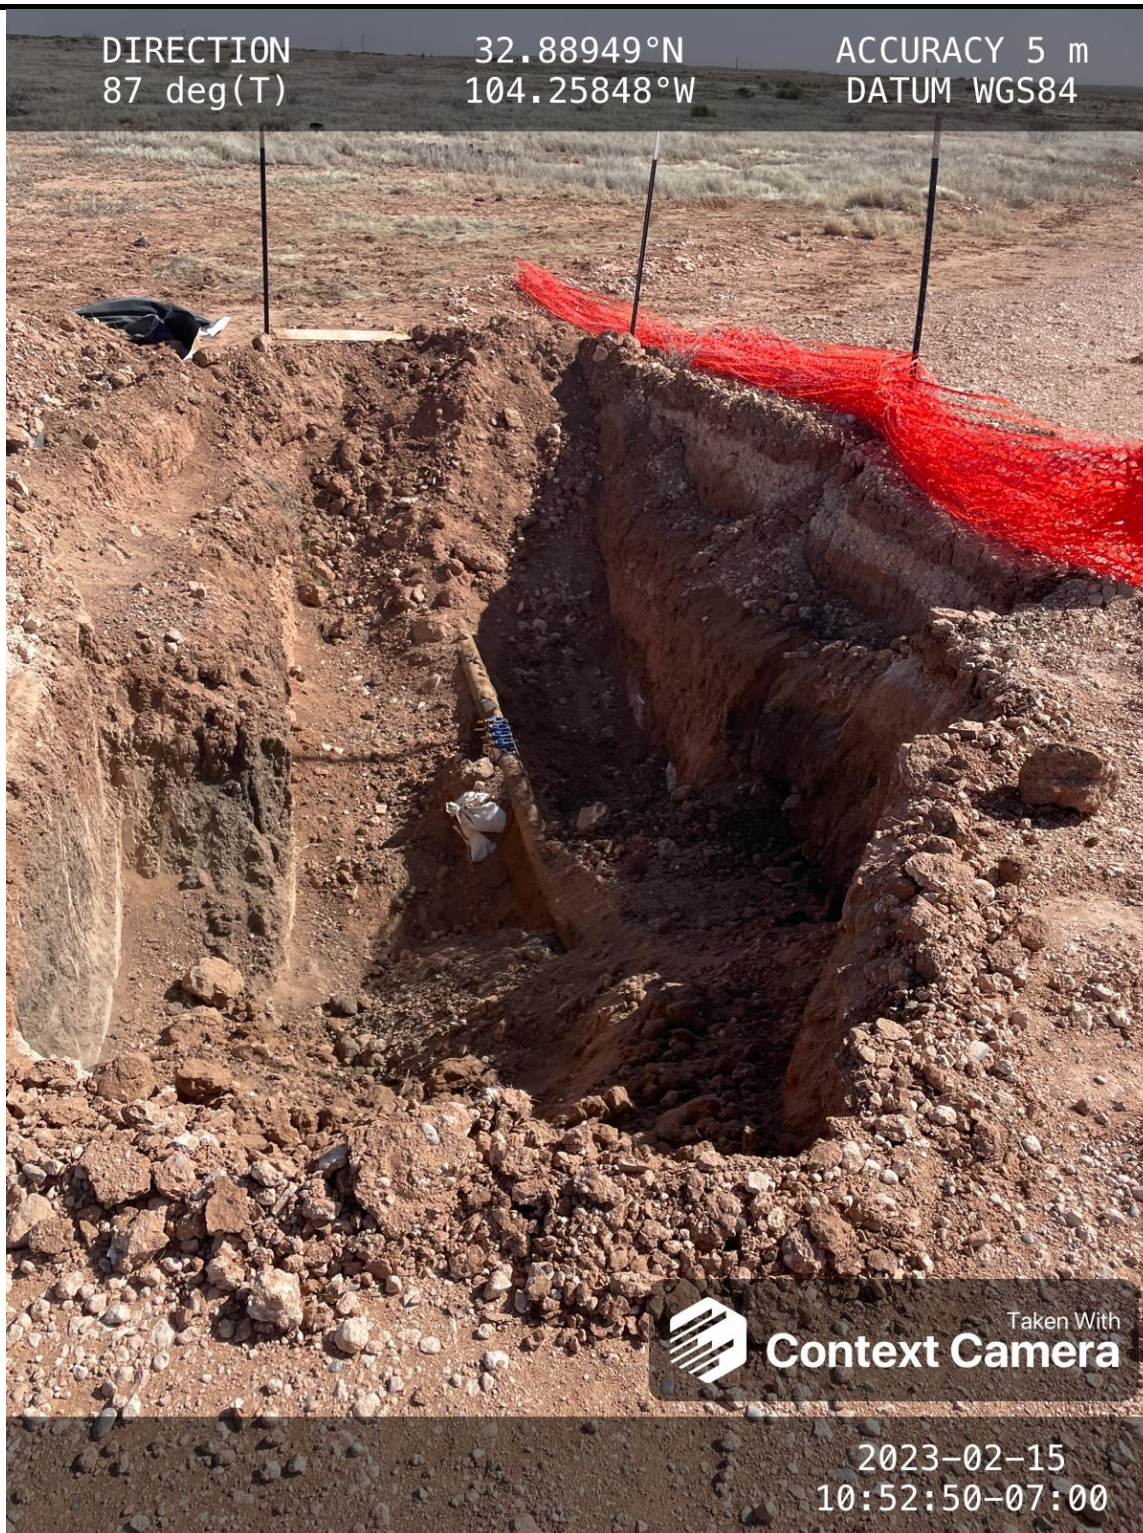
PHOTO 3: View of area during excavation

Required Information	Site and Release information	
Quantity of released material	nAPP2304838742	Natural Gas: 68.95 Mcf
Immediate corrective actions	The leaking pipeline was closed in at the nearest isolation valve, blown down, and clamped. A backhoe was utilized to excavate soils to discover the source of the release.

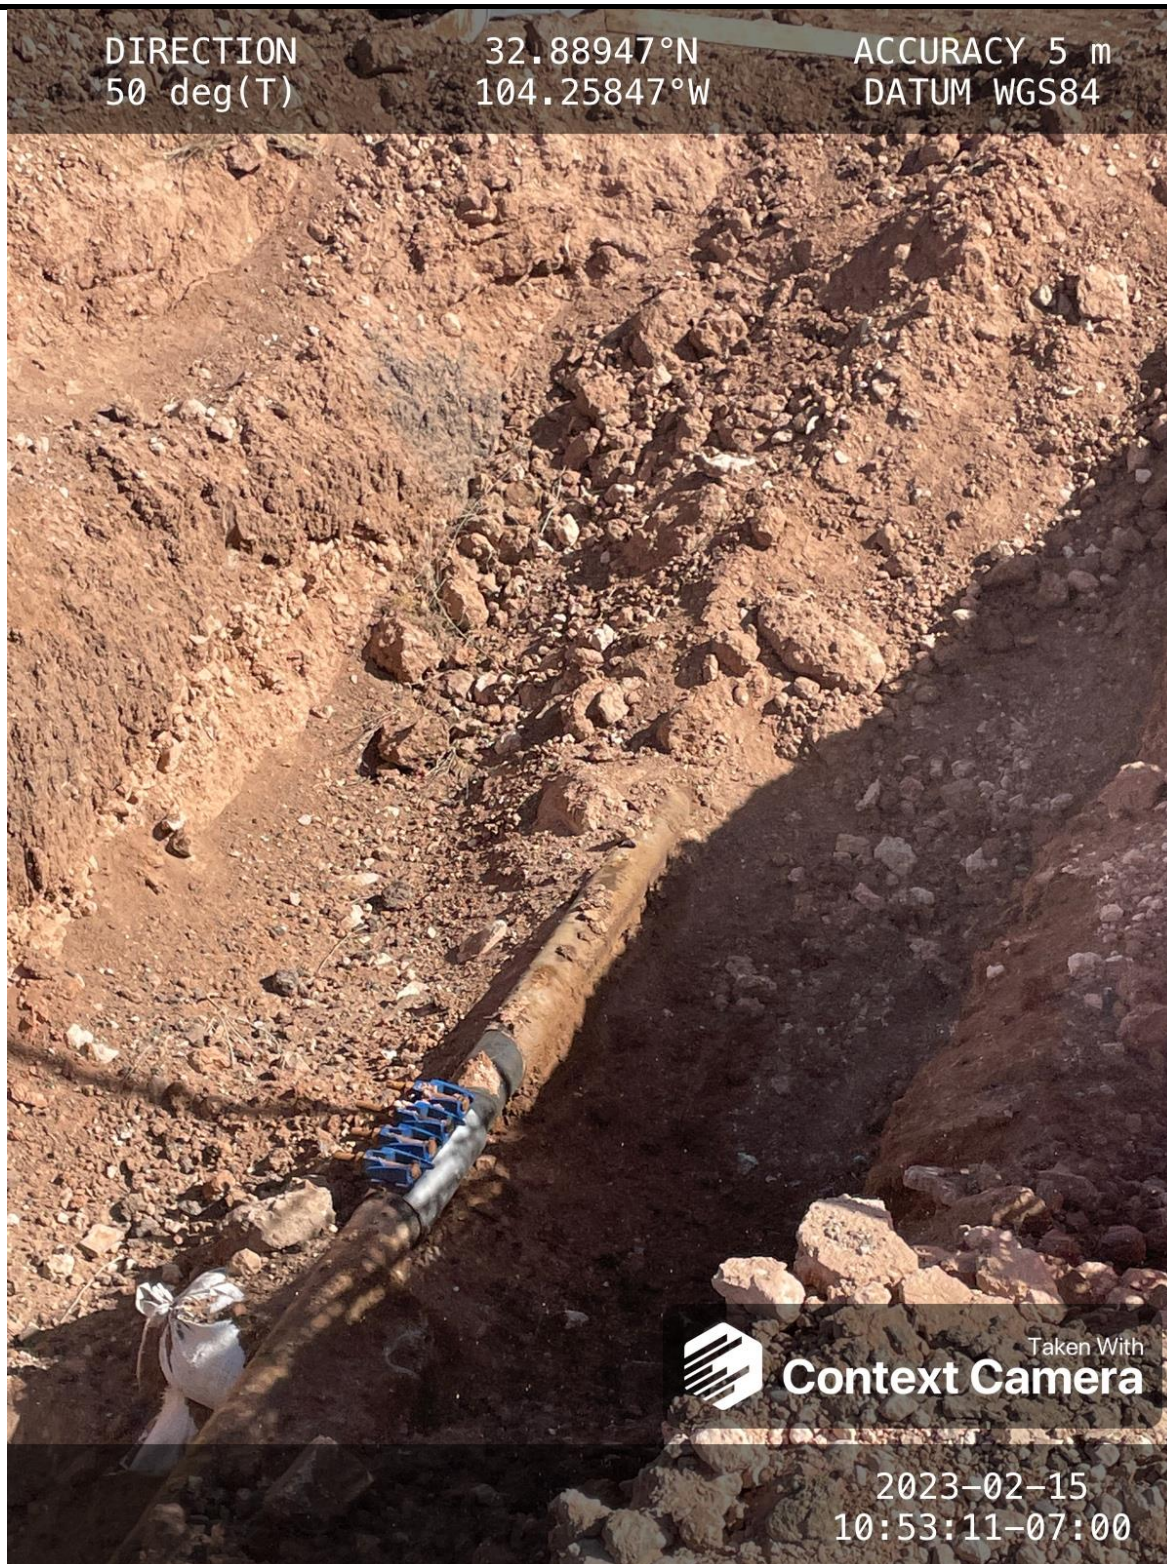
PHOTO 4: View of area during post excavation

In accordance with NMAC 19.15.29.12, remediation of the impacted material is complete, and Terracon along with Frontier Field Services respectfully requests closure of incidents nAPP2231250350 and nAPP2304838742.
