Terracon Consultants, Inc. (Terracon) is pleased to submit our Release Investigation and Closure Report for the site referenced above. The scope of services was developed in accordance with the New Mexico Oil Conservation Division (NMOCD) regulations concerning clean-up actions required for releases of crude oil and produced water. The investigative response actions resulted from two separate natural gas releases along a suspected corroded lateral line. The below sections detail Terracon's assessment and remediation actions in response to the noted release events.

In accordance with NMAC 19.15.29.12, remediation of the impacted material is complete, and Terracon along with Frontier Field Services respectfully requests closure of the incidents nAPP2302727428 and nAPP2304840170.

Exhibit 3 – Site Sample Map
Santo Nino Steel Line 8” 32.72646°, -103.98410° Eddy County, New Mexico

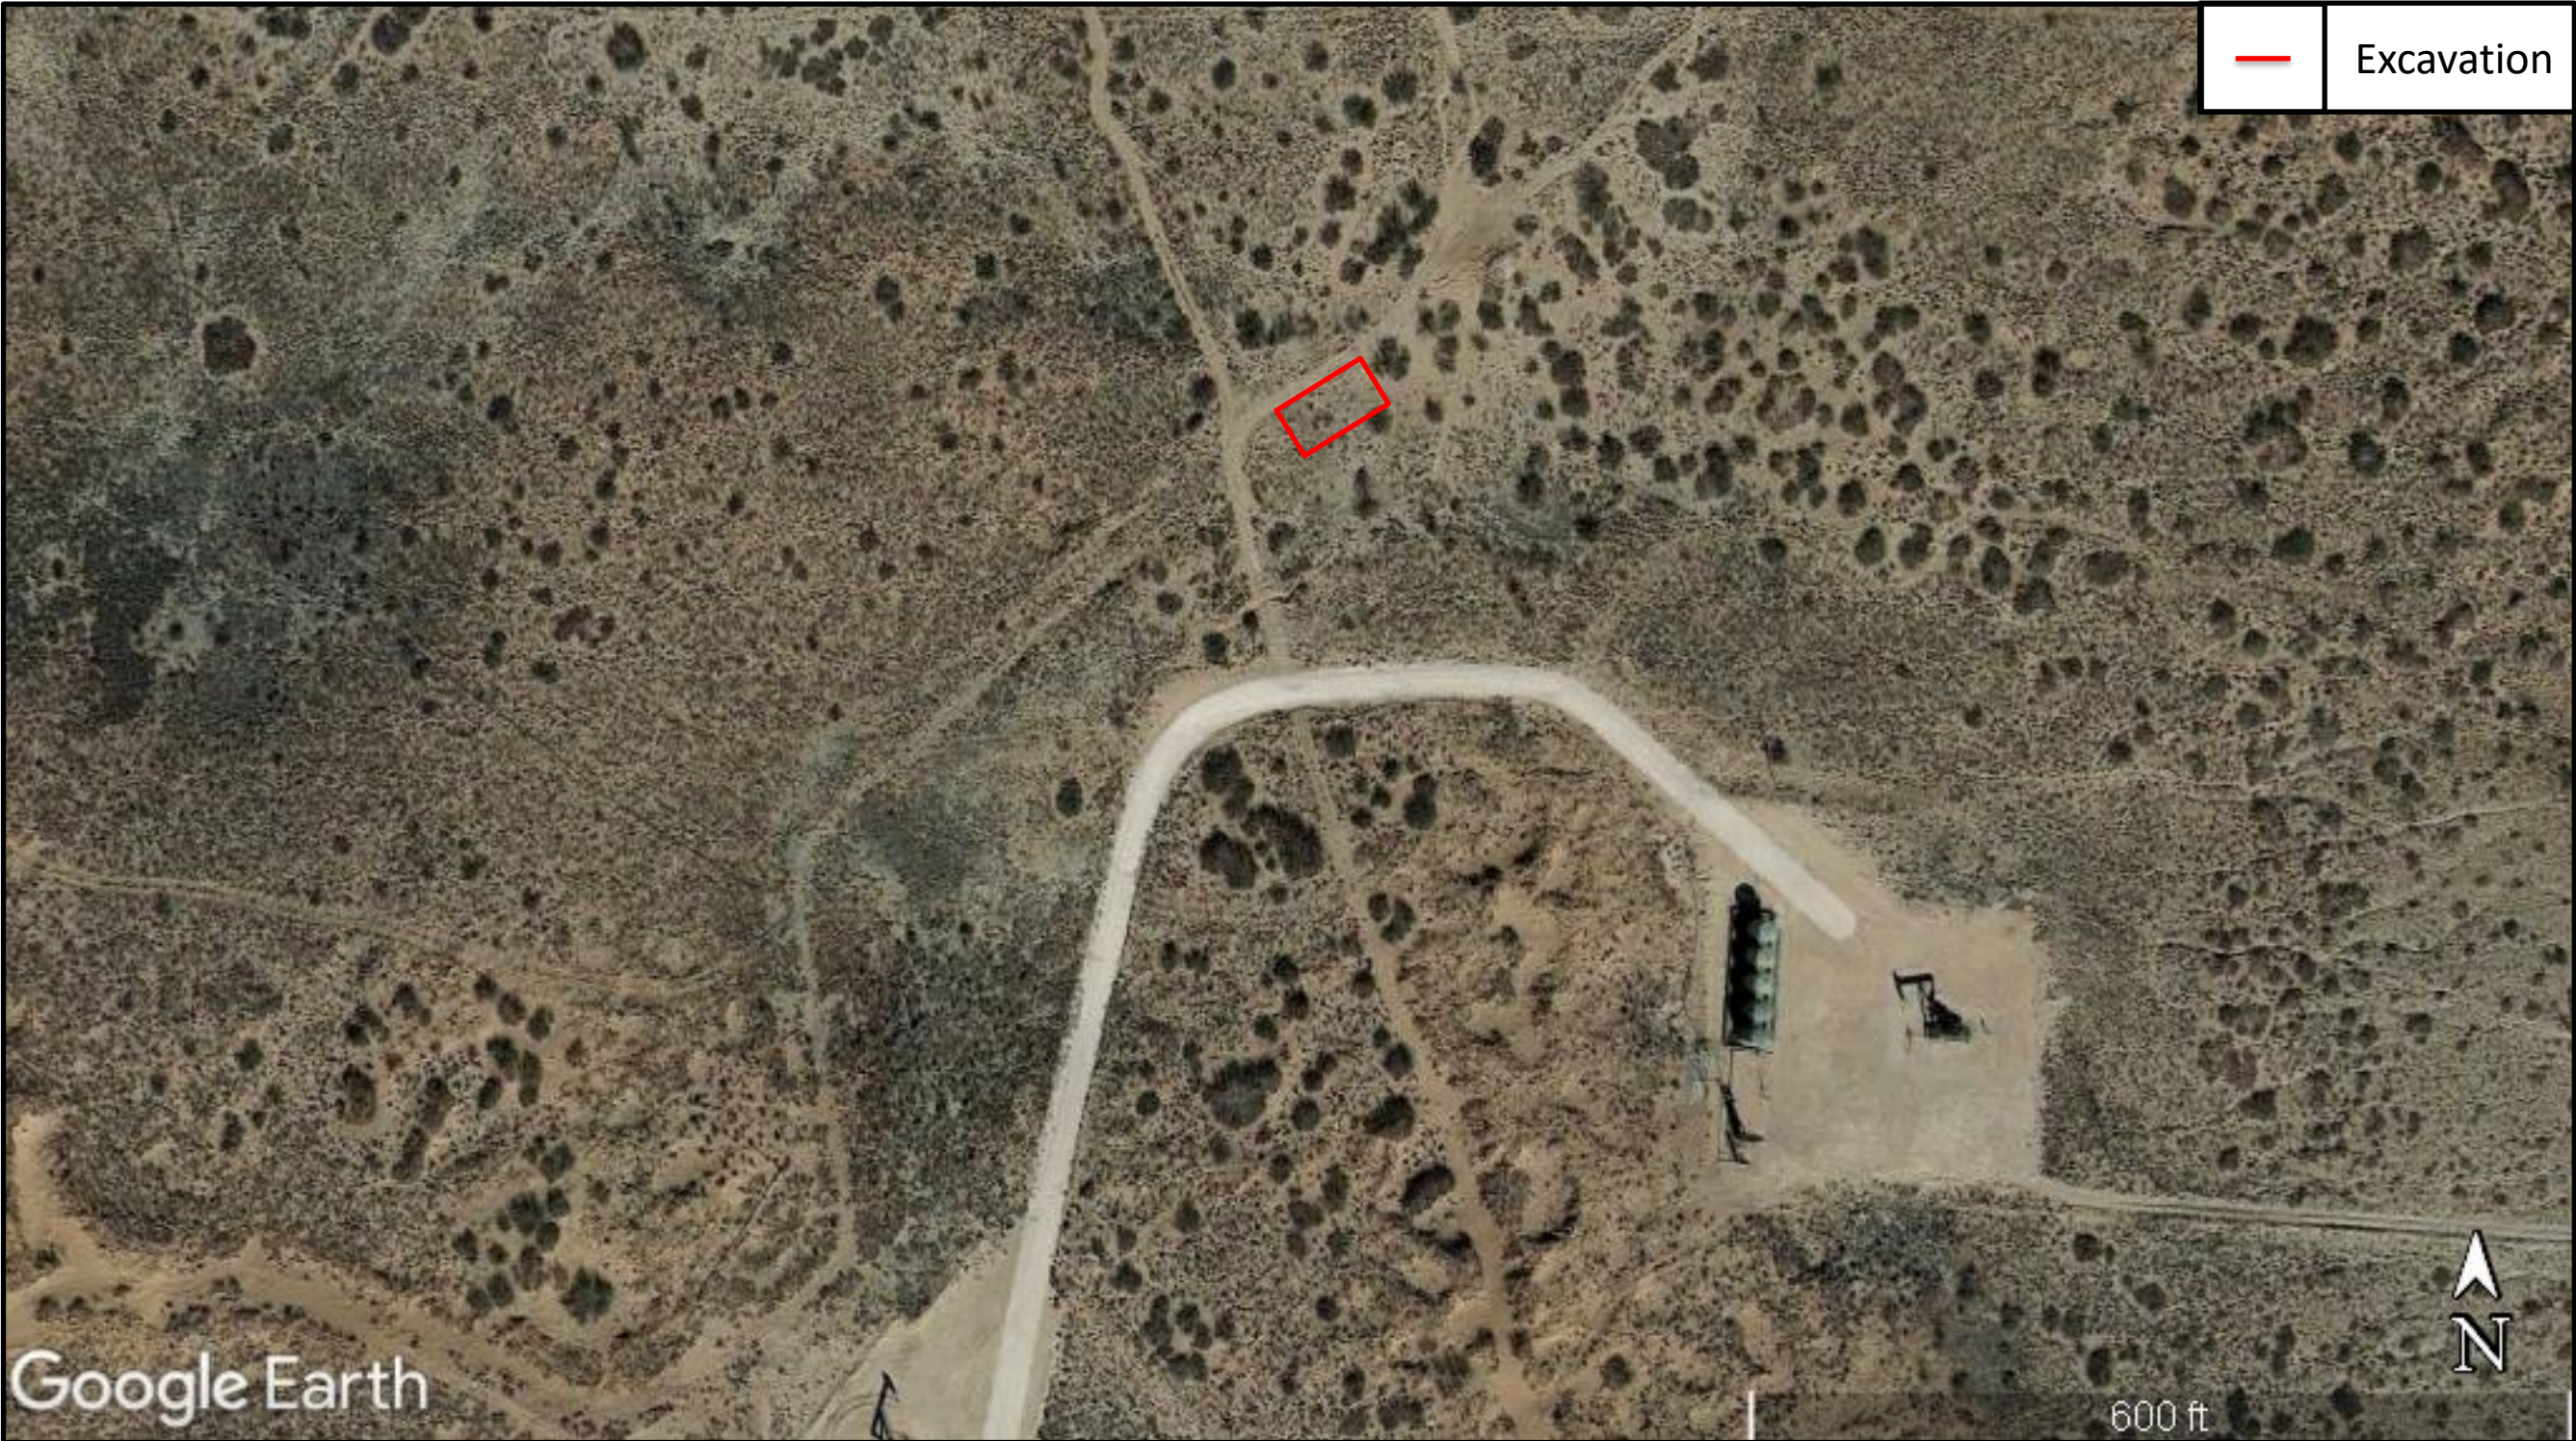
Explore with us 4518 W. Pierce St. Carlsbad, NM 88220 PH. (575)689-4020 FAX. (806) 797 0947	Exhibit 2 - Site Map
Scale:	As Shown		Santa Nino Steel Line 8"
Source:	Google Earth		32.72646,-103.98410
Date:	03/14/2023		Eddy County, New Mexico

Discharge event	The natural gas pipeline leaks were caused by corrosion of the steel line and liquid was discovered leaking to the surface during normal field inspections and remedial efforts. The Site is illustrated in Exhibits 1 and 2 of Appendix A	
Type of discharge	The documented natural gas releases occurred in an open right-of-way (ROW), BLM-owned, native pastureland area. Soils at the site were affected at the surface and surrounding the pipeline.	
Quantity of spilled material	Total Fluids: 12.4 bbls	Natural Gas: 124.52 Mcf

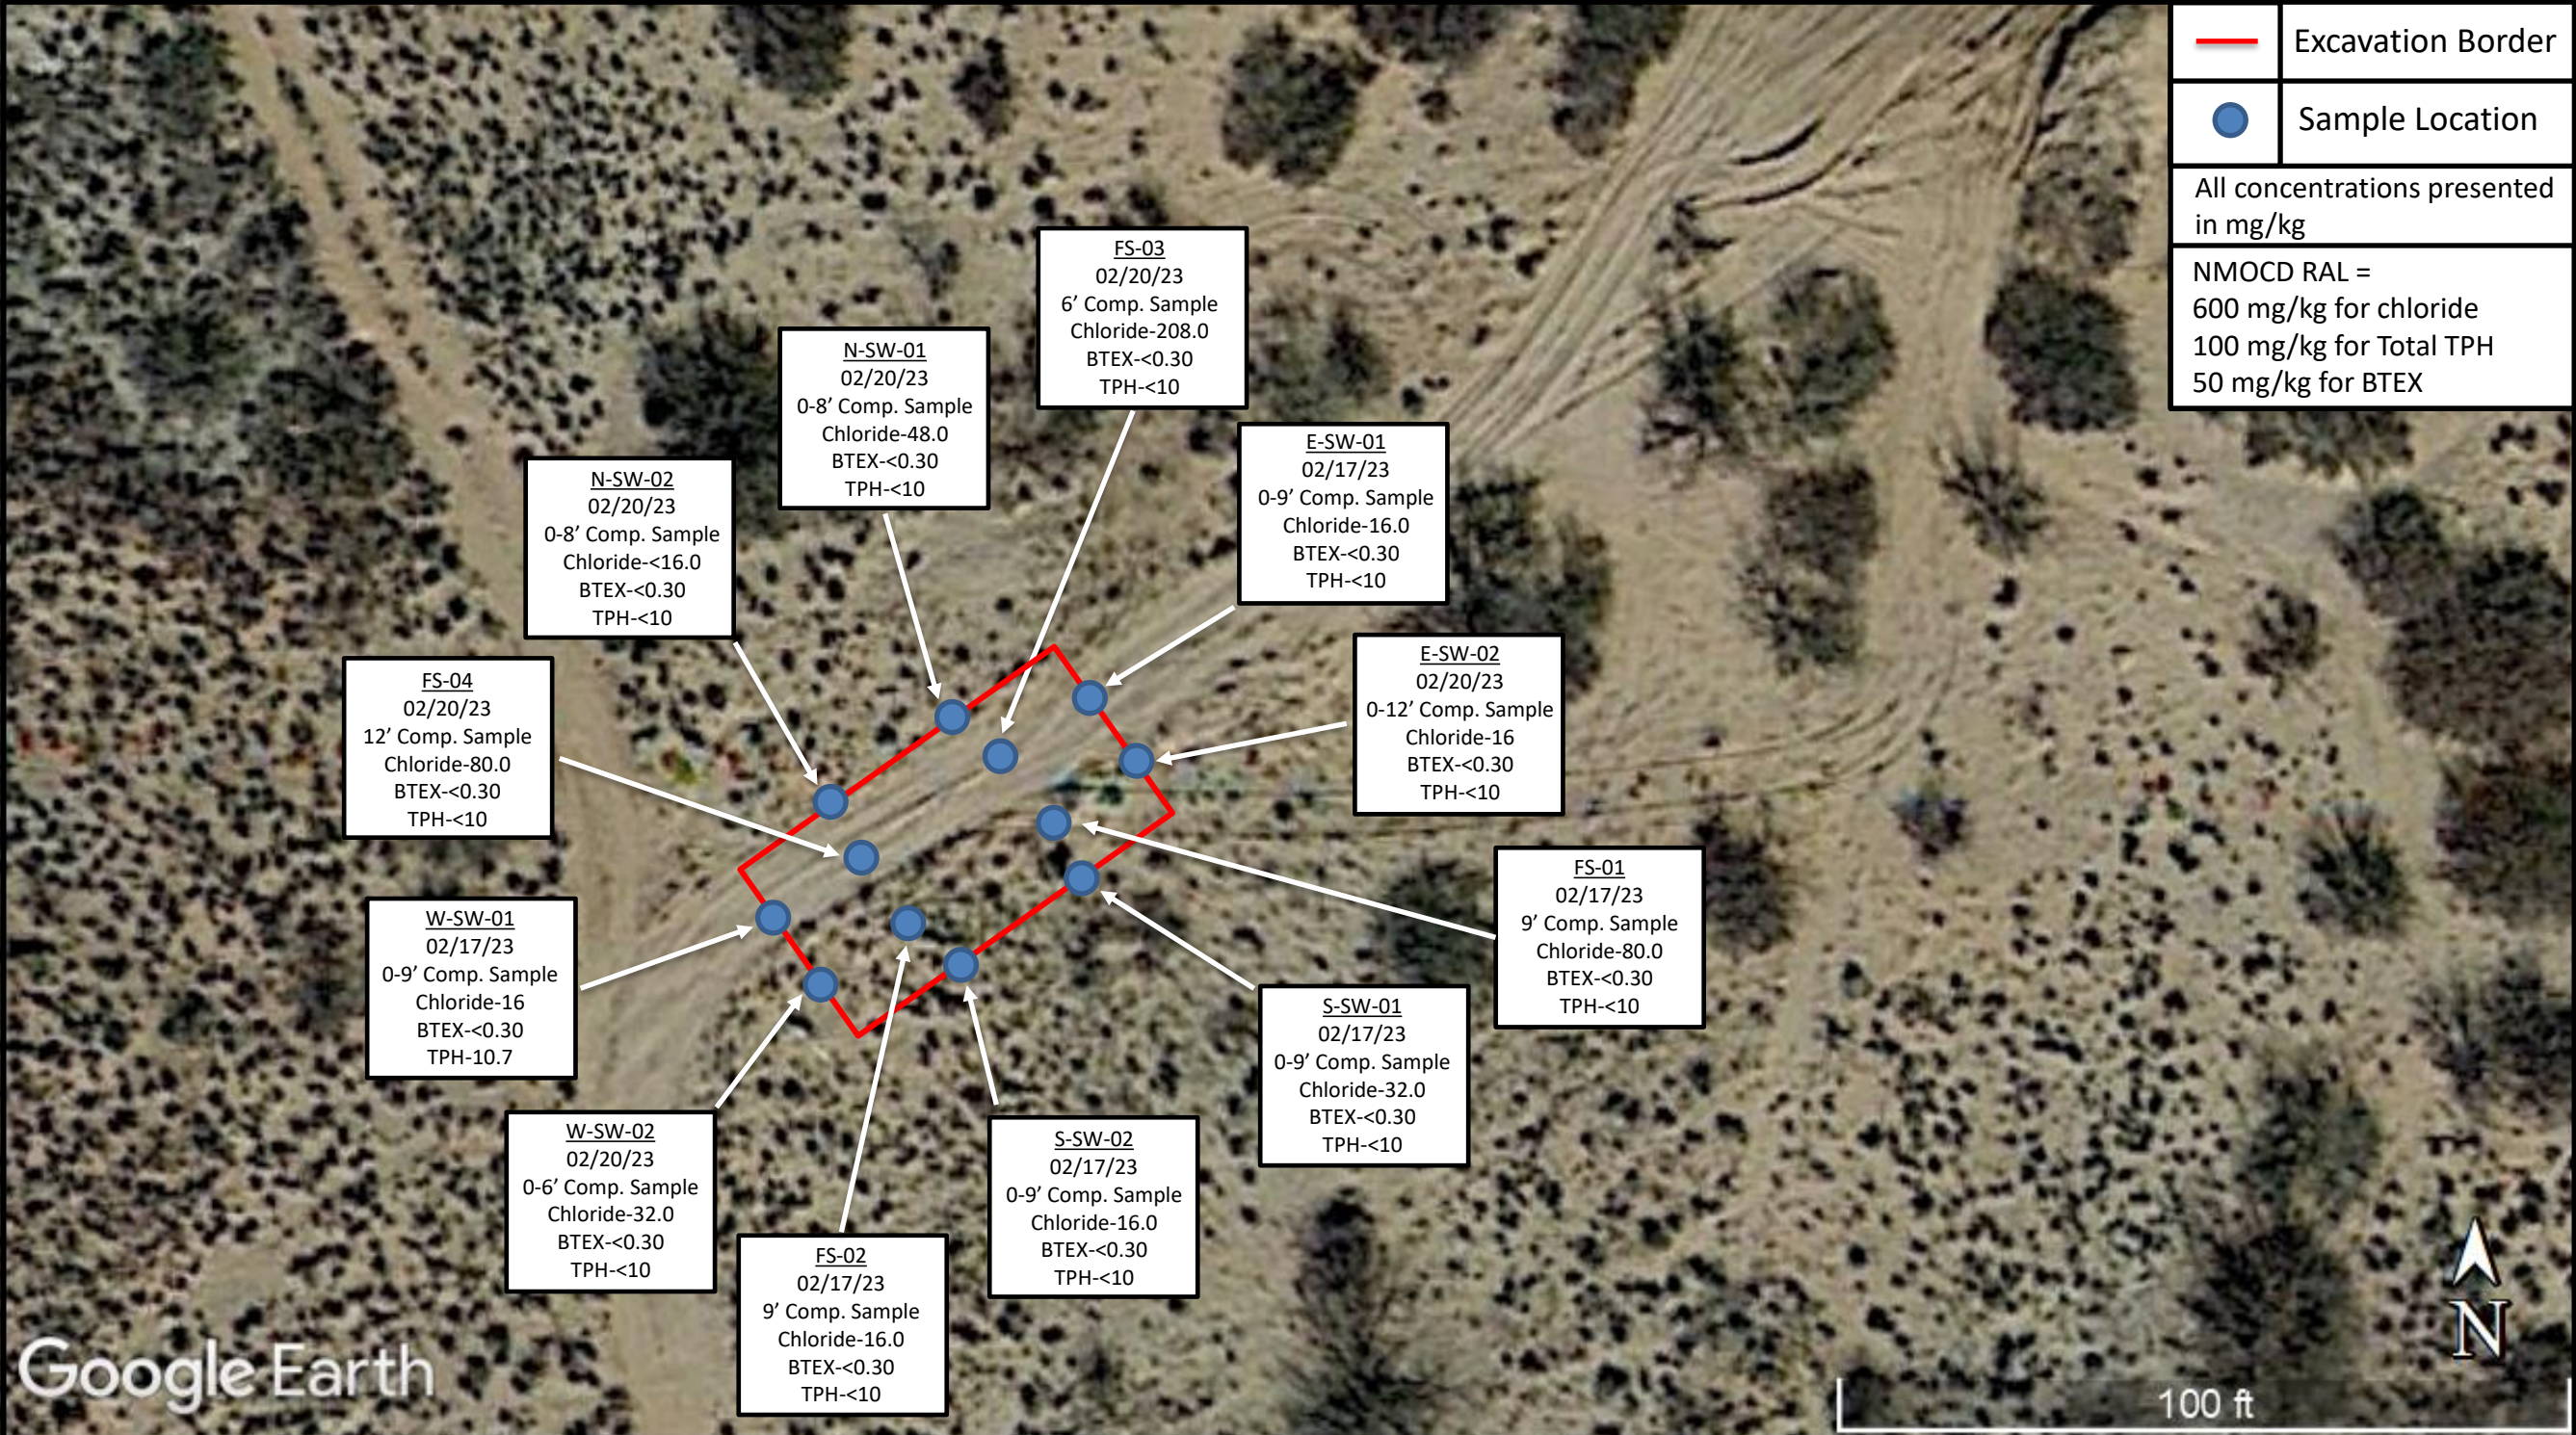
Excavation Border
	Sample Location
All concentrations presented in mg/kg	
NMOCD RAL = 600 mg/kg for chloride 100 mg/kg for Total TPH 50 mg/kg for BTEX

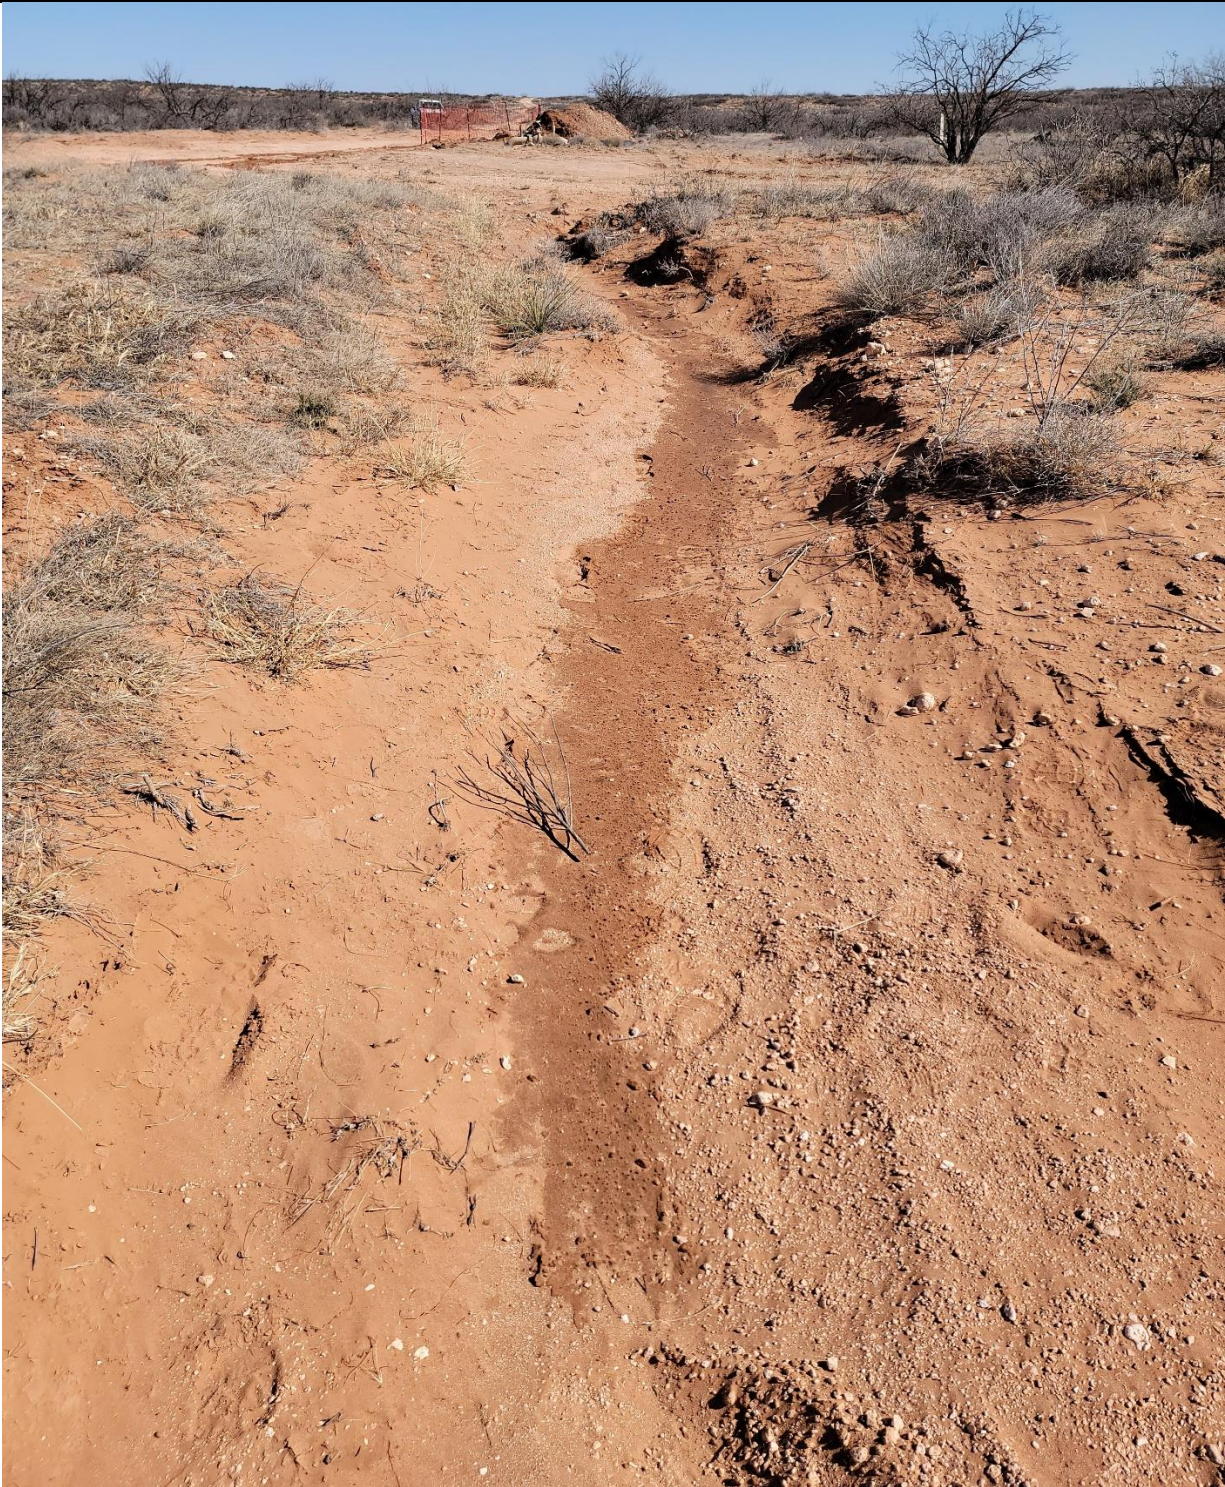
**PHOTO 1:** View of the area prior to excavation from the southwest facing northeast.

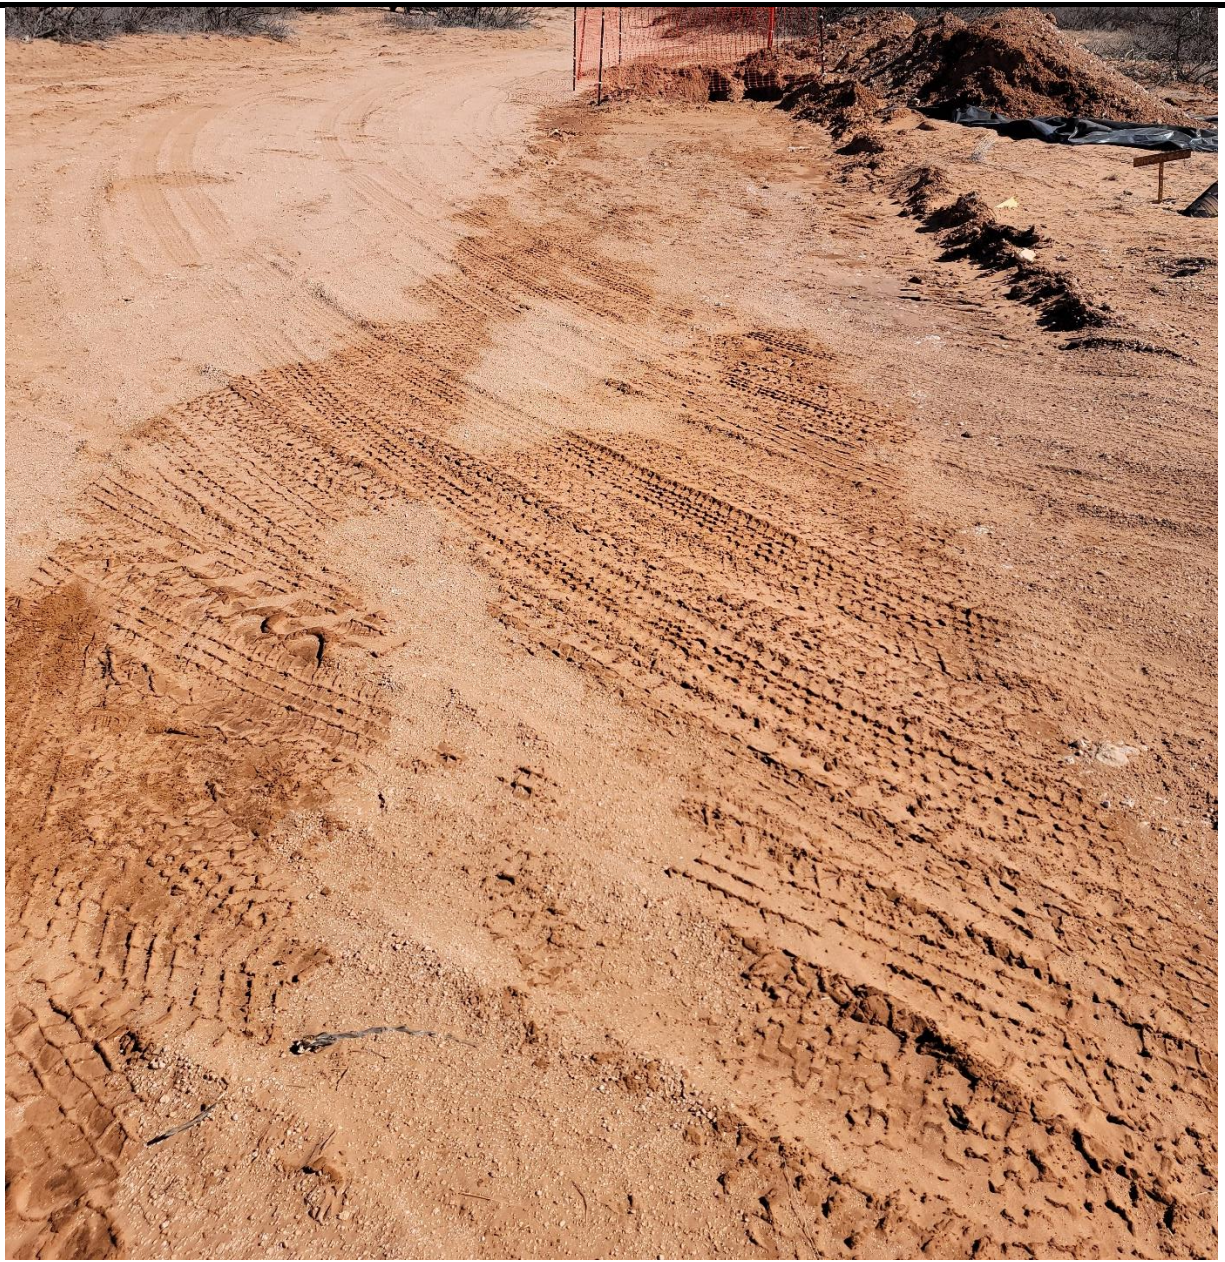
**PHOTO 2:** View of the area prior to excavation from the southwest facing northeast.

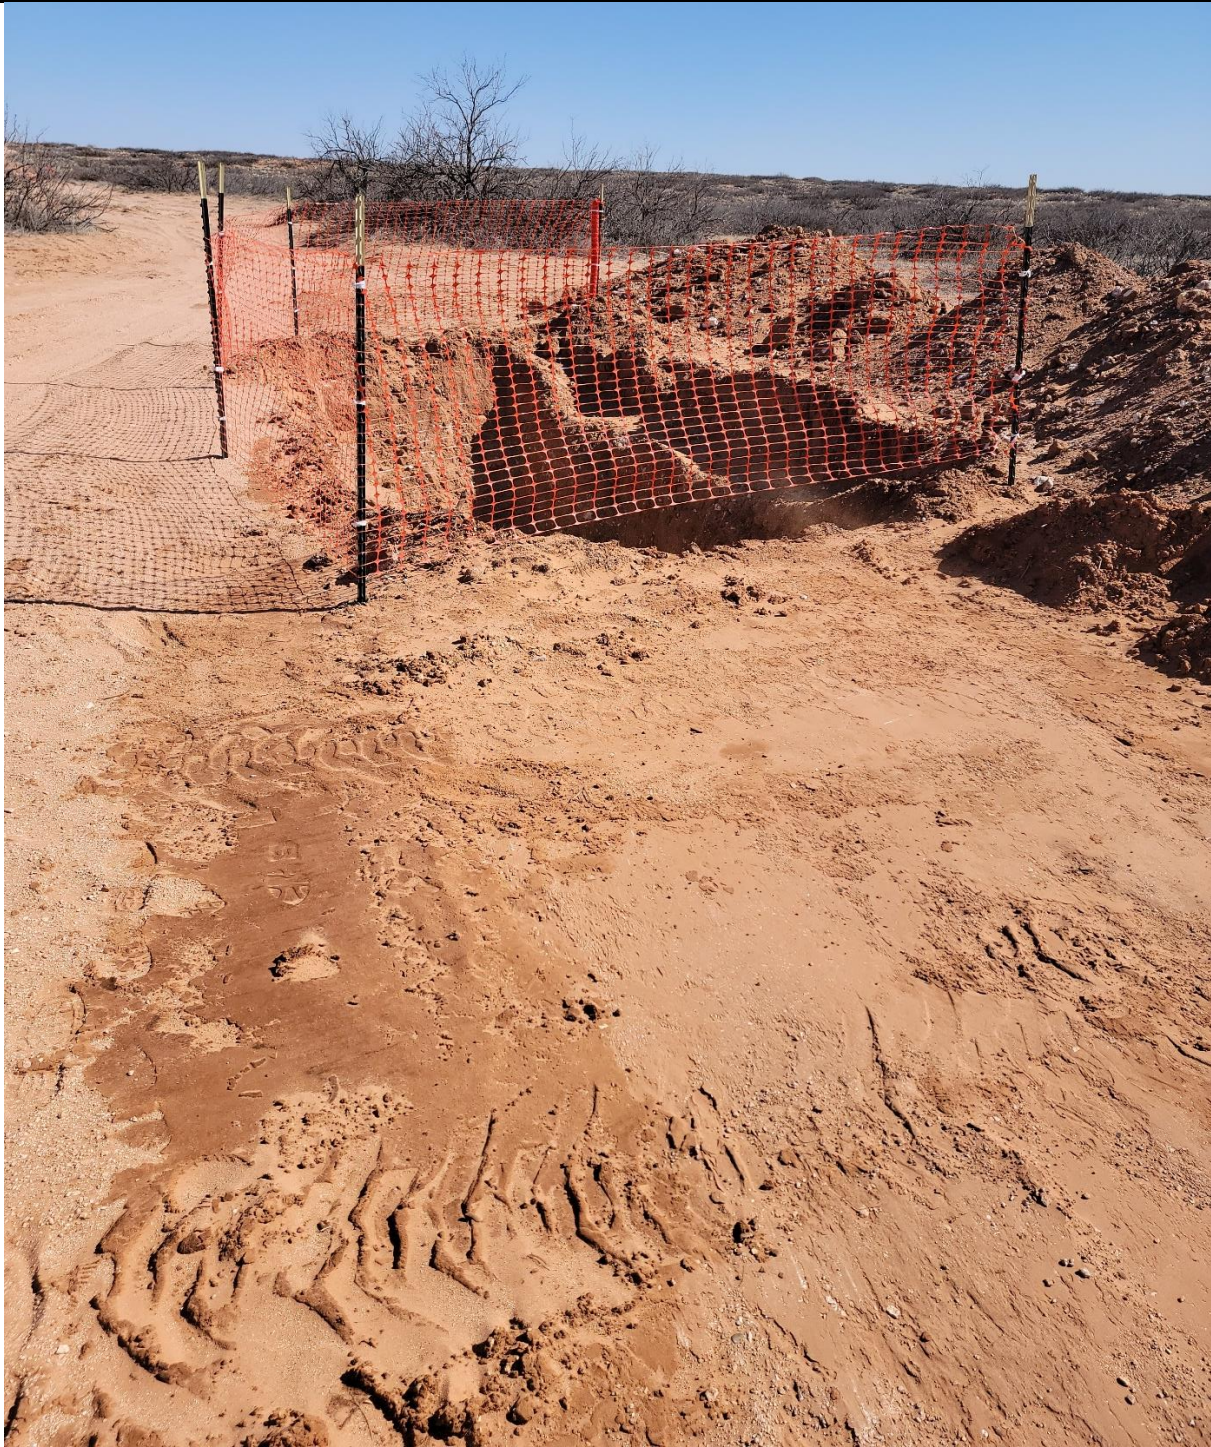
**PHOTO 3:** View of the area prior to excavation from the southwest facing northeast.

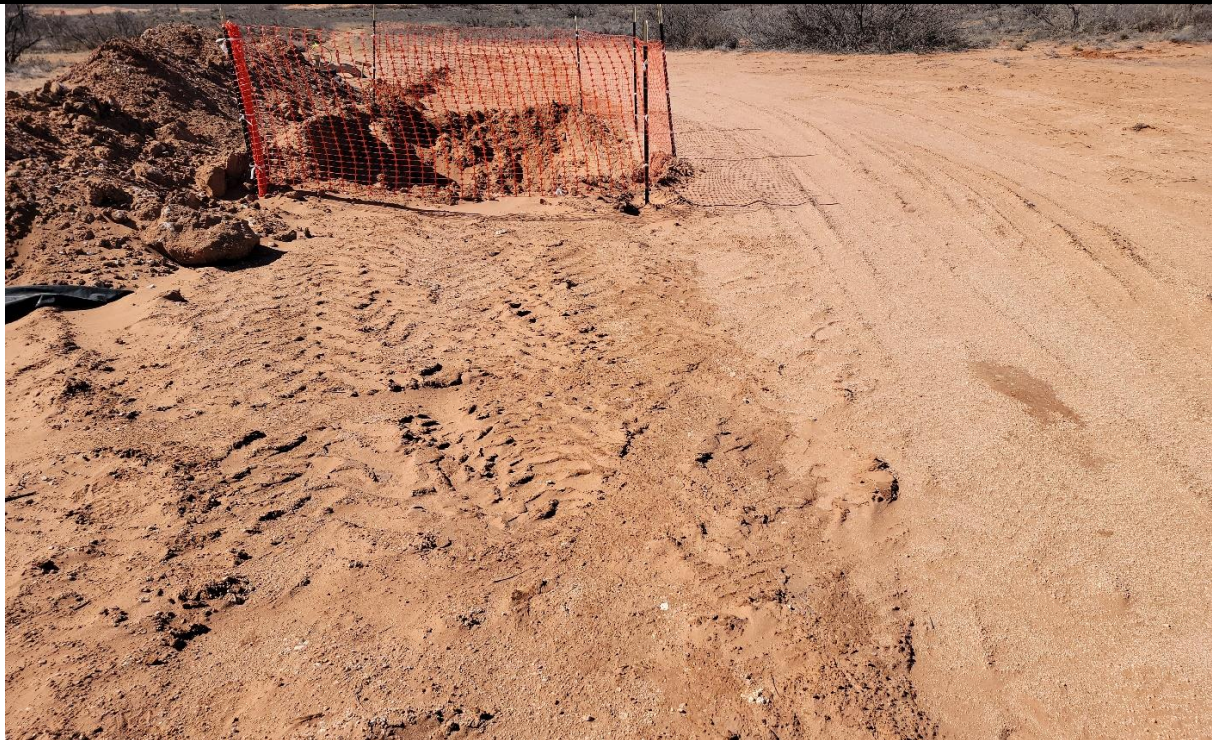
PHOTO 5: View of the area prior to excavation from the northeast facing southwest.
