Terracon Consultants, Inc. (Terracon) is pleased to submit our Release Investigation and Closure Report for the site referenced above. The scope of services was developed in accordance with the New Mexico Oil Conservation Division (NMOCD) regulations concerning clean-up actions required for releases of crude oil and produced water. The investigative response actions resulted from a natural gas release from a corroded lateral line. The below sections detail Terracon's assessment and remediation actions in response to the noted releases.

Project No.	KH237012	Exhibit 2 – Site Map	
Scale:	As Shown	Elliot Fed 1 Steel Line 2	
Source:	Google Earth	32.719488°, -104.009502°	
Date:	03/09/2023	Eddy County, New Mexico

Elliot Fed 1 Steel Line 2 ■ Eddy County, New Mexico  
March 10, 2023 ■ Terracon Project No. KH237012

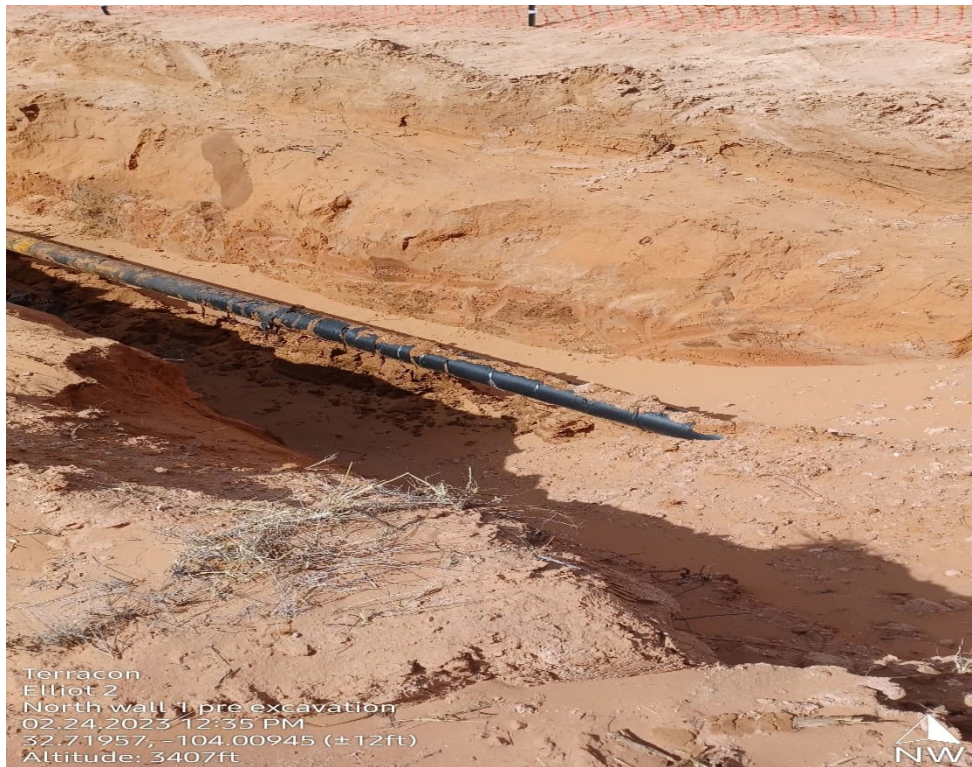
**PHOTO 1:** View of North wall prior to Excavation

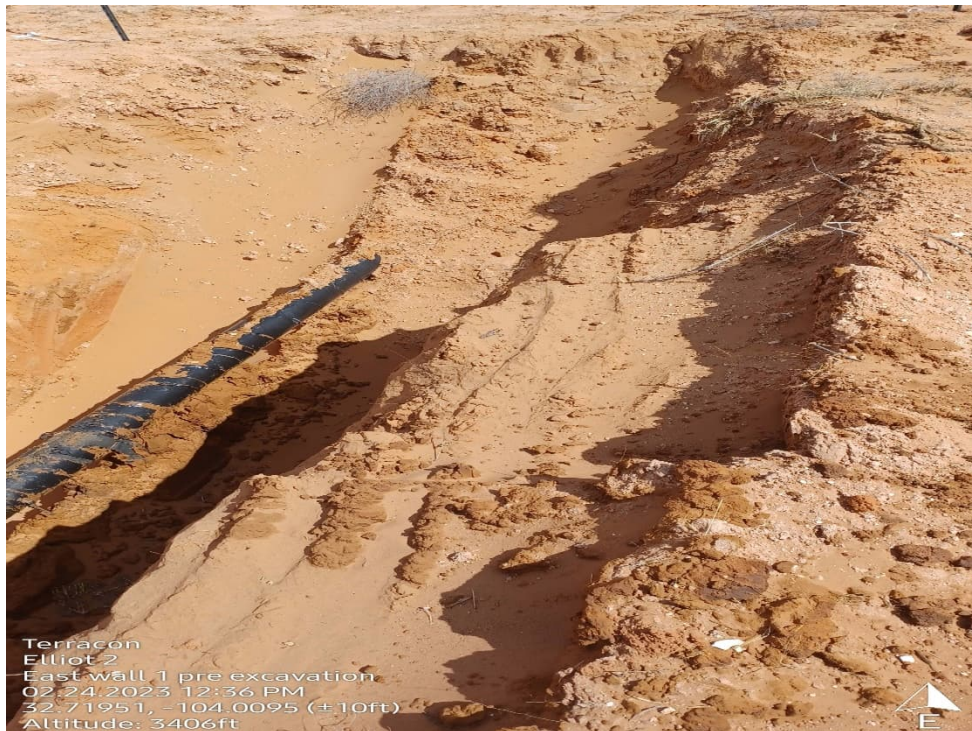
**PHOTO 2:** View of East wall prior to Excavation

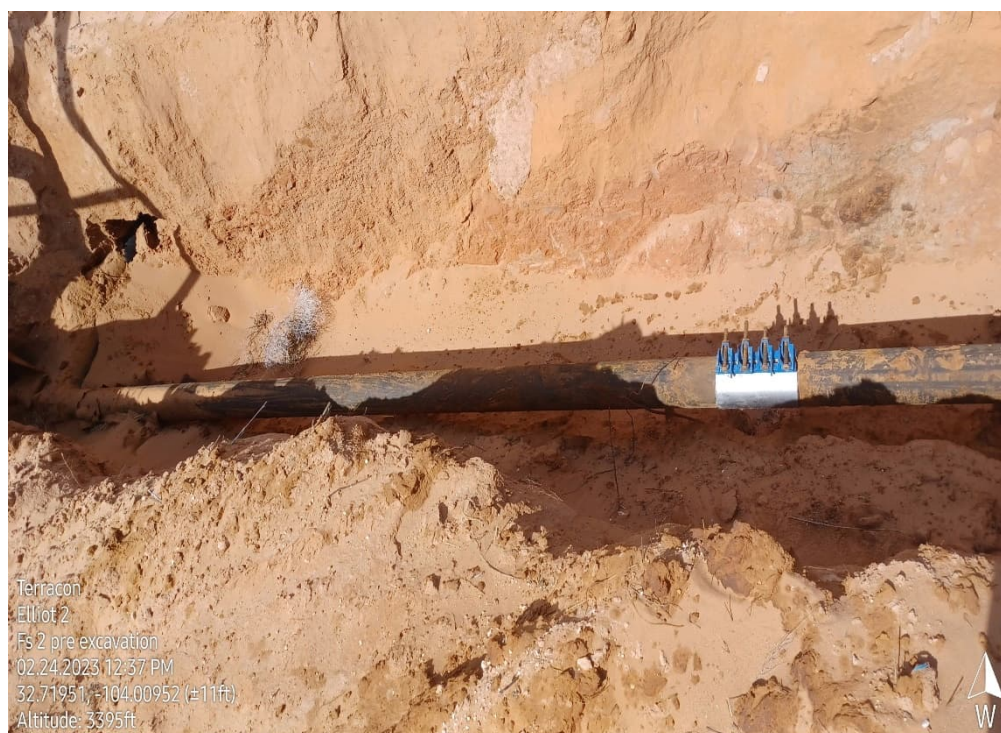
**PHOTO 3:** View of Floor prior to Excavation

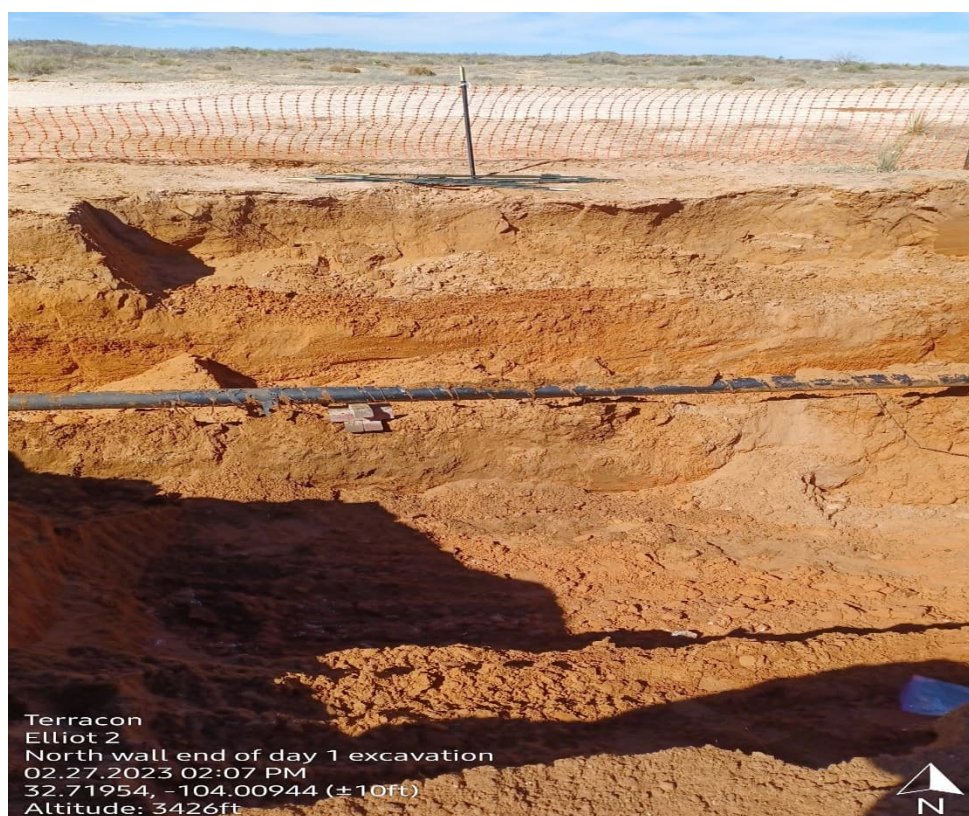
**PHOTO 4:** View of North wall following Excavation

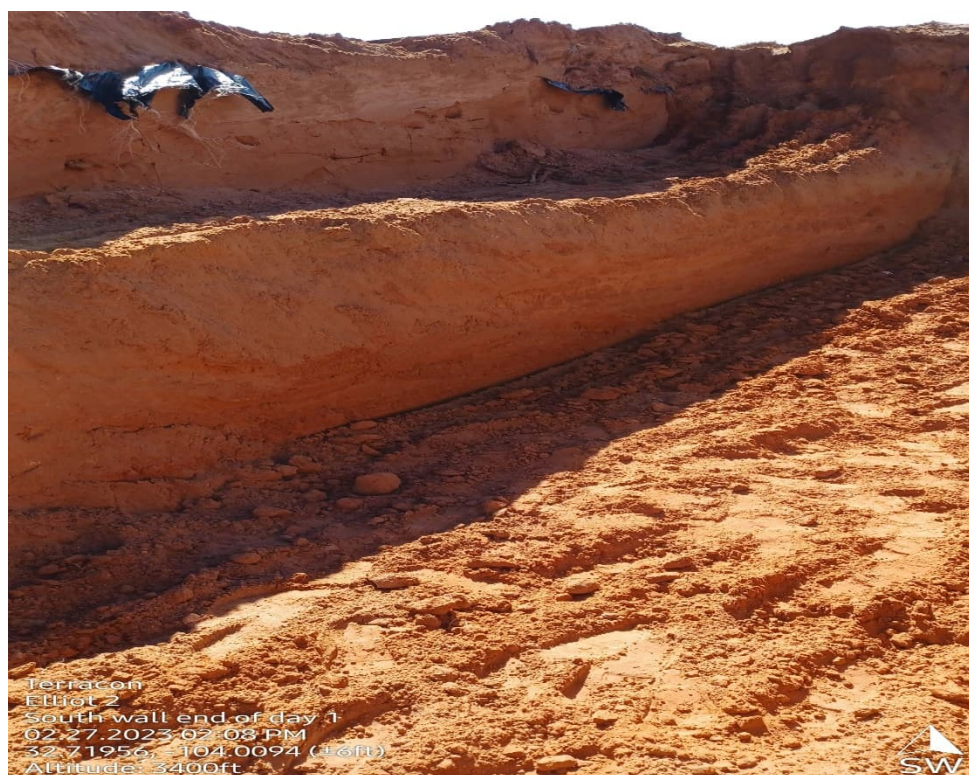
**PHOTO 5:** View of South wall following Excavation

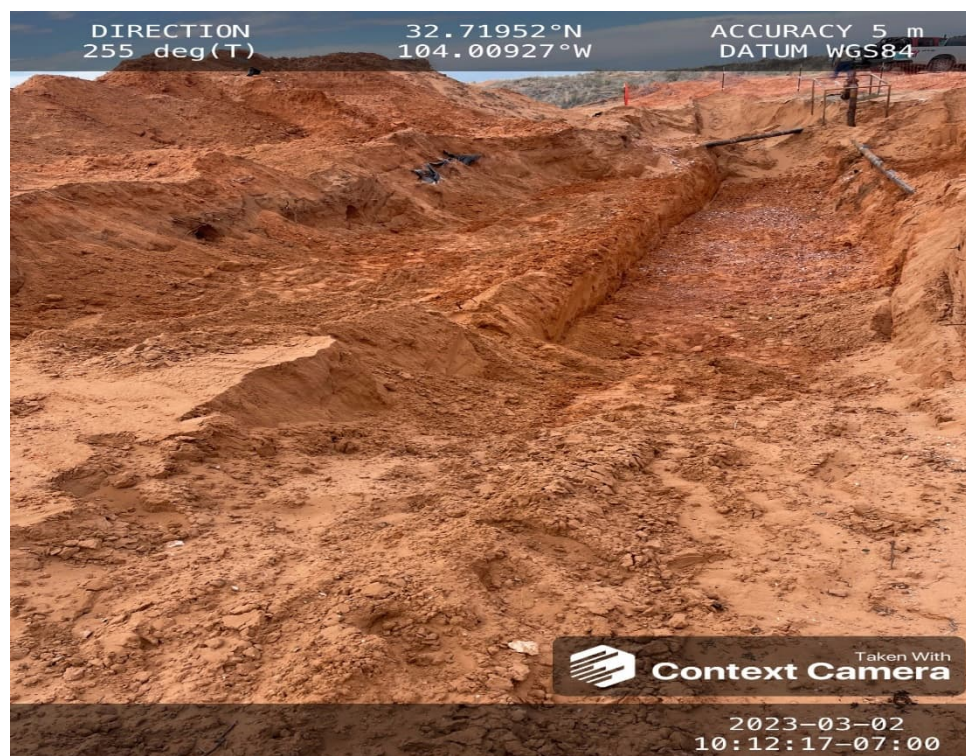
**PHOTO 6:** View of West end of Excavation

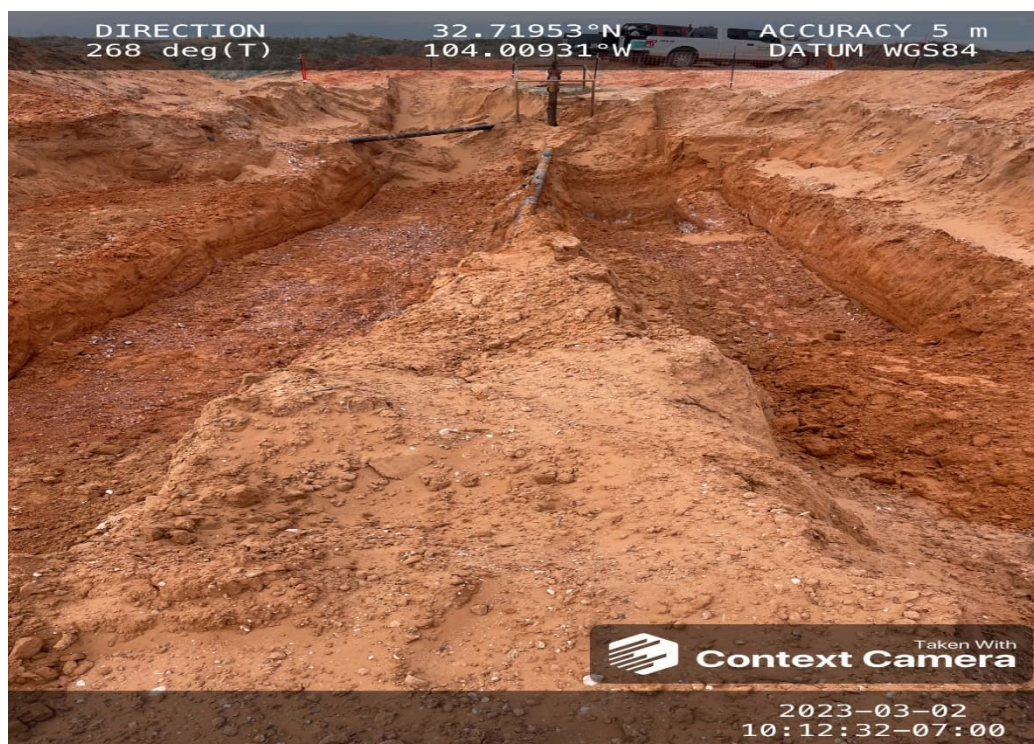
**PHOTO 7:** View of Floor following Excavation

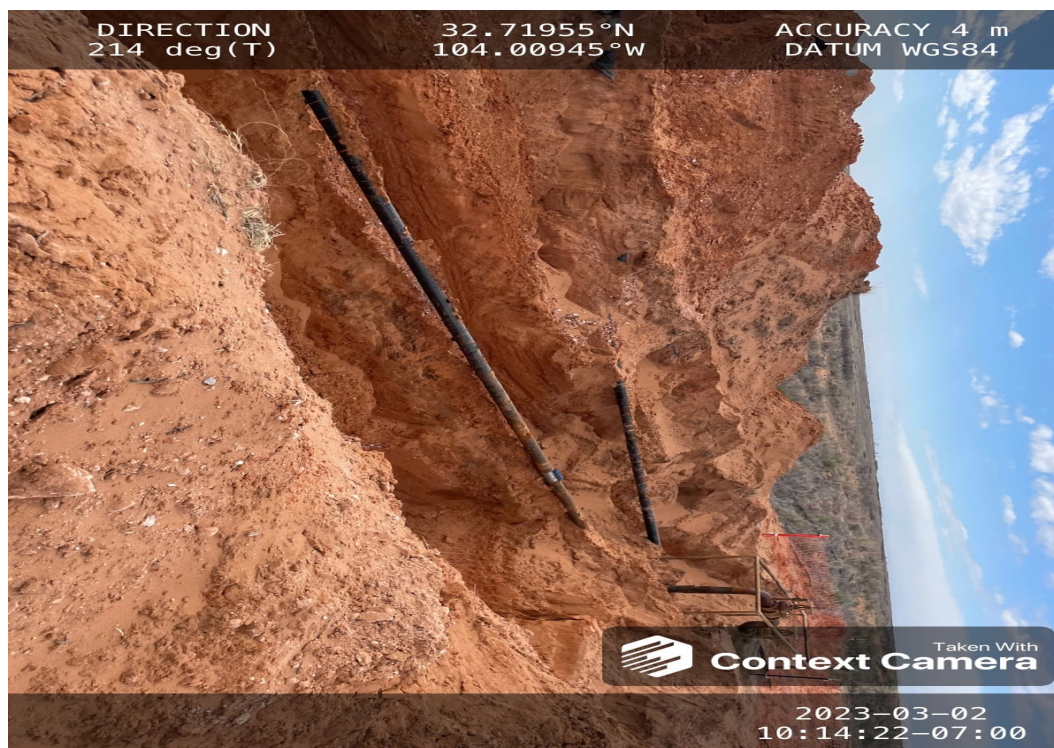
**PHOTO 8:** View of South wall following Excavation
