Incident ID	NAB1801651958
District RP	
Facility ID	
Application ID

**Re: Amendment to Closure Report
Black River 10 State Com #002H
Marathon Oil Corporation
2RP-4559
Site Location: Unit P, S15, T24S, R27E
(Lat 32.21064077°, Long -104.17339692°)
Eddy County, New Mexico**

Site:	Black River 15-10 State Com #2H					
Company:	Marathon Oil Company					
Section, Township and Range	Unit P	Sec. 15	T 24S	R 27E		
Lease Number:	API No. 30-015-42728					
County:	Eddy County					
GPS:	32.21064077° N			104.17339692° W		
Surface Owner:	State					
Mineral Owner:	State					
Directions:	From the intersection of HWY 285 and Black River Village Rd travel west on Black River Village Rd for approximately 4.9 mi, turn south onto lease road for 2.25 miles, turn south onto lease road for 0.30 miles, turn east onto lease road for 0.5 miles to location.

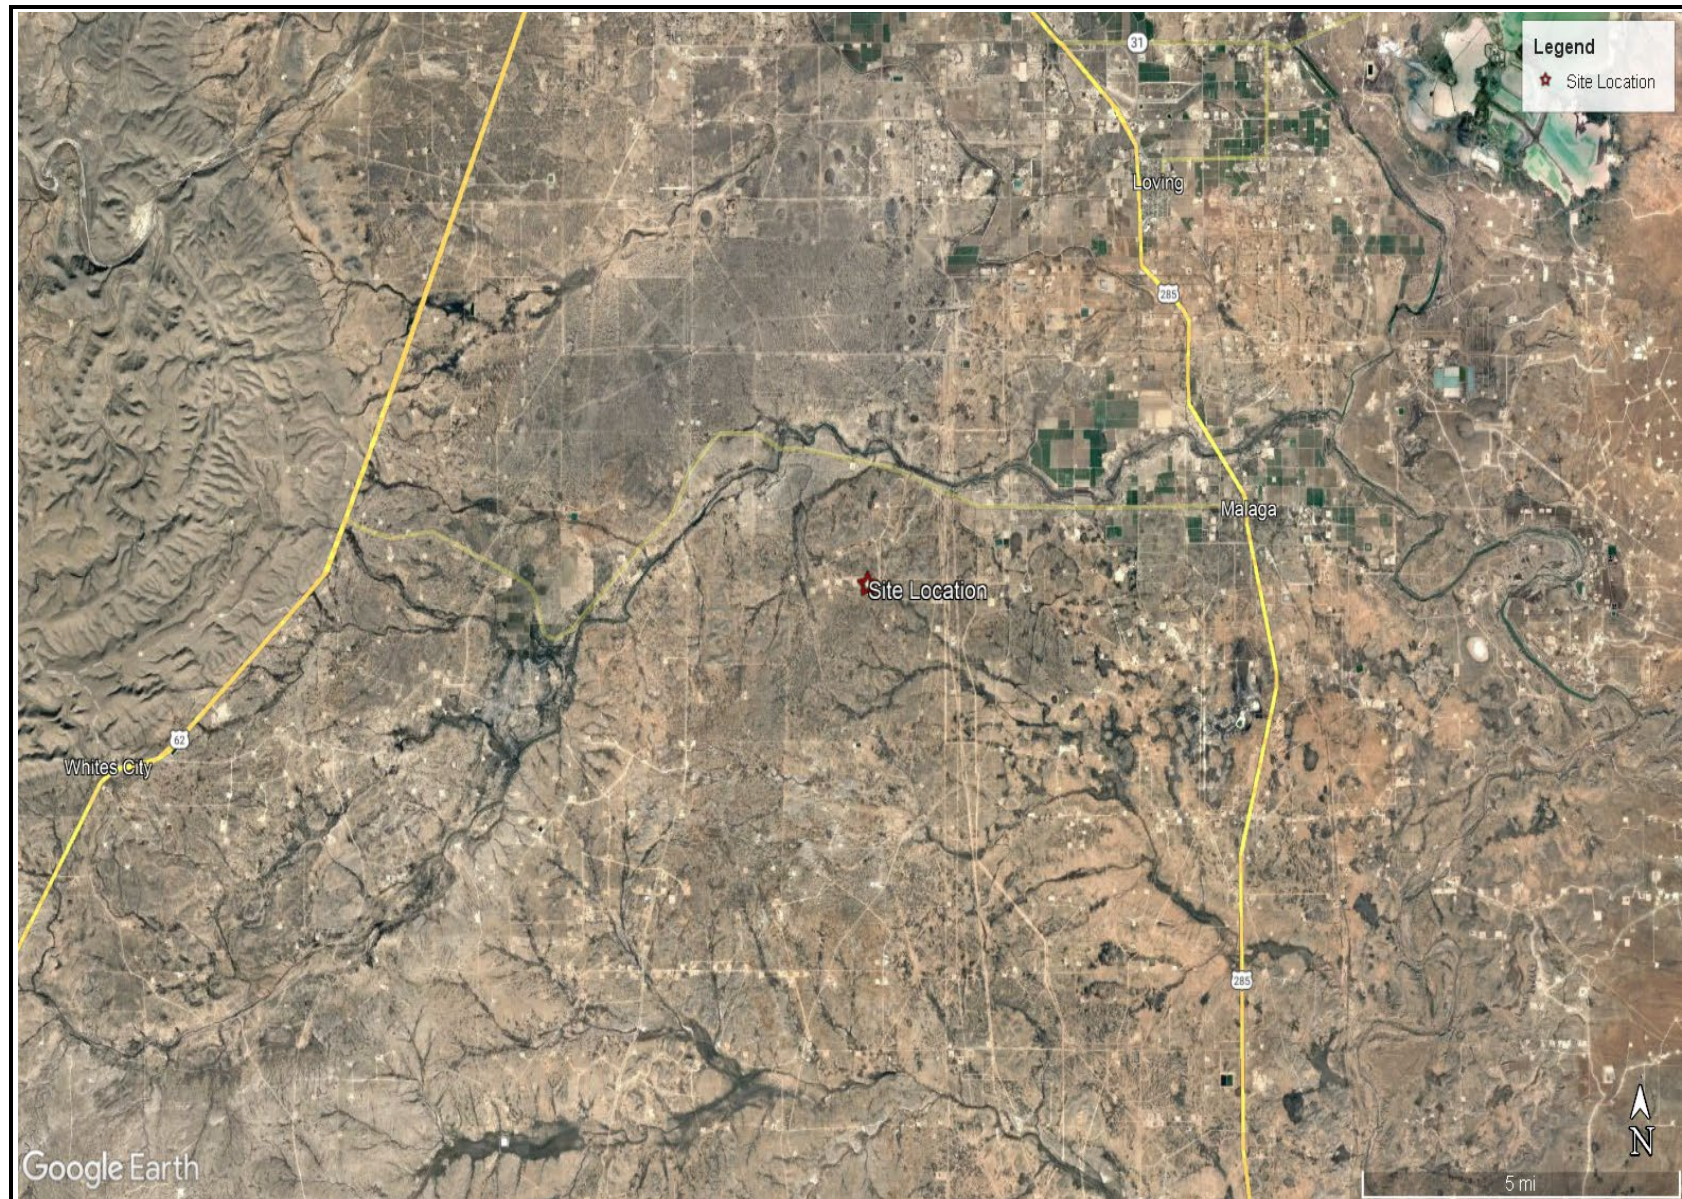
OVERVIEW MAP
MARATHON OIL CORPORATION
BLACK RIVER 10 STATE COM #002H
EDDY COUNTY, NEW MEXICO
32.21064077°, -104.17339692°

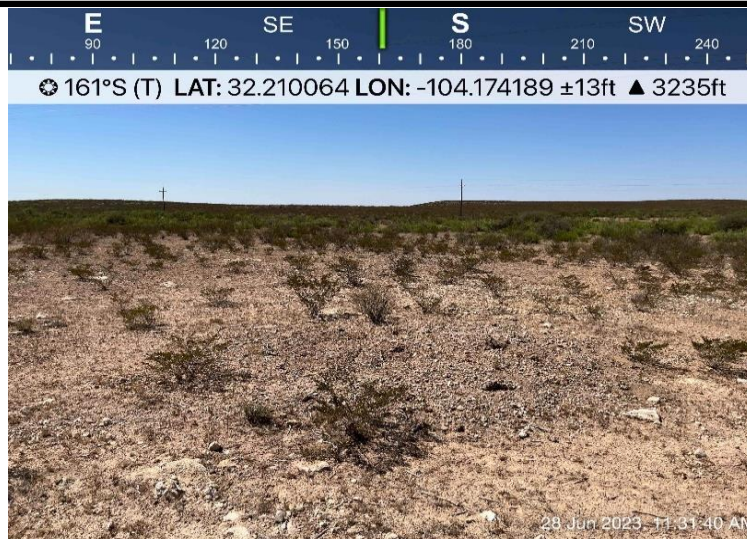
PHOTOGRAPHIC LOG**Marathon Oil Corporation****Photograph No. 1****Facility:** Black River 10 State Com #002H**County:** Eddy County, New Mexico**Description:**

View South of sample points Comp #1 and Comp #2.

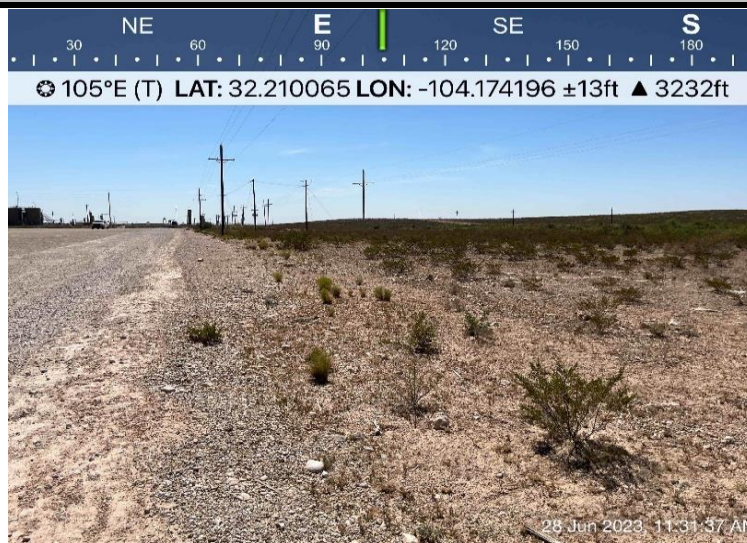
**Photograph No. 2****Facility:** Black River 10 State Com #002H**County:** Eddy County, New Mexico**Description:**

View East of sample points Comp #1 and Comp #2.

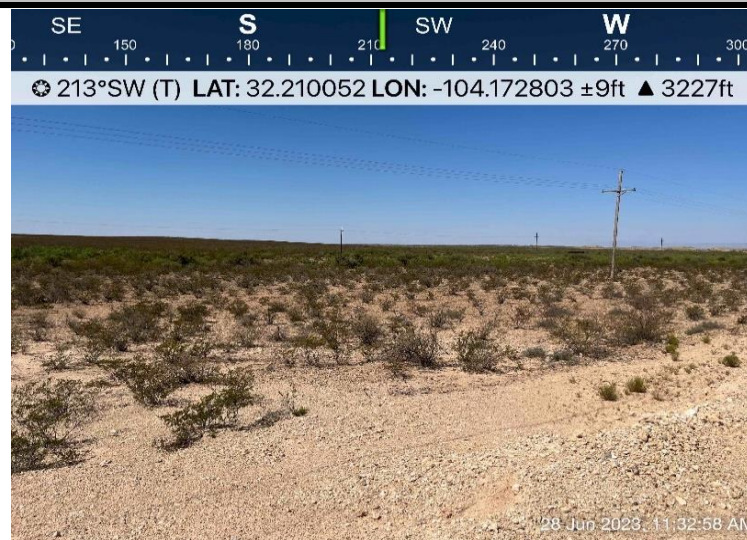
**Photograph No. 3****Facility:** Black River 10 State Com #002H**County:** Eddy County, New Mexico**Description:**

View Southwest of sample points Comp #1 and Comp #2.

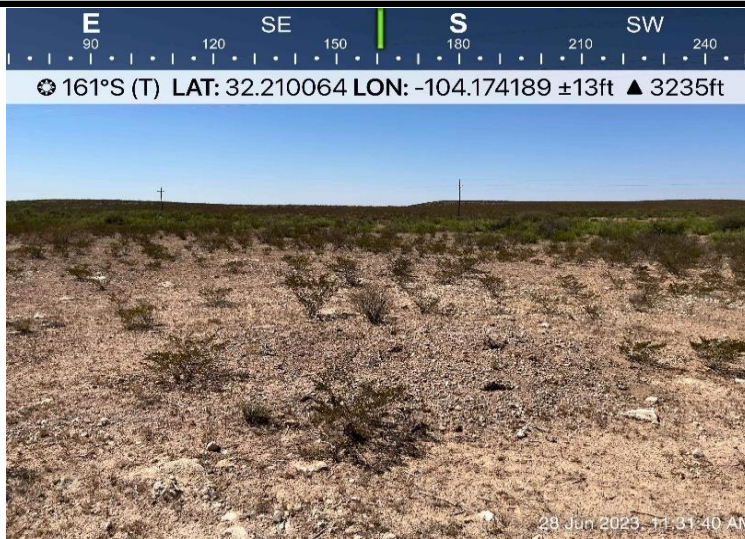
PHOTOGRAPHIC LOG**Marathon Oil Corporation****Photograph No. 1****Facility:** Black River 10 State Com #002H**County:** Eddy County, New Mexico**Description:**

View South of sample points Comp #1 and Comp #2.

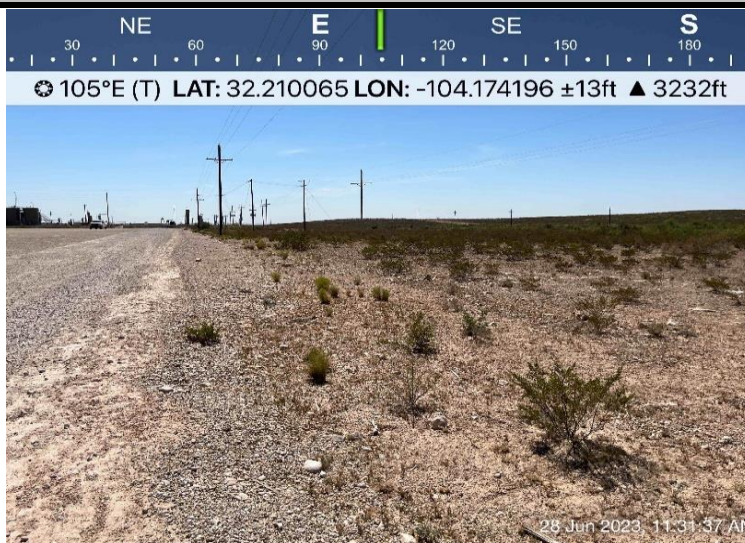
**Photograph No. 2****Facility:** Black River 10 State Com #002H**County:** Eddy County, New Mexico**Description:**

View East of sample points Comp #1 and Comp #2.

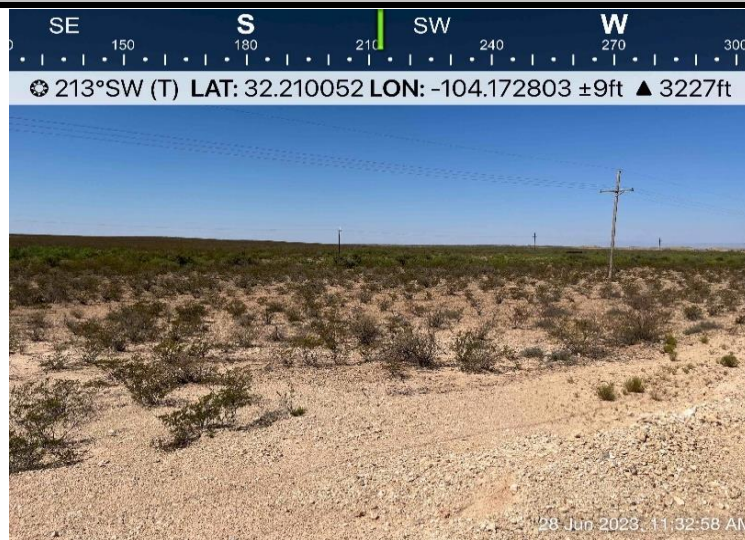
**Photograph No. 3****Facility:** Black River 10 State Com #002H**County:** Eddy County, New Mexico**Description:**

View Southwest of sample points Comp #1 and Comp #2.
