Re: Site Assessment, Remediation, and Closure Report
Merlyn 27 22 Fed 2H
API No. 30-015-42386
GPS: Latitude 32.4396133 Longitude -103.7720556
UL -- D, 34, T21S, R31E
Eddy County, NM
NMOCD Ref. No. NAPP2227246284

Pima Environmental Services, LLC. (Pima) has been contracted by Devon Energy Production Company, LP (Devon) to perform a spill assessment, remediation activities, and submit this closure report for a Crude oil release that occurred at the Merlyn 27 22 Fed 2H (Merlyn). The initial C-141 was submitted on September 29, 2022 (Appendix C). This incident was assigned Incident ID NAPP2227246284 by the New Mexico Oil Conservation Division (NMOCD).

**SITE PHOTOGRAPHS
DEVON ENERGY
MERLYN 27-22 FED H**

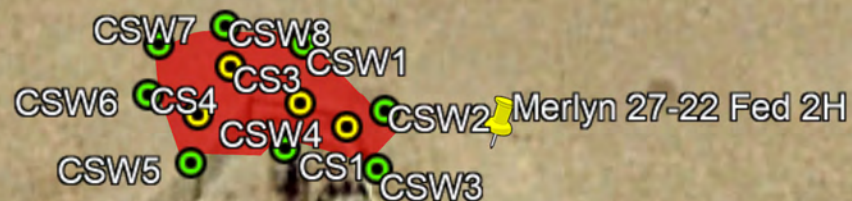
Devon Energy
API: N/A
Eddy County, NM
Confirmation Sample Map

On January 12, 2023, after sending a 48-hour notification (Appendix C), Pima returned to the site to collect confirmation samples of the excavation. The results of this sampling event can be found in the following table. A Confirmation Sample Map can be found in Figure 5.

Based on the sample results, the bottoms and sidewalls were below NMOCD Closure Criteria 19.15.29 NMAC. The contaminated material was sufficiently removed then transported to an NMOCD approved disposal site. The excavation was then backfilled with clean like material, machine compacted and returned to its previous state. See Appendix D for Photographic Documentation.

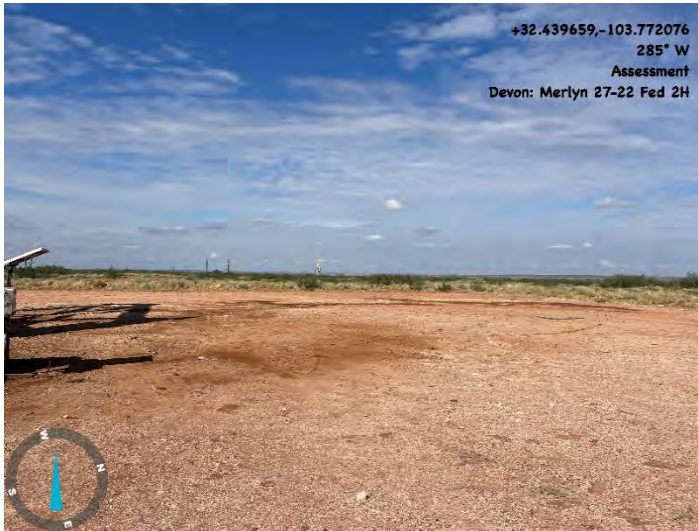
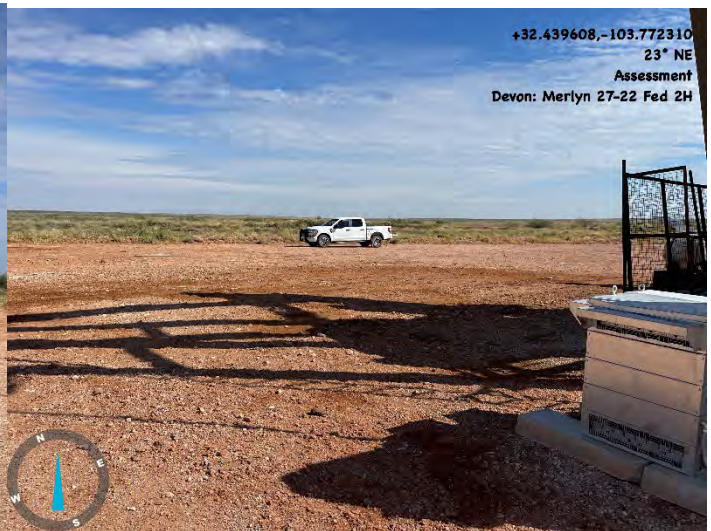
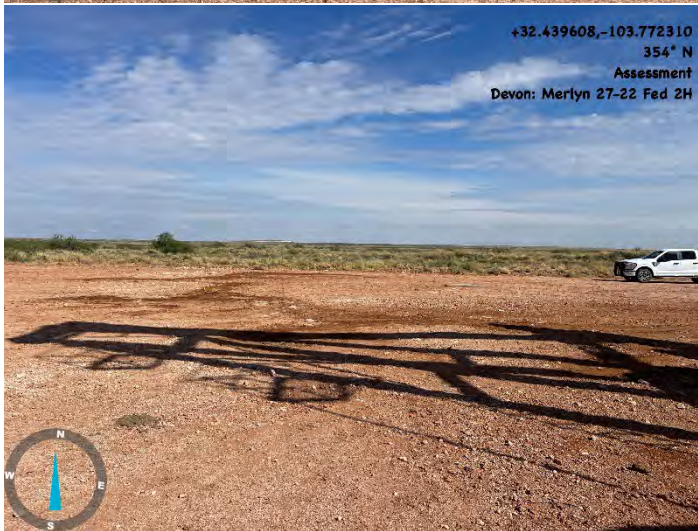
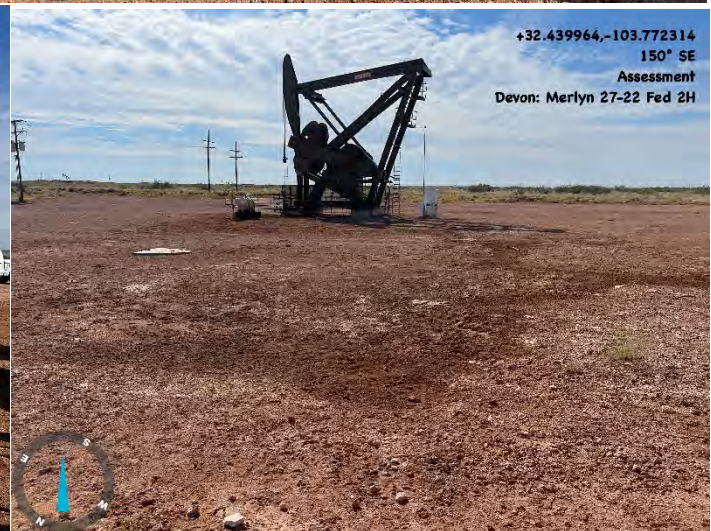
Pre-Excavation

NAPP2227246284: On July 4, 2022, the LO notice spraying mist coming from the well head causing a fluid release. The released fluids were calculated to be approximately 11 barrels (bbls) of crude oil. Vacuum truck was able to recover approximately 6 bbls of standing fluid.

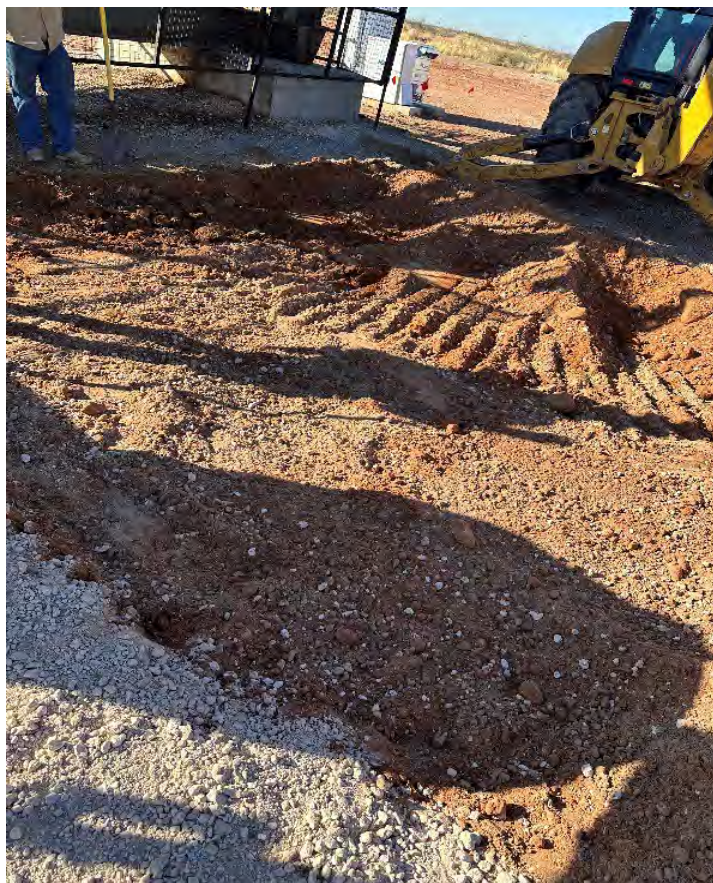
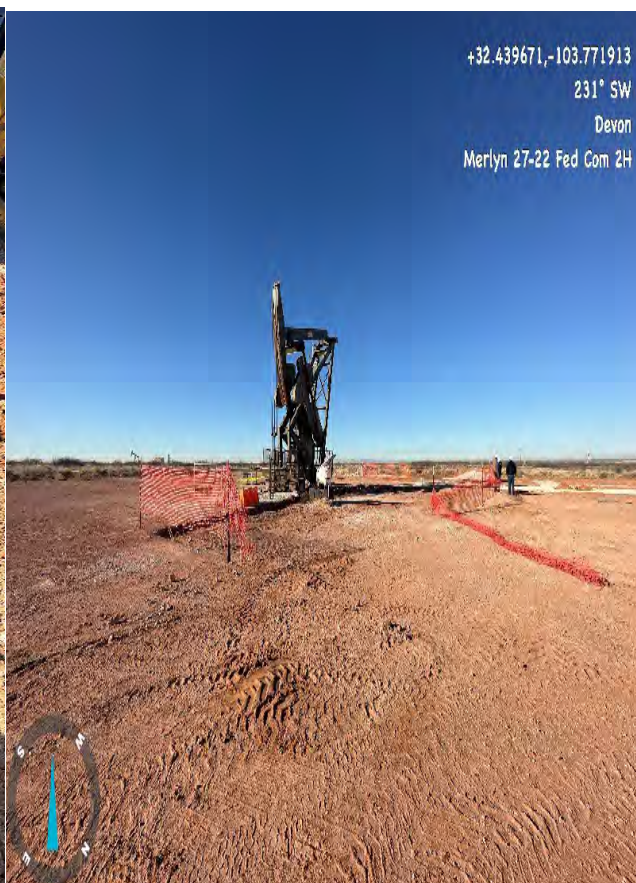
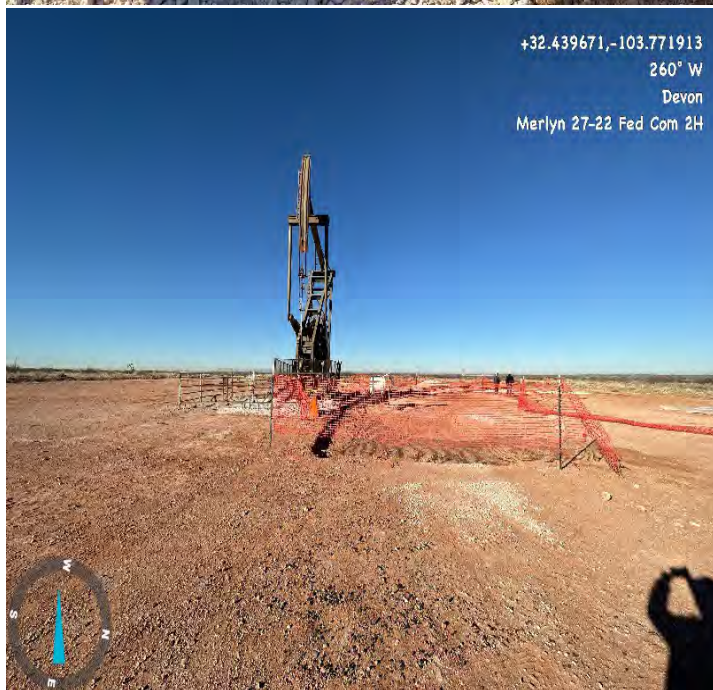
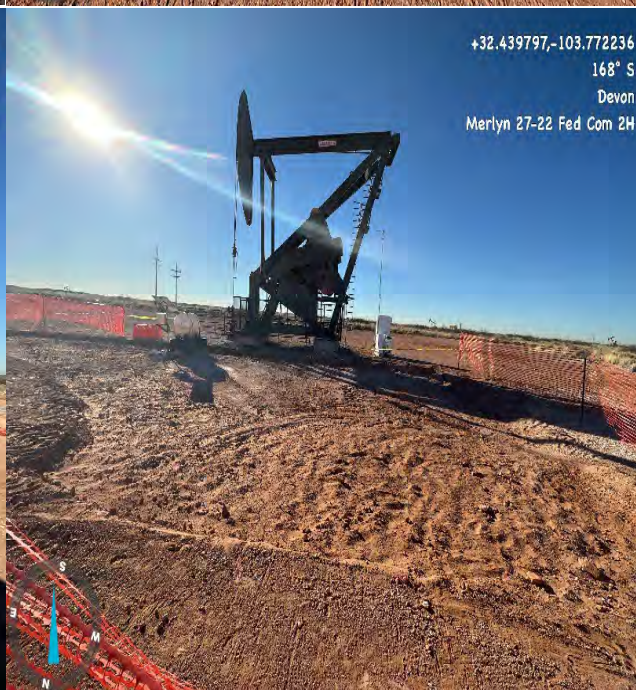
Excavation

On January 6, 2023, the Devon Construction Department mobilized personnel and equipment to begin immediate remediation activities. They began excavating the area to a depth of 2' BGS. The contaminated soil 29 cubic yards were hauled to an approved, lined disposal facility and clean backfill material was brought in.
