## Liner Inspection and Closure Request

**BTA Oil Producers, LLC**

**Pardue D #2 WI**

**NMOCD Incident # nAPP2225376858**

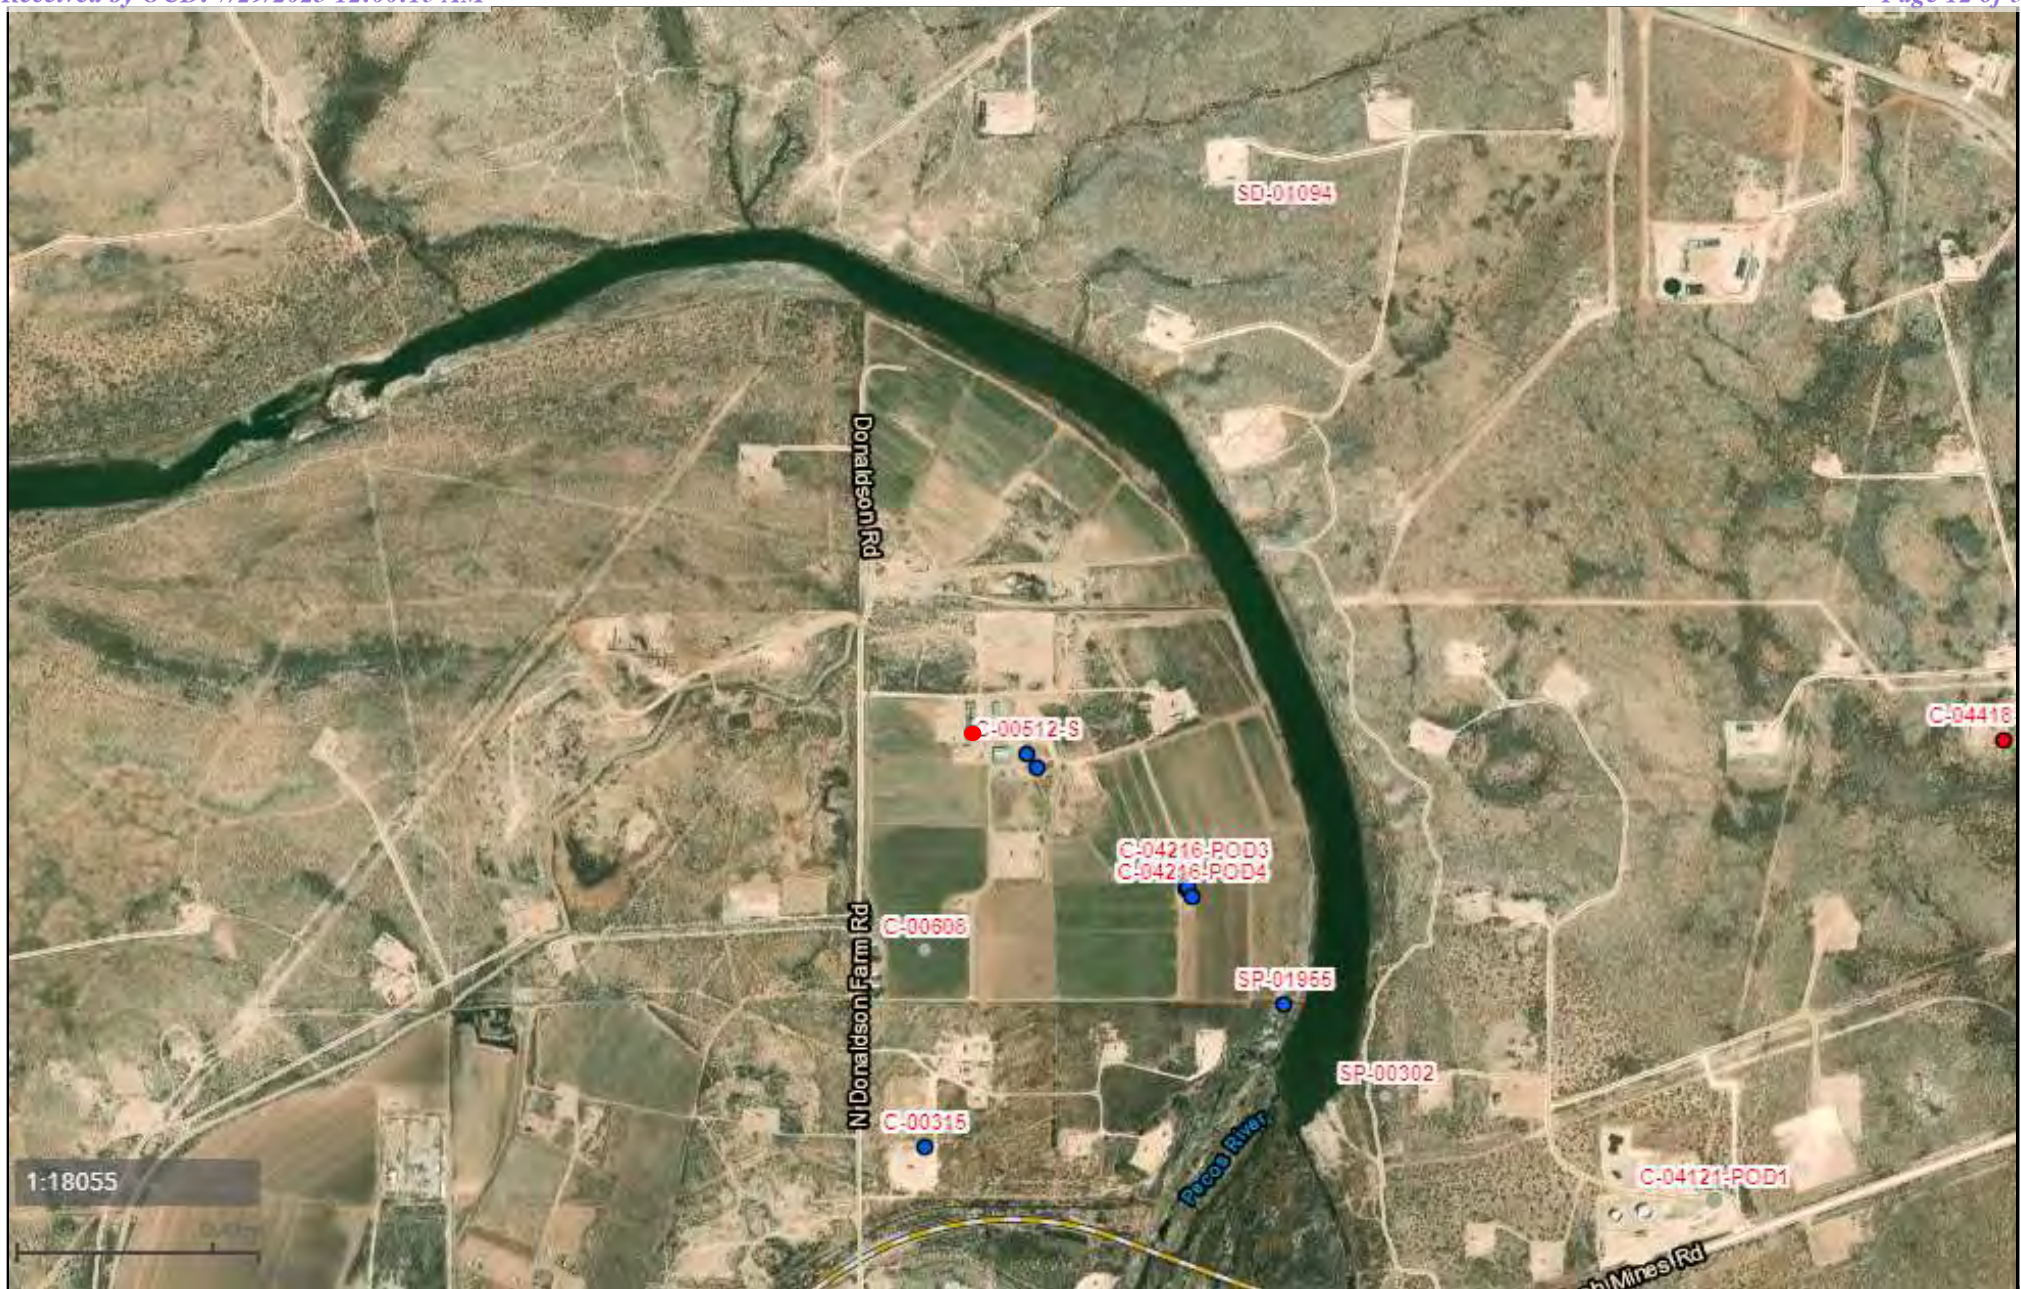
**Figure 2**

OSE POD Locations Map  
 BTA Oil Producers, LLC  
 Pardue D #2 WI  
 GPS: 32.325028, -104.064426  
 Eddy County

A search of the New Mexico Office of the State Engineer (NMOSE) and United States Geological Survey (USGS) groundwater databases was completed in an effort to determine the horizontal distance to known water sources within a half mile radius of the Release Site. Approximate depth to groundwater was determined using maintained and published water well data. Karst mapping indicates the site is located in a Karst designated area. Karst and Wetland Maps are provided as Attachment I. Depth to groundwater information is provided as Attachment IV and the results are depicted on Figures 2 & 3.

A total of eight water wells were located within a half mile of the release area. With depth to water ranging between 10 to 20 feet bgs. It was also determined that the release occurred within a Karst designated area. Utilizing this information, the NMOCD Closure Criteria for the Site is depicted in the table below. However, due to the release being contained within a lined containment area and all fluid was recovered, a liner inspection was scheduled.

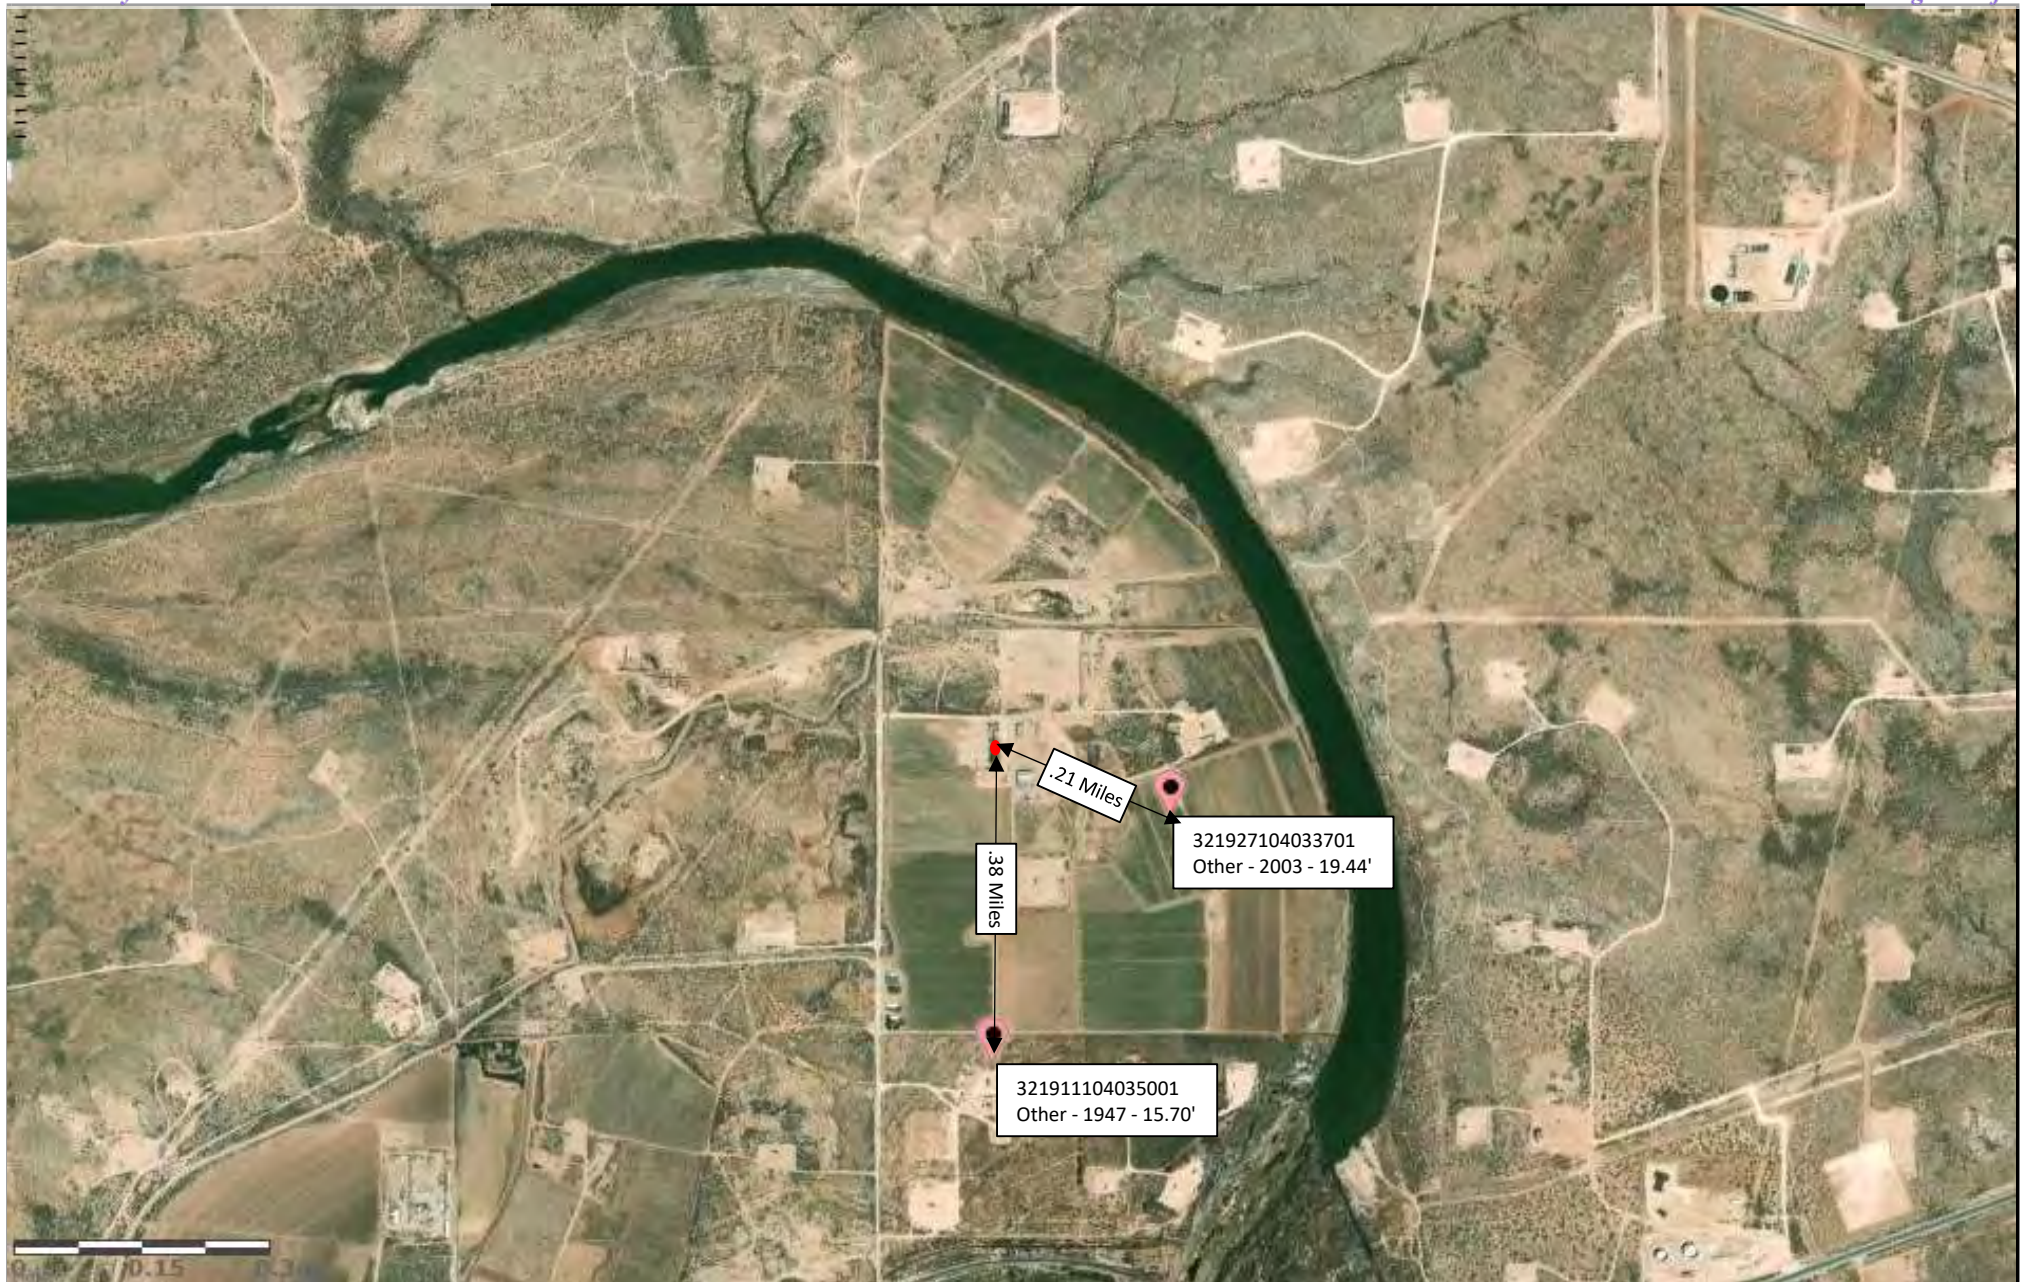
**Figure 3**

USGS Well Locations Map  
BTA Oil Producers, LLC  
Pardue D #2 WI  
GPS: 32.325028, -104.064426  
Eddy County

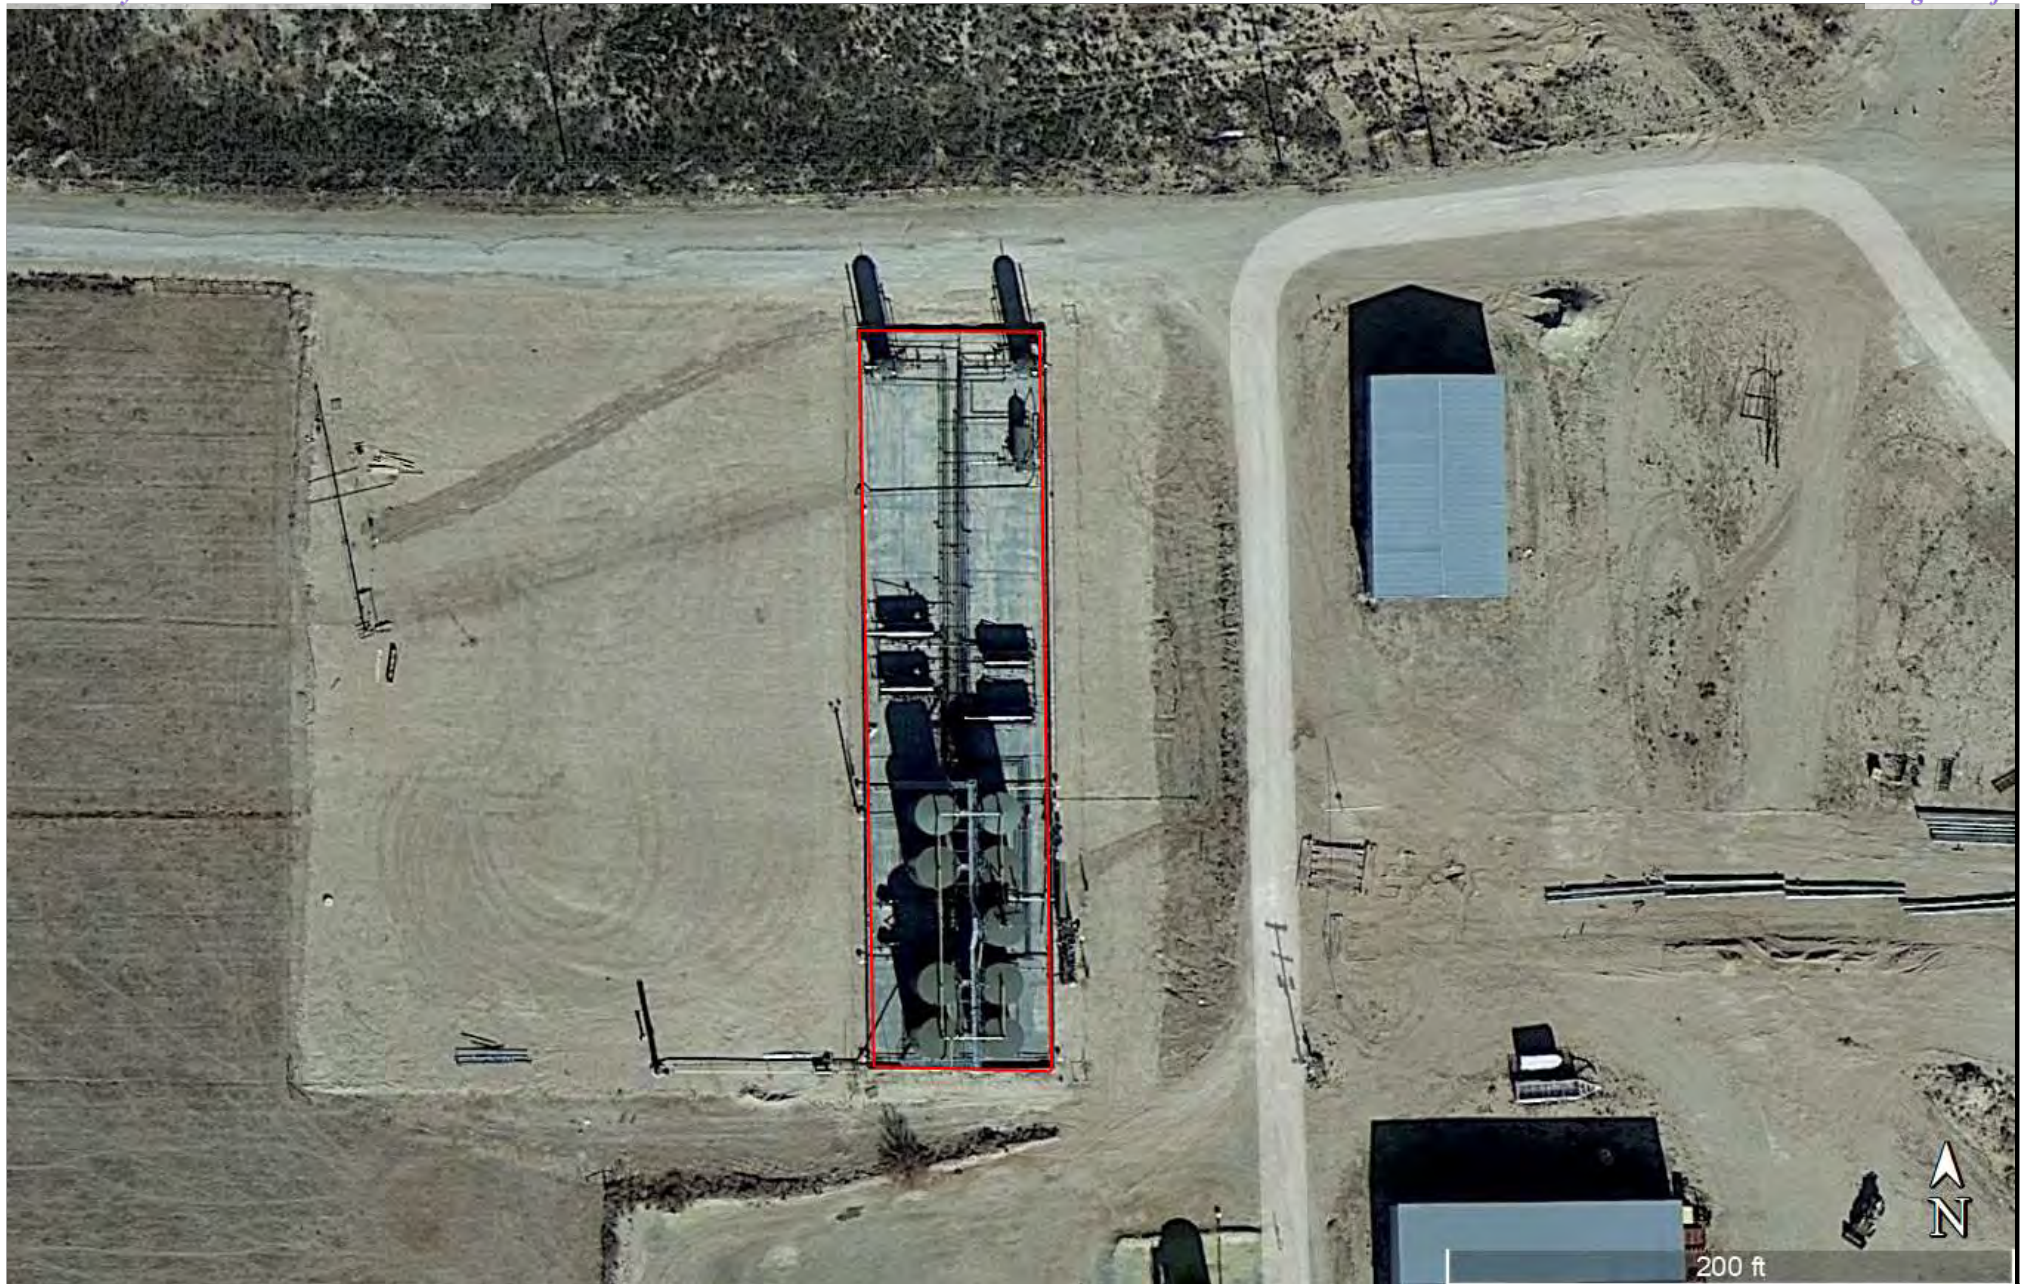
**Figure 4**

Liner Inspection Map  
BTA Oil Producers, LLC  
Pardue D #2 WI  
GPS: 32.325028, -104.064426  
Eddy County

Release Within Lined Containment Area

On July 19, 2023, Hungry Horse personnel arrived on location to inspect the liner. The liner and metal containment were thoroughly inspected form edge to edge, as well as around the tanks and process equipment installed on the liner itself (reference Attachment III – Site Photographs). The liner was found to be in place, intact, with no visible, breaks, or tears. There was no evidence of the release escaping the metal containment area. A completed Liner Inspection Form is attached as Attachment V.
