Re: Site Assessment, Remediation, and Closure Report

Lone Tree Draw 14 State Com #3H

API No. 30-015-42083

NMOCD Ref. No. NAPP2300161700

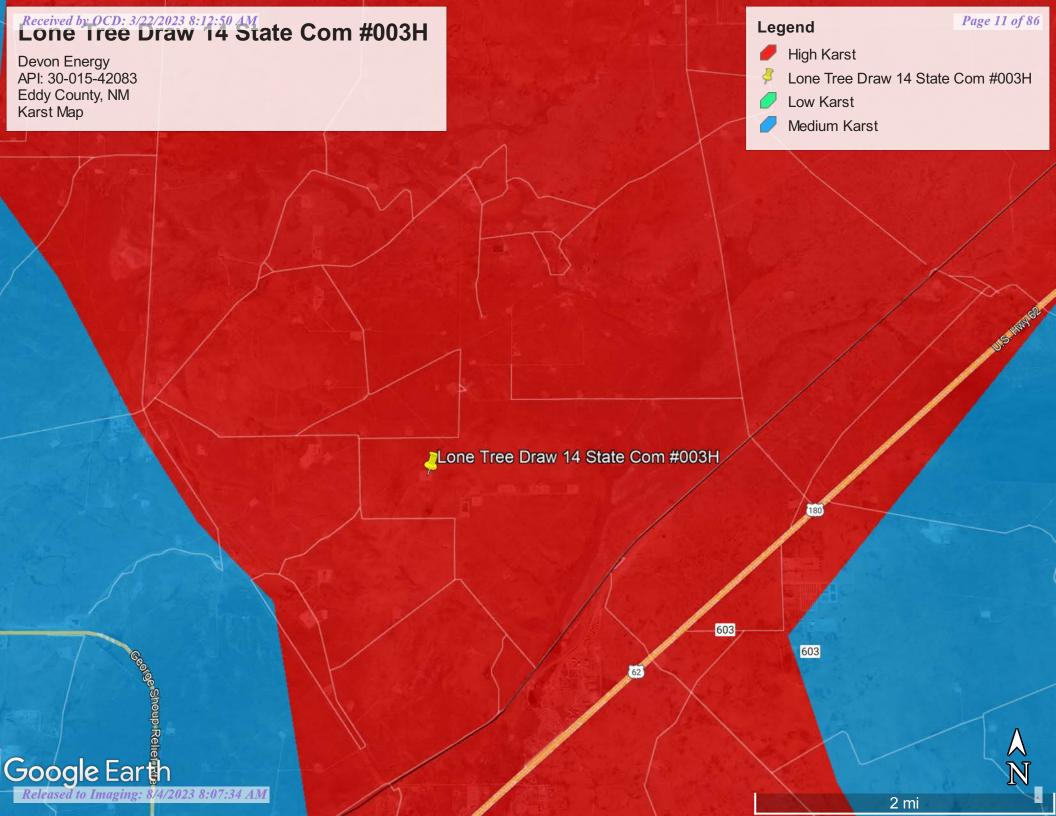
3-Karst Map

Per the New Mexico Bureau of Geology and Mineral Resources, the geology is made up of Eolian deposits, Holocene to middle Pleistocene. The soil in this area is made up of Gypsum land-Reeves complex, 0 to 3 percent slopes according to the United States Department of Agriculture Natural Resources Conservation Service soil survey (Appendix B). The drainage class in this area is well drained. There is a high potential for karst geology to be present around the Lone Tree (Figure 3).

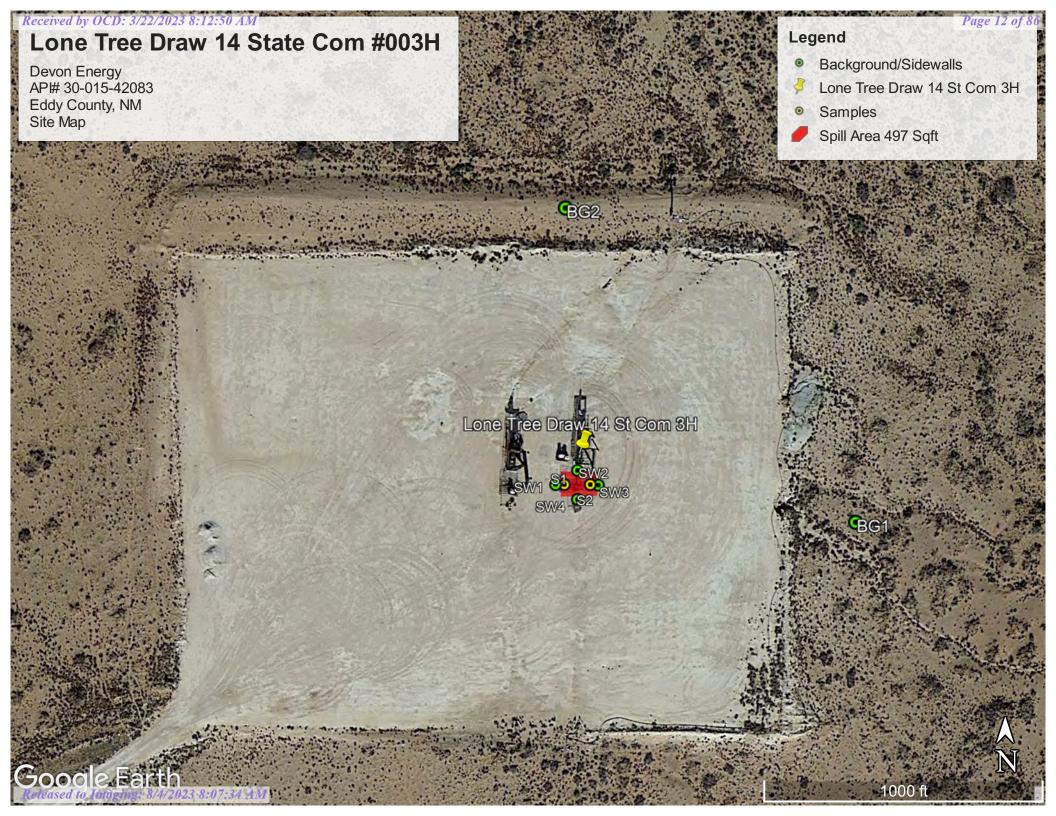
4-Site Map

On January 13, 2023, Pima mobilized personnel to the site to begin collecting soil samples from spill area. The laboratory results of this sampling event can be found in the following data table. A Site Map can be found in Figure 4.

On February 7, 2023, the Devon Construction Department mobilized personnel and equipment to begin remediation activities. They began excavating the area to an average depth of 4' BGS. The contaminated soil, approximately 73 cubic yards, was hauled to an approved, lined disposal facility and clean backfill material was brought in.

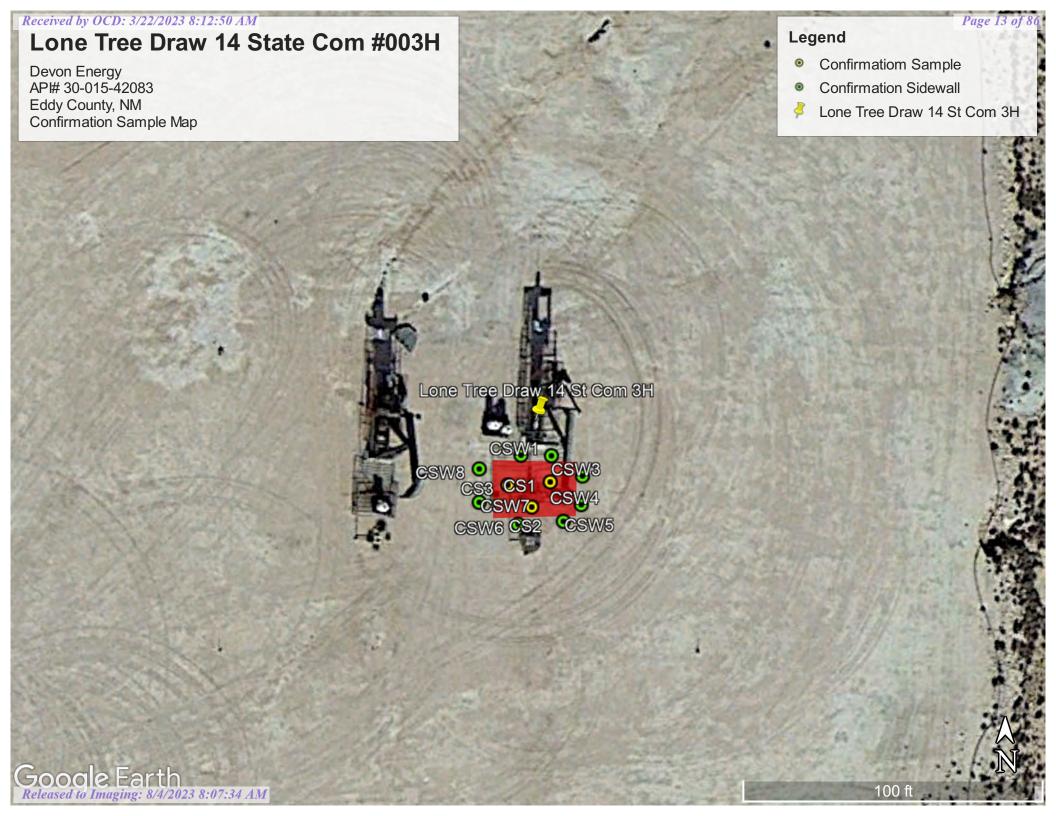
5-Confirmation Sample Map

On March 2, 2023, after sending a 48-hour notification (Appendix C), Pima returned to the site to collect 5-point composite confirmation samples of the excavation. The results of this sampling event can be found in the following table. A Confirmation Sample Map can be found in Figure 5.

Based on the sample results, the bottoms and sidewalls were below NMOCD Closure Criteria 19.15.29 NMAC. The contaminated material was removed then transported to an NMOCD approved disposal site. The excavation was then backfilled with clean like material, machine compacted and returned to its previous state. See Appendix D for Photographic Documentation.

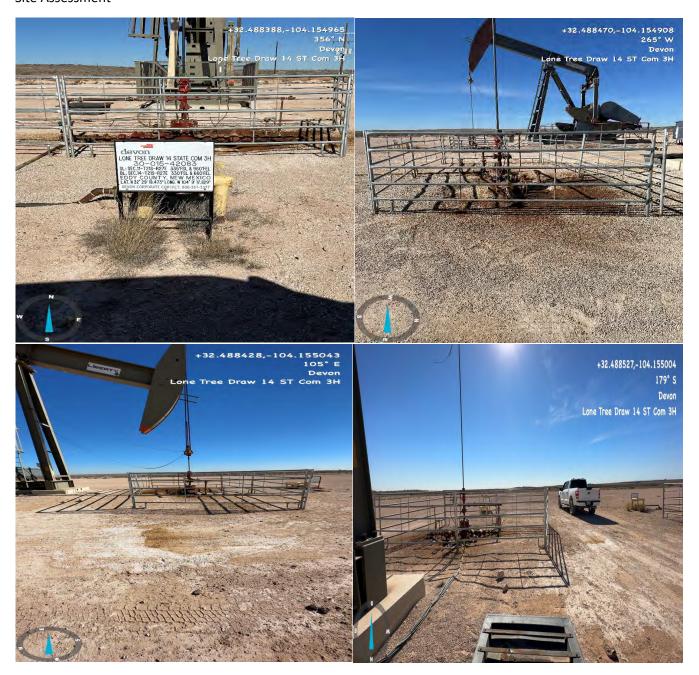
#### Site Assessment

<u>NAPP2300161700:</u> On January 1, 2023, Lease Operator arrived at location and noticed fluid on the ground. The 2" pipe on the tubing had developed a hole before the 2" valve, causing fluid to be released onto the pad. The released fluids were calculated to be approximately 9.2 barrels (bbls) of crude oil. A vacuum truck was able to recover 1 bbls of standing fluid.
