Tom Cat 16, State 2

Site Assessment – Characterization & Remediation Plan

Lea County, New Mexico

Water District #2	UNIT LETTER	SECTION	TOWNSHIP	RANGE	COUNTY
Roswell, NM	H	16	23S	32E	LEA
LOCATION AND ACCESS TO FACILITY					
	Responsible Party:			Harvard Petroleum Company, LLC	
	Land Owner:			Unknown	
	GPS coordinate of oil & chloride spill:			N 32.299038°	
	GPS coordinate of oil & chloride spill:			W 103.685944°	
	Facility GPS coordinate production well Tom Cat 16, State #2:			N 32.299150°	
	Facility GPS coordinate production well Tom Cat 16, State #2:			W 103.686034°	
	Driving directions from nearest city to spill:			Jal, New Mexico: From the intersection of Highway 128 and Highway 18 in Jal, New Mexico, travel west by northwest 31 miles on Highway 128. At entrance GPS coordinates listed below, exit right, and proceed northeast on lease road for approximately 3.8 miles, turn left and travel due north 1.8 miles to tank battery and well #2.	
	Spill physical location from Highway 128:			The spill is located 4.6 miles from the center of Highway 128 to production facility.

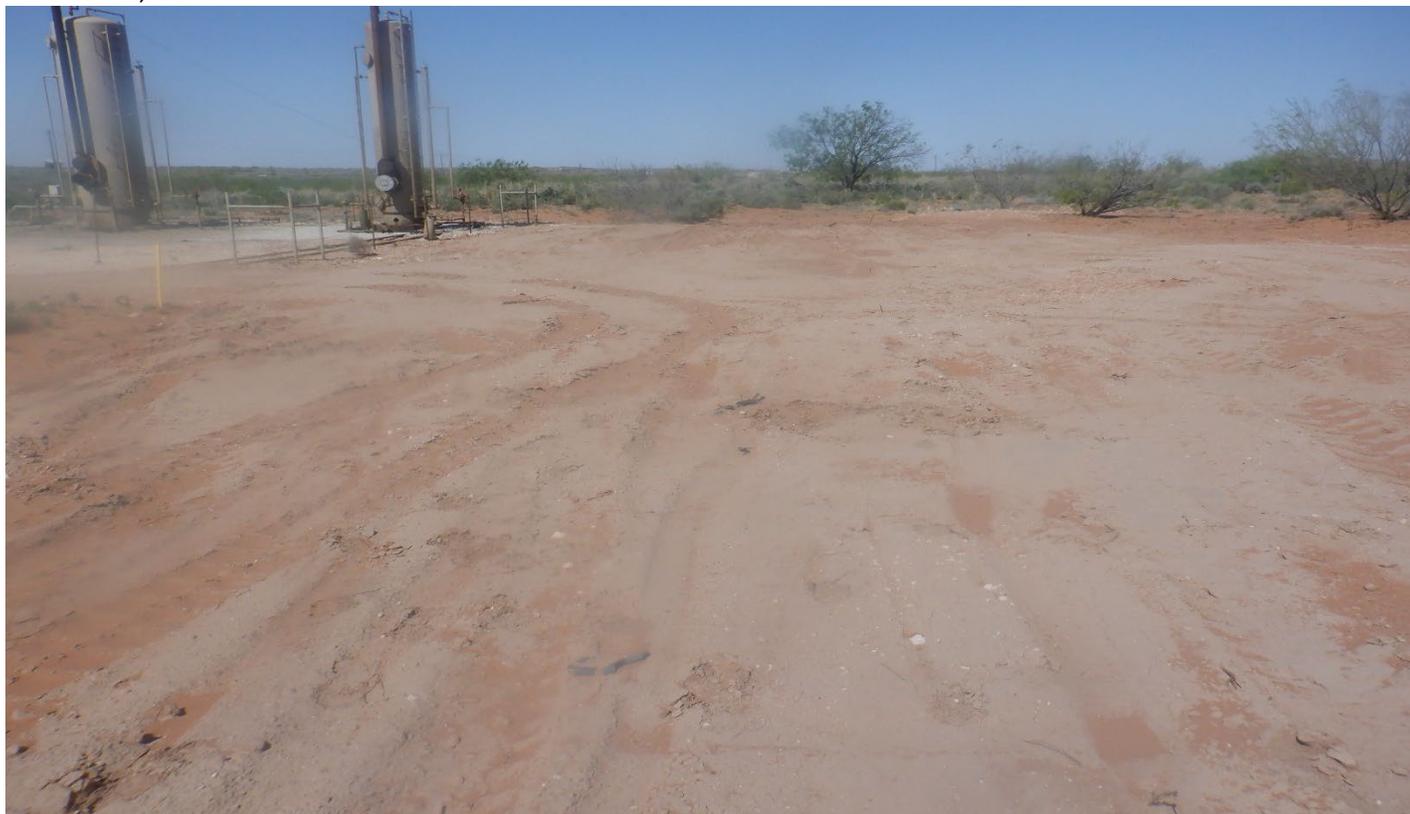
PHOTO #1; SPILL AREA:

On April 26th, 2023, COMM Engineering conducted an initial site assessment. The inspector found the spill area to be cleared of all heavy oil and produced water on the surface. Further investigation through boring and soil sampling revealed no wet soil containing visible oil or produced water from 0-inches to 15-inches under the surface. However, through on-site field testing, the inspector found chloride levels exceeding 3,000 ppm continuously over the spill area down to 6-inches in depth, and 12-inches in multiple areas within the spill site.

- Utilizing heavy equipment and labor to excavate and remove the contaminated soil from the area north and northeast of the release point.
- Remove the surface oil spray in all areas impacted by wind-blown oil spillage.
- All excavated contaminated soil will be removed from the spill site and transported to a licensed soil disposal facility. No contaminated soil will be stockpiled at the location after final remediation.
- After excavation, the impacted area will be sampled to determine all NMOCD thresholds have been adhered to, with the ability to collect soil samples every 200 square feet.
- If side walls are created after excavating or trenching, all side walls will follow the same collection standards of every 200 square feet.

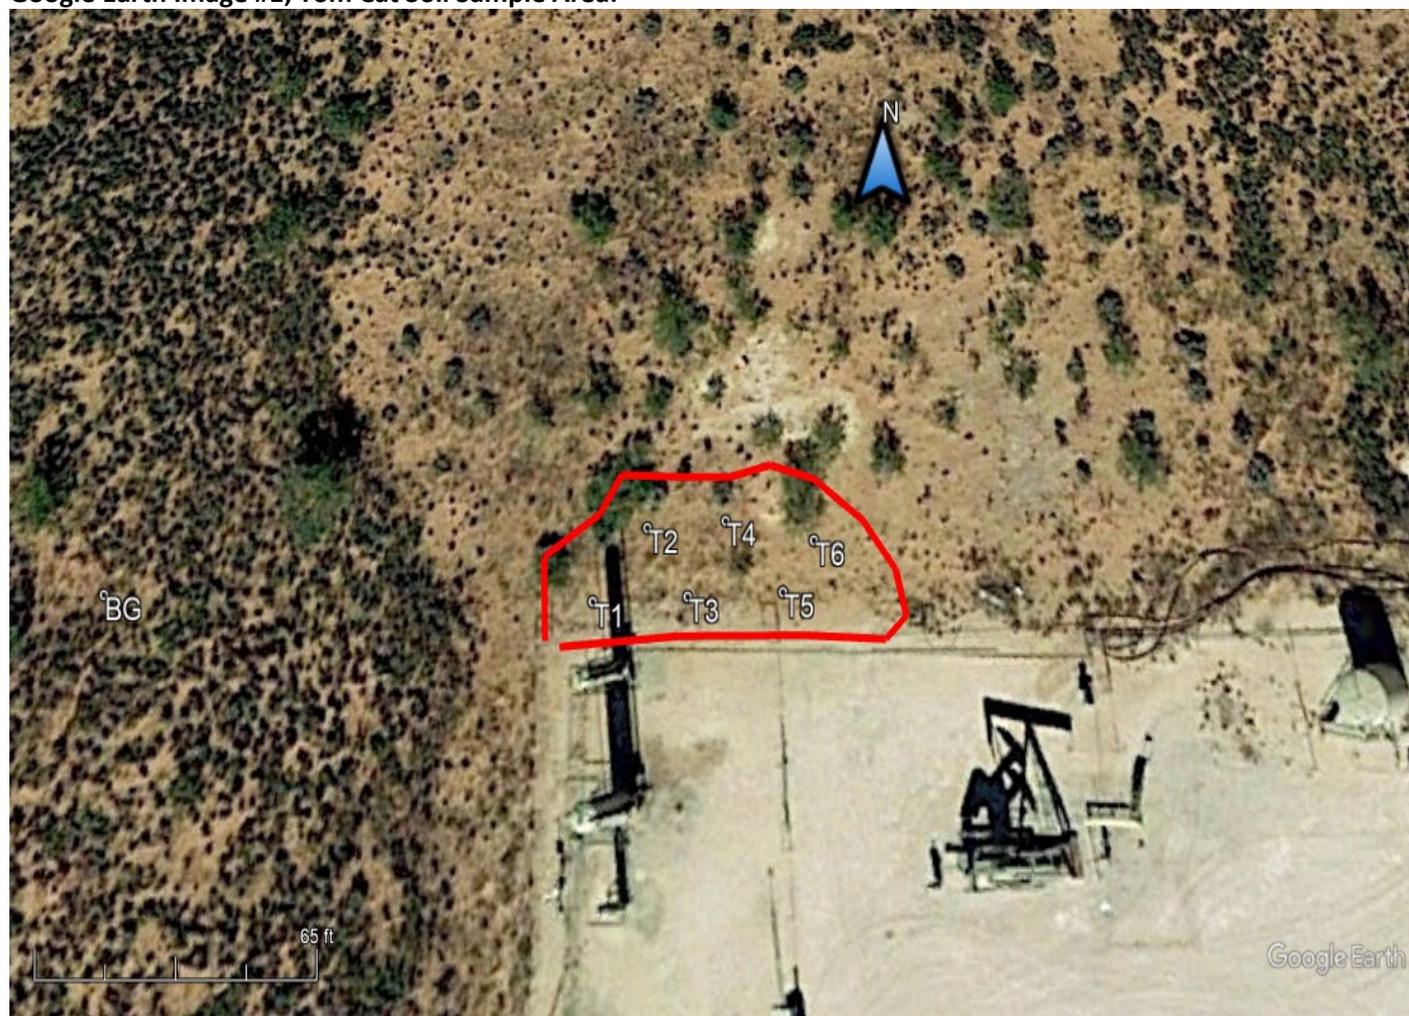
Google Earth Image #1; Tom Cat Soil Sample Area:

The assessment team completed (5) field test from 0-inches to 6-inches with the spill area and (2) field test from 7-inches to 12-inches; Google Earth image of the spill area below.

Chloride test showed readings in excess of 3,000 ppm. Further testing in select areas under the soil found native soil also containing chloride in excess of 3,000 ppm. Hand-augured soil bores were completed (TC-T1 to TC-T6 & (1) BG Sample within the release spill area was collected and taken to Cardinal Labs in Hobbs, New Mexico for analytical testing. Soil sampling purposes is for the development of the remediation plan only. After remediation composite confirmation samples will be collected from the bottom and sidewalls of the excavation from areas representing no more than two hundred (200) square feet. Those samples will be documented in the final closure report.

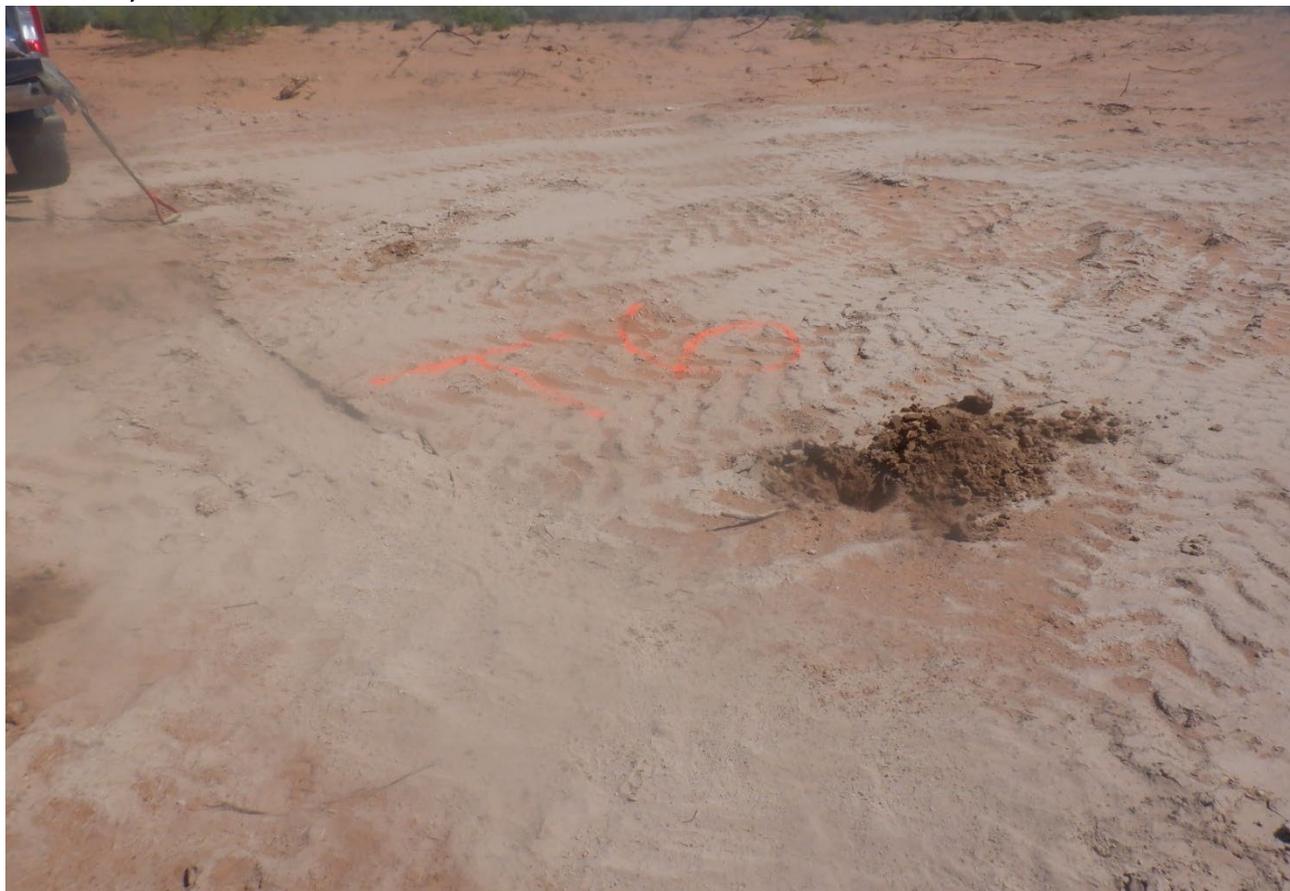
PHOTO #2; TEST BORE EXAMPLE:

TOM CAT LEASE – SOIL SAMPLE AREA & GPS COORDINATES			
TEST BORE #	TEST BORE DEPTH	GPS LOCATION N	GPS LOCATION W
TC-T1	0 - 6-Inches	32.299285	-103.686431
TC-T1	7 - 12-Inches	32.299285	-103.686431
TC-T2	0-6-Inches	32.299329	-103.686389
TC-T3	0 - 6-Inches	32.299288	-103.686355
TC-T4	0 - 6-Inches	32.299334	-103.686324
TC-T5	0 - 6-Inches	32.299322	-103.686278
TC-T6	7 - 12-Inches	32.299290	-103.686829
BG=Background	0 – 3 Inches	32.299290	-103.686829
