Remediation and Closure Report

Burton 6 Federal #002
Incident# nAPP2303839212
Eddy County, New Mexico

Subject: **Remediation and Closure Report**
Burton 6 Federal #002
Eddy County, NM

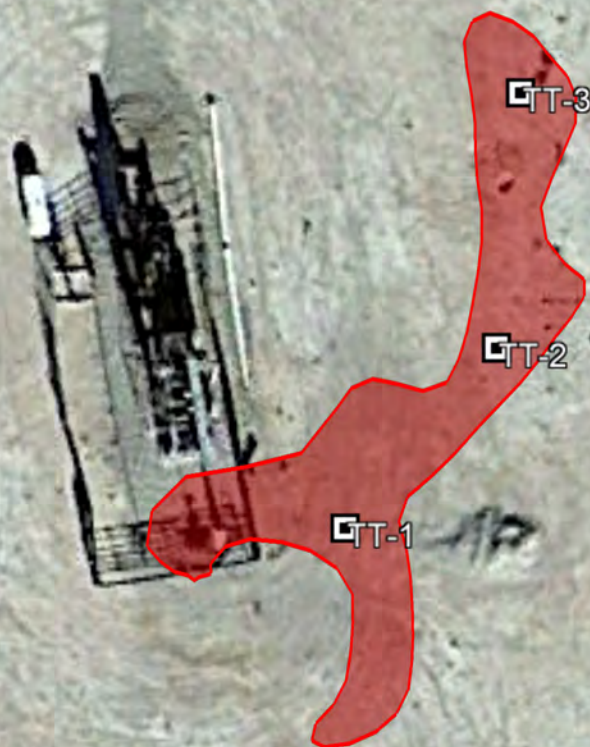
Test Trench

100 ft

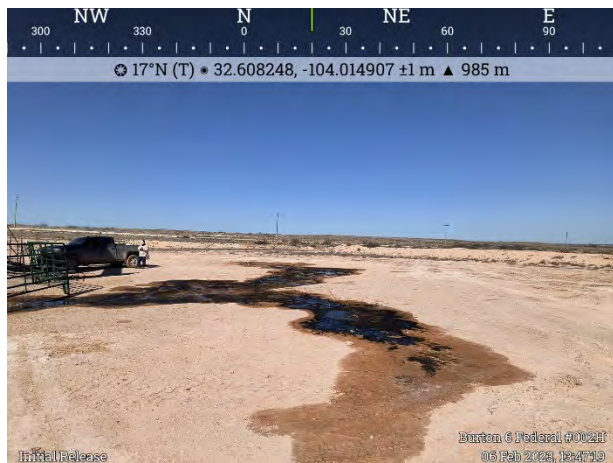
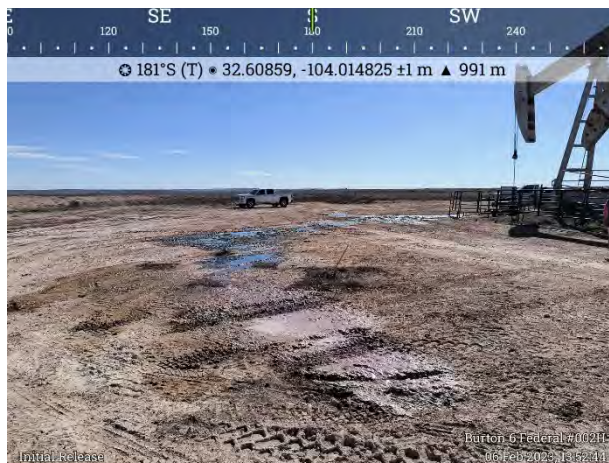
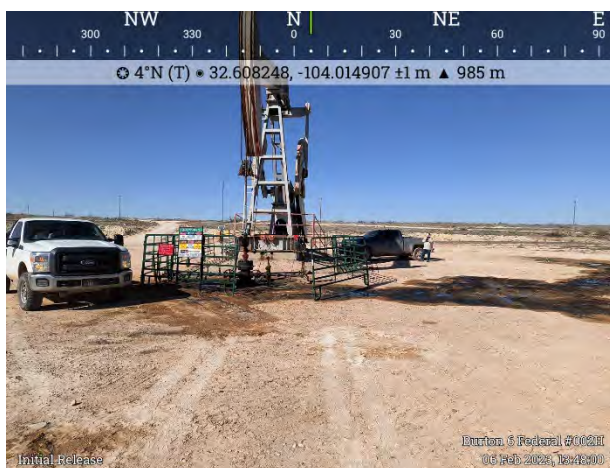
INITIAL PHOTOGRAPHS

On February 06, 2023, the wellhead packing failed causing a release of 26 barrels (bbls) of produced water onto the well pad. Of the 26 bbls released, a vac truck was able to recover 18 bbls. An initial surface scrape was performed to help minimize impact.
