Re: Site Assessment, Remediation, and Closure Report
Cotton Draw Unit 294H (occurred at CDU 25 CTB)
API No. 30-015-44105
GPS: Latitude 32.187890 & 32.187845 Longitude -103.732432 & -103.731823
UL - K, Sect 25, T24S, R31E
Eddy County, NM
NMOCD Ref. No. NAB1805851923

Pima Environmental Services, LLC. (Pima) has been contracted by Devon Energy Production Company, LP (Devon) to perform a spill assessment, remediation activities, and submit this closure report for a Crude Oil release that occurred at the Cotton Draw Unit 294H (occurred at CDU 25 CTB) (Cotton). The initial C-141 was submitted on February 27, 2018 (Appendix C). This incident was assigned Incident ID NAB1805851923 by the New Mexico Oil Conservation Division (NMOCD).

SITE PHOTOGRAPHS
DEVON ENERGY
COTTON DRAW UNIT 294H (CDU 25 CTB)

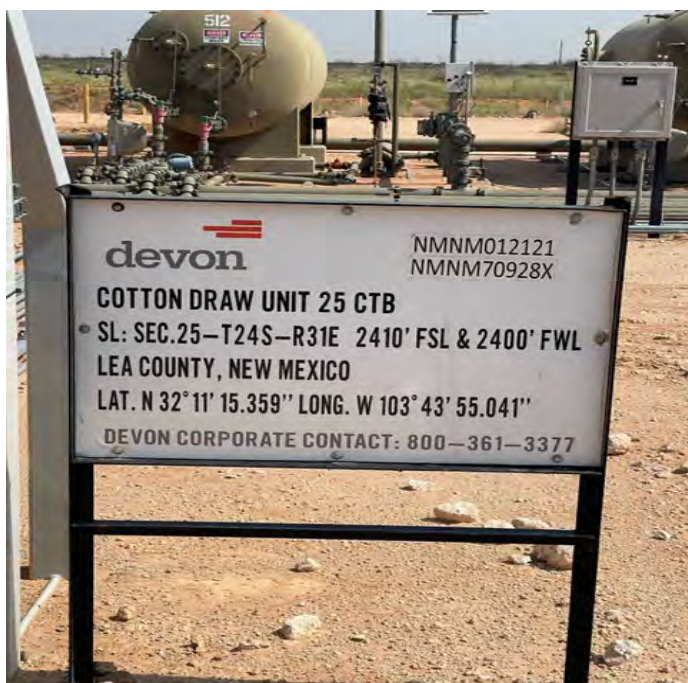
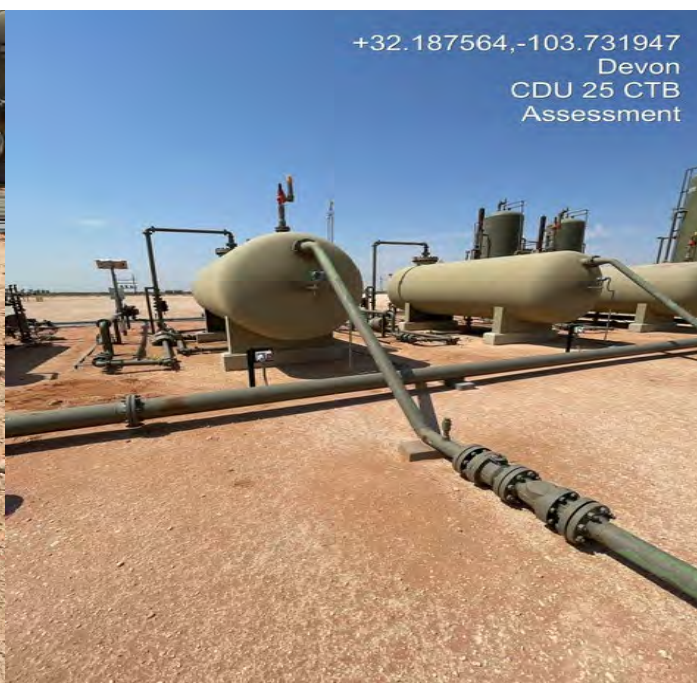
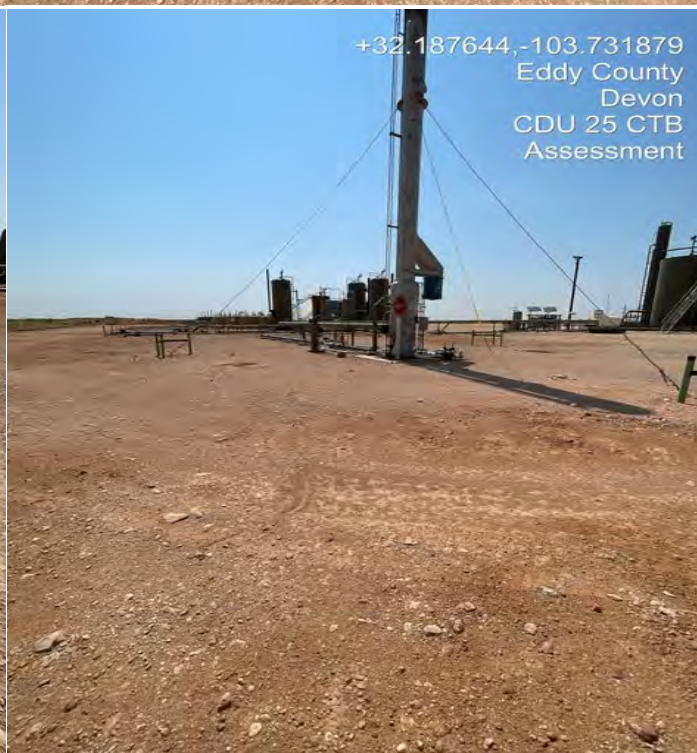
Site Assessment

June 23, 2023, Pima mobilized personnel to the site to begin collecting soil samples from spill area. The laboratory results of this sampling event can be found in the following data table. A Site Map can be found in Figure 4.

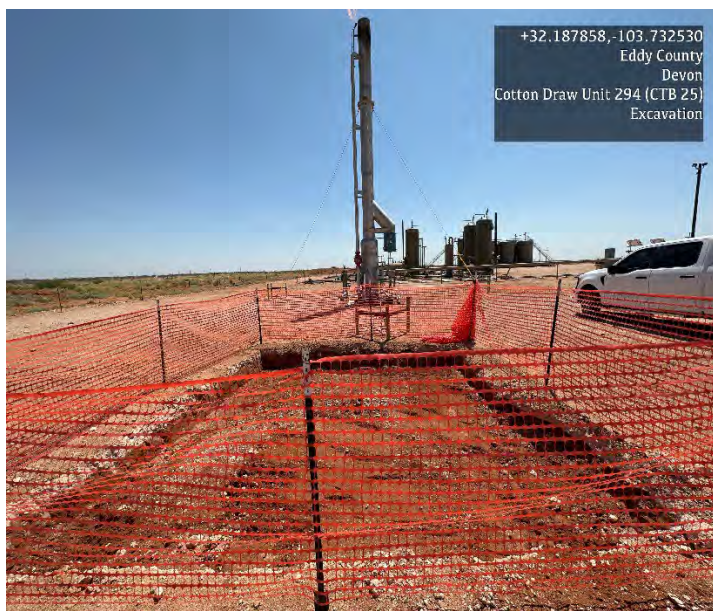
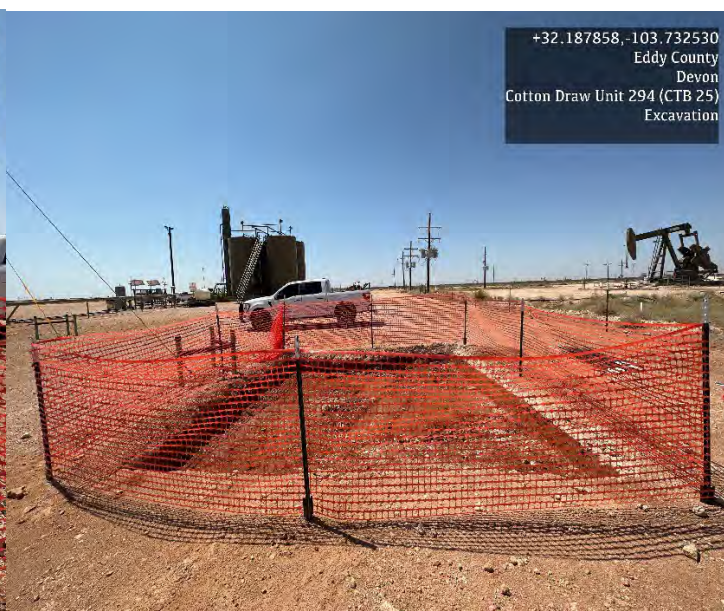
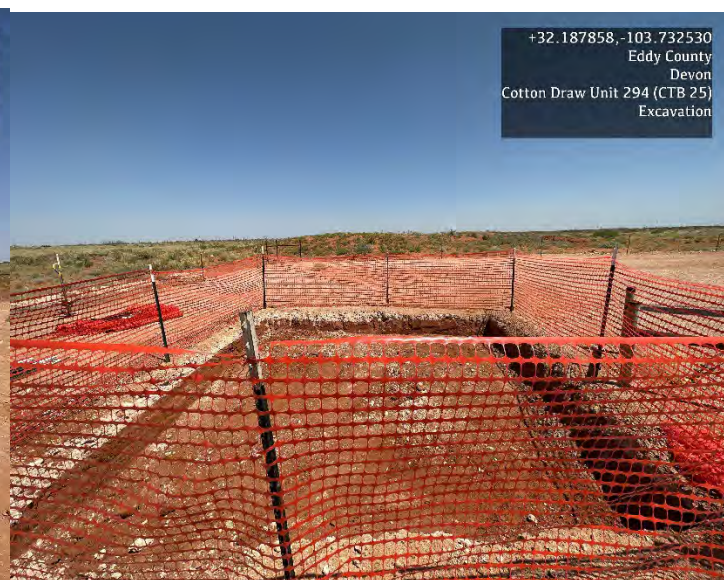
Excavation

On July 19, 2023, the Devon Construction Department mobilized personnel and equipment to begin immediate remediation activities. They began excavating the area of S-2 to a depth of 1.5' BGS. The contaminated soil 15 cubic yards were hauled to an approved, lined disposal facility and clean backfill material was brought in.

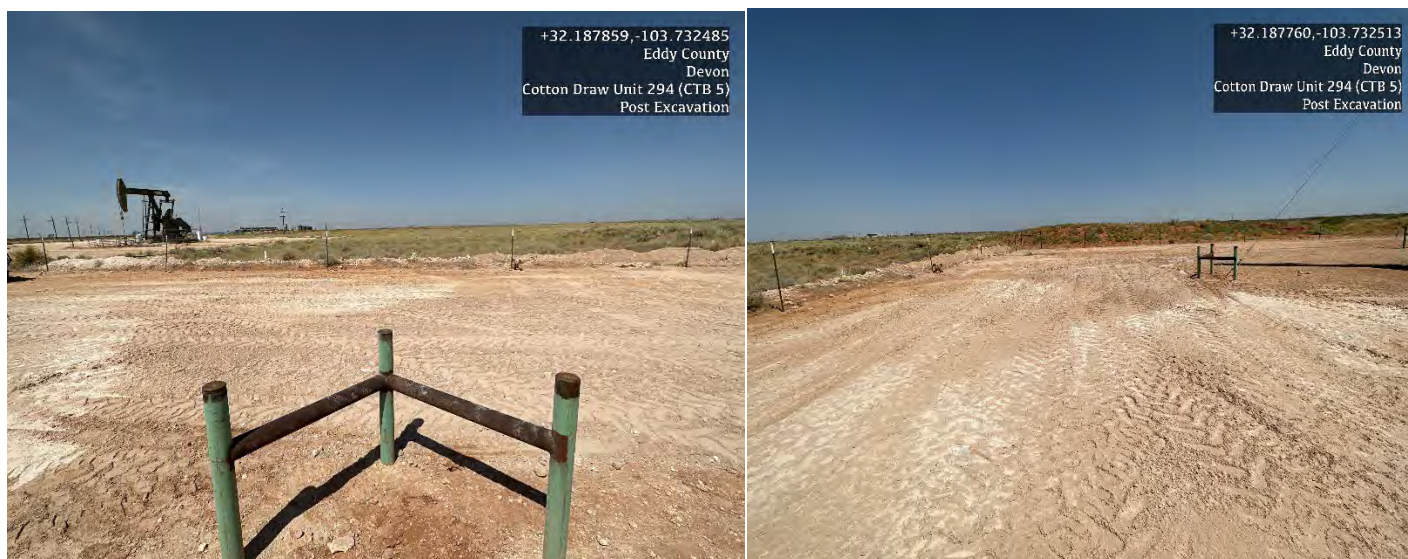
Post Excavation

Based on the sample results, the bottoms and sidewalls were below NMOCD Closure Criteria 19.15.29 NMAC. The contaminated material was sufficiently removed then transported to an NMOCD approved disposal site. The excavation was then backfilled with clean like material, machine compacted and returned to its previous state. See Appendix D for Photographic Documentation.
