**Closure Report**  
**Cooper 31 Federal #001H (07.05.18)**  
**2RP-4846**  
**Eddy County, New Mexico**  
**Unit A Sec 31 T25S R29E**  
**32.0917931°, -104.0170746°**

**Produced Water Release**  
**Point of Release: Line Corrosion**  
**Release Date: 07.05.18**  
**Volume Released: 20 barrels of Produced Water**  
**Volume Recovered: 15 barrels of Produced Water**

**Re: Closure Report  
Cooper 31 Federal #001H (07.05.18)  
Concho Operating, LLC  
2RP-4846  
Site Location: Unit A, S31, T25S, R29E  
(Lat 32.0917931°, Long -104.0170746°)  
Eddy County, New Mexico**

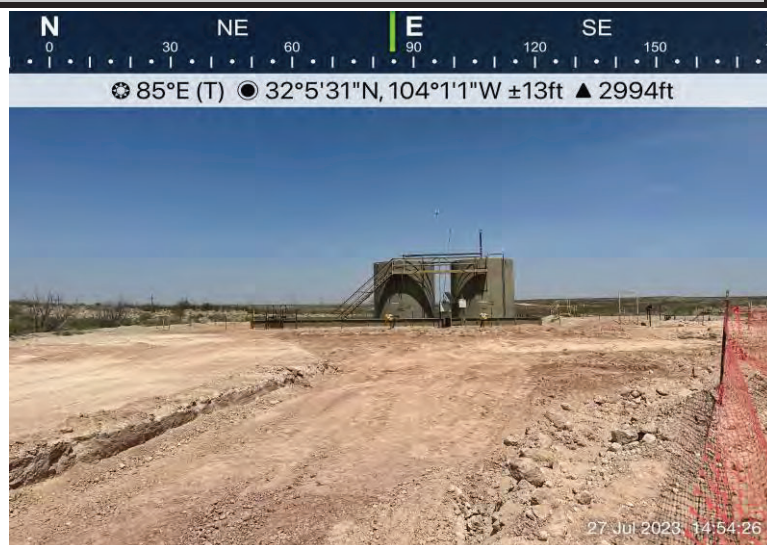
## Photograph No. 2

View East, area of Confirmation samples (10-25).

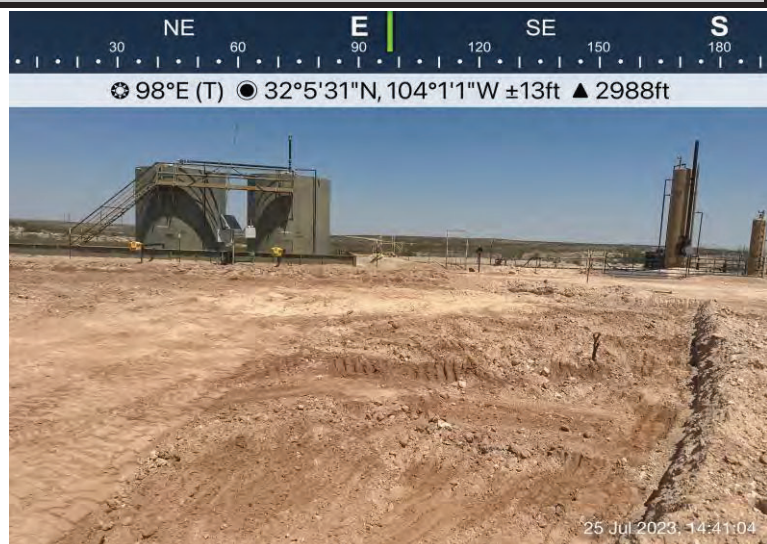
## Photograph No. 3

View Northeast, area of Confirmation samples (11-25).

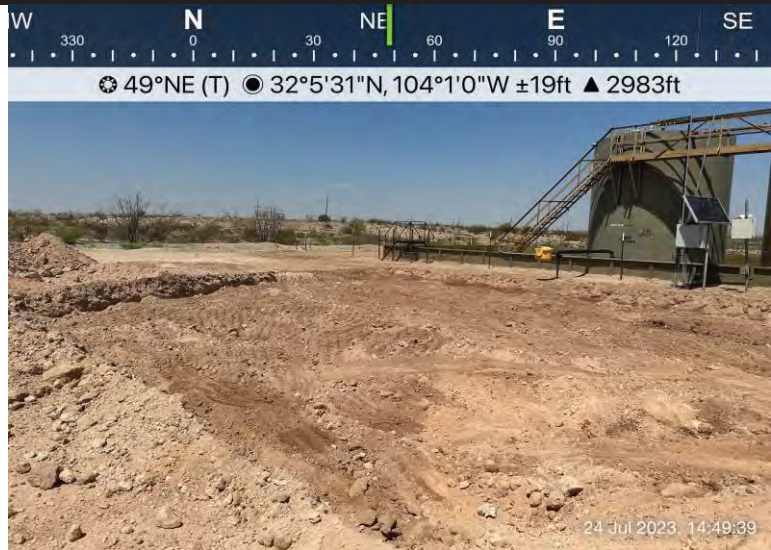
**Description:**  
View Northeast, area of Confirmation samples (21-25).
