Re: Site Assessment, Remediation, and Closure Report
Federal Bi #1 SWD
API No. 30-025-27068
GPS: Latitude 32.79969 Longitude -103.77356
UL "N", Sec. 28, T17S, R32E
Lea County, NM
NMOCD Ref. No. nAPP2234734667

Paragon Environmental, LLC (Paragon) has been contracted by Spur Energy Partners (Spur) to perform a spill assessment, conduct remediation activities, and reclaim the old containment area for the release site known as the Federal Bi #1 SWD (Federal Bi). Details of the release are summarized below:

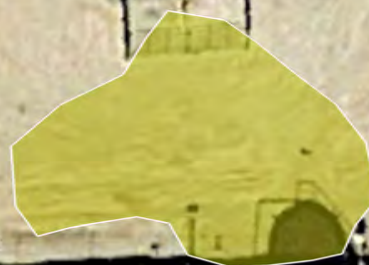
Federal Bi 1 SWD
API # 30-025-27068
Lea County, NM
Site Map

On March 16, 2023, Paragon conducted an initial site assessment. During the initial site assessment, our field tech performed field titrations to determine the vertical and horizontal extents of the spill. We found that the soil cleaned up at 2 feet BGS and covered an area of approximately 2000 sq/ft.

A Site Map & Sample Maps are provided in Figures #1 and #5.

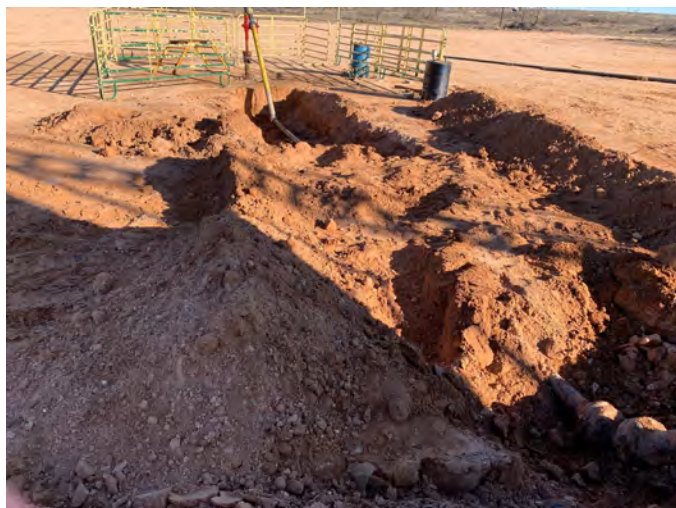
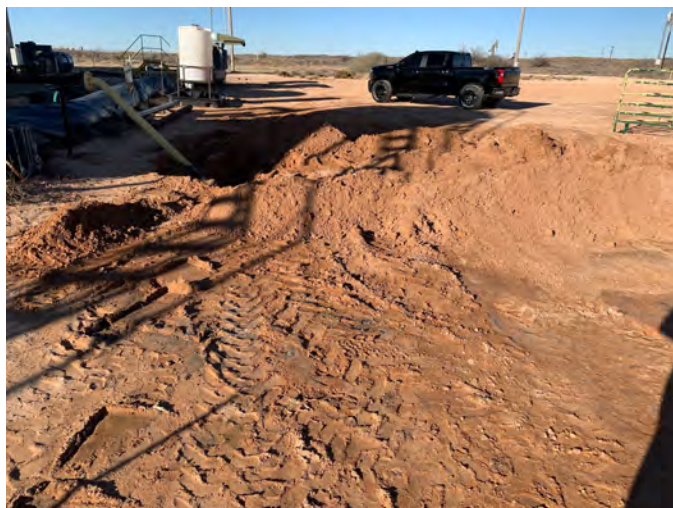
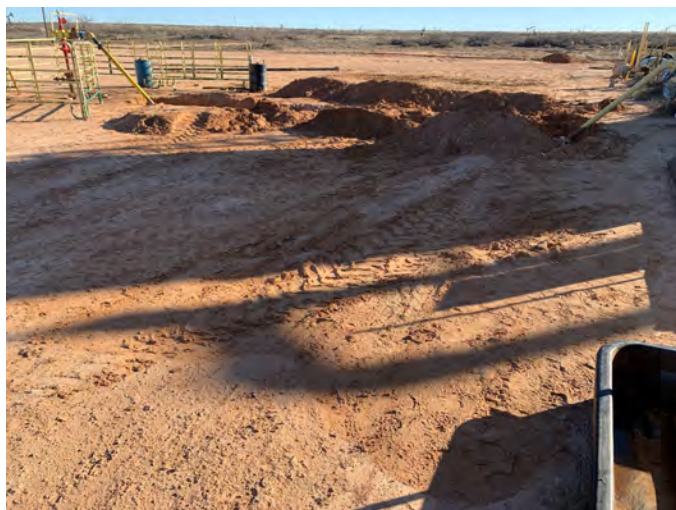
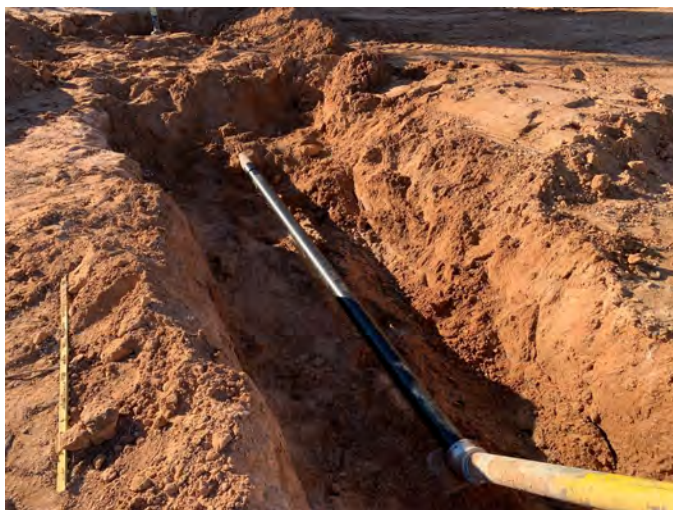
Before Remediation

Release Details			
Type of Release:	Produced Water	Volume of Release:	45 bbls
		Volume Recovered:	3 bbls
Source of Release:	Injection Line	Date of Release:	12/12/22
Was Immediate Notice Given?	Yes	If, Yes, to Whom?	Mike Bratcher, NMOCD
Was a Watercourse Reached?	No	If Yes, Volume Impacting Watercourse:	N/A
Surface Owner:	Federal	Mineral Owner:	Federal
High pressure on a flow line caused the injection line to release produced water onto the pad.

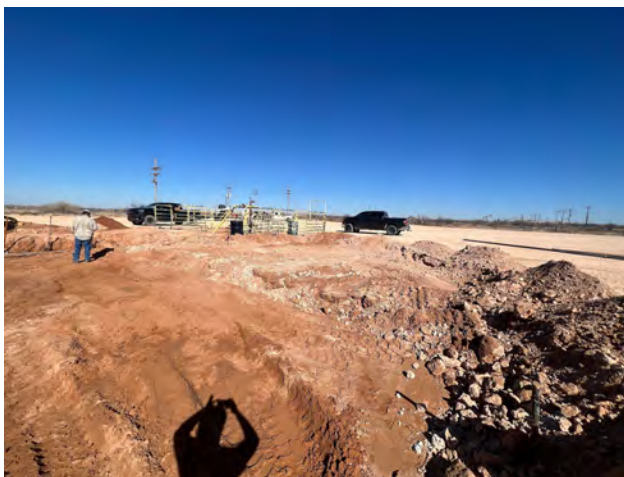
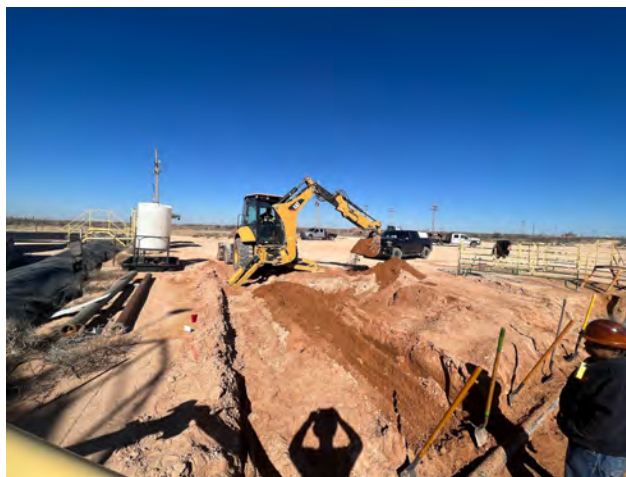
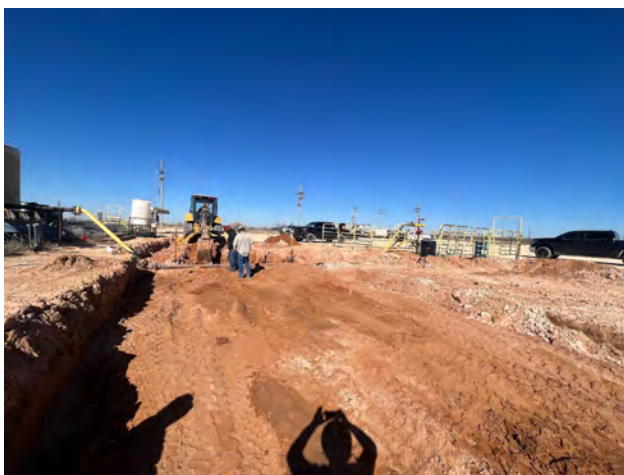
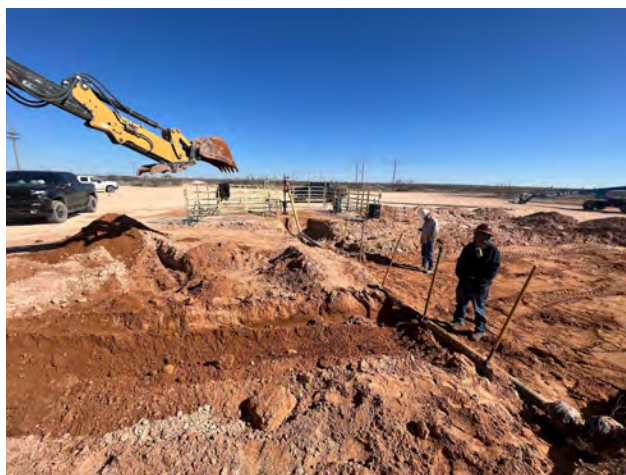
During Remediation

Our remediation began by working around the already exposed injection line. We used the backhoe on the east side of the injection line to dig out 2 ft BGS. Meanwhile, on the west side of the injection line, we used a hand crew to dig out and expose some lines marked from our 1 call. Once all the lines were exposed via hand crew we utilized the backhoe to excavate the remaining contaminated soil.
