I Release Notification

Closure

Executive Summary – Incident #nAPP2310831128

Huerfano Unit HZMC #1H
Wellsite
API: 30-045-35370

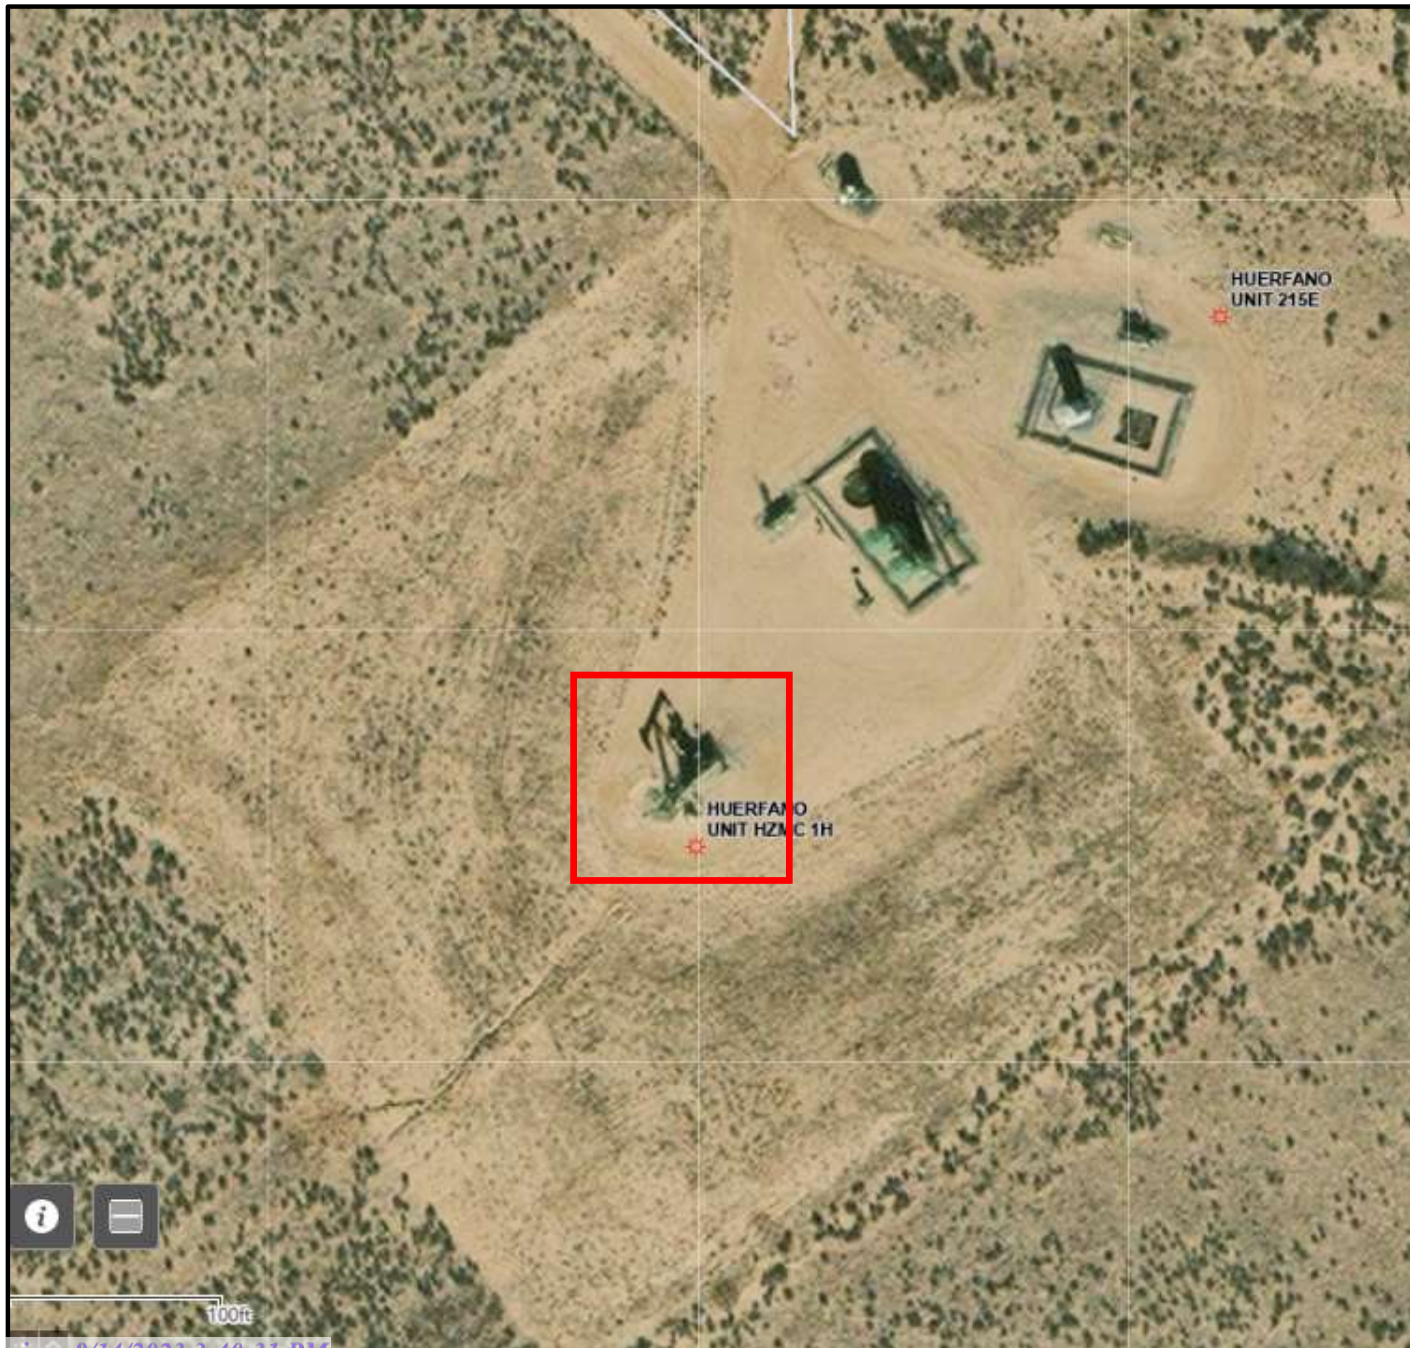
Scaled Site Map

Release Area

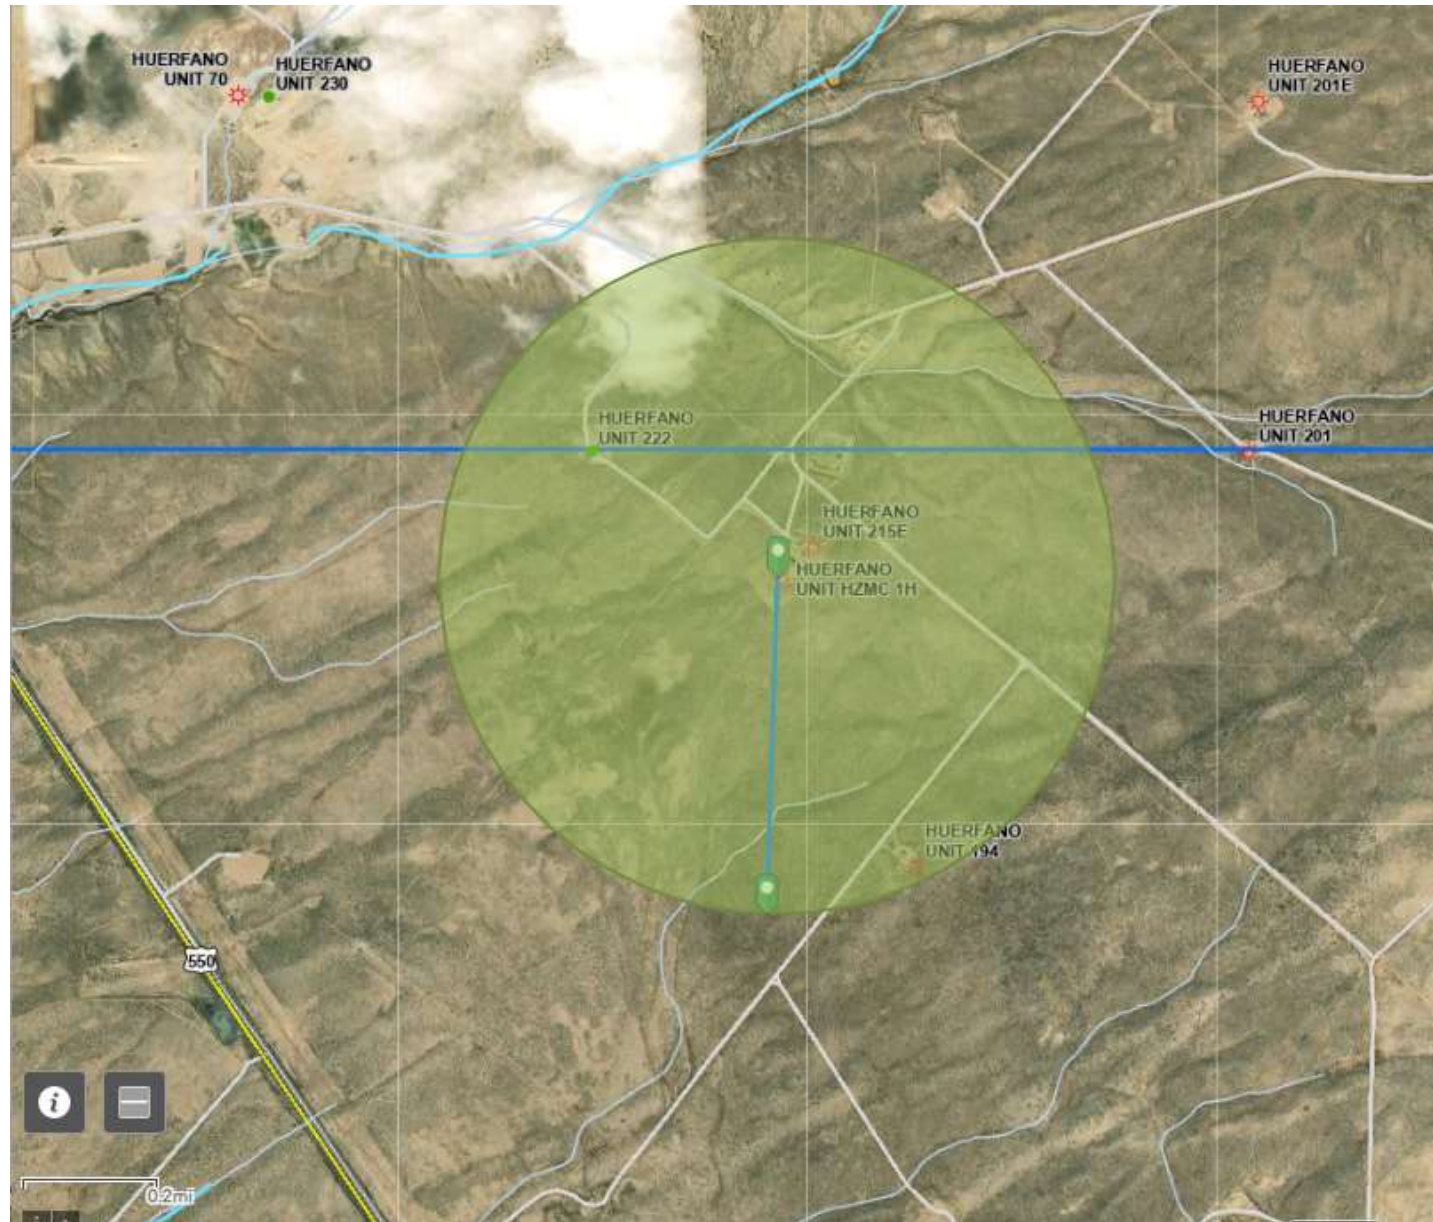
Determination of water sources and significant watercourses within ½ mile of the lateral extent of the release

Note 1: Release point is not within 300 ft of a continuously flowing watercourse or other significant water course.

Note 2: The lateral extents of the release point are not within 300 feet of a mapped wetland.

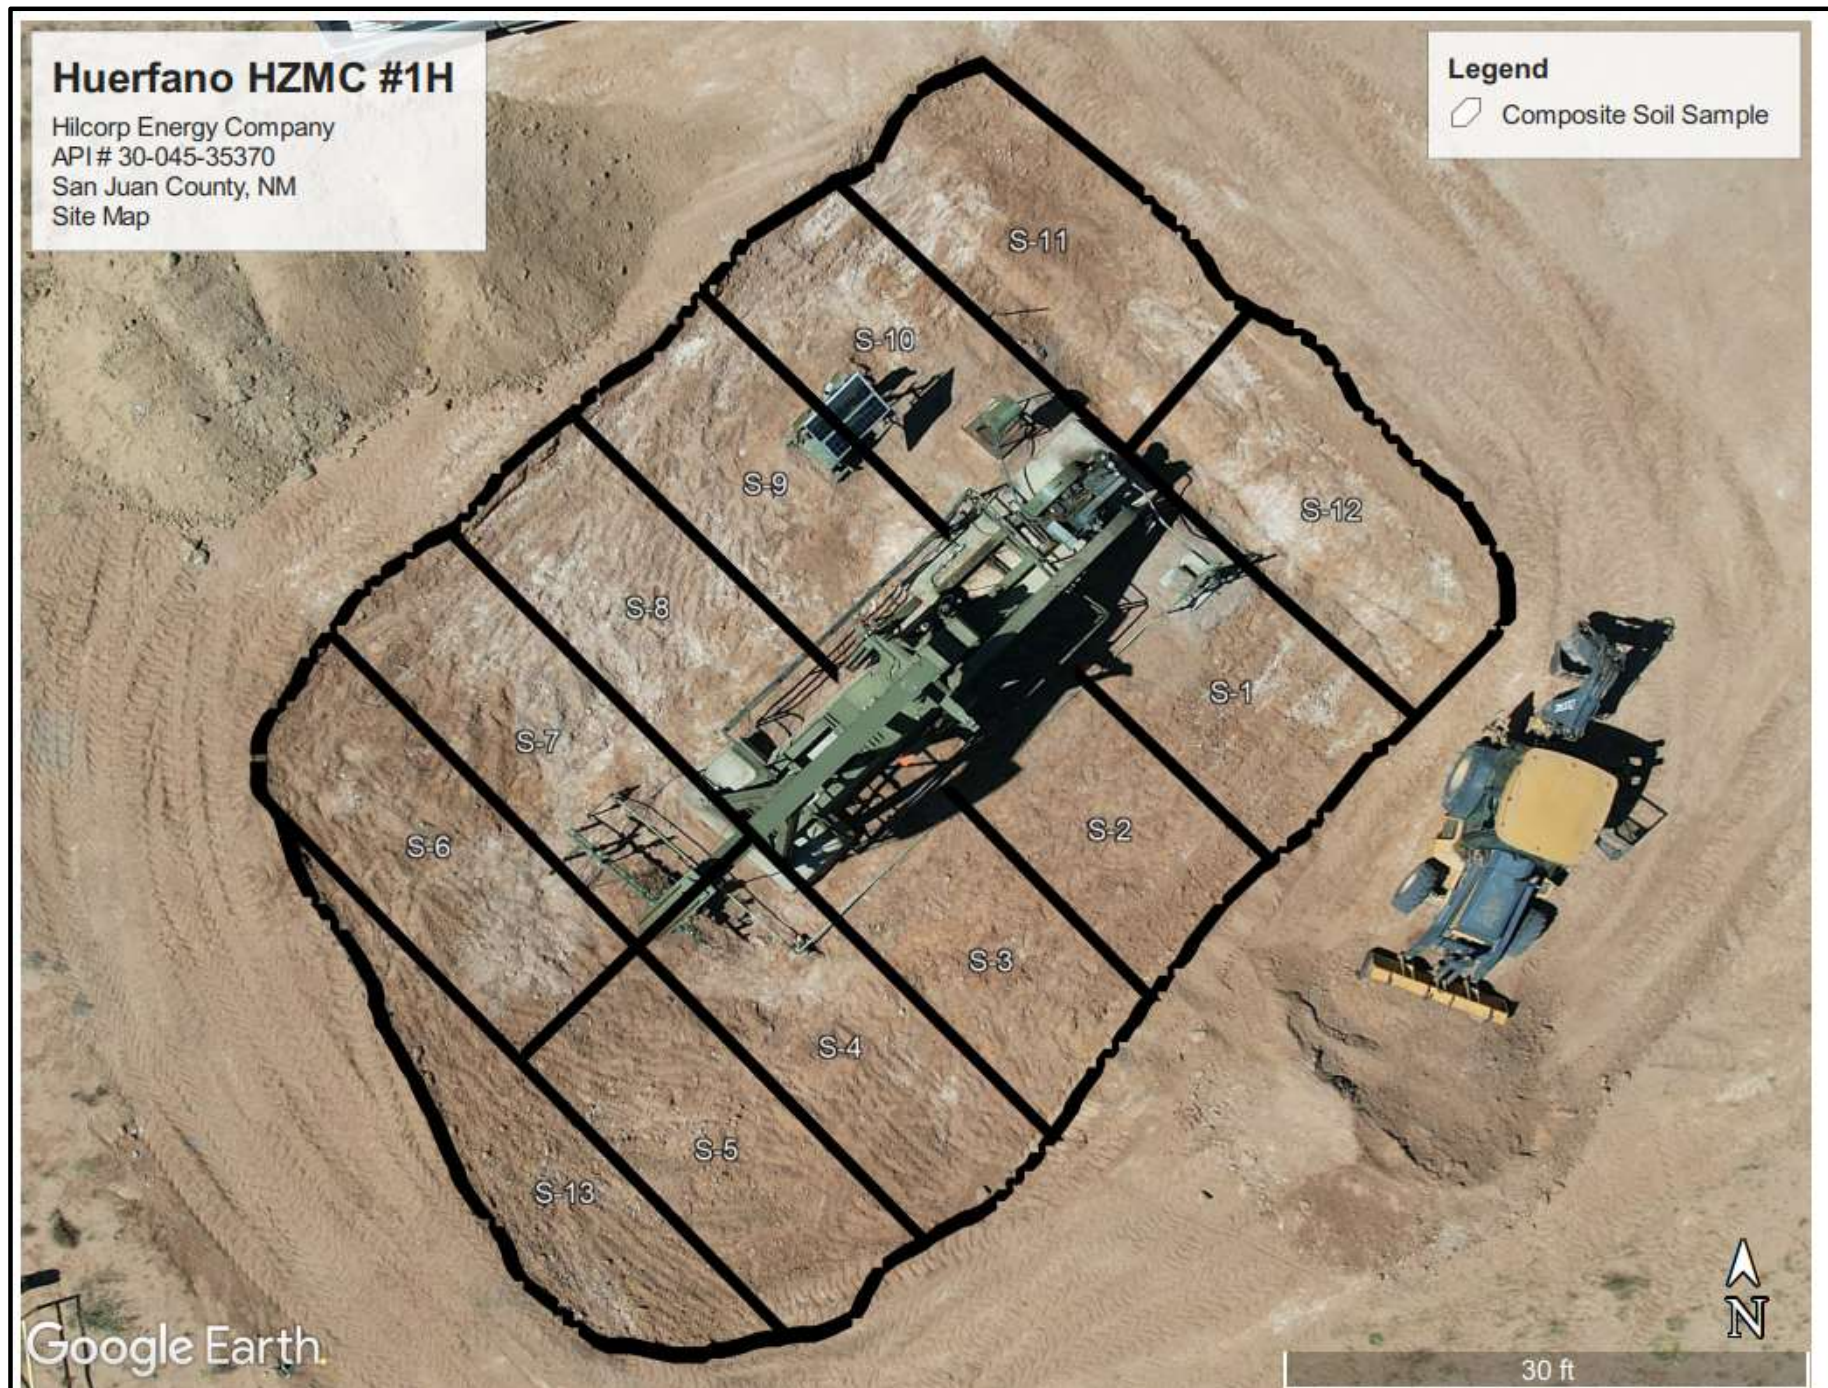
Field Sample Diagram

Samples were collected to delineate the extent of impacts on the pad. Based on delineation sample results, impacted soil was removed from the pad and transported offsite for disposal. Excavation area is shown in the field sample diagrams below.

Confirmation samples were collected on 7/5/2023 and 7/28/2023 by Hilcorp personnel and all results were below NMOCD 19.15.29.12.D Table 1 closure criteria. Impacted soil at Sample Point 7 (1' BGS) was removed for disposal. Sample results subsequently collected on 7/28/2023 at 2' BGS were clean.

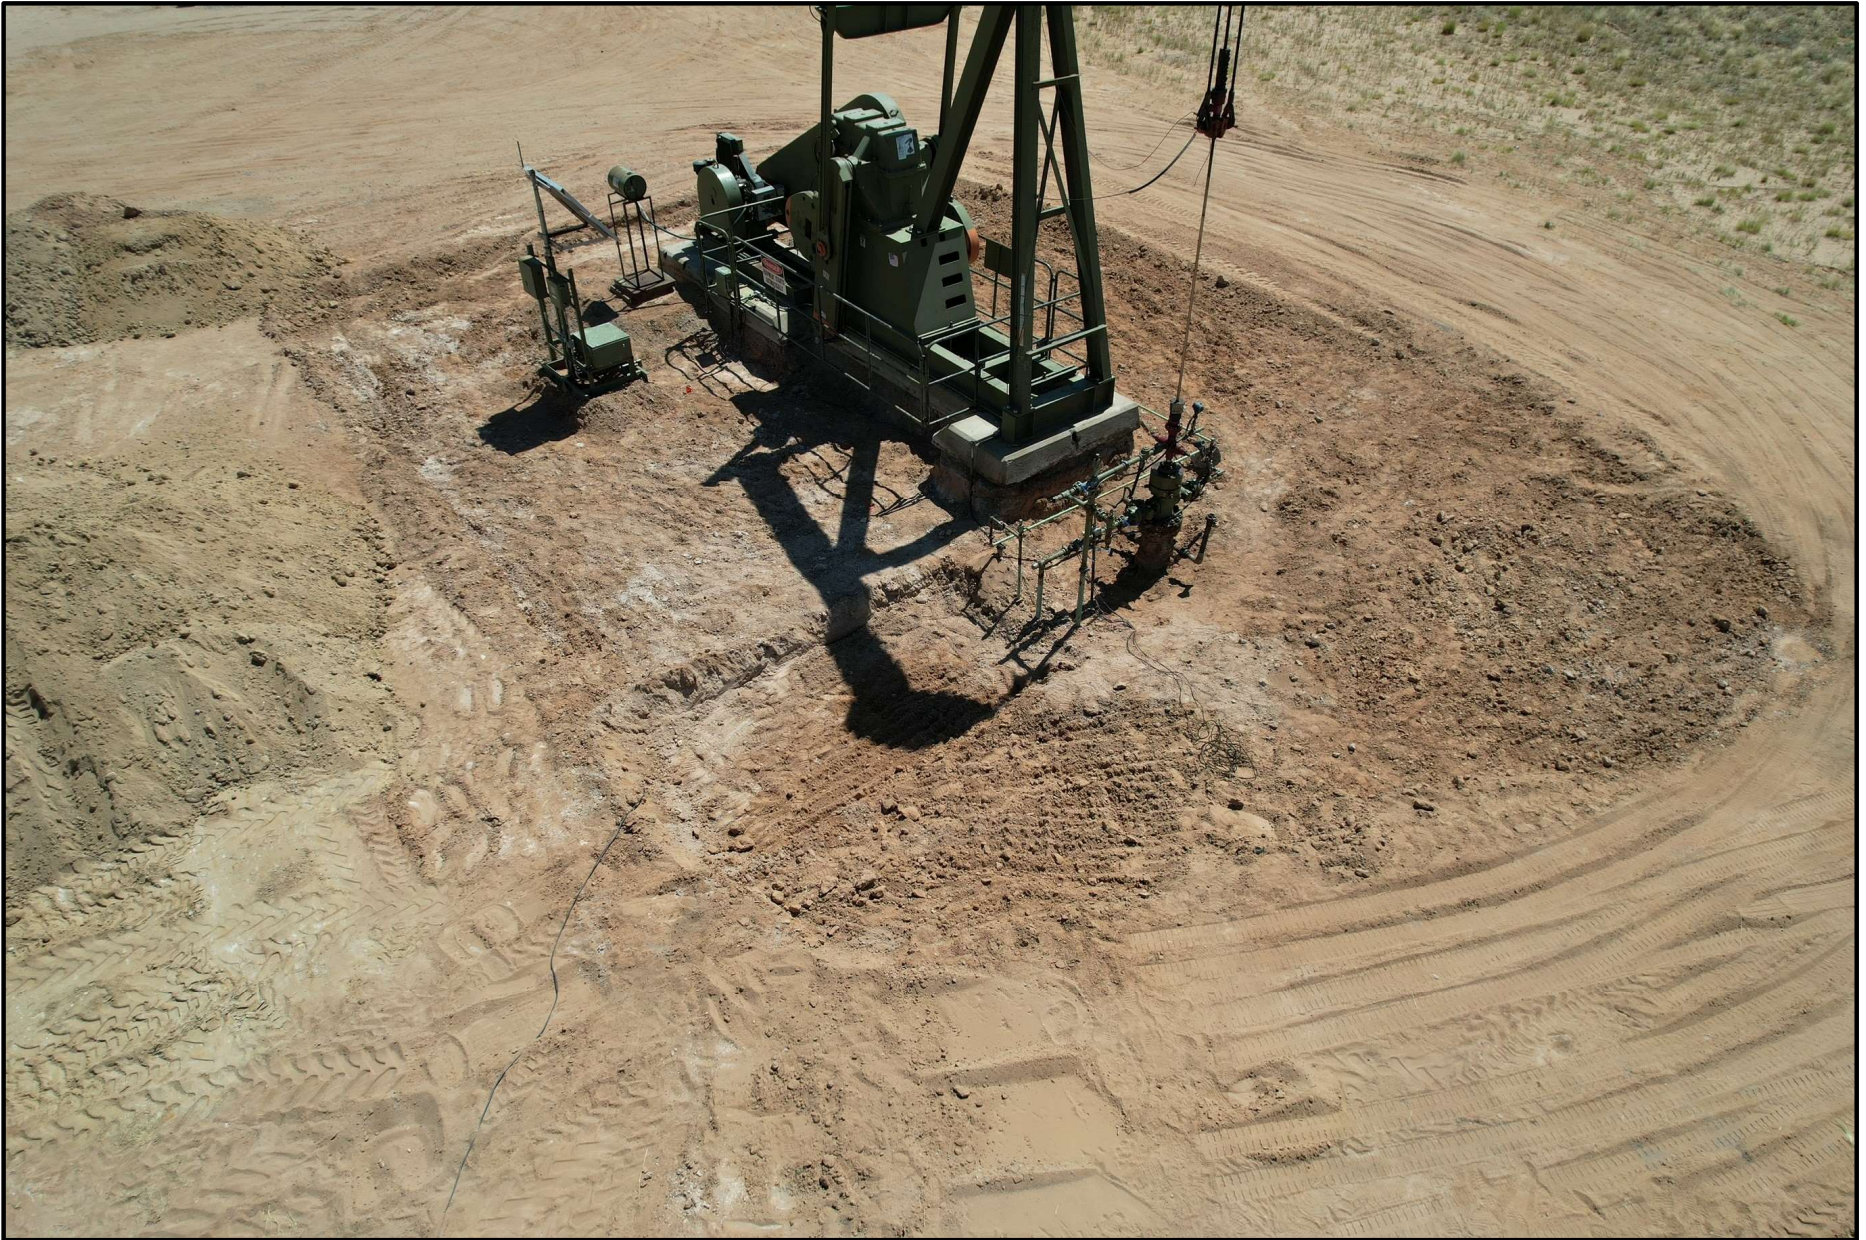
Site Photos

A Hilcorp operator identified a leaking stuffing box on a pumping unit at the Huerfano Unit HZMC #1H well site (API 30-045-35370) on 3/29/2023. The unit was shut in and the stuffing box was repaired prior to being put back into service. All leaked fluids remained on location around the base of the pumping unit. Approximately 2 bbls of free liquids were recovered from the surface and containment around the pumping unit and transported offsite for disposal. The pumping unit was washed and impacted soils were recovered and sent off site for disposal.
