RE: Site Assessment, Liner Inspection and Closure Report
Burton Flat Deep Unit 61H
API No. 30-015-43136
GPS: Latitude 32.5076509 Longitude -104.1585985
UL- L, Section 02, Township 21S, Range 27E,
Eddy County, NM
NMOCD Reference No. NAB1916437520

Devon Energy Production Company (Devon) has contracted Pima Environmental Services, LLC (Pima) to perform a liner inspection, spill assessment, remediation activities, and prepare this closure report for a produced water and condensate release that happened at the Burton Flat Deep Unit 61H (Burton). An initial C-141 was submitted on June 7, 2019, and can be found in Appendix B. This incident was assigned Incident ID NAB1916437520, by the New Mexico Oil Conservation Division (NMOCD).

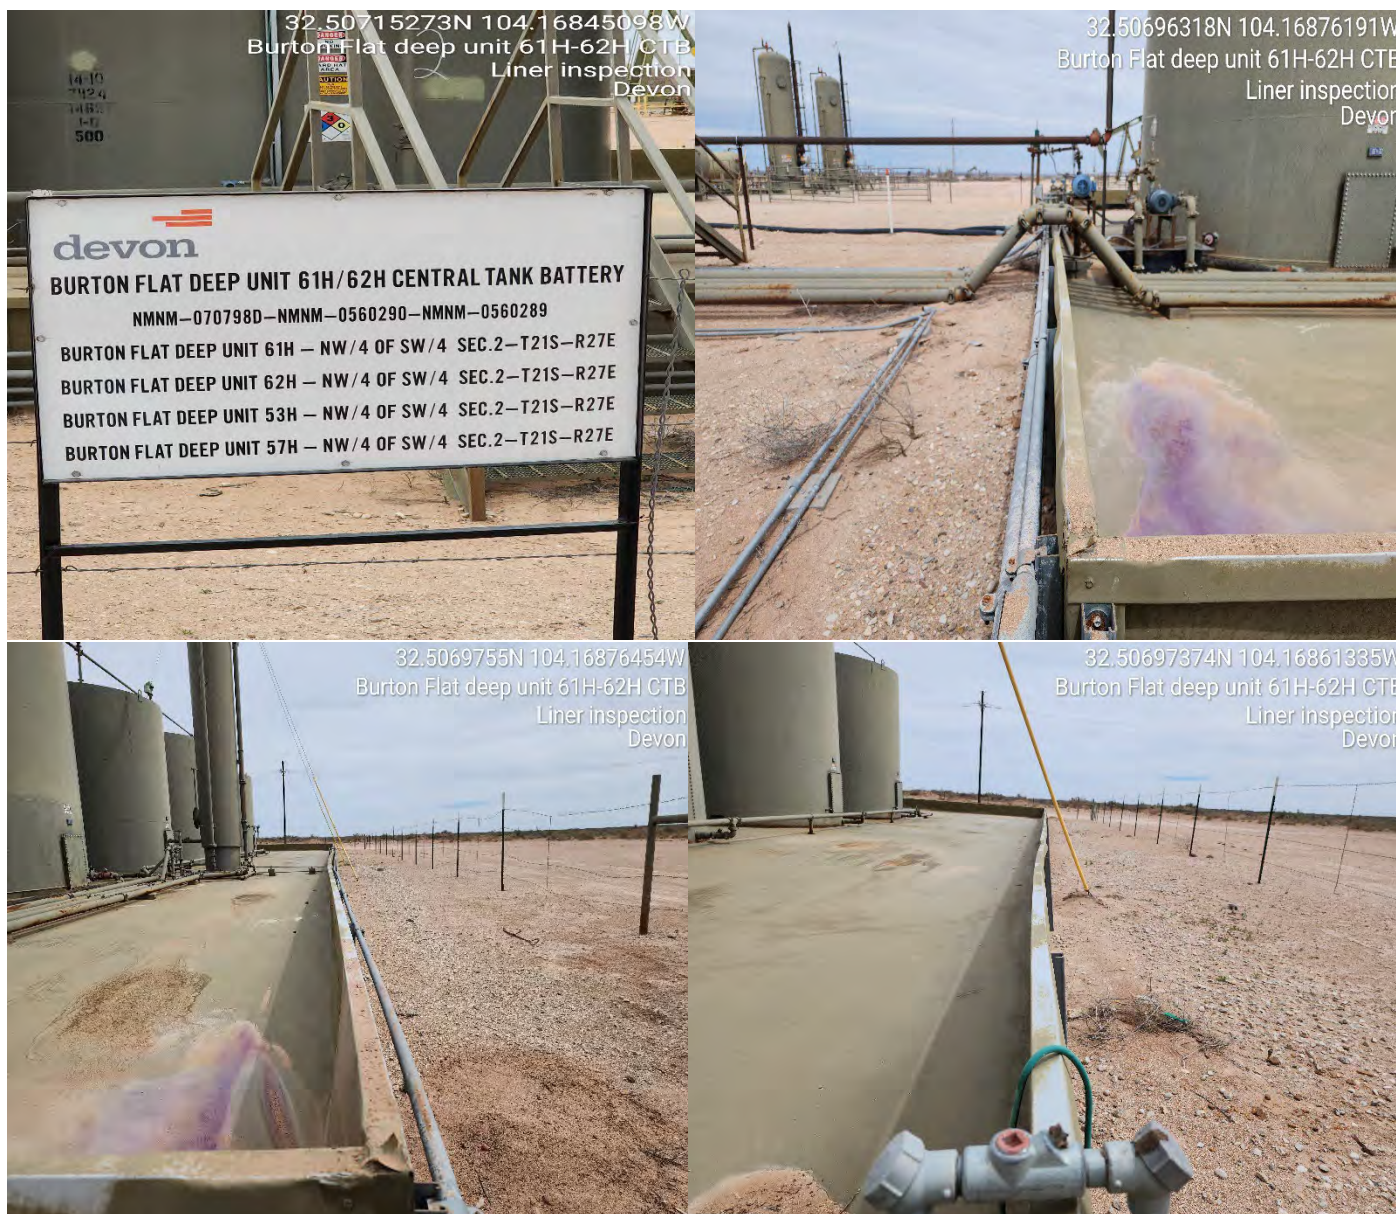
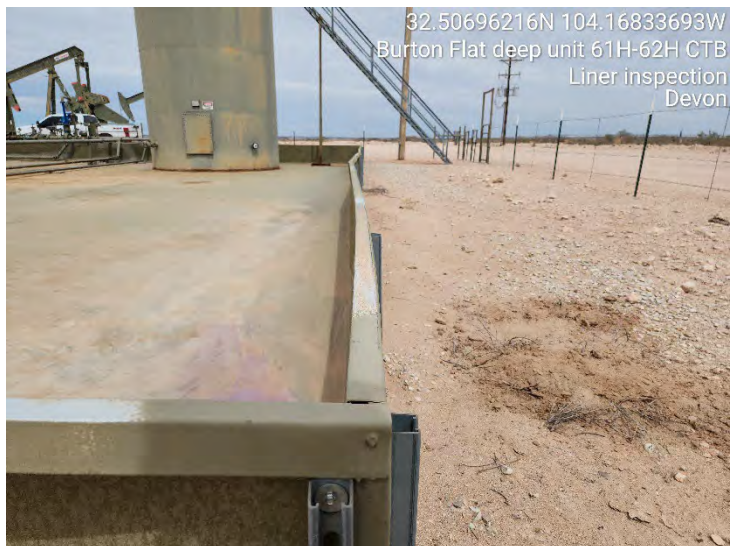
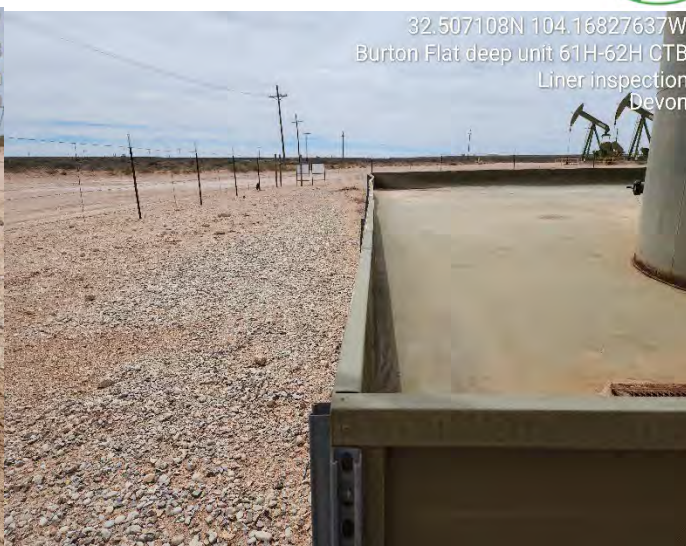
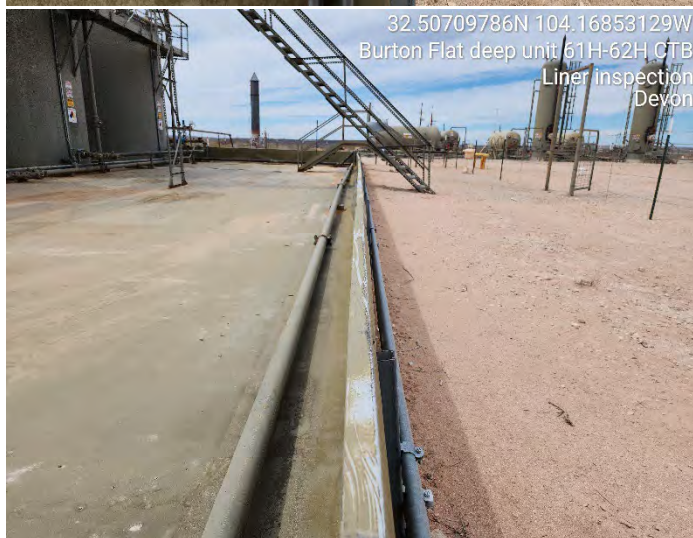
Liner Inspection

On March 25, 2023, after sending the 48-hour notification via email, Pima Environmental conducted a liner inspection at this location. We concluded that this liner had been repaired and this containment can maintain its integrity and its able to retain fluids. The liner inspection form and photographic documentation can be found in Appendix C.

Visualization	Yes	No	Comments
Is there a tear in the liner?		X	
Are there holes in the liner?		X	
Is the liner retaining any fluids?		X	
Does the liner have integrity to contain a leak?	X

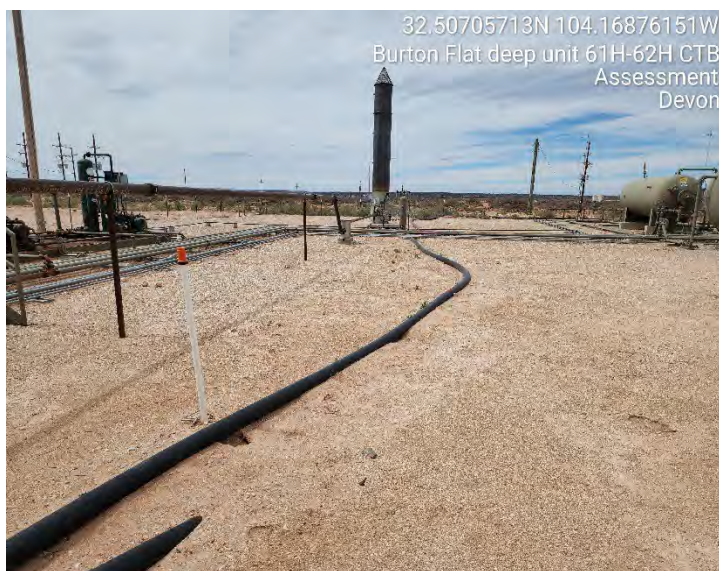
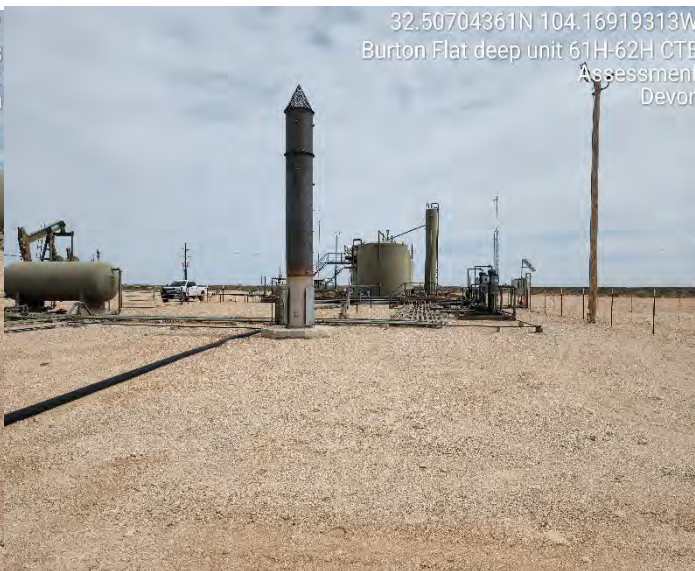
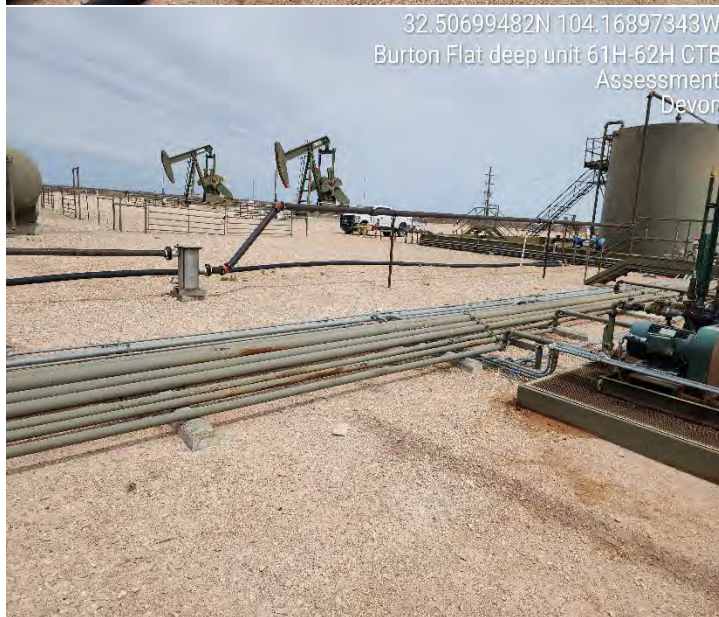
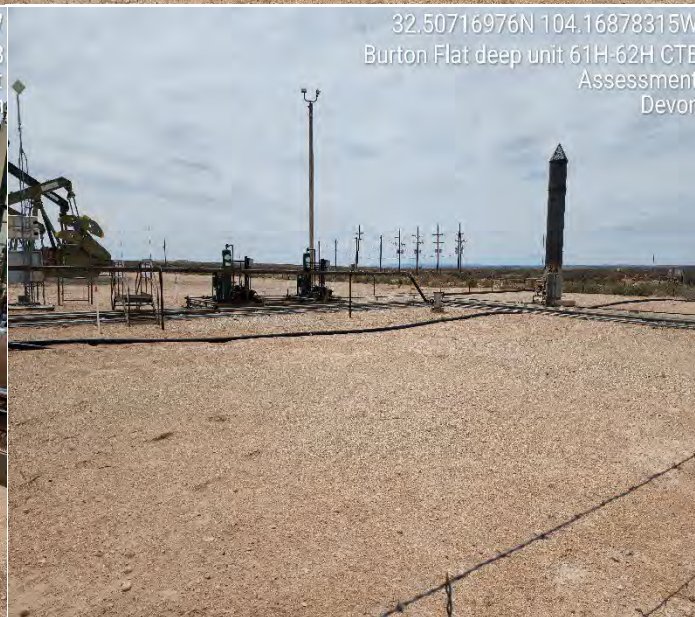
Site Assessment

On March 23, 2023, Pima mobilized personnel to the site to assess the area. We sampled the impacted area. Laboratory results of this sampling event can be found in the following data table. A site map can be found in Figure 4.

Based on the soil sample results, the contamination levels are already less than the regulatory limits of the most stringent criteria in Table 1 of NMAC 19.15.29.1.

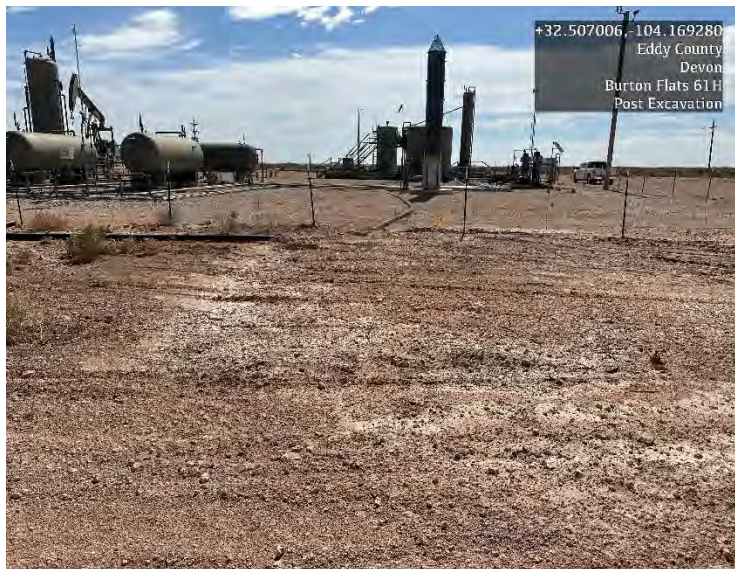
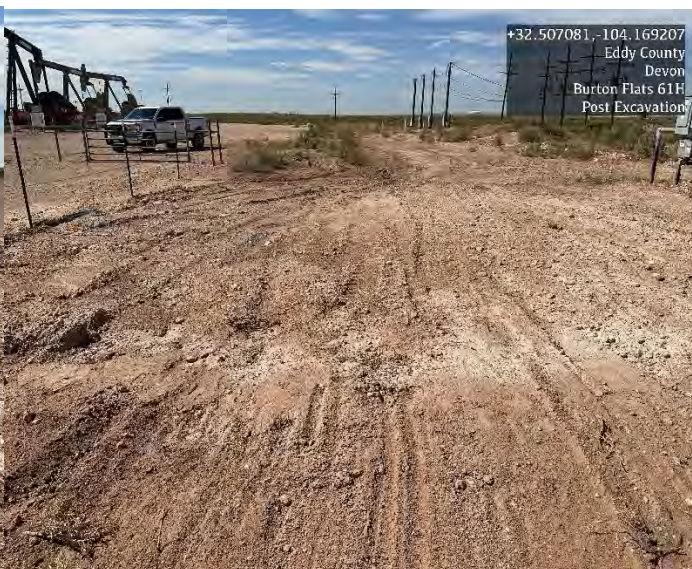
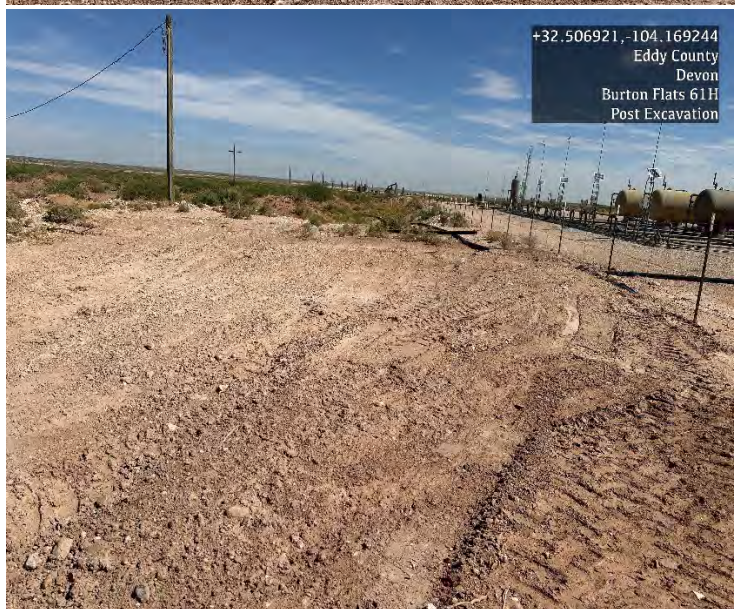
Post Excavation

On July 29, 2023, after sending a 48-hour notification (Appendix C), Pima collected 5-point composite confirmation samples of the excavated areas. Laboratory results of this sampling event can be found in the following data table. A Confirmation Sample Map can be found in Figure 5.

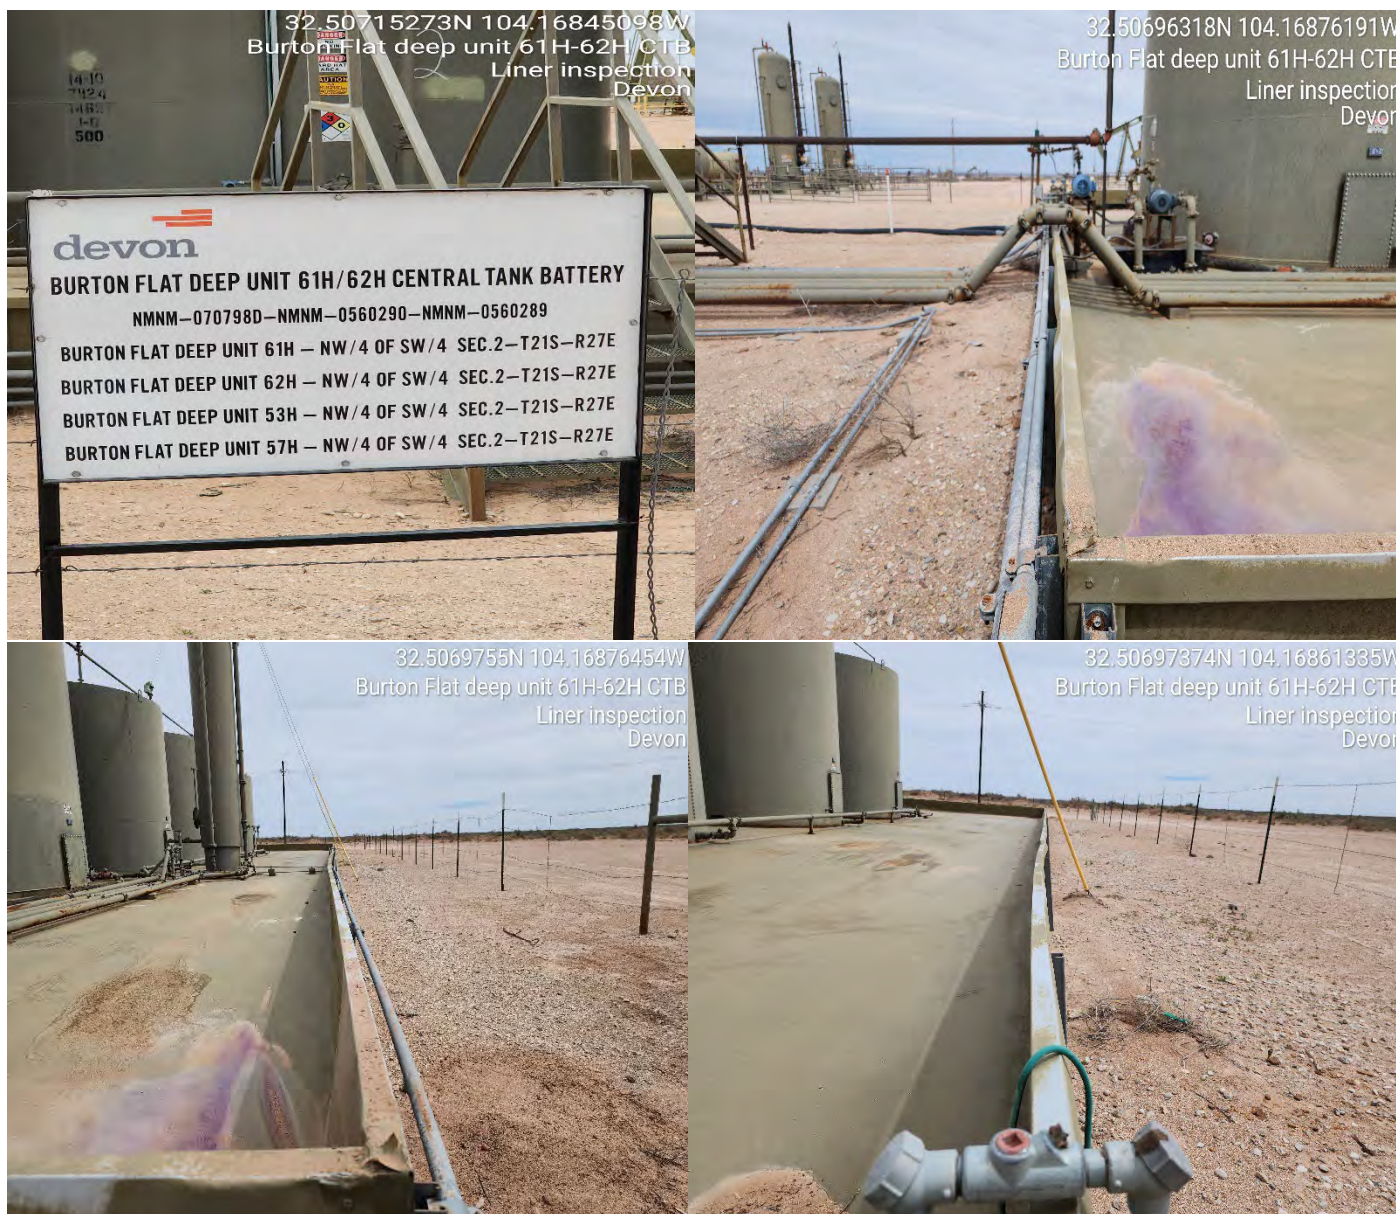
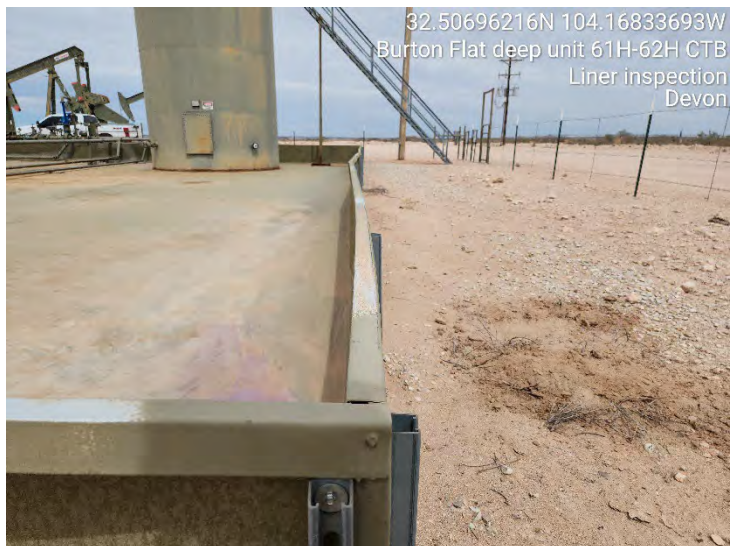
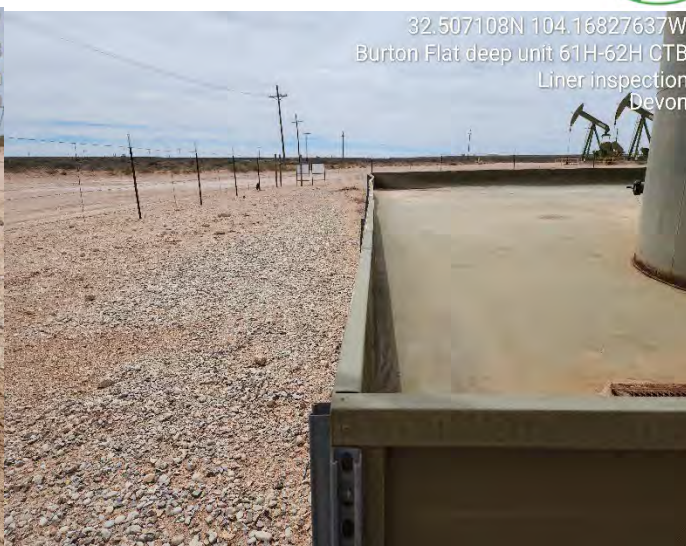
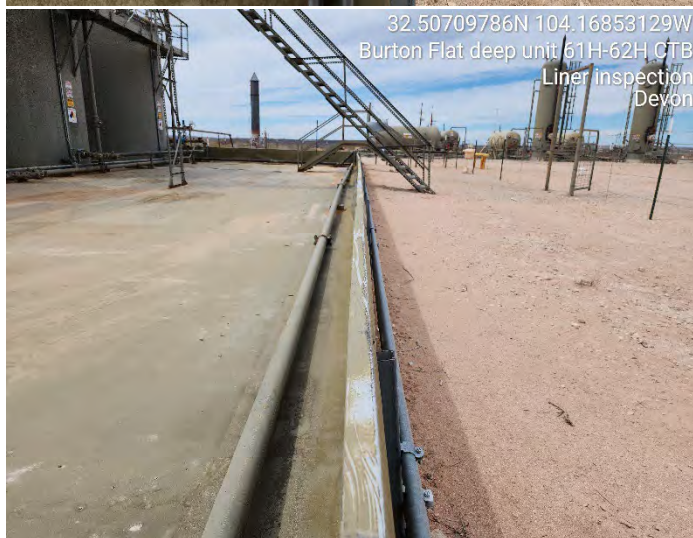
Liner Inspection

On March 25, 2023, after sending the 48-hour notification via email, Pima Environmental conducted a liner inspection at this location. We concluded that this liner had been repaired and this containment can maintain its integrity and its able to retain fluids. The liner inspection form and photographic documentation can be found in Appendix C.

Visualization	Yes	No	Comments
Is there a tear in the liner?		X	
Are there holes in the liner?		X	
Is the liner retaining any fluids?		X	
Does the liner have integrity to contain a leak?	X

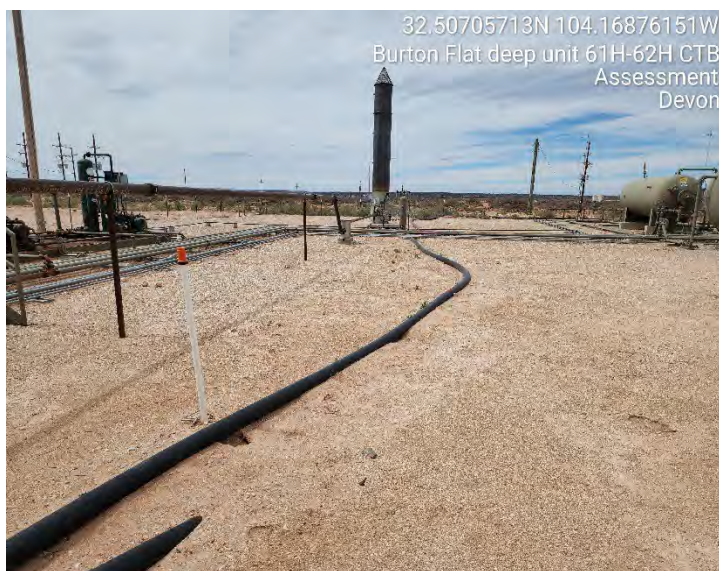
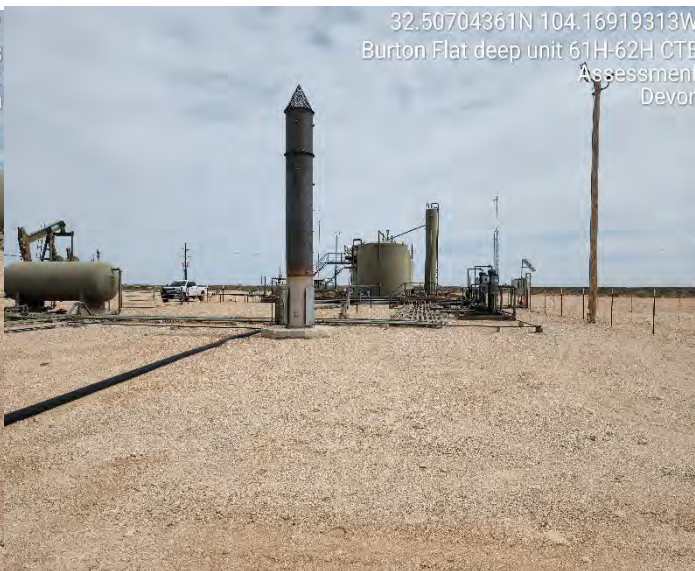
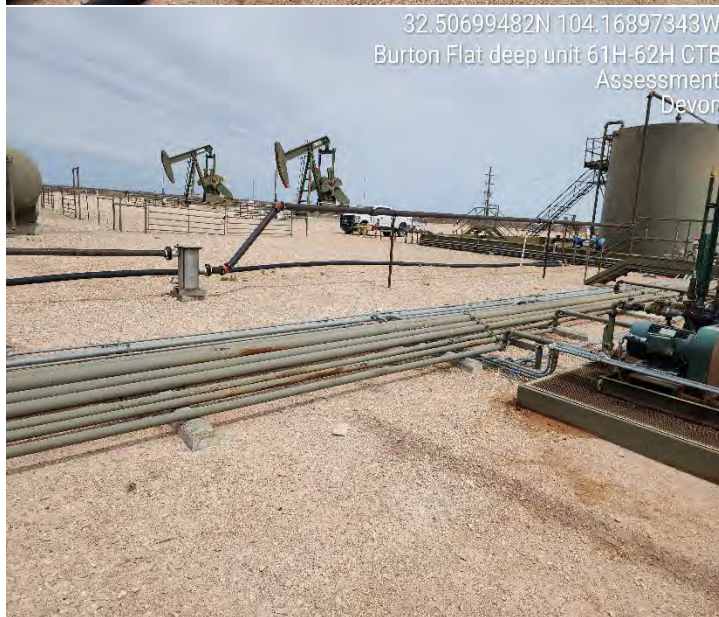
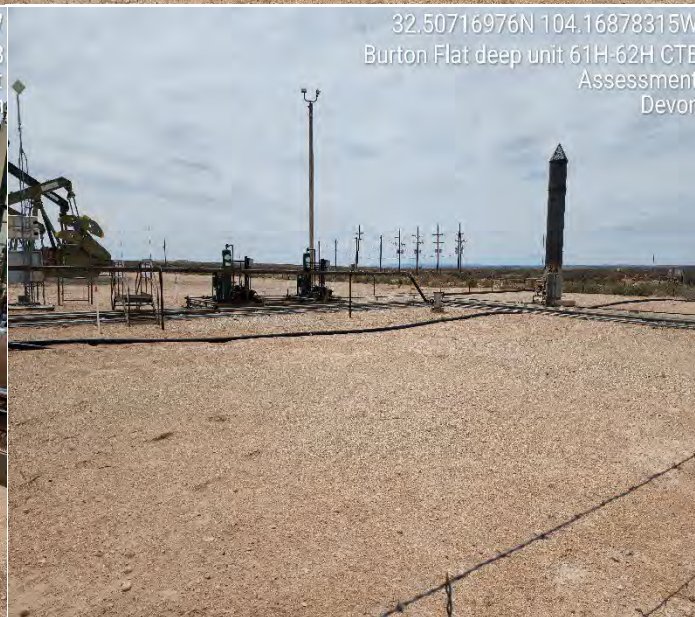
Site Assessment

On March 23, 2023, Pima mobilized personnel to the site to assess the area. We sampled the impacted area. Laboratory results of this sampling event can be found in the following data table. A site map can be found in Figure 4.

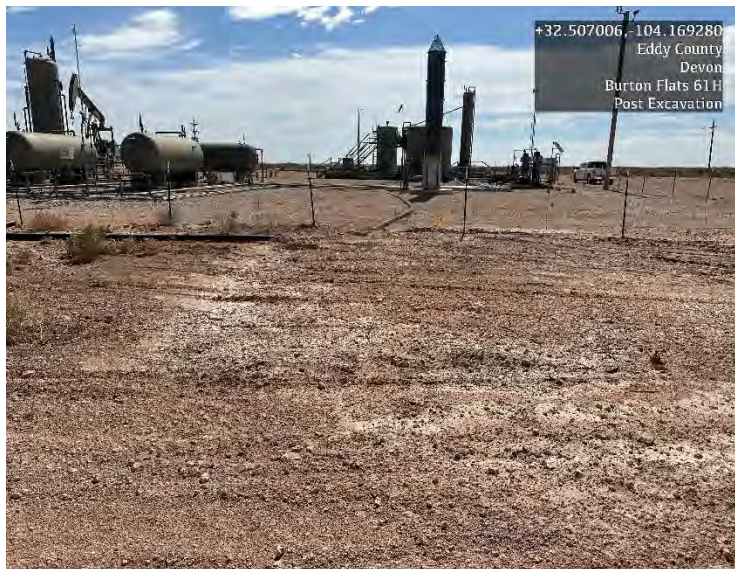
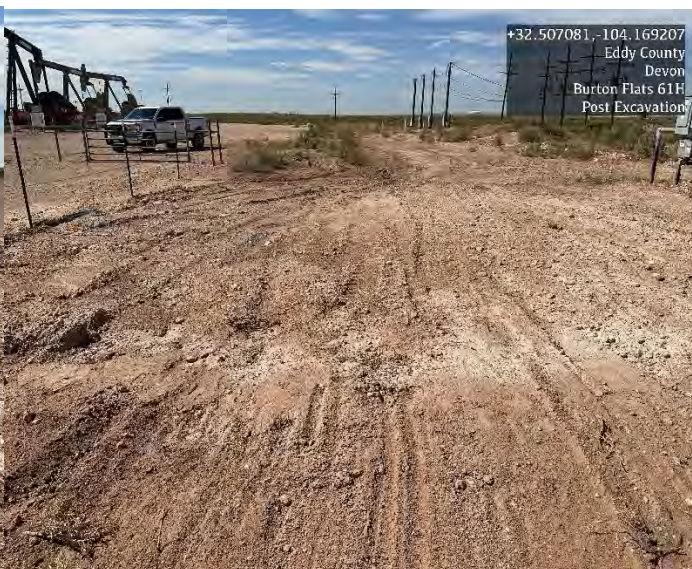
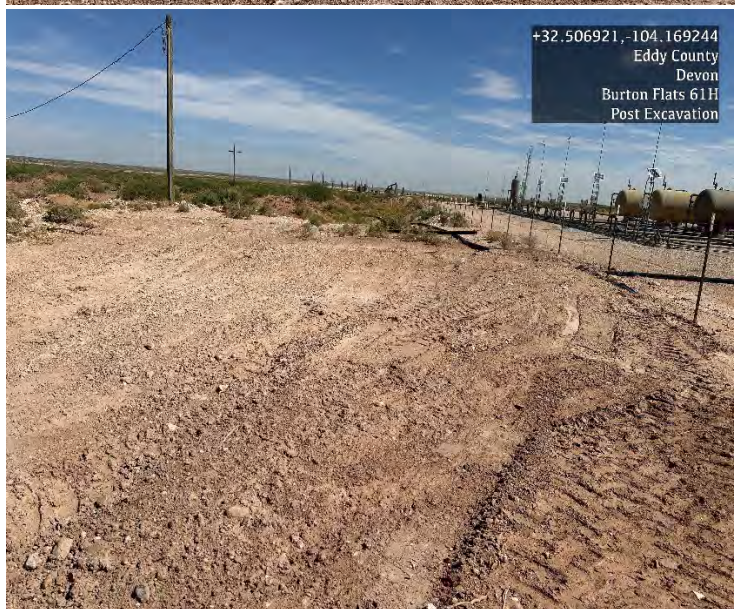
Post Excavation

On July 29, 2023, after sending a 48-hour notification (Appendix C), Pima collected 5-point composite confirmation samples of the excavated areas. Laboratory results of this sampling event can be found in the following data table. A Confirmation Sample Map can be found in Figure 5.
