Site Assessment and Closure Report

East Lusk 15 Federal #001Y ROW Release
Incident# nRM2015742721
Lea County, New Mexico

Cimarex Energy Co. of Colorado
600 Marienfeld St.
Midland, TX 79701

H&R Enterprises, LLC
5120 W. Kansas St.
Hobbs, New Mexico 88242

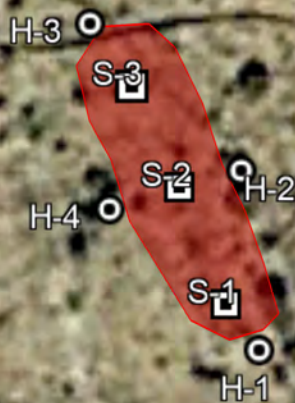
Cimarex Energy Co. of Colorado
Incident# nRM2015742721
Lea County, NM
Site Assessment Map

H&R mobilized personnel to begin site assessment, and sampling activities. Grab samples were obtained by way of hand auger, from the impacted area as well as outside the impacted area on all 4 sides. Samples were transported to Cardinal Laboratory for analysis, and the results are presented in the following data table. Initial site assessment sampling locations are illustrated on Site Assessment Map in [Appendix I](#). Photographs of the sample locations are attached in [Appendix IV](#). Complete laboratory reports can be found in [Appendix V](#).

Based on the results of our site assessment, all contaminated soil was removed/remediated during the surface and subsurface line repair process and no remediation is needed.
