Incident ID	NRM2018258355
District RP	
Facility ID	
Application ID

On June 20, 2020, a release was discovered at the Hognose Viper 23 Federal #001H site due to a water pump being out of adjustment and unable to keep up with the water being produced from the system. Upon a routine site visit the lease operator found water spraying from the pop-off valve on the free water knock out. Initial response activities were conducted by the operator, and included source elimination and site stabilization activities, which recovered approximately 0.9 barrels of crude oil and 3.5 barrels of produced water. Figure 1 illustrates the vicinity and site location; Figure 2 illustrates the release location. The C-141 form is included in Appendix A.

Vicinity and Well Head Protection Map  
 Hognose Viper 23 Federal #001H- Devon Energy Production Company  
 UL: M S:23 T:23S R:33E - Lea County, New Mexico

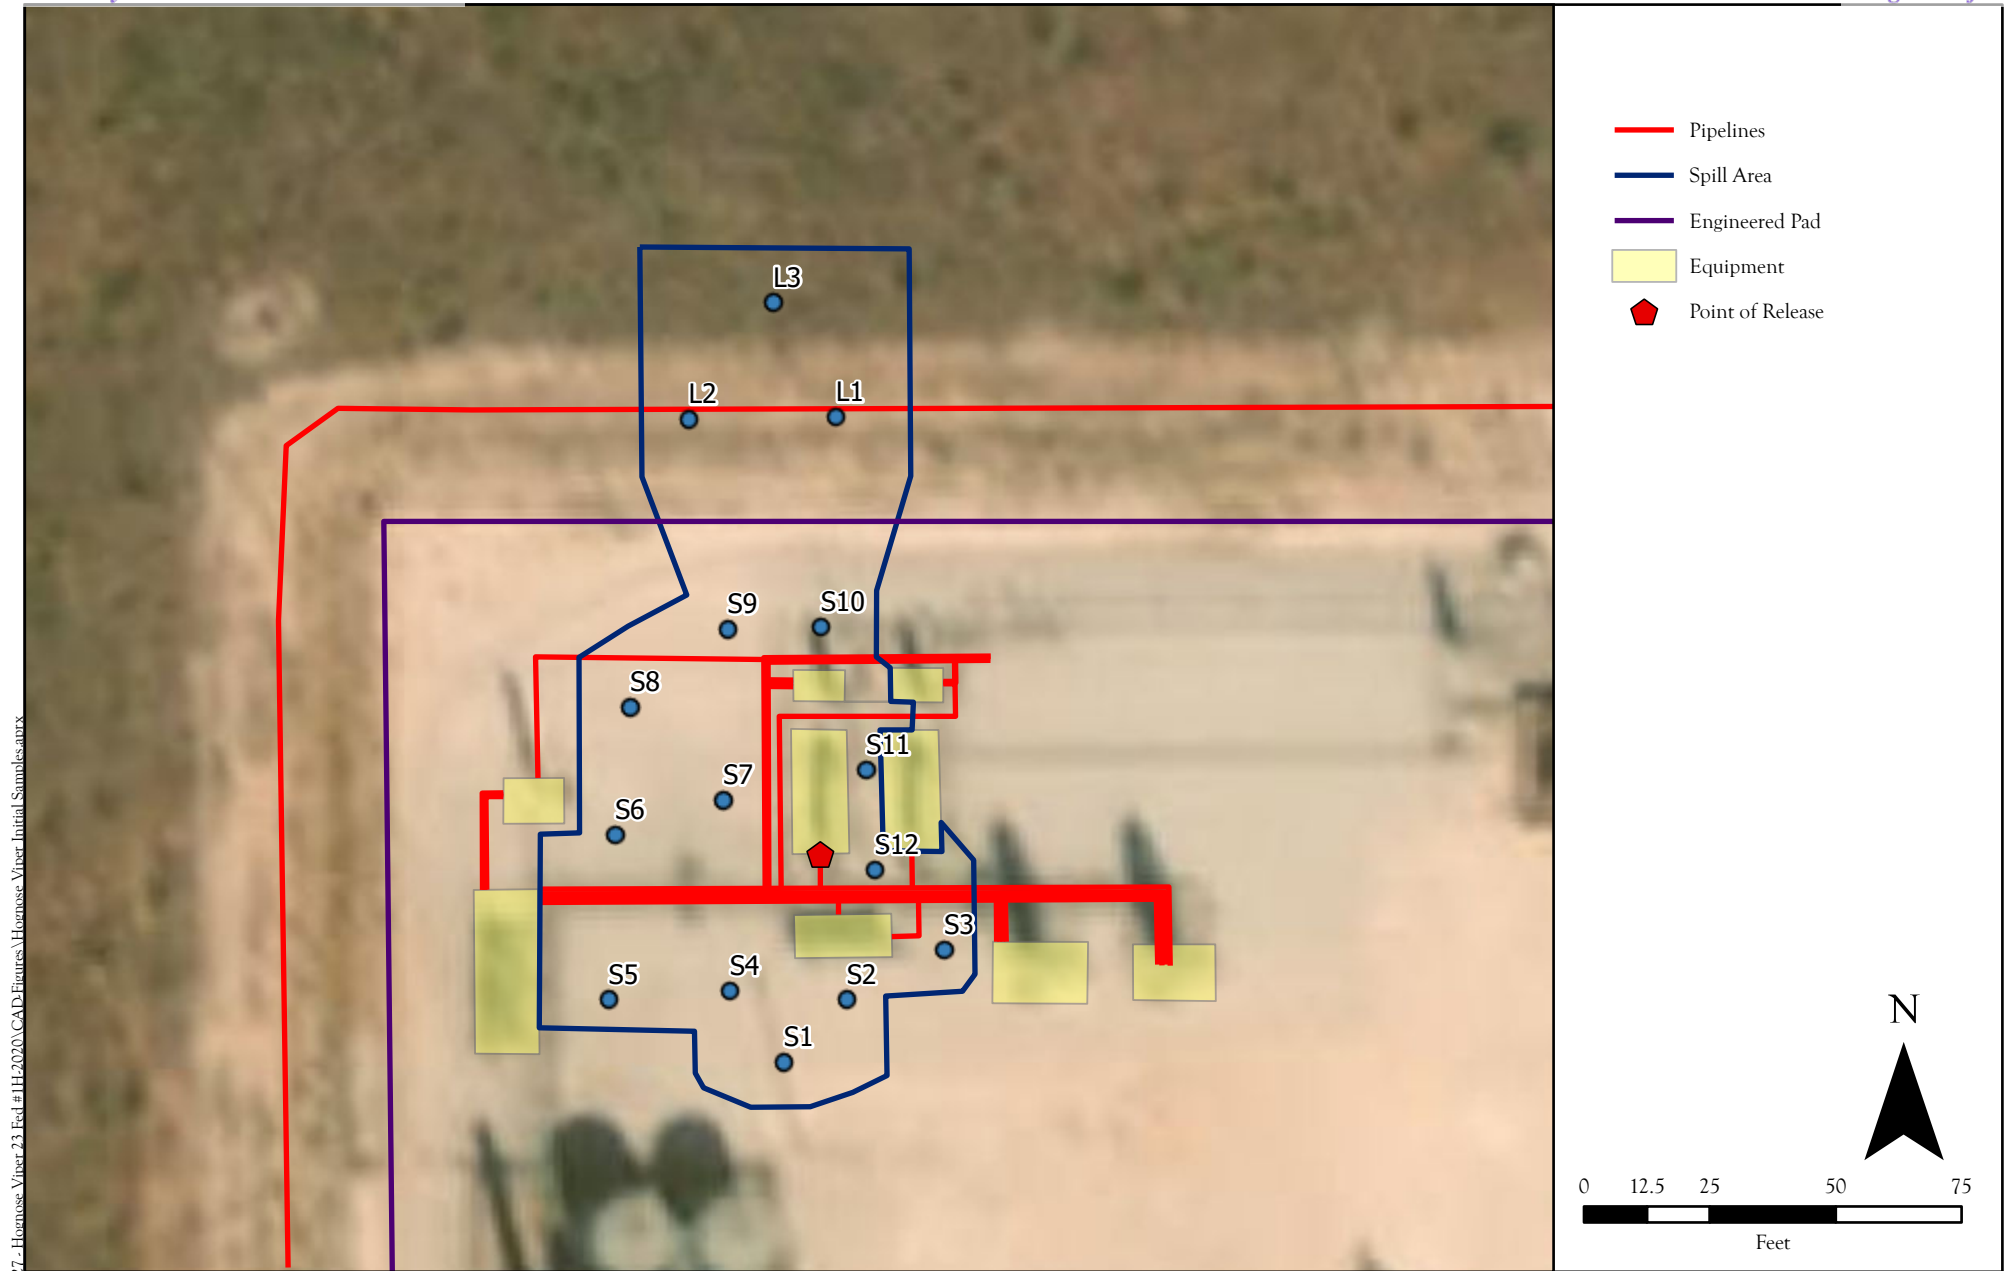
Figure 3a

On July 16, August 29, and September 5, 2020, SMA personnel performed site delineation activities at the Hognose Viper 23 Federal #001H site. SMA collected soil samples around the release site and throughout the visibly stained area. The area(s) of visual impact was located partially within the boundary of the developed storage facility, and partially in the pasture.

Site and Initial Sample Location Map  
Hognose Viper 23 Federal 1H- Devon Energy  
32.2834969, -103.5488968 Lea County, New Mexico

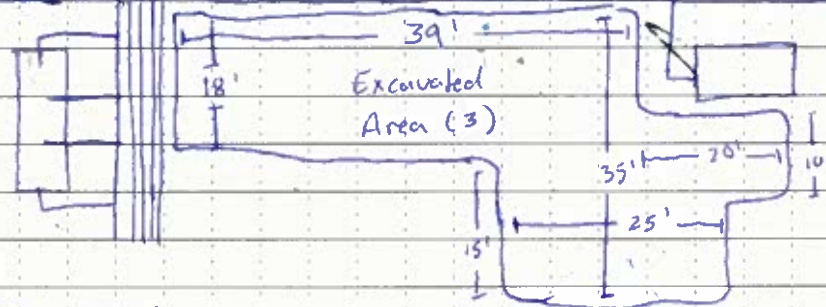
• Area (3)

$$\sim 18' \times 39' = 702'$$
