Closure Report
Cuervo Federal #020H
Incident ID: NCH1830572329
Lea County, New Mexico
Unit A Sec 14 T23S R32E
32.314287°, -103.648751°

Point of Release:
Vehicular traffic created a gash in a 4" poly SWD line
Release Date: 10/24/2018
Volume Released: 20 Barrels of Produced Water
Volume Recovered: 5 Barrels of Produced Water

Re: Closure Report
Cuervo Federal #020H
Cimarex Energy Co.
Site Location: Unit A, S14, T23S, R32E
(Lat 32.314287°, Long -103.648751°)
Lea County, New Mexico

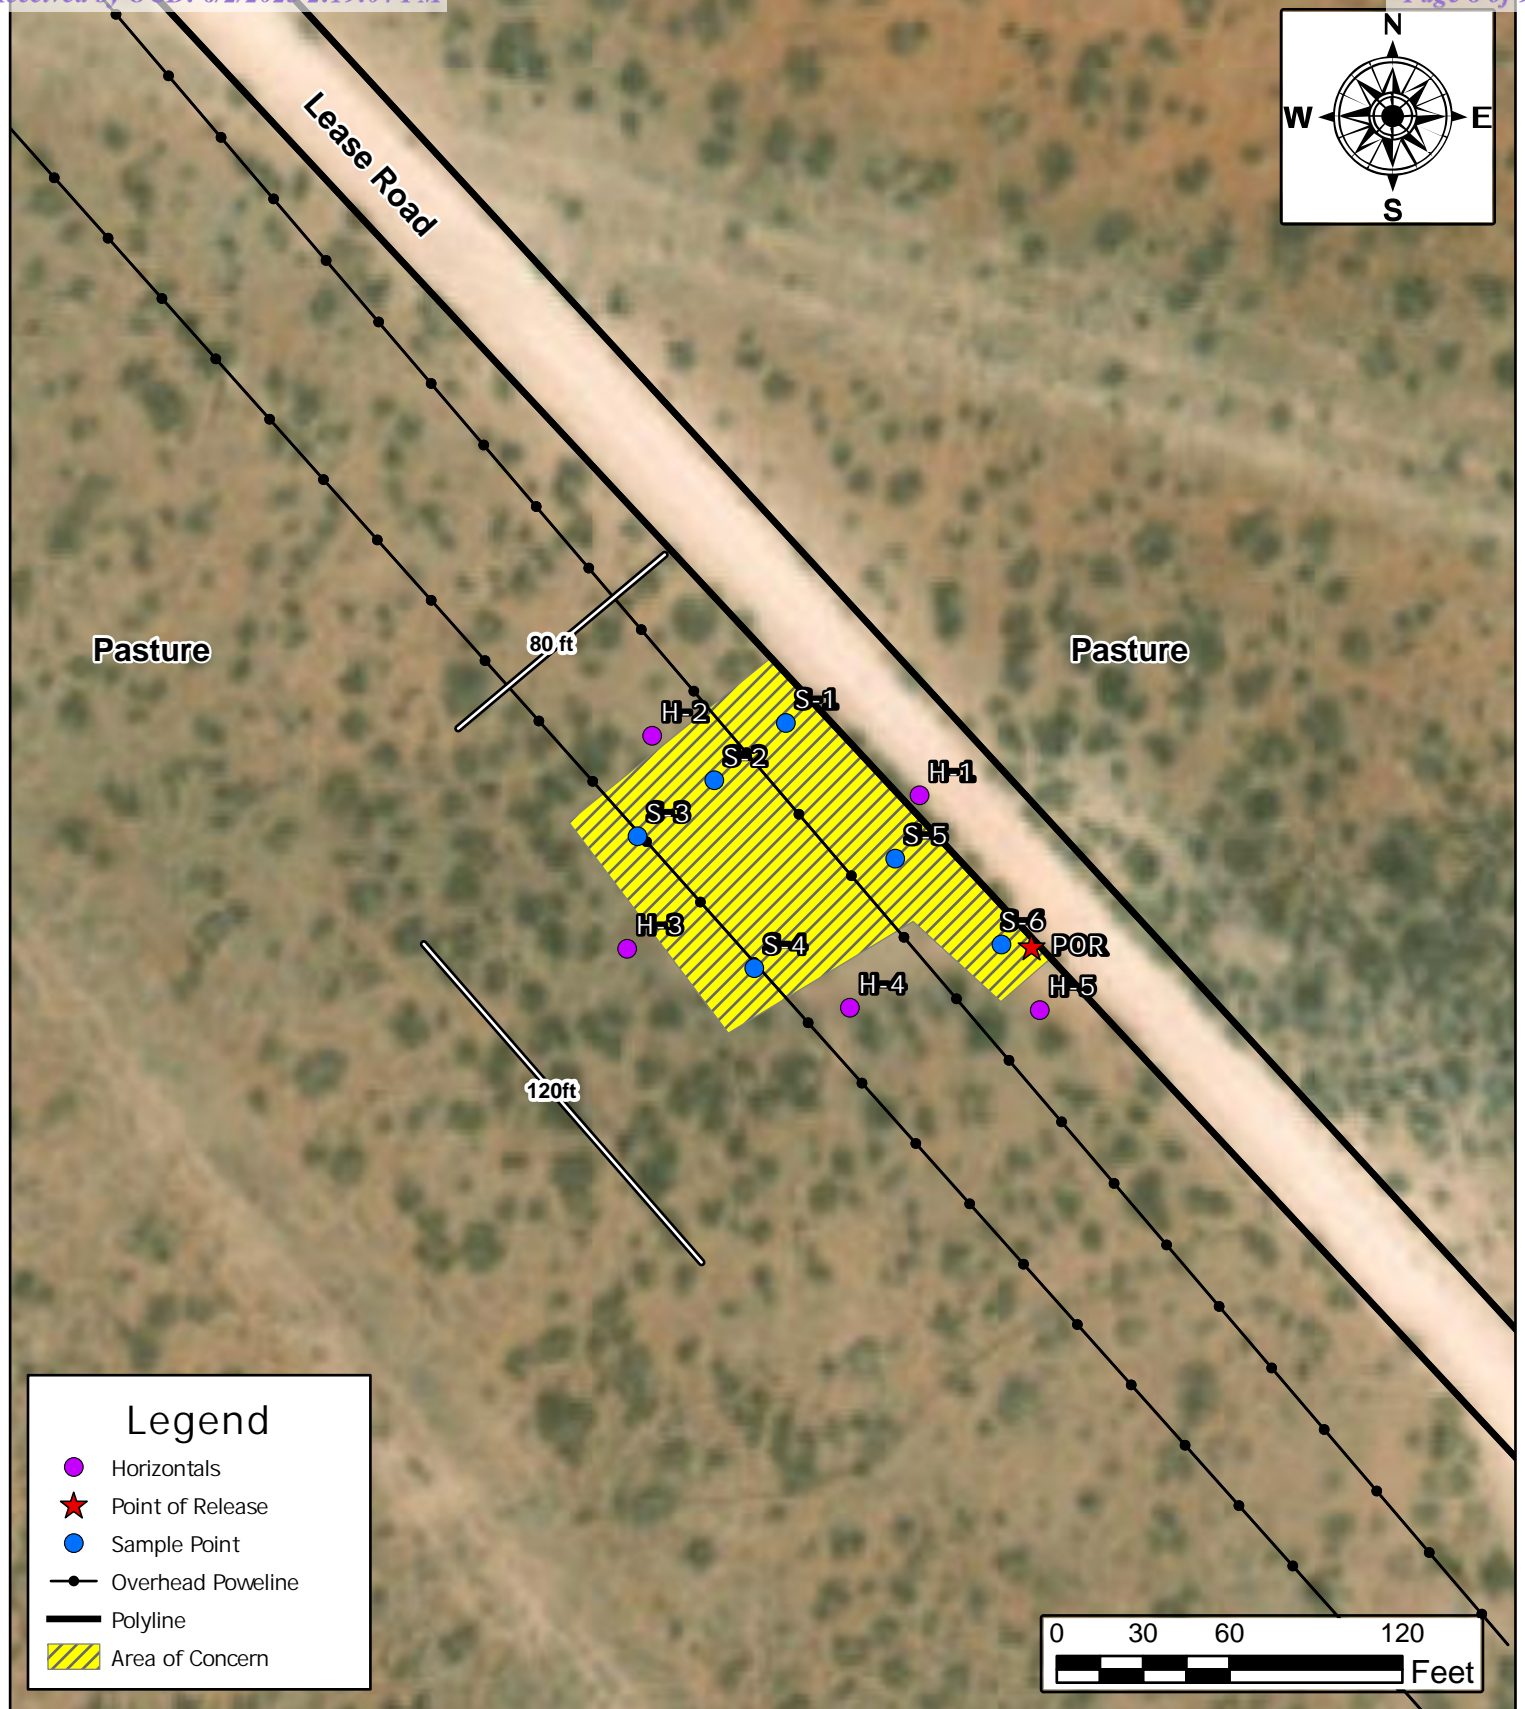
SAMPLE LOCATION MAP
CIMAREX ENERGY CO.
 CUERVO FEDERAL #020H
 LEA COUNTY, NEW MEXICO
 32.314287, -103.648751

Based on the initial C-141 obtained from the New Mexico Oil Conservation Division (NMOCD), the leak was discovered on October 24, 2018, caused by gash in the 4" poly SWD line created by vehicular traffic. It resulted in the release of approximately twenty (20) barrels of produced water, and five (5) barrels of produced water were recovered. The impacted area is located in the pasture. Refer to Figure 3 for a spill overview. The initial C-141 form is attached in Appendix C.

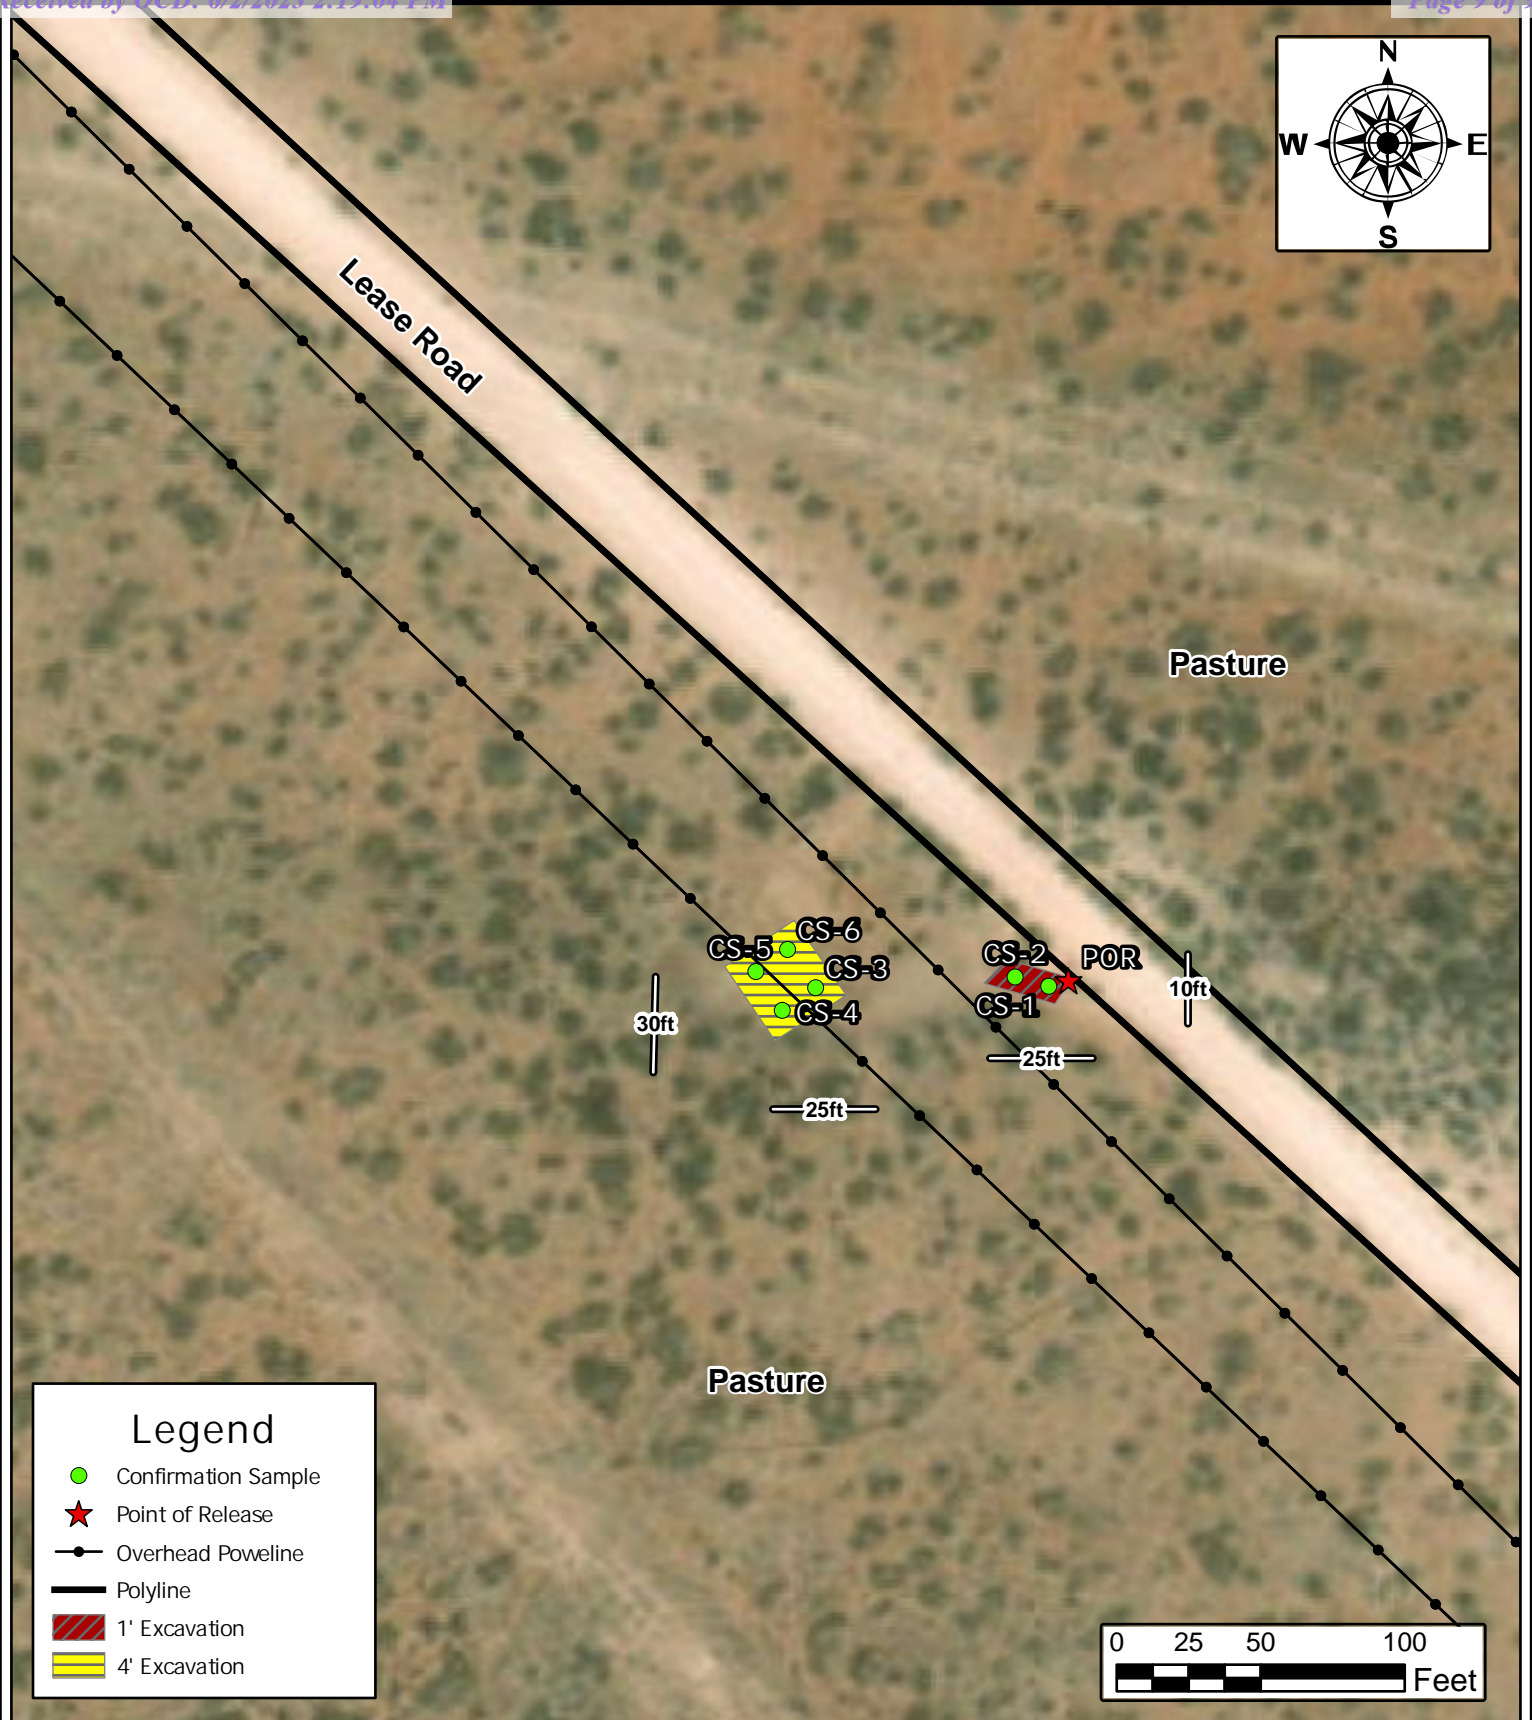
DRAWING NUMBER:
FIGURE 4A
SHEET NUMBER:
1 of 2

EXCAVATION DEPTH MAP CIMAREX ENERGY CO. CUERVO FEDERAL #020H LEA COUNTY, NEW MEXICO 32.314287, -103.648751	
SCALE: As Shown	Date: 4/25/2023

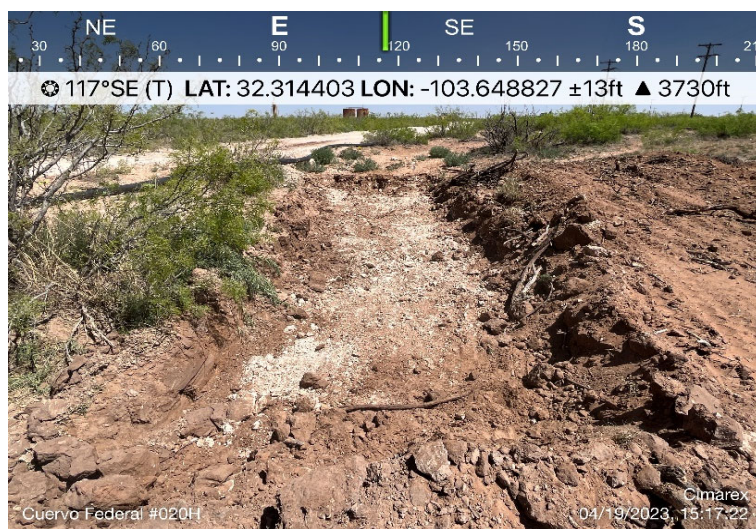
View Southeast, area of CS-1 through CS-2.

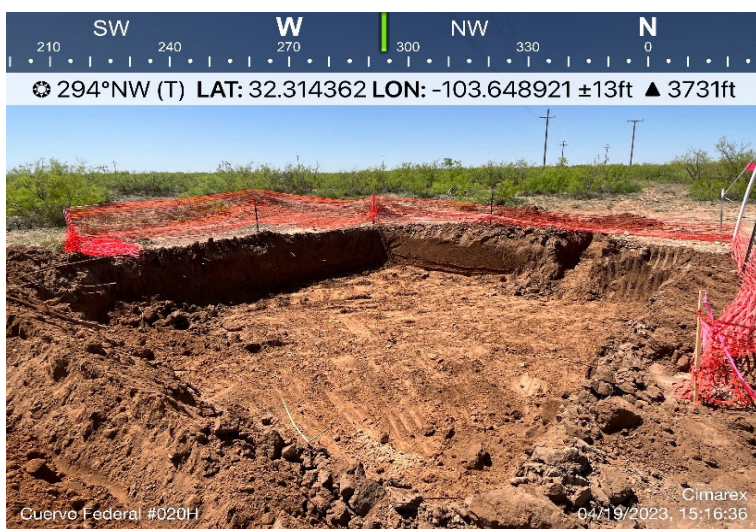
Photograph No. 2

View Northwest, area of CS-3 through CS-6.

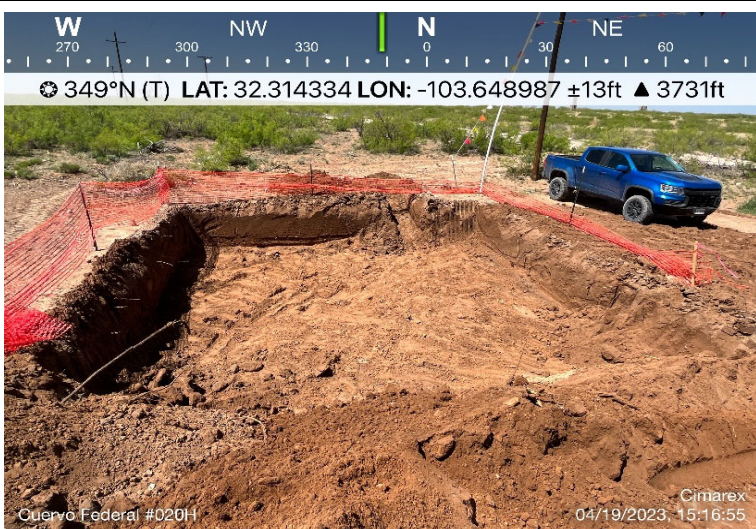
Photograph No. 3

View North, area of CS-3 through CS-6.
