Site Assessment/Characterization

State of New Mexico
Oil Conservation Division

Based on laboratory analytical results and field activities conducted to date, Etech recommends Mewbourne Oil Company provide copies of this *Remediation Summary & Soil Closure Request* to the appropriate agencies and request closure be granted to the Black Sheep release site.

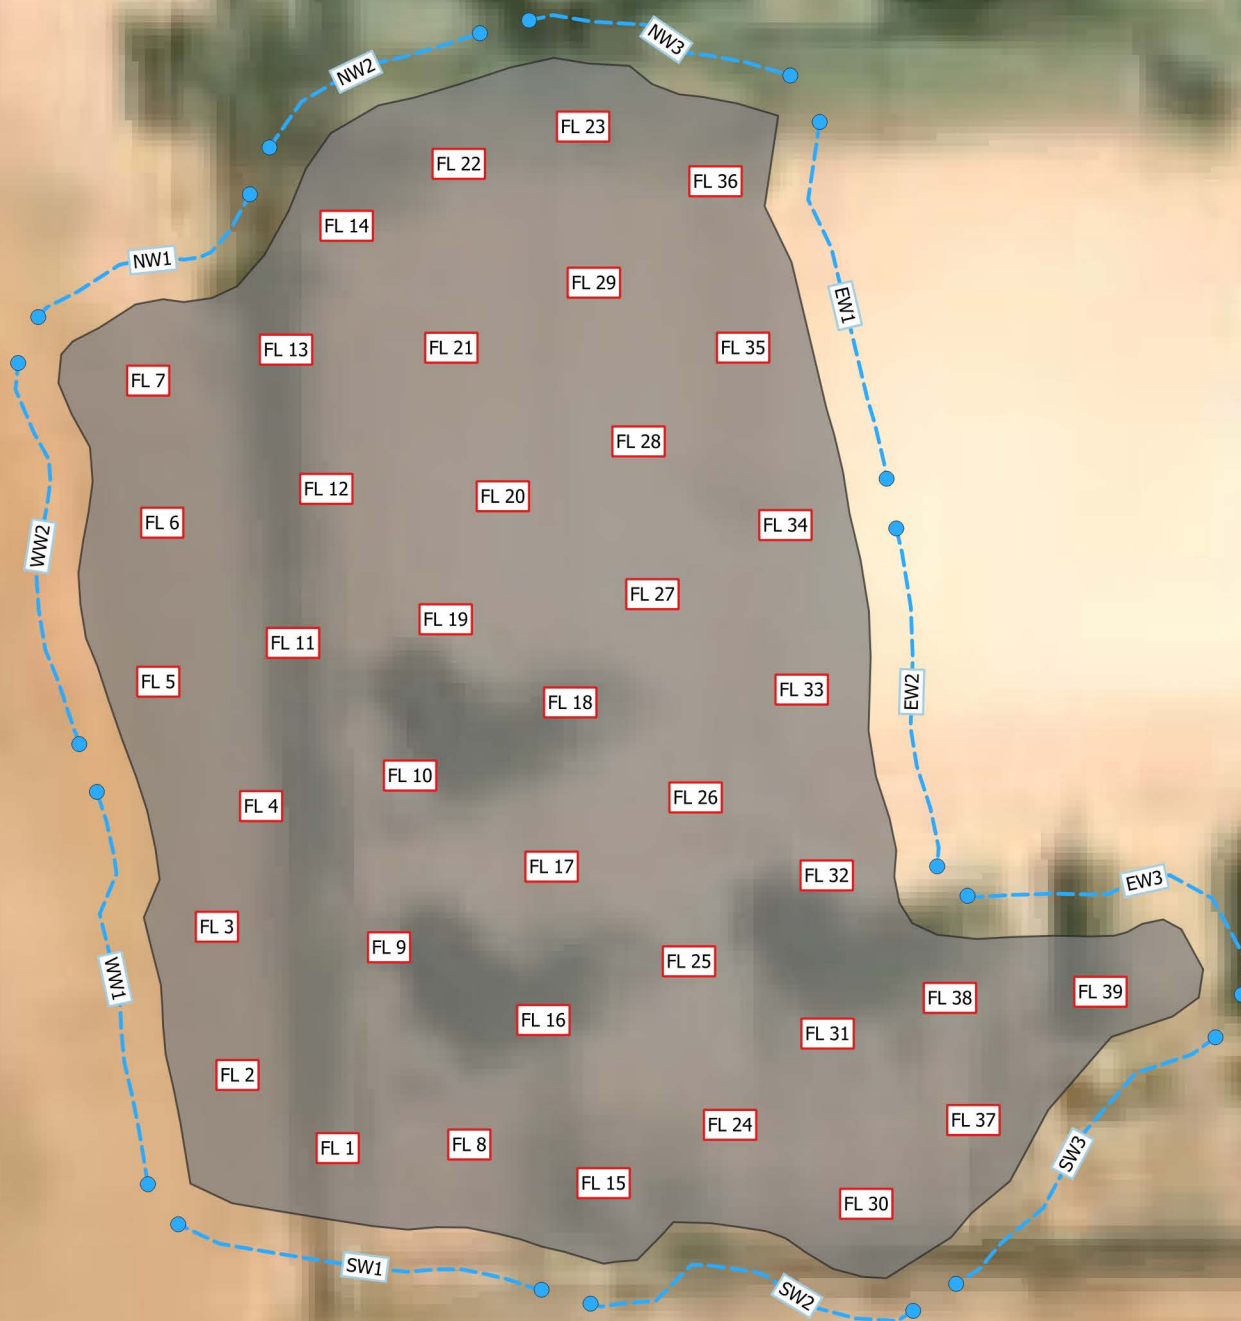
Figure 3

Site & Sample Location Map

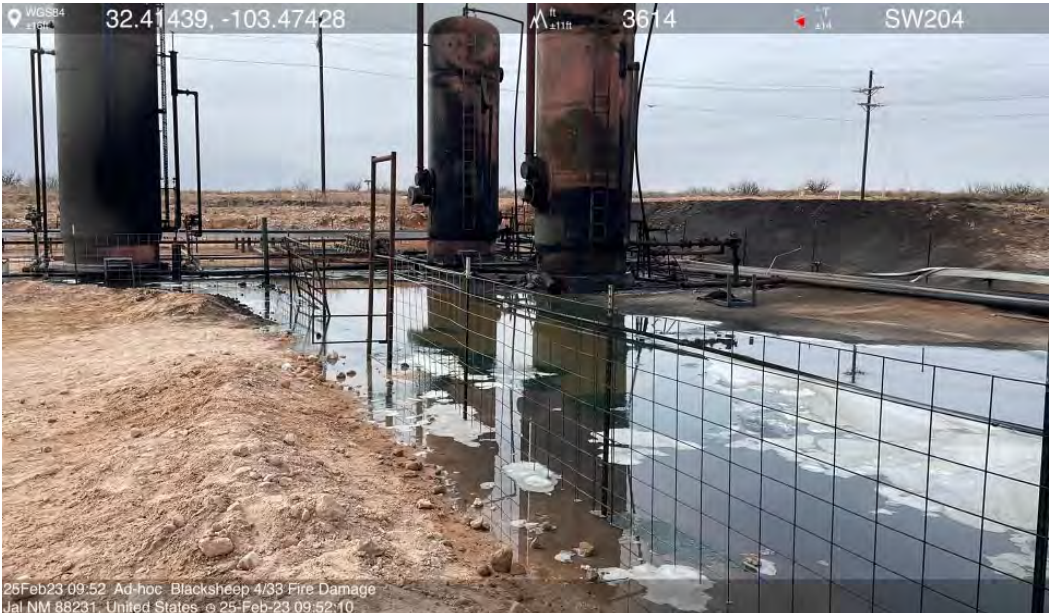
Photo Number: 4

<p>WGSR4 32.41439, -103.47428 3614 SW204</p> <p>26Feb23 09:52 Ad-hoc: Blacksheep 4/33 Fire Damage Jai NM 88231, United States © 25-Feb-23 09:52:10</p>
Photo Direction: South-Southwest	
Photo Description: View of the affected area.

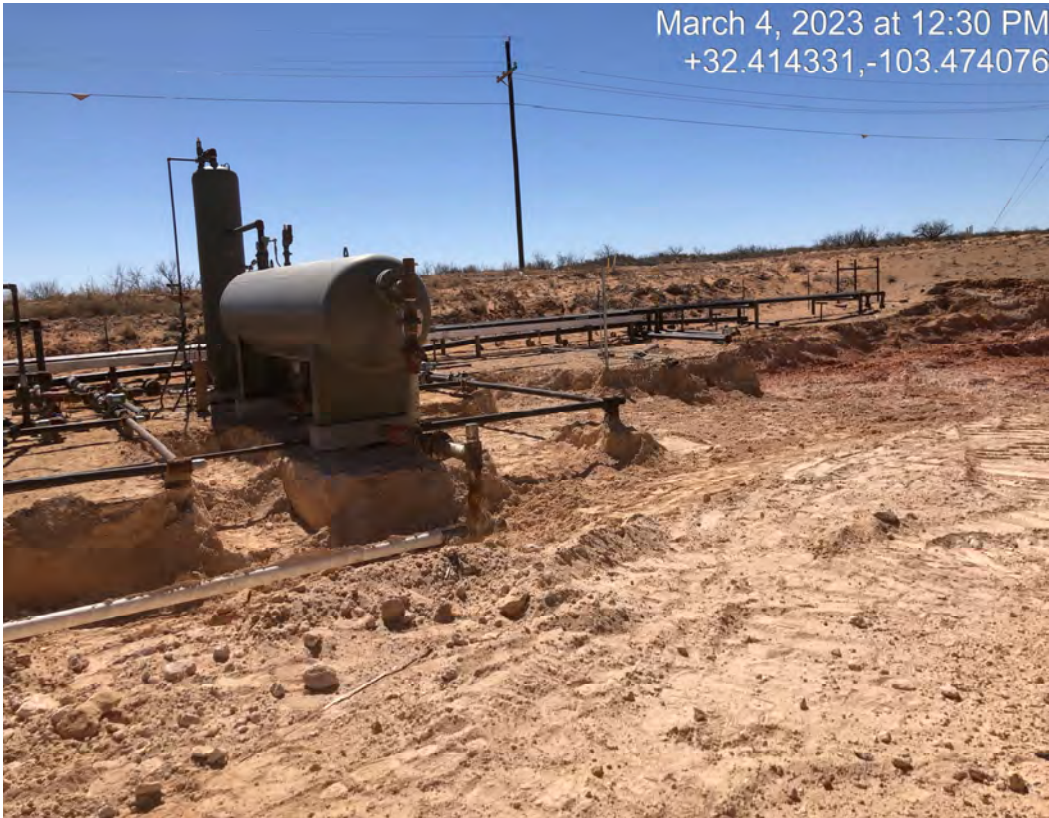
Photo Number: 5

<p>March 4, 2023 at 12:30 PM +32.414331,-103.474076</p>
Photo Direction: West-Northwest	
Photo Description: View of the excavated area.

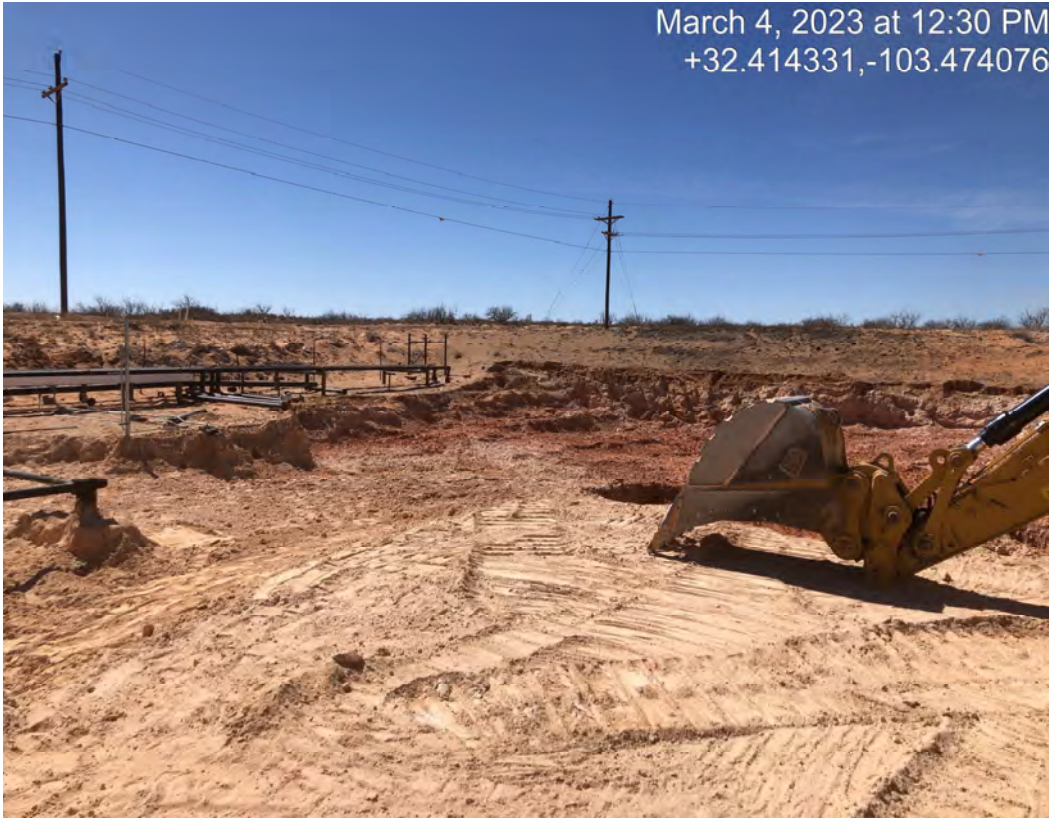
Photo Number: 6

<p>March 4, 2023 at 12:30 PM +32.414331,-103.474076</p>
Photo Direction: Northwest	
Photo Description: View of the excavated area.

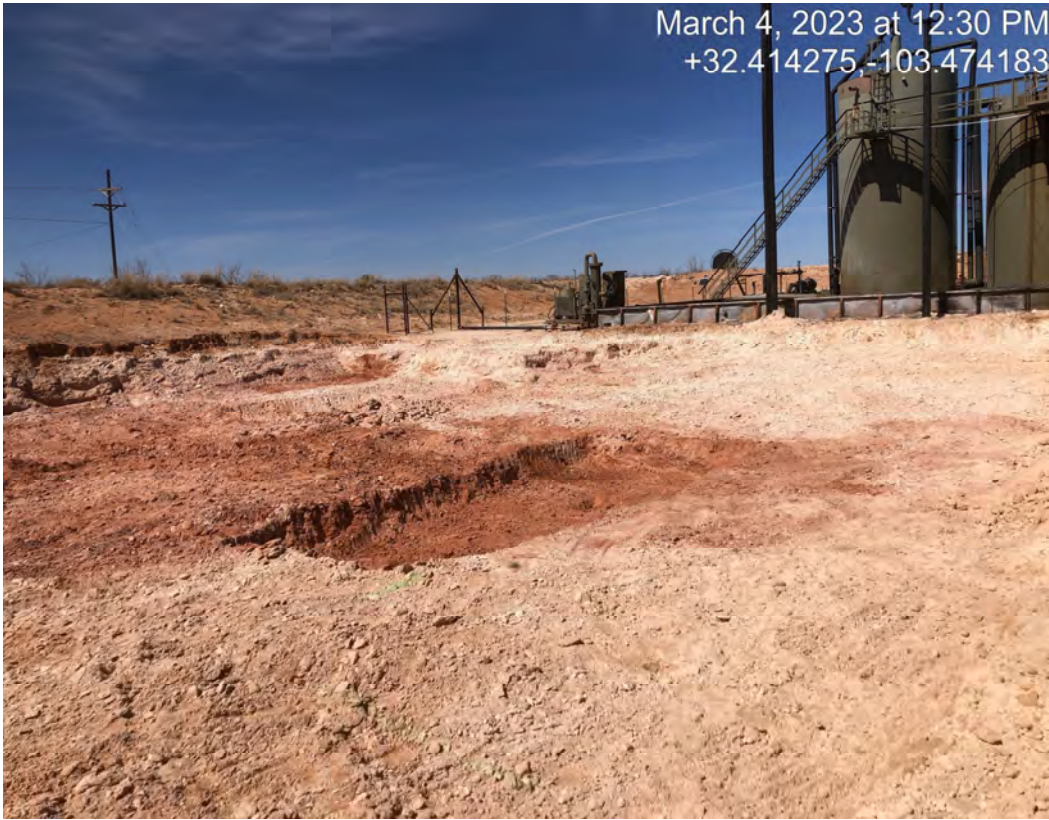
Photo Number: 7

<p>March 4, 2023 at 12:30 PM +32.414275,-103.474183</p>
Photo Direction: North-Northwest	
Photo Description: View of the excavated area.
