Goodnight Midstream Permian, LLC Stateline Pipeline Valve Leak

Etech Environmental & Safety Solutions, Inc. (Etech), on behalf of Goodnight Midstream Permian, LLC, has prepared this *Remediation Summary and Soil Closure Request* for the release site known as the Stateline Pipeline Valve Leak (henceforth, "Site"). Details of the release are summarized below:

Site Name: <u>Stateline Pipeline Valve Leak</u>	Site Type: <u>Pipeline</u>
Date Release Discovered: <u>1/18/2023</u>	API # (if applicable): <u>N/A</u>

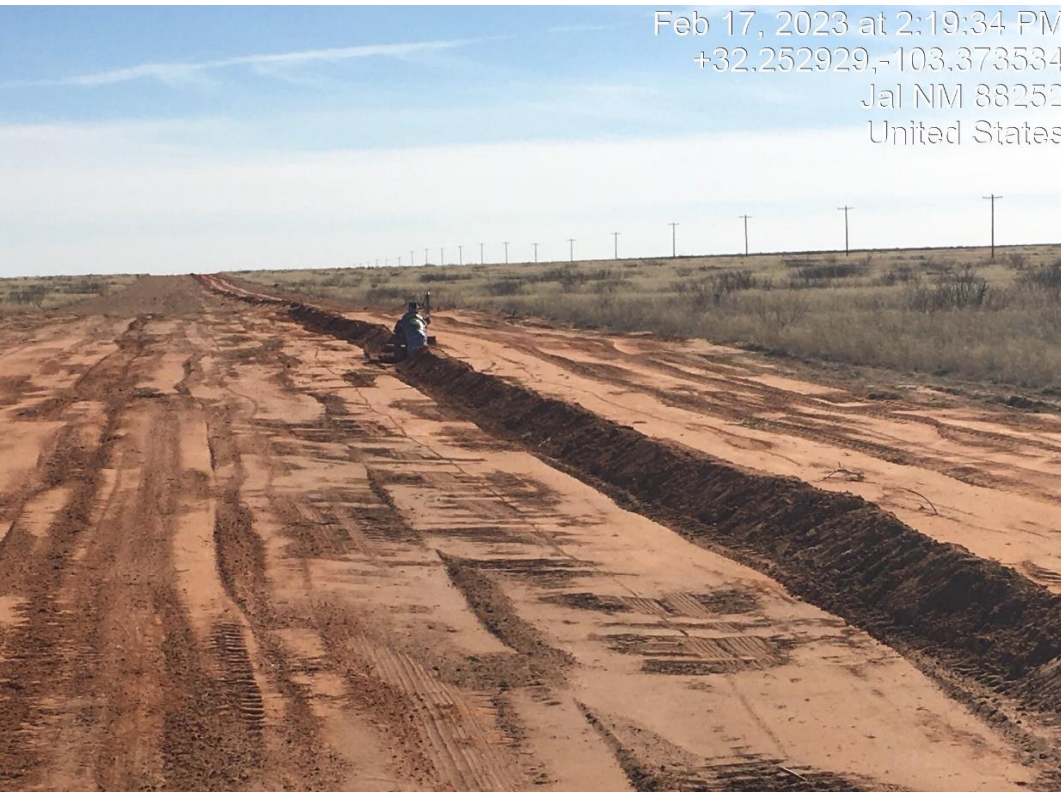
POINT OF DIVERSION SUMMARY

<p>Feb 17, 2023 at 2:19:34 PM +32.252929,-103.373534 Jal NM 88252 United States</p>
Photo Direction: South	
Photo Description: View of remediated area after backfill and regrading.

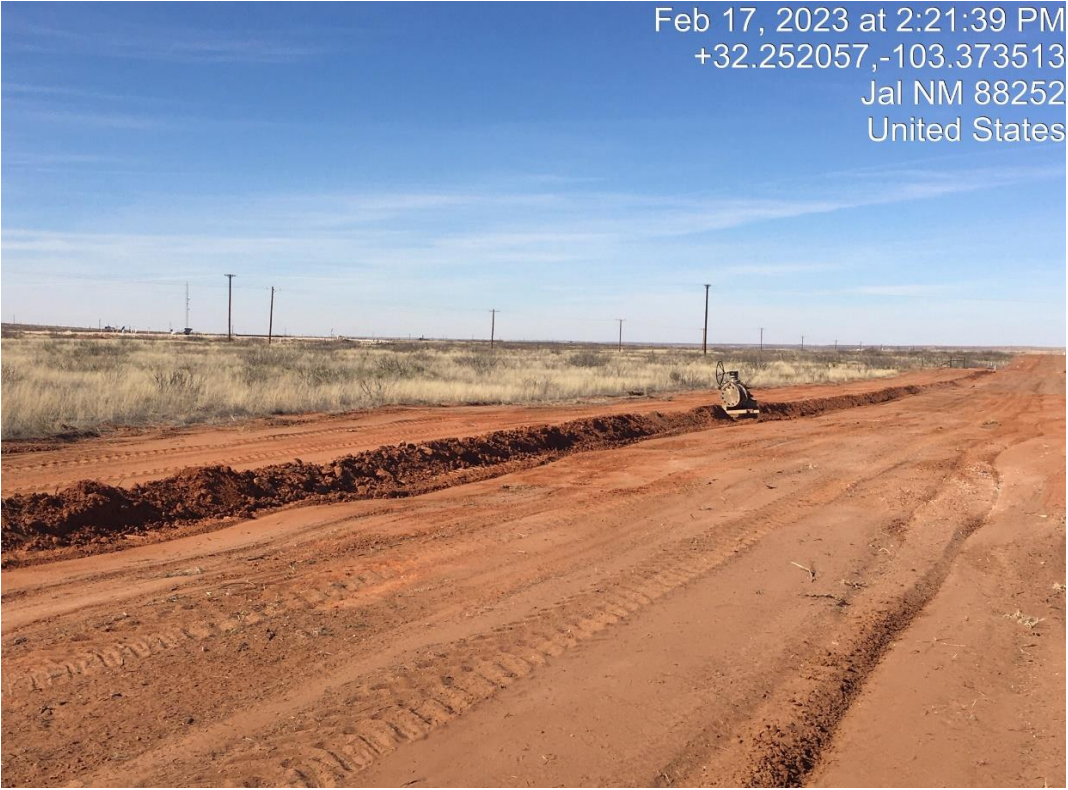
Photo Number: 5	<div>Feb 17, 2023 at 2:21:39 PM +32.252057,-103.373513 Jal NM 88252 United States</div>

Photo Direction: Northwest	
Photo Description: View of remediated area after backfill and regrading.
