Site Assessment/Characterization

Closure

Re: Site Assessment, and Closure Report
Coral PWU 28 4H
API No. 30-015-39328
GPS: Latitude 32.625395 Longitude -104.074521
UL -- P, Section 28, T19S, R29E
Eddy County, NM
NMOCD Ref. No. NAB1715035797

Coral PWU 28 4H|Devon Energy

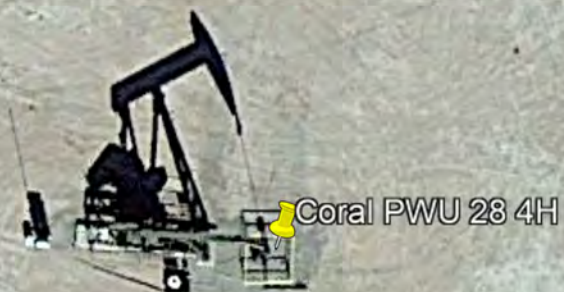
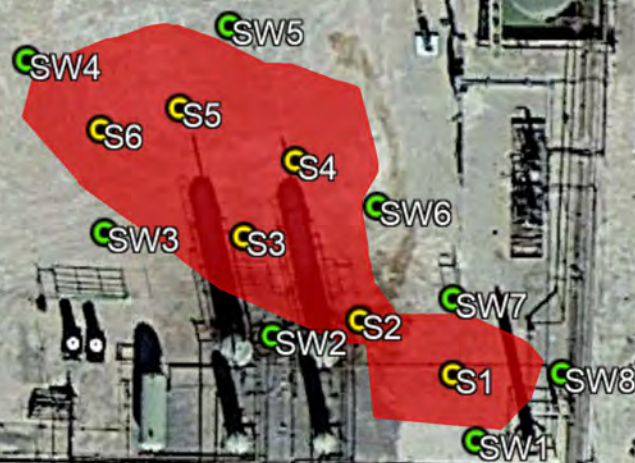
Devon Energy
API:30-015-39328
Eddy County, NM
Site Map

On July 13, 2023, Pima mobilized personnel to the site to begin collecting soil samples from spill area. The laboratory results of this sampling event can be found in the following data table. A Site Map can be found in Figure 4.

NMOCD Table 1 Closure Criteria 19.15.29 NMAC (Depth to Groundwater is <50')								
DEVON ENERGY -CORAL PWU 28 #004H								
Sample Date: 7/13/2023		NM Approved Laboratory Results						
Sample ID	Depth (BGS)	BTEX mg/kg	Benzene mg/kg	GRO mg/kg	DRO mg/kg	MRO mg/kg	Total TPH mg/kg	CI mg/kg
S-1	1'	ND	ND	ND	ND	ND	ND	83.6
	3'	ND	ND	ND	ND	ND	ND	179
	4'	ND	ND	ND	ND	ND	ND	ND
S-2	1'	ND	ND	ND	ND	ND	ND	126
	3'	ND	ND	ND	ND	ND	ND	191
	4'	ND	ND	ND	ND	ND	ND	ND
S-3	1'	ND	ND	ND	ND	ND	ND	96.6
	3'	ND	ND	ND	ND	ND	ND	183
	4'	ND	ND	ND	ND	ND	ND	ND
S-4	1'	ND	ND	ND	ND	ND	ND	145
	3'	ND	ND	ND	ND	ND	ND	194
	4'	ND	ND	ND	ND	ND	ND	ND
S-5	1'	ND	ND	ND	ND	ND	ND	116
	3'	ND	ND	ND	ND	ND	ND	189
	4'	ND	ND	ND	ND	ND	ND	ND
S-6	1'	ND	ND	ND	ND	ND	ND	110
	3'	ND	ND	ND	ND	ND	ND	193
	4'	ND	ND	ND	ND	ND	ND	ND
SW 1	6"	ND	ND	ND	ND	ND	ND	ND
SW 2	6"	ND	ND	ND	ND	ND	ND	ND
SW 3	6"	ND	ND	ND	ND	ND	ND	ND
SW 4	6"	ND	ND	ND	ND	ND	ND	ND
SW 5	6"	ND	ND	ND	ND	ND	ND	ND
SW 6	6"	ND	ND	ND	ND	ND	ND	ND

Based on the sample results, the bottoms and sidewalls were below NMOCD Closure Criteria 19.15.29 NMAC. See Appendix D for Photographic Documentation.

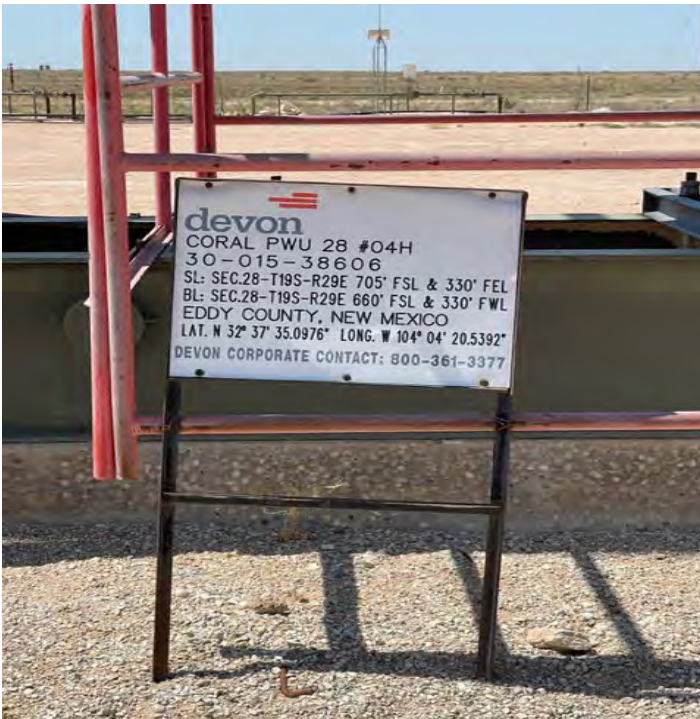
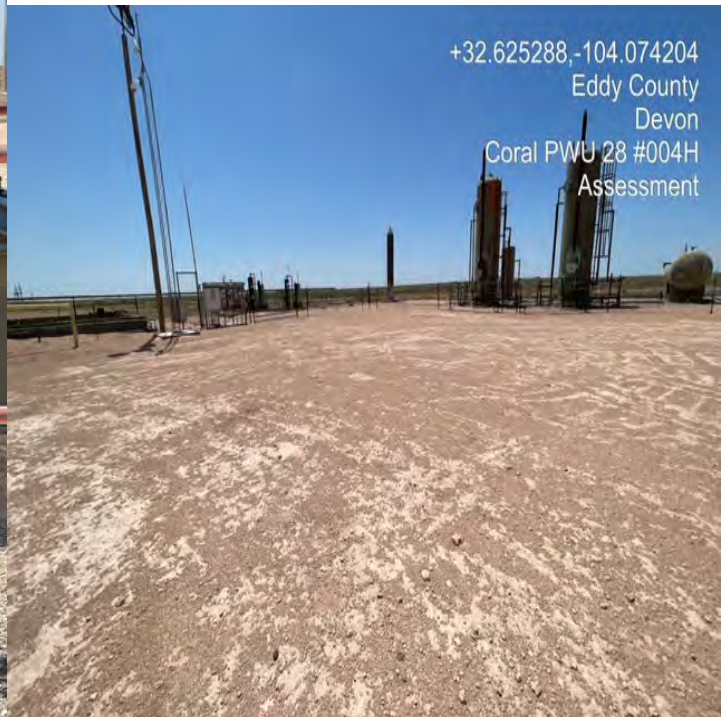
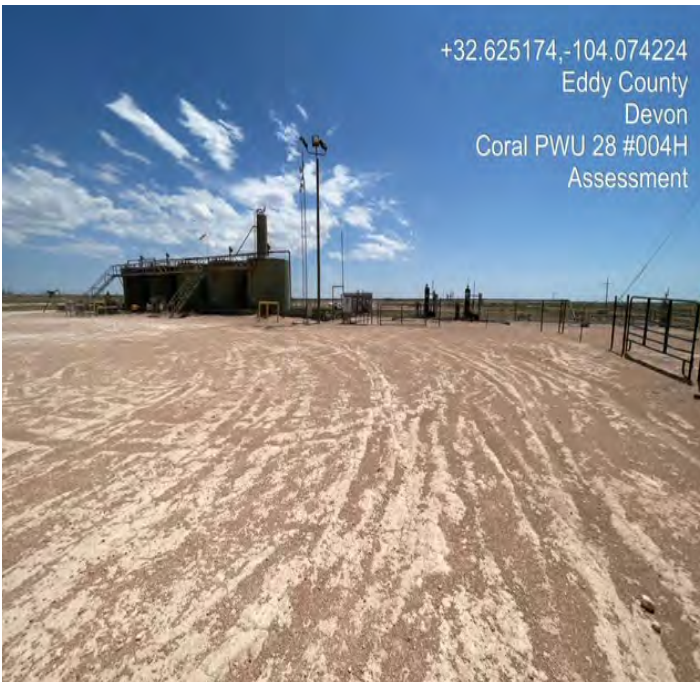
**SITE PHOTOGRAPHS
DEVON ENERGY
CORAL PWU 28 4H**

Site Assessment
