**RE: Liner Inspection and Closure Report  
Right Meow 31 CTB 5  
API No. N/A  
GPS: Latitude 32.25612417 Longitude -103.7180631  
UL M, Section 31, Township 23S, Range 32E  
NMOCD Reference No. NAPP2215432080**

Devon Energy Production Company (Devon) has contracted Pima Environmental Services, LLC (Pima) to perform a liner inspection and prepare this closure report for a produced water release that happened at the Right Meow 31 CTB 5 (Right Meow). An initial C-141 was submitted on June 22, 2022, and can be found in Appendix B. This incident was assigned Incident ID NAPP2215432080, by the New Mexico Oil Conservation Division (NMOCD).

# Right Meow 31 CTB 5

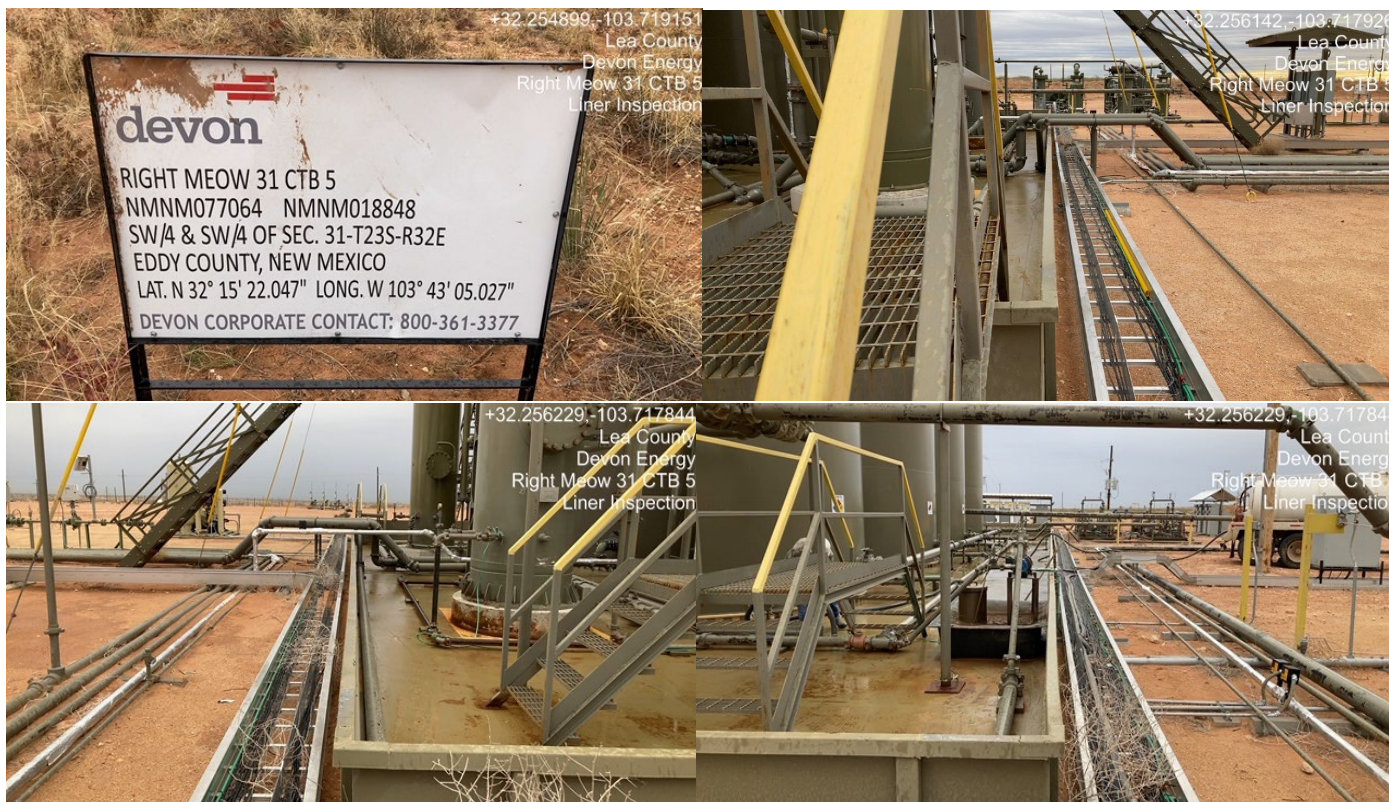
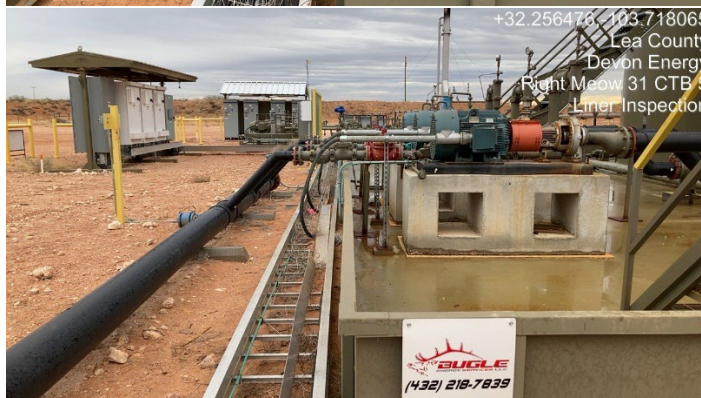
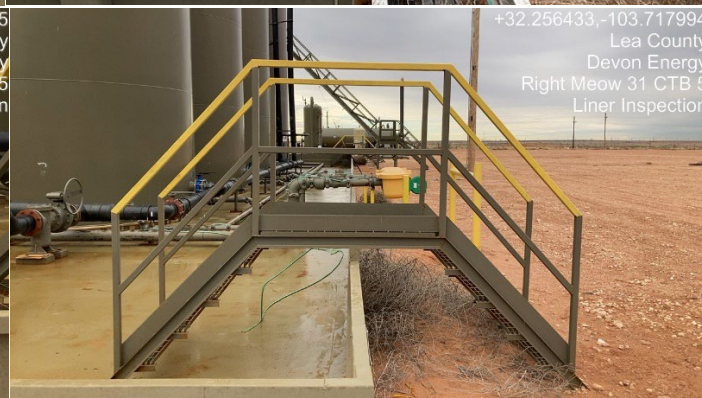
**SITE PHOTOGRAPHS**  
**DEVON ENERGY**  
**RIGHT MEOW 31 CTB 5**  
**LINER INSPECTION**

On December 3, 2022, after sending the 48-hour notification email, Pima Environmental conducted a liner inspection at this location. We concluded that this liner and containment maintained its integrity and was able to retain the fluids. The liner inspection form and photographic documentation can be found in Appendix C.

| Visualization | Yes | No | Comments |
|---|---|---|---|
| Does the liner have integrity to contain a leak? | X | | |

After careful review, Pima requests that this incident, NAPP2215432080 be closed. Devon has complied with the applicable closure requirements.
