Release Notification and Corrective Action

Name of Company	WPX Energy Inc/RKI	Contact	Karolina Blaney
Address	5315 Buena Vista Dr.	Telephone No.	970 589 0743
Facility Name:	RDX 17-25	Facility Type:	Well Pad

WPX Energy Permian, LLC
RDX 17-25/RDX Federal 17 #36H
nAB1712952339/NRM2017643736

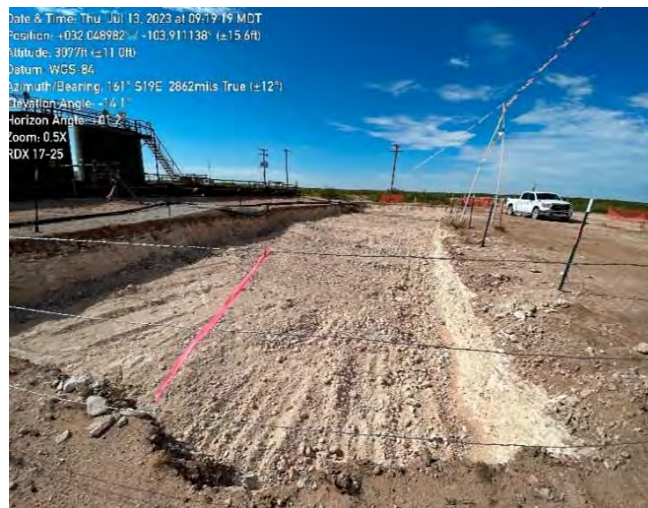
Photograph 1
Date:07/13/2023

Description: Southeastern view of excavation extent.

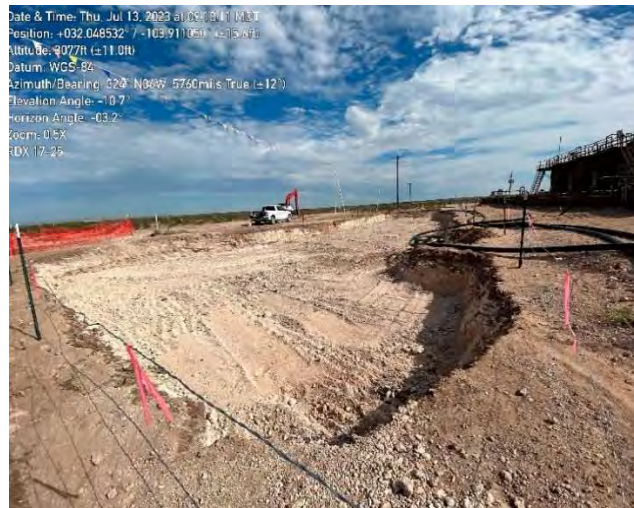
Photograph 2
Date:07/13/2023

Description: Northwestern view of excavation extent.

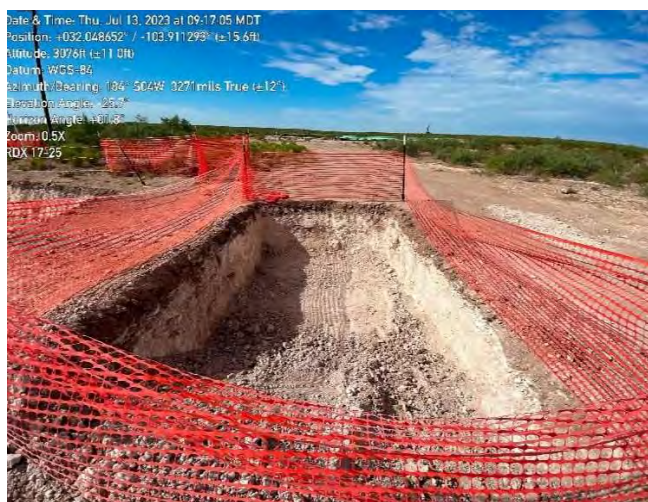
Photograph 3
Date:07/13/2023

Description: Southwestern view of excavation extent.

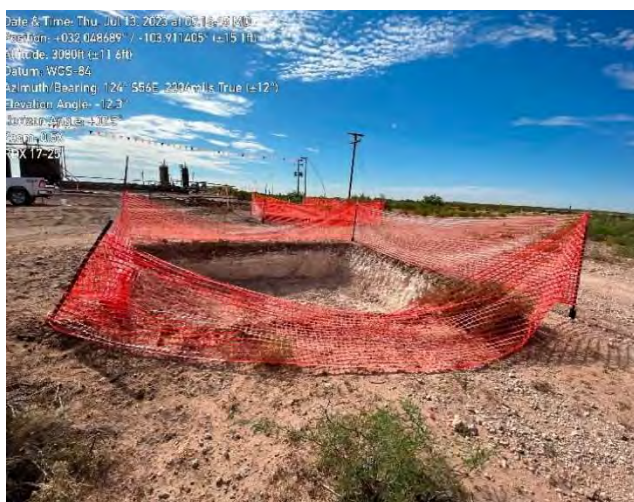
Photograph 4
Date:07/13/2023

Description: Southeastern view of excavation extent.

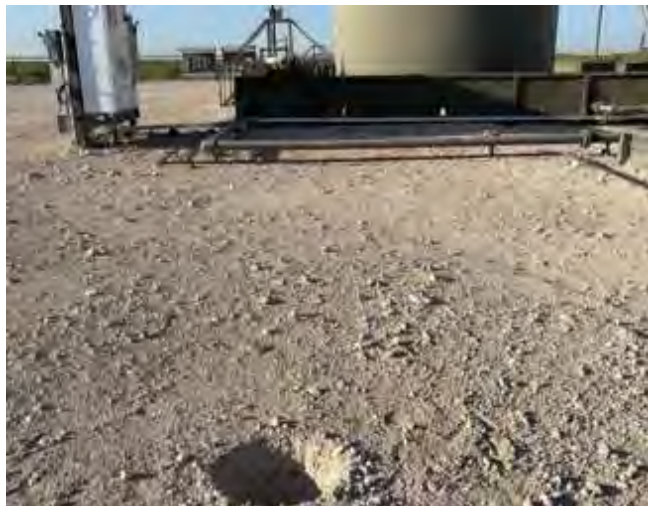
Photograph 5

Description: Southern view of delineation activities surrounding the secondary lined containment.

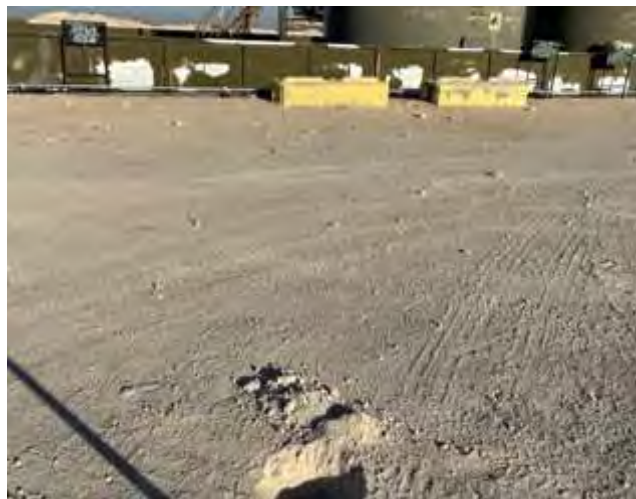
Photograph 6

Description: Southern view of delineation activities surrounding the secondary lined containment.

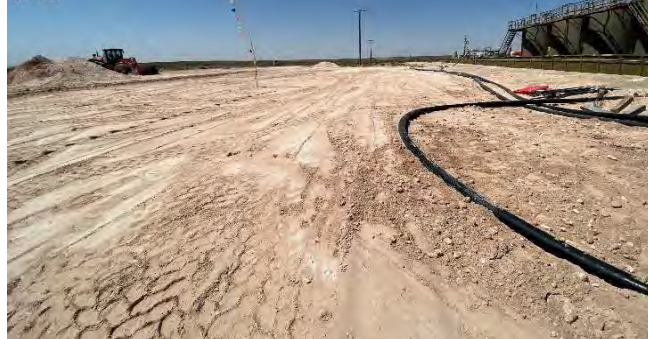
Photograph 7

Description: Northwestern view of backfilled excavation.

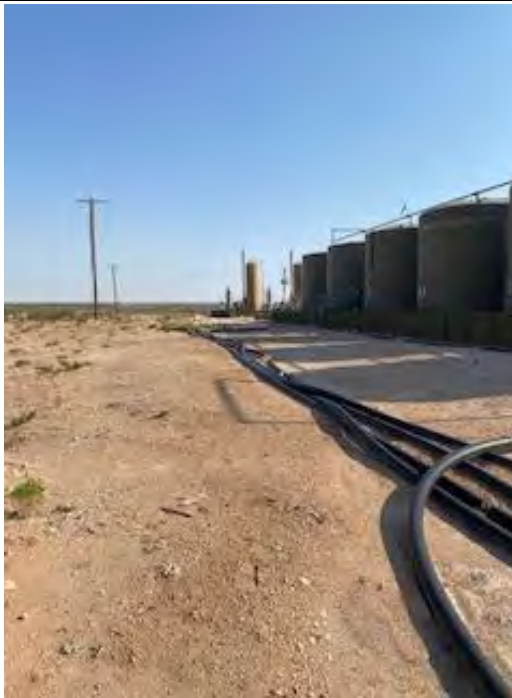
Photo No.	Date	
1	August 27, 2020	
North view of the release area before delineation activities.
