Re: **Closure Request**
FNR 26-1 CTB
Tracking #: NAPP2306752819

Site Information	
Incident ID	NAPP2306752819
Site Name	FNR 26-1 CTB
Company	OXY USA, Inc.
County	Eddy
ULSTR	M-26-23S-30E
GPS Coordinates (NAD 83)	32.27025, -103.85793
Landowner	Federal

On 3/8/2023, OXY USA, Inc. reported a release at the FNR 26-1 CTB. The release was caused because a valve was left open on the discharge line. The entire release was in a Lined and Contained Facility, and no crude oil escaped the container.

This release was contained within a lined and contained facility. Soiled pea gravel was removed from the containment and the liner was cleaned with a pressure washer. Upon inspection the liner is found to be in satisfactory condition.

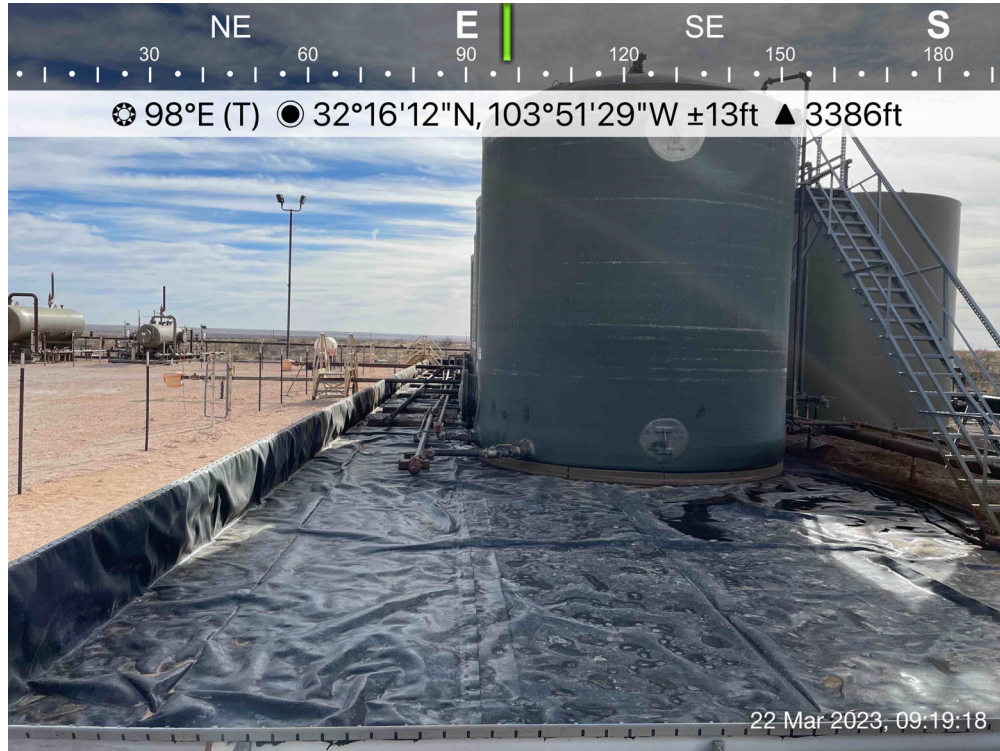
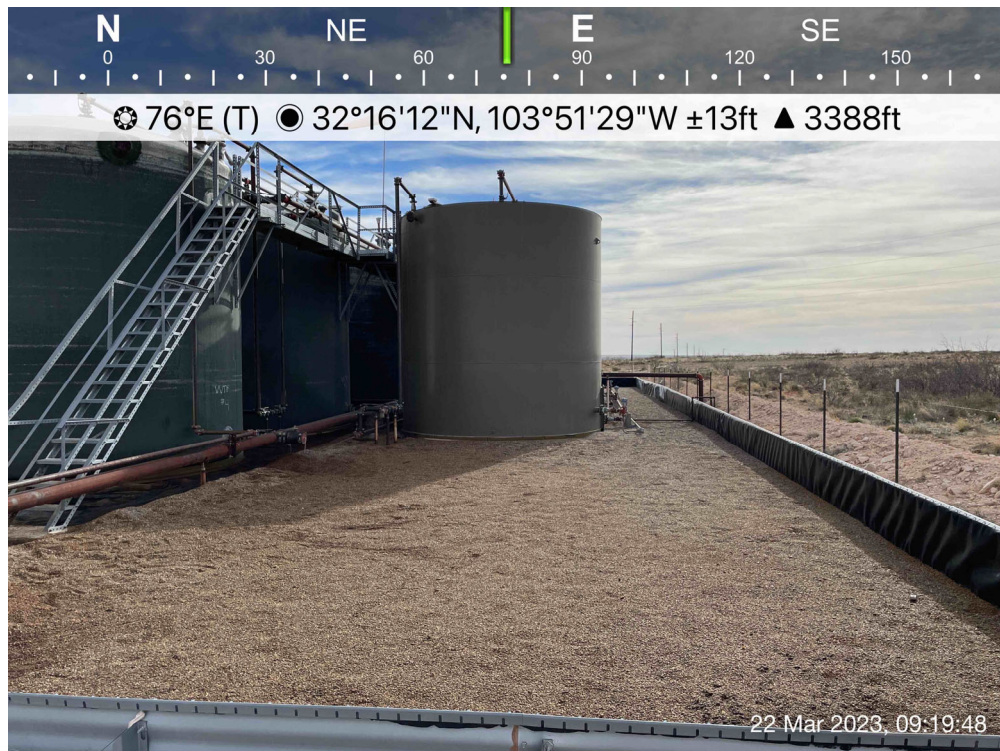
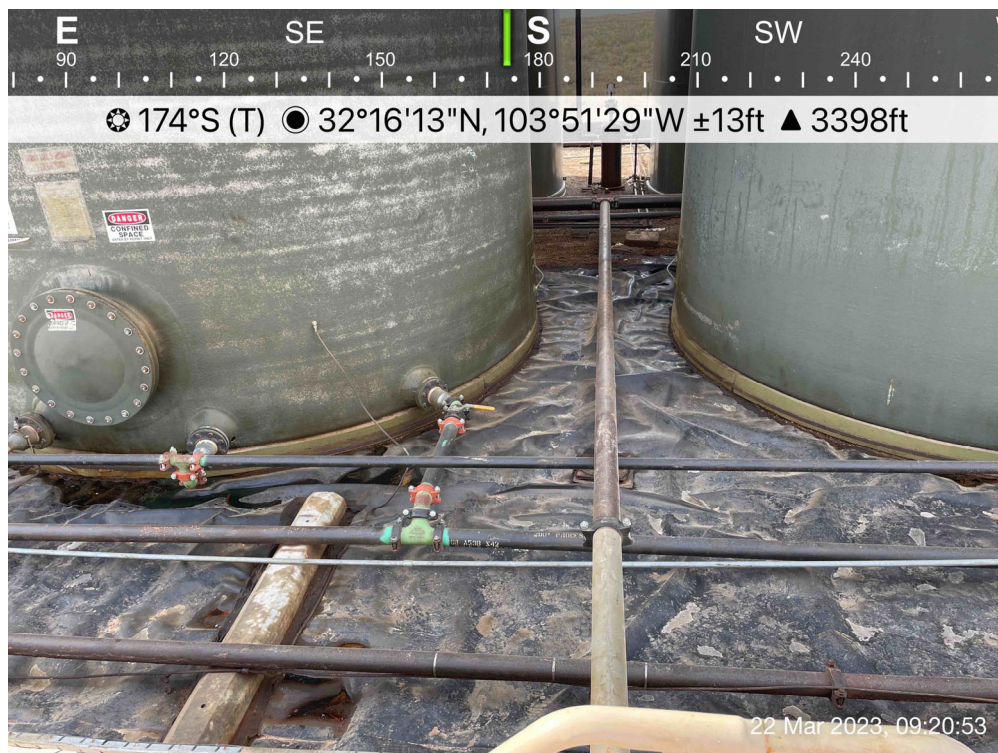
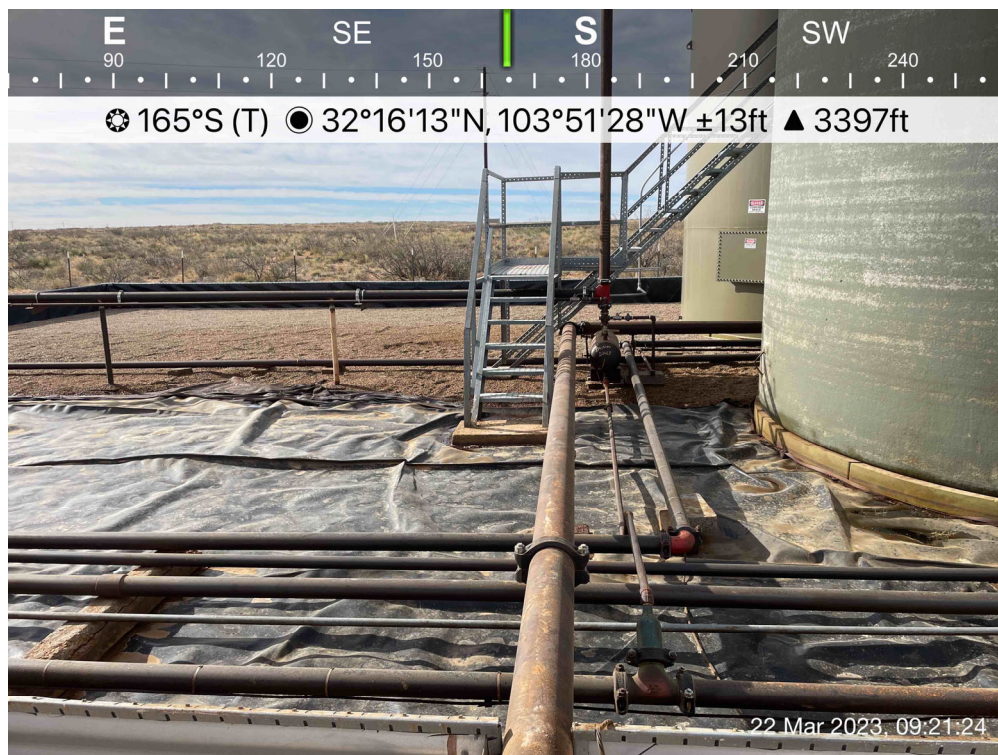
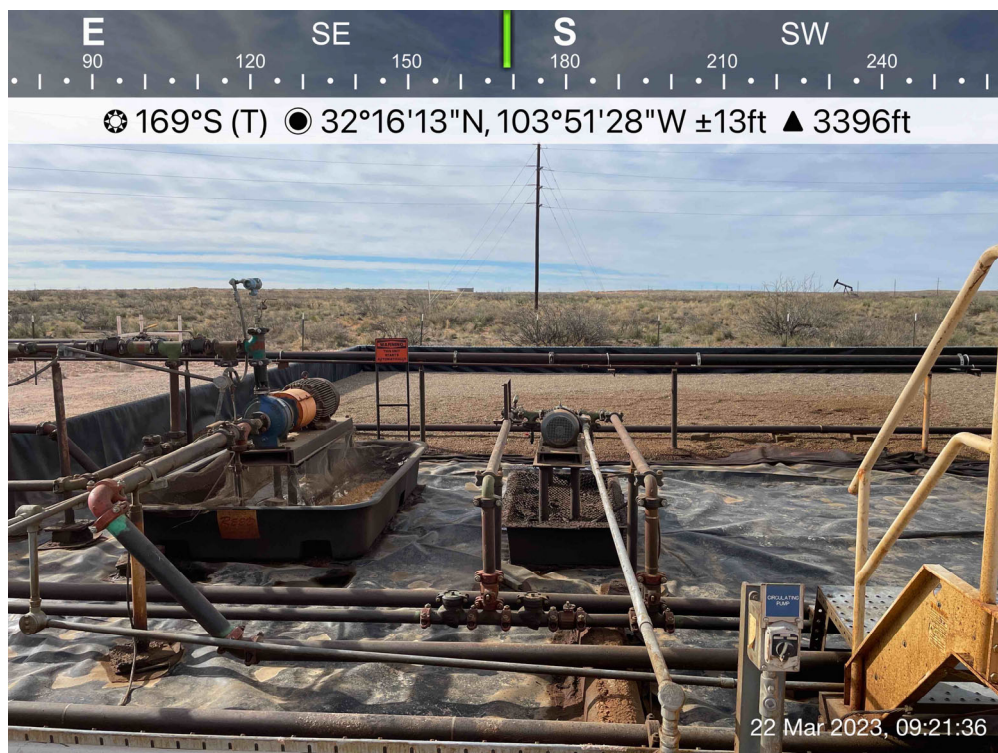
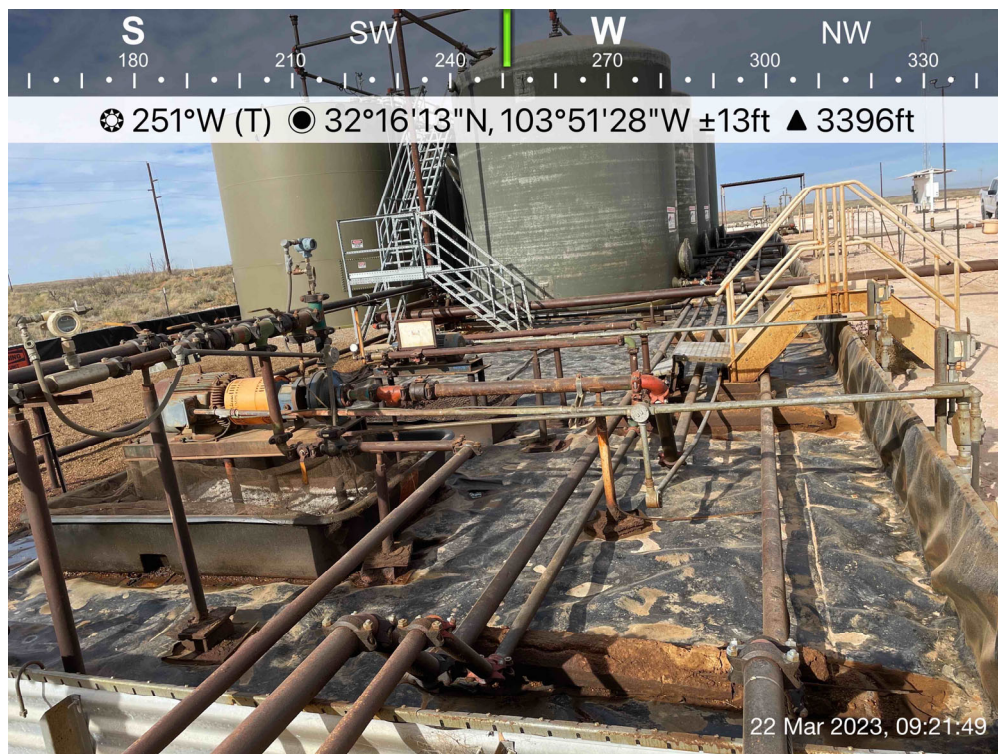
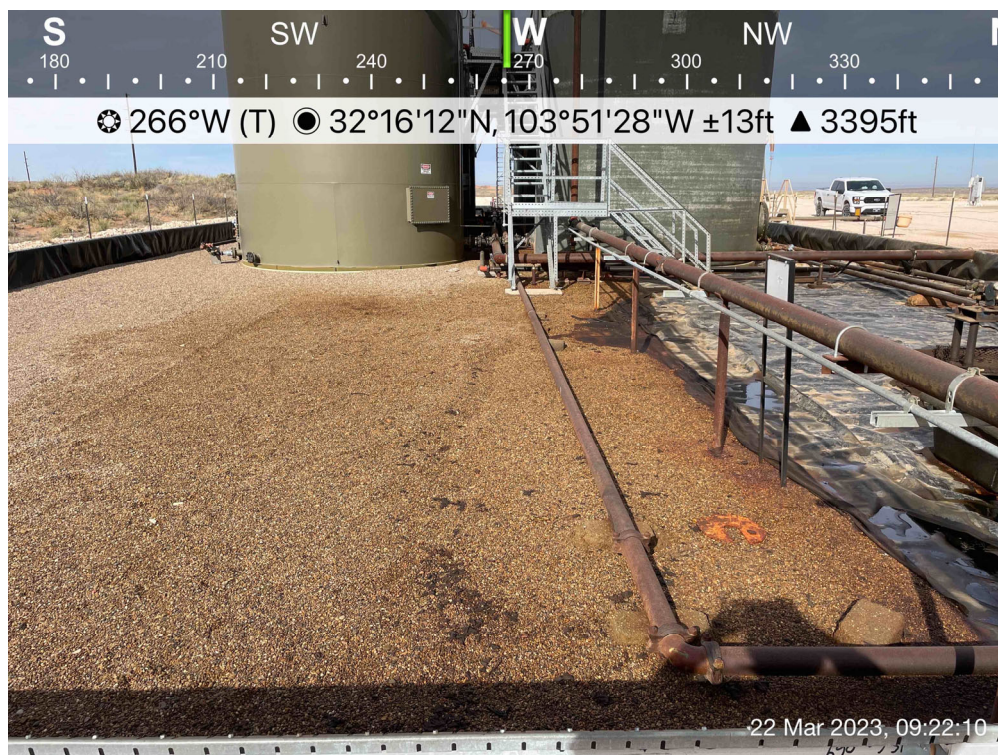
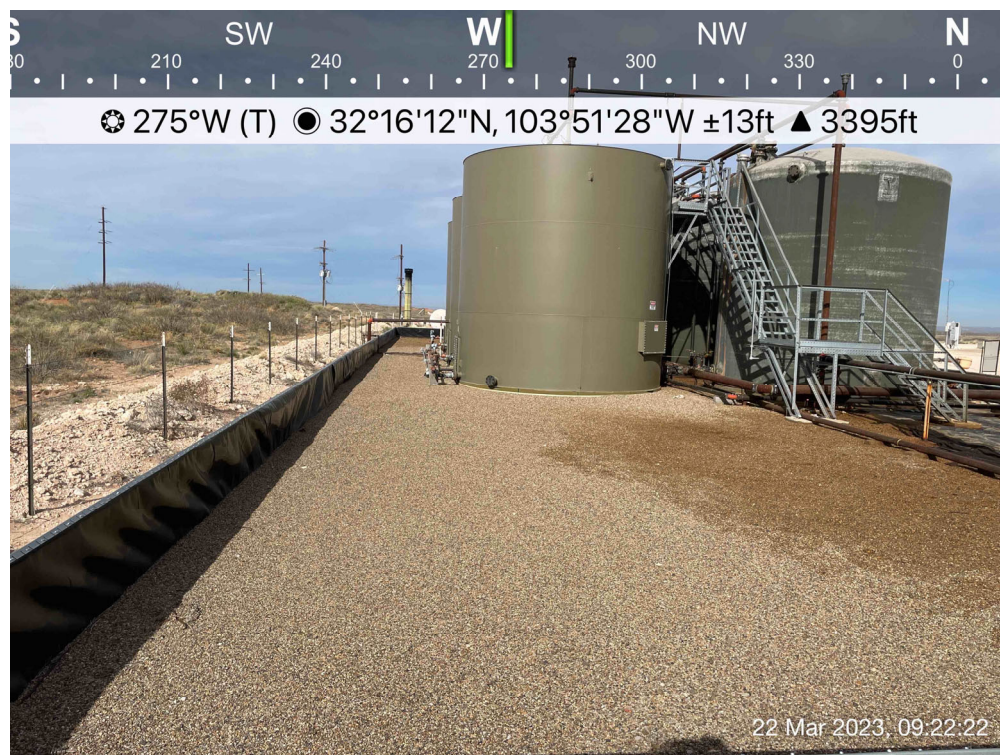
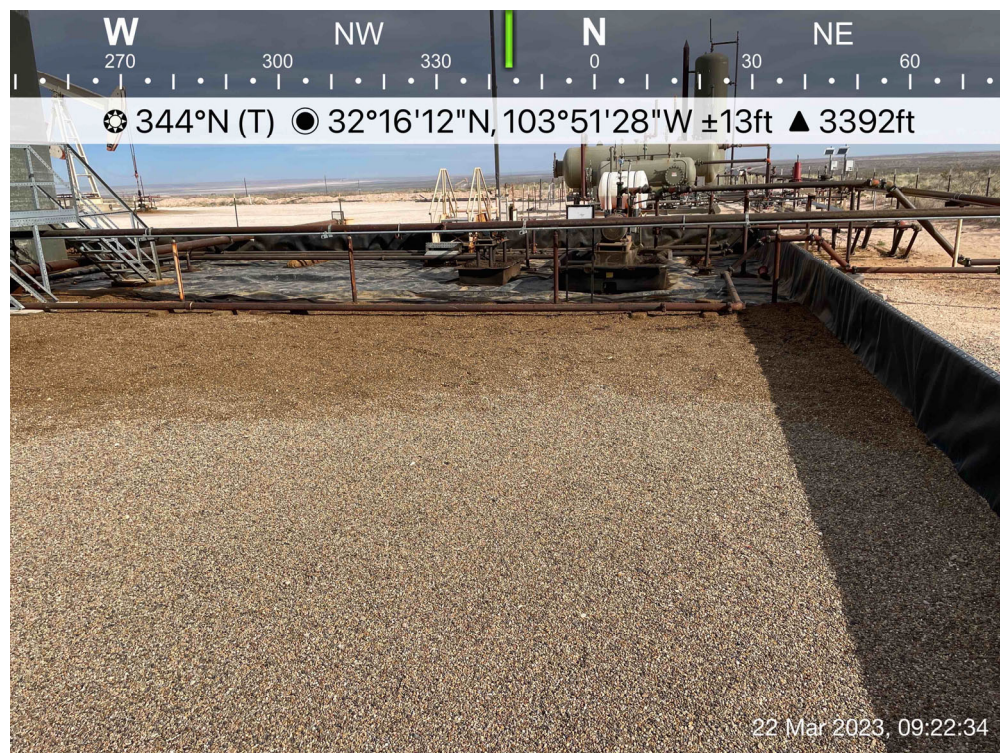
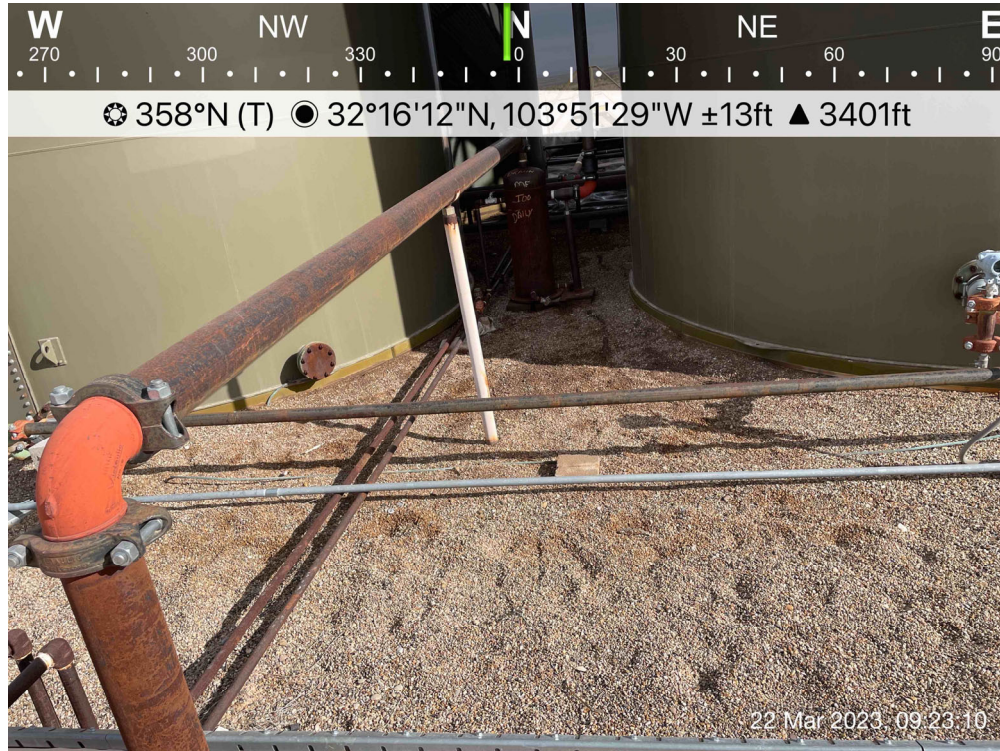
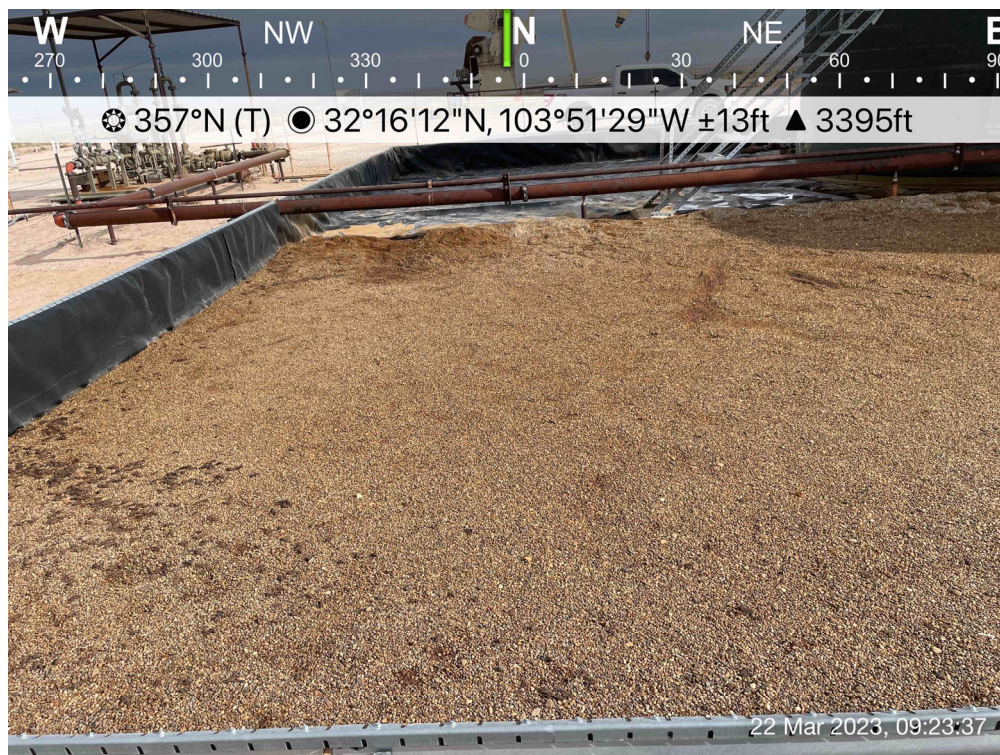
Initial Release

Lined Containment:

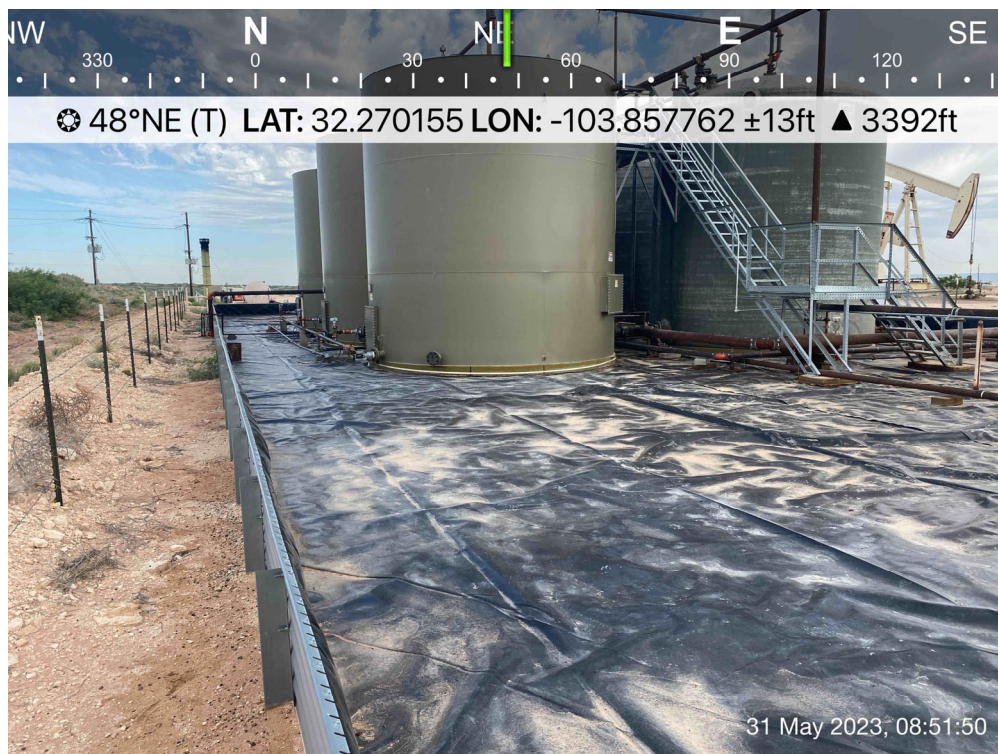
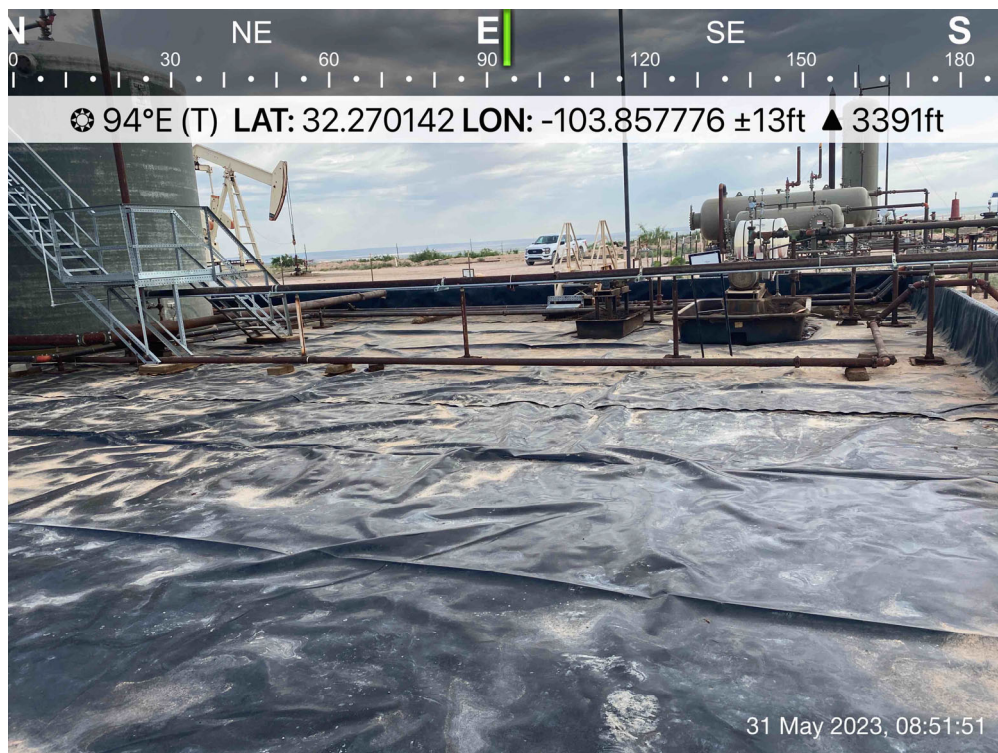
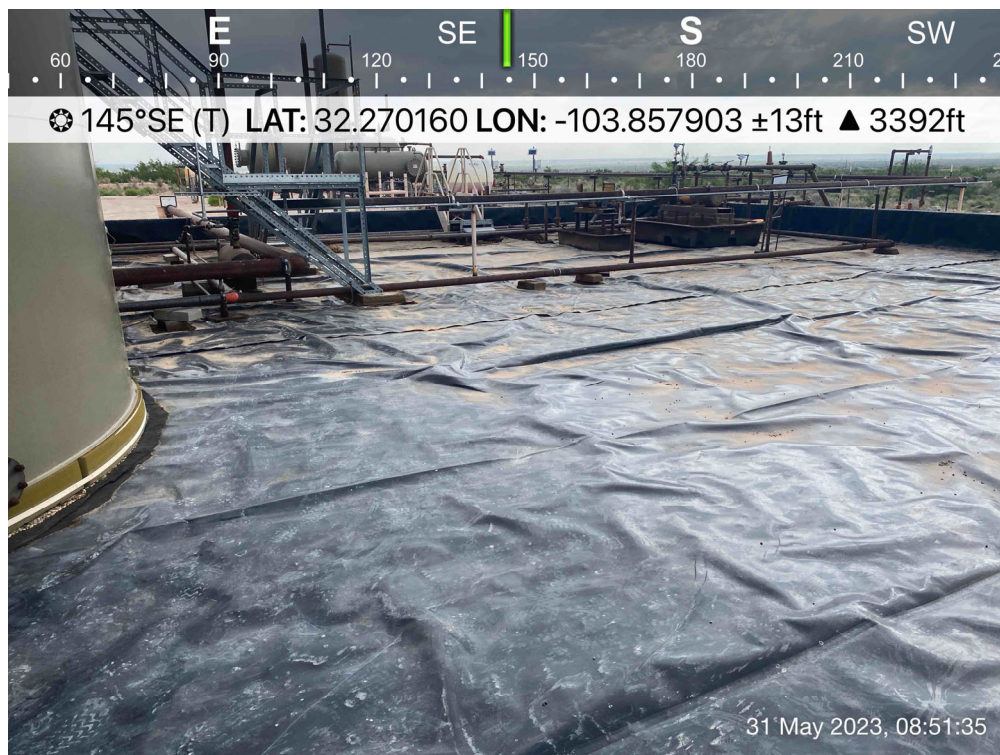
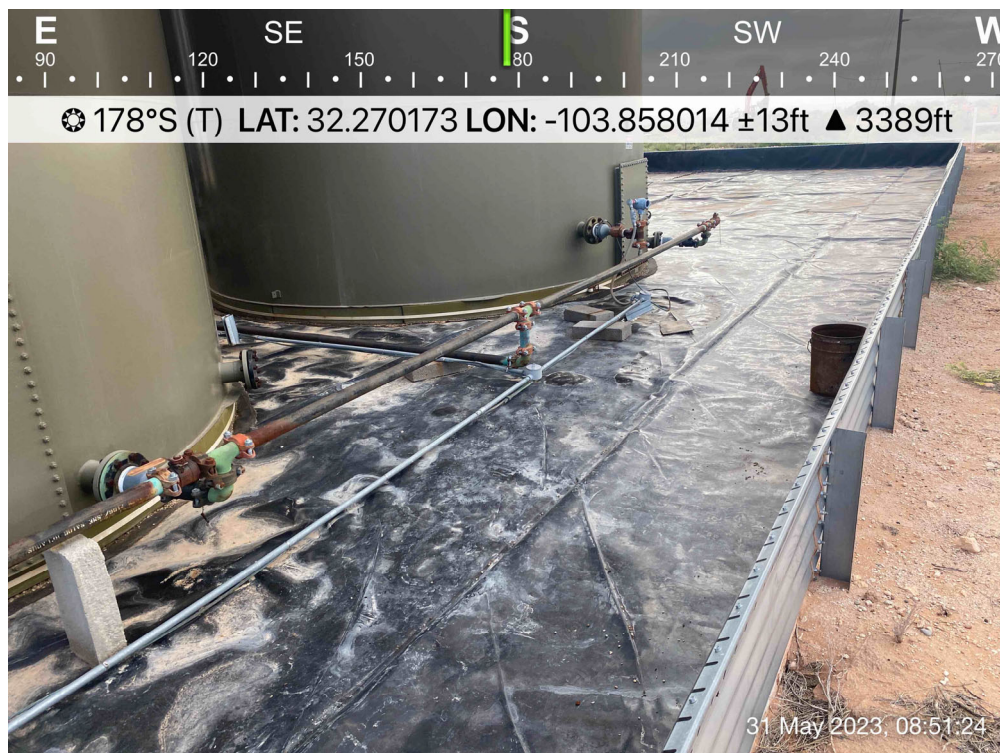
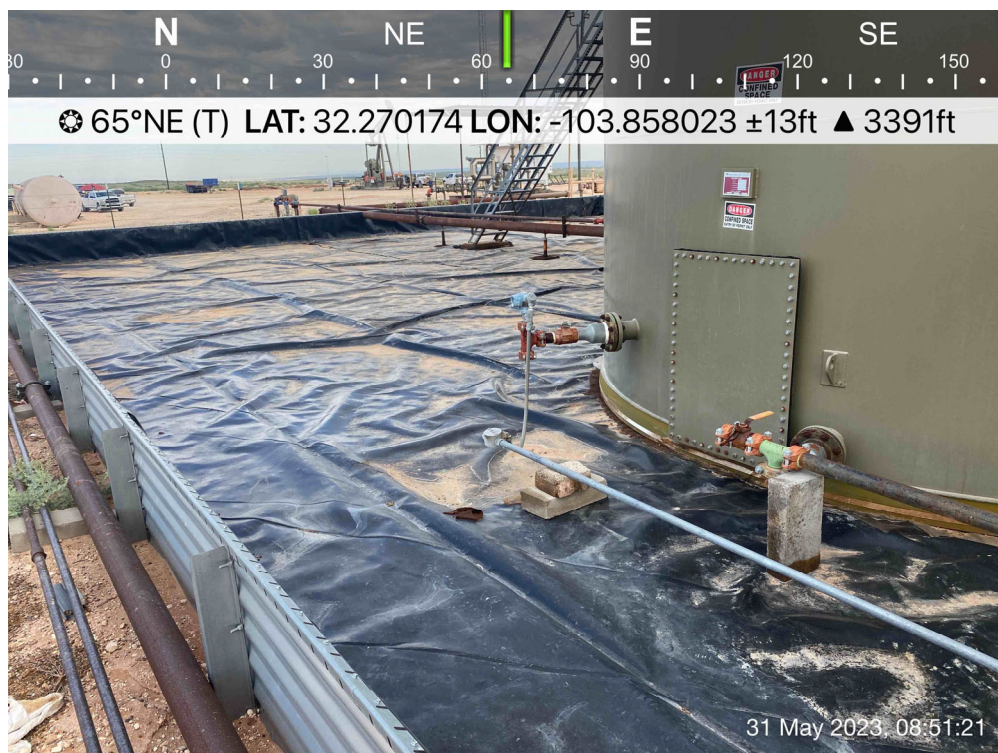
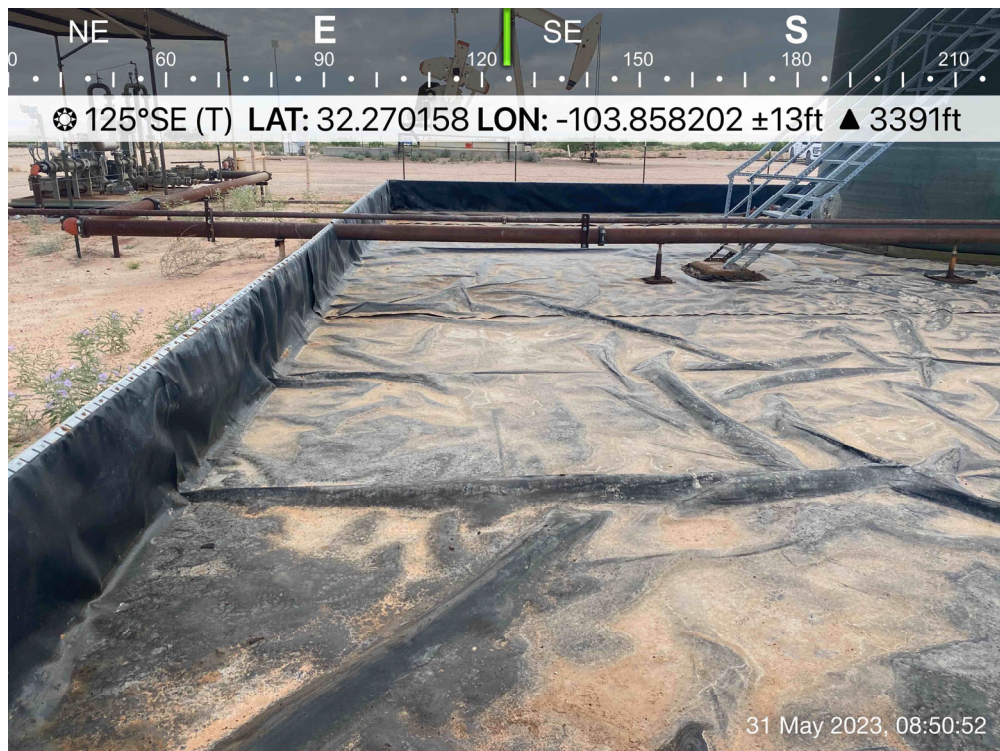
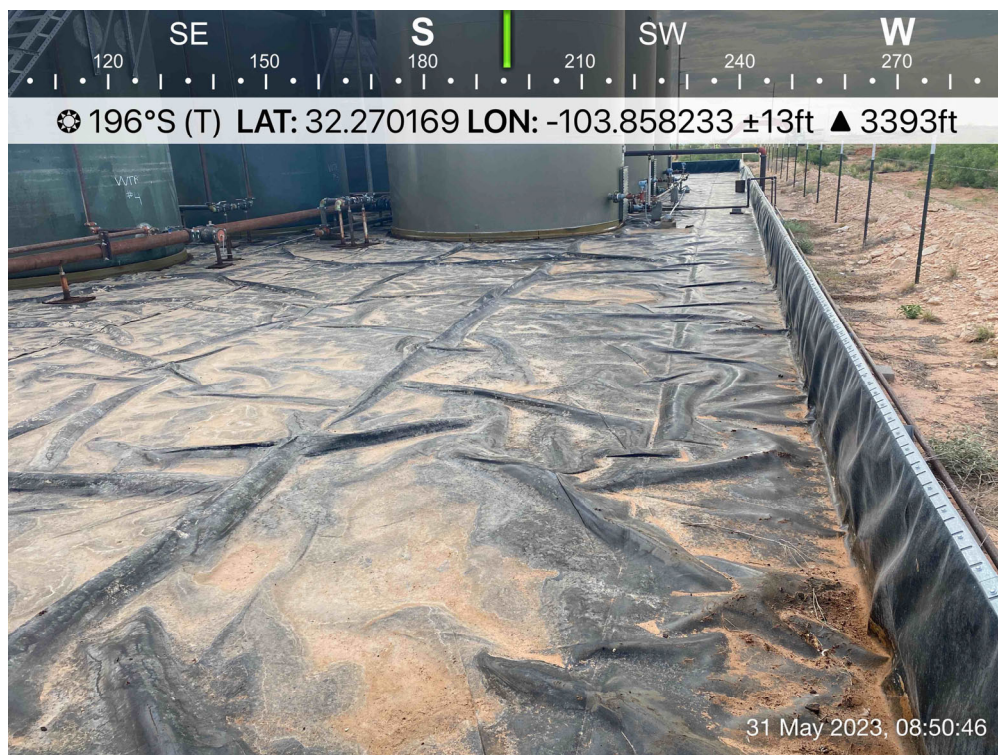
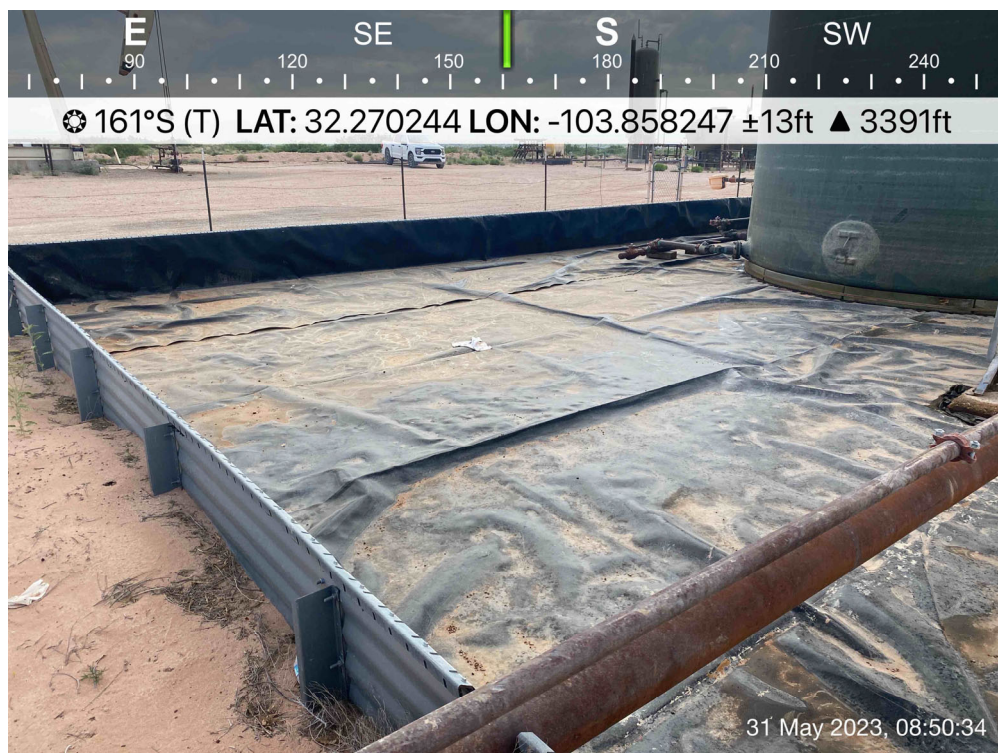
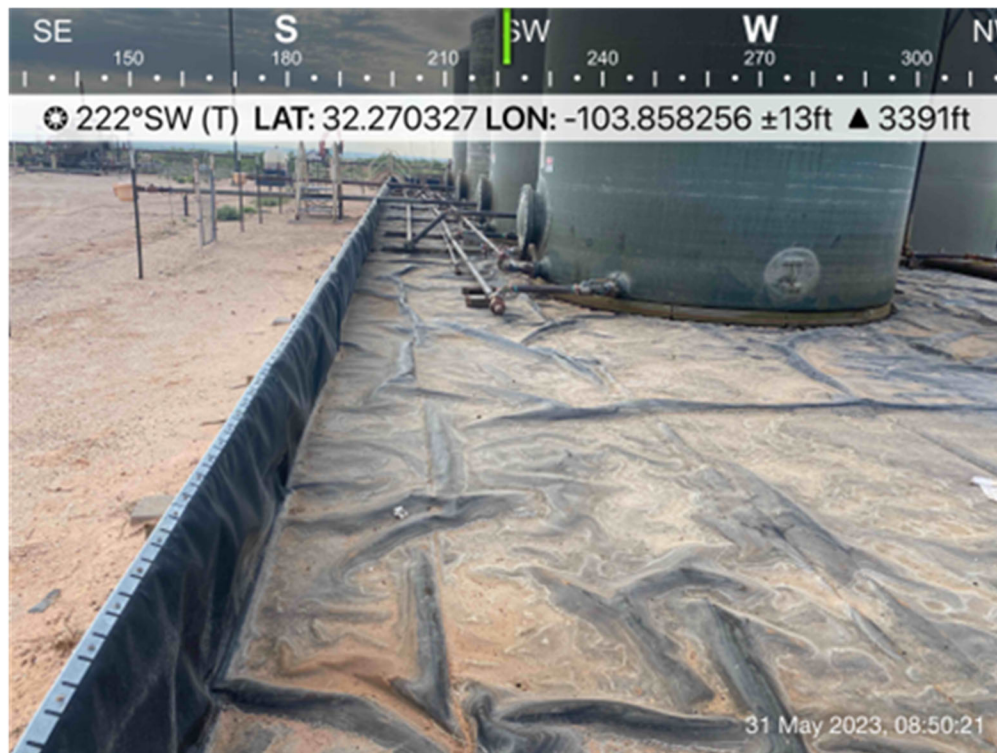
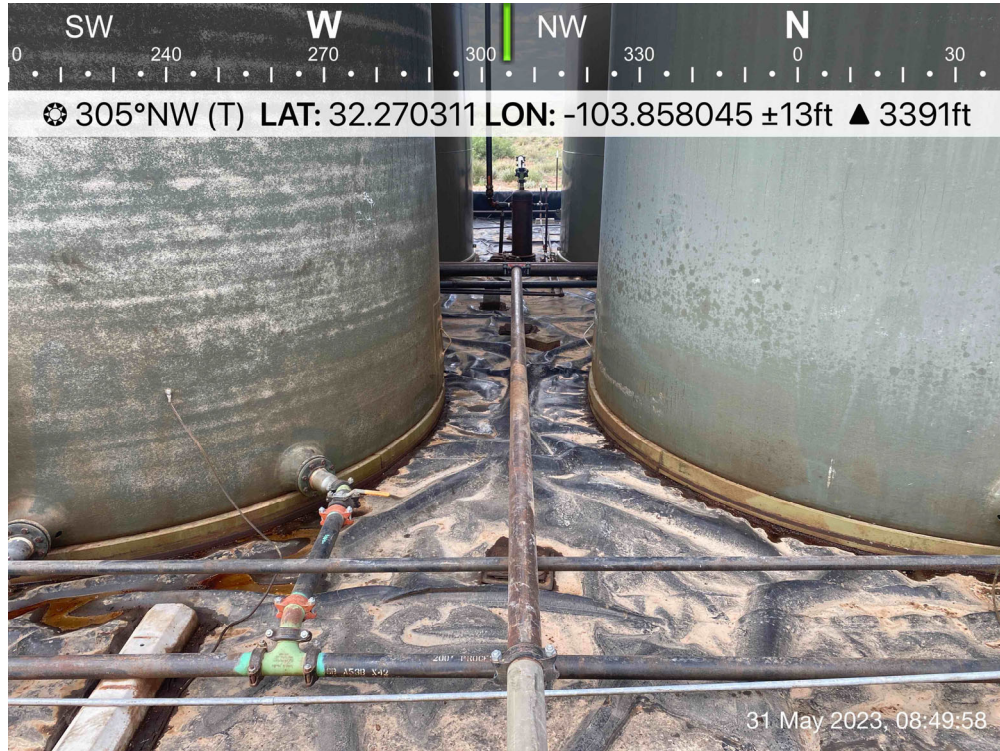
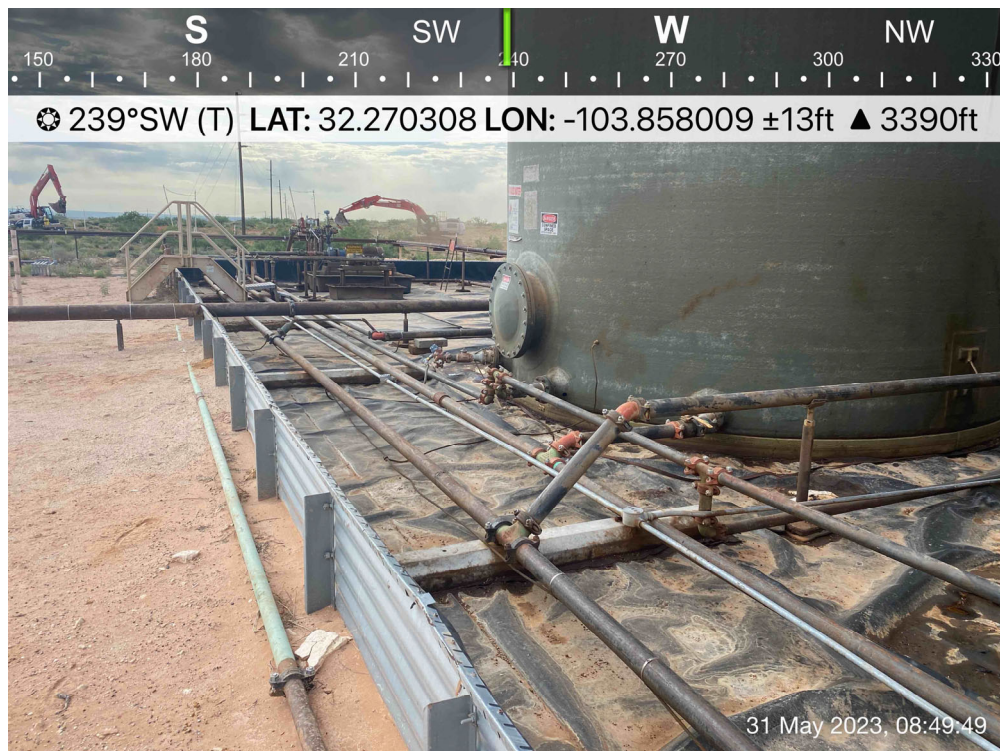
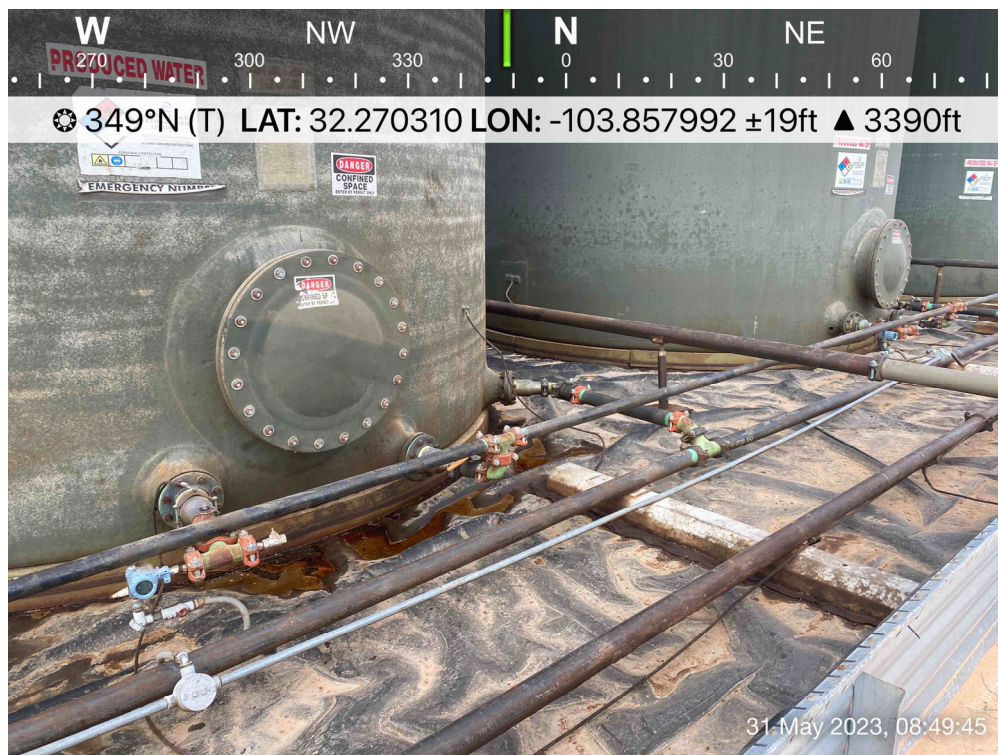
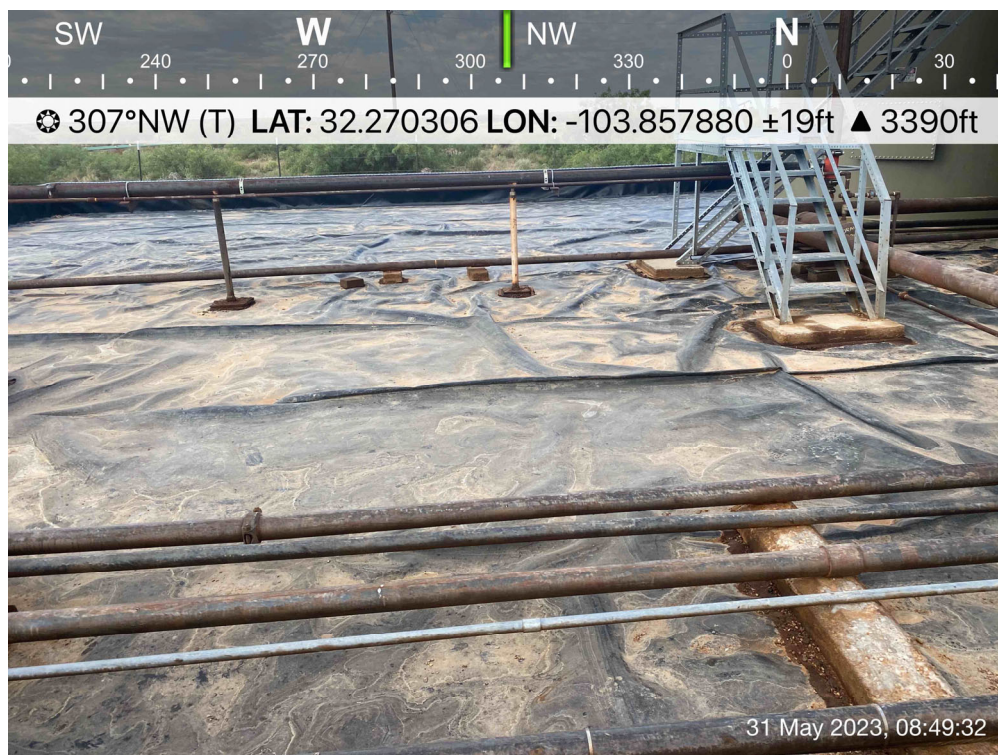
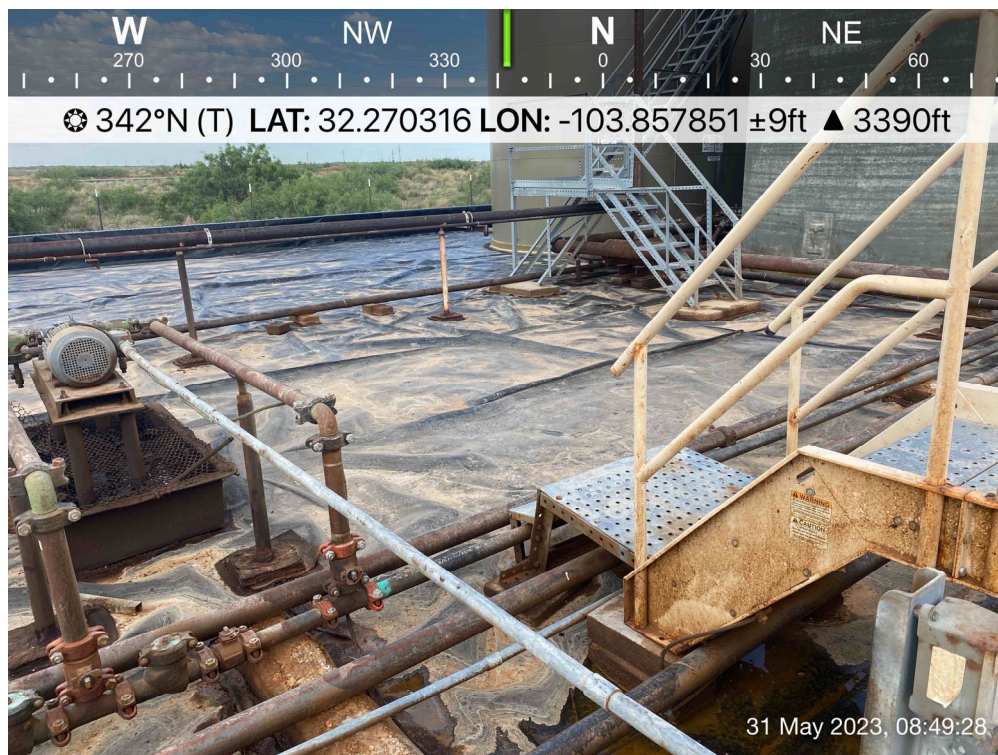
At the time of inspection, it is noted that the liner material used at the FNR 26-1 Battery containment is typical 20-mil reinforced liner, consistent with material used in oilfield containment structures. The overall condition of the liner was good, and no defects or holes were observed. No significant debris were observed in the containment area.

Remediation

Lined Containment:

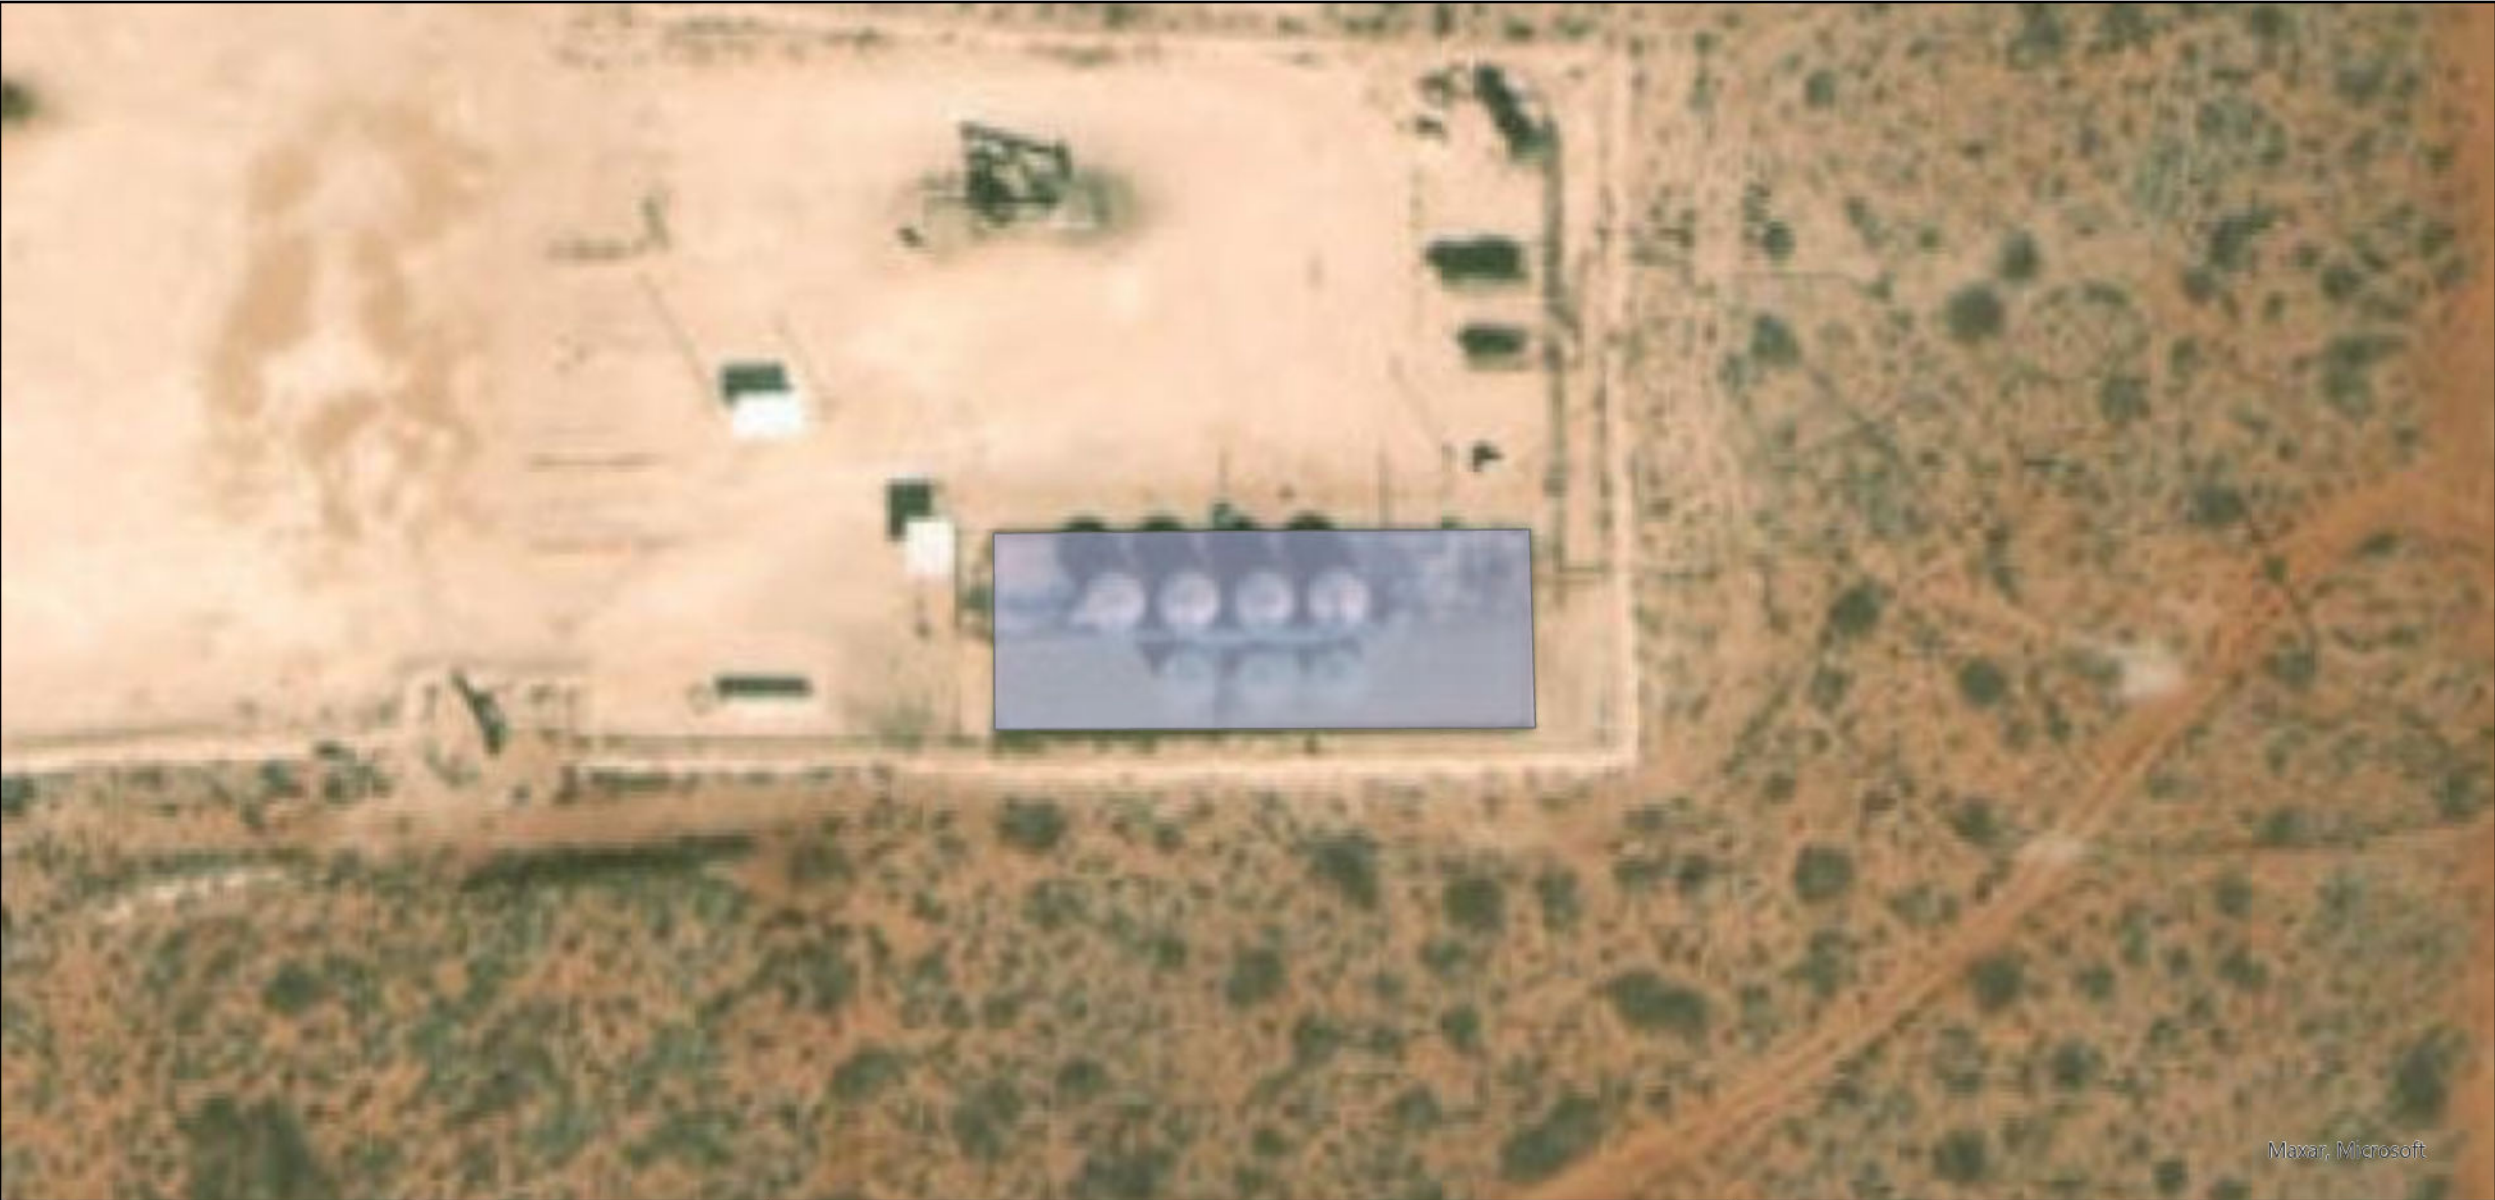
Remediation Map
OXY USA, Inc.
FNR 26-1 CTB
32.27025,-103.85793
Eddy County, New Mexico
NMOCD Reference #: NAPP2306752819

Contained Release
