**Release Notification and Corrective Action**

Name of Company	OXY USA INC	Contact	WADE DITTRICH
Address	PO BOX 4294; HOUSTON, TX 77210	Telephone No.	575-390-2828
Facility Name	LOST TANK 35 STATE #7	Facility Type	WELL
Surface Owner	STATE	Mineral Owner	STATE
		API No.	30-015-31640

**Figure 1**  
**Site Location Map**  
**OXY USA, Inc.**  
**Lost Tank 35 State #7**  
**Eddy County, New Mexico**  
**NMOCD Reference #: 2RP-4496**

**OXY USA, Inc. – Lost Tank 35 State #7**  
Unit Letter “K” (NE/SW), Section 35, Township 21S, Range 31E

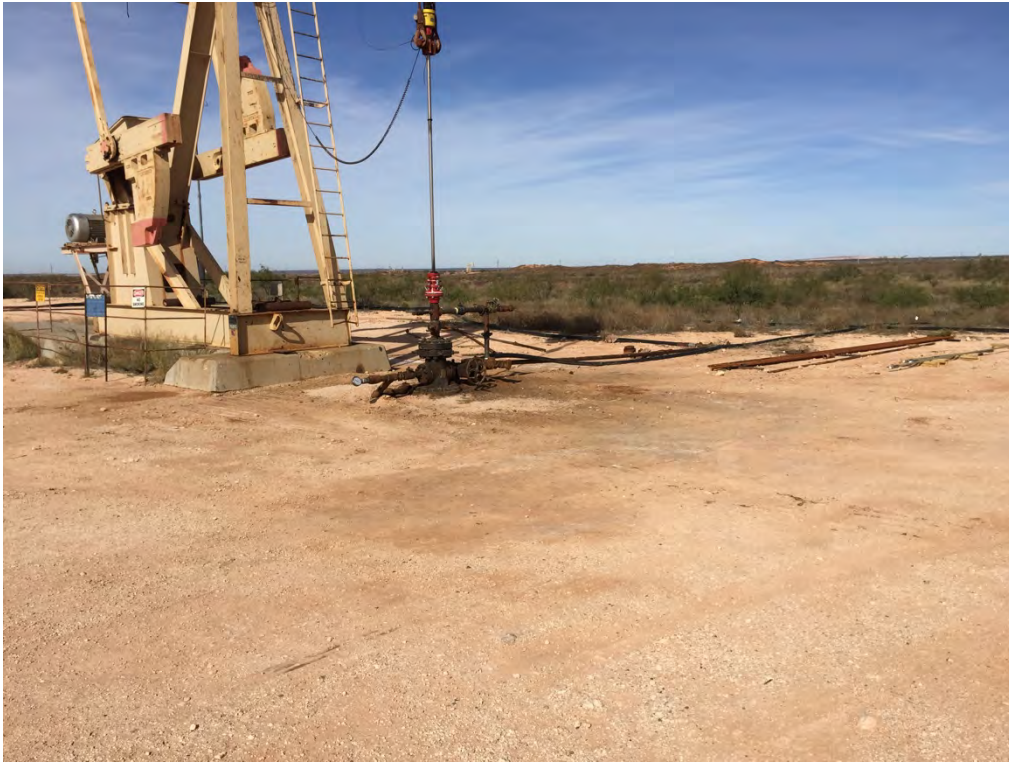
Lost Tank 35 St. 0007 – Release (Looking Northwest)

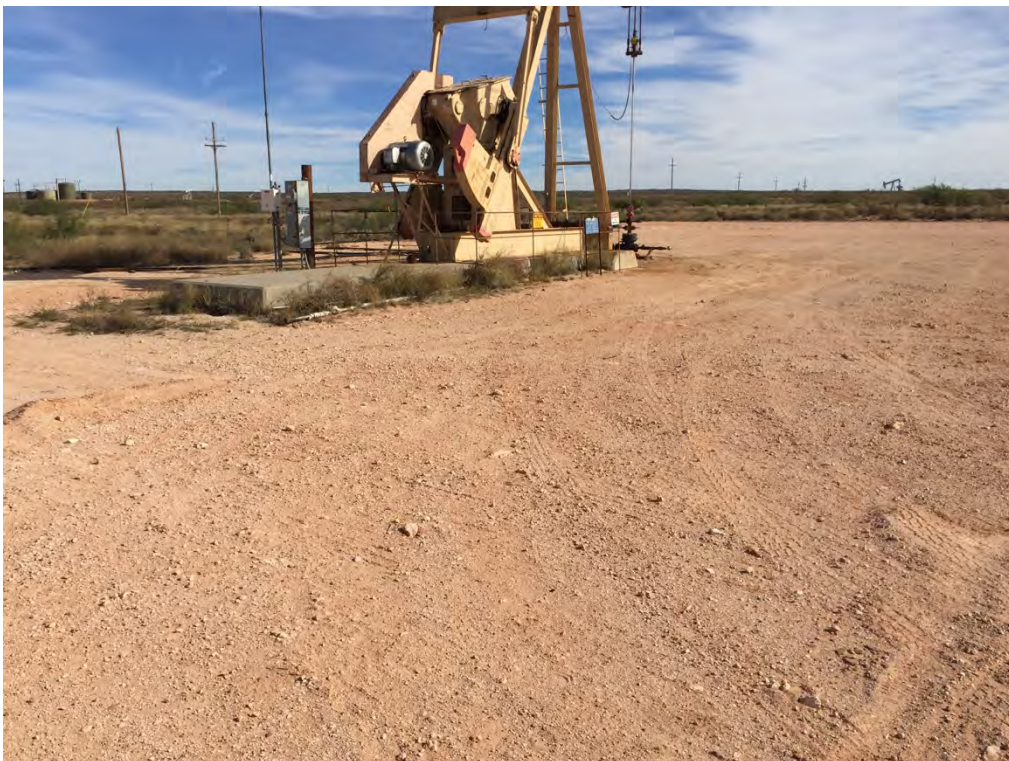
Lost Tank 35 St. 0007 – Release (Looking Northeast)

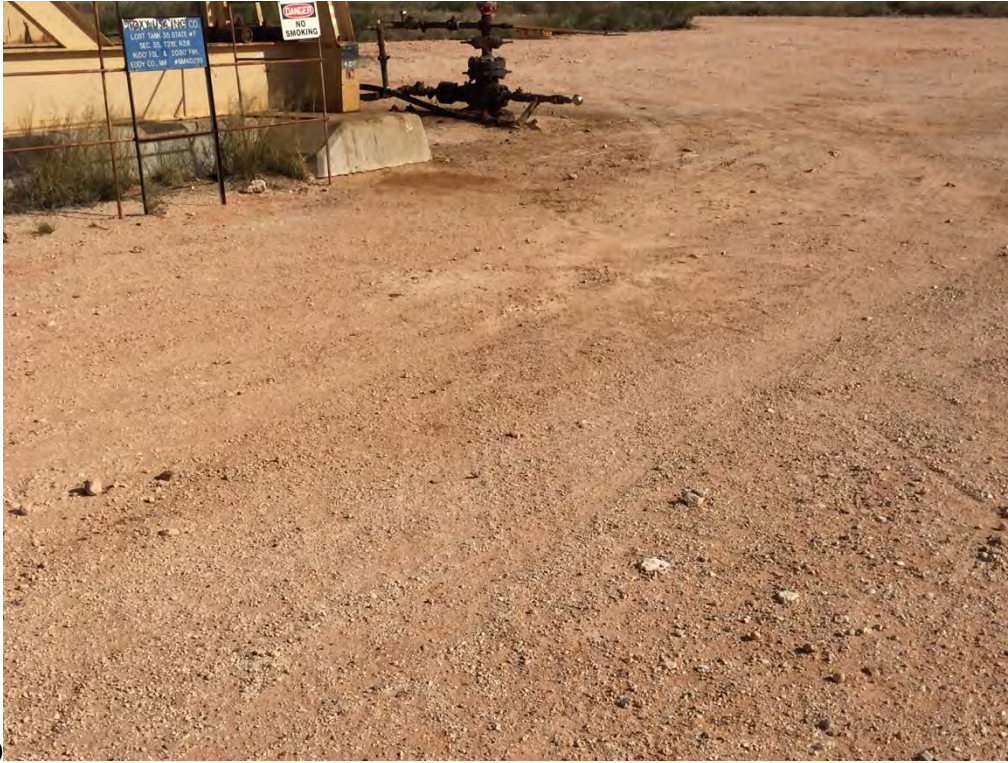
Lost Tank 35 St. 0007 – Release (Looking North-Northeast)

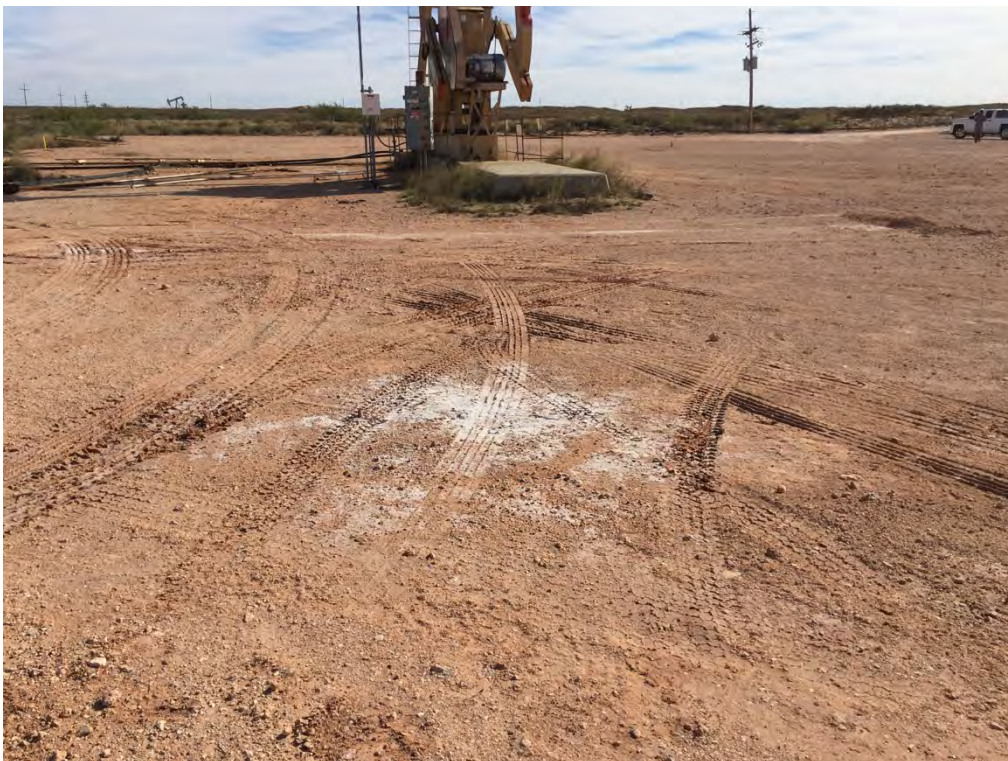
Lost Tank 35 St. 0007 – Release (Looking East-Southeast)

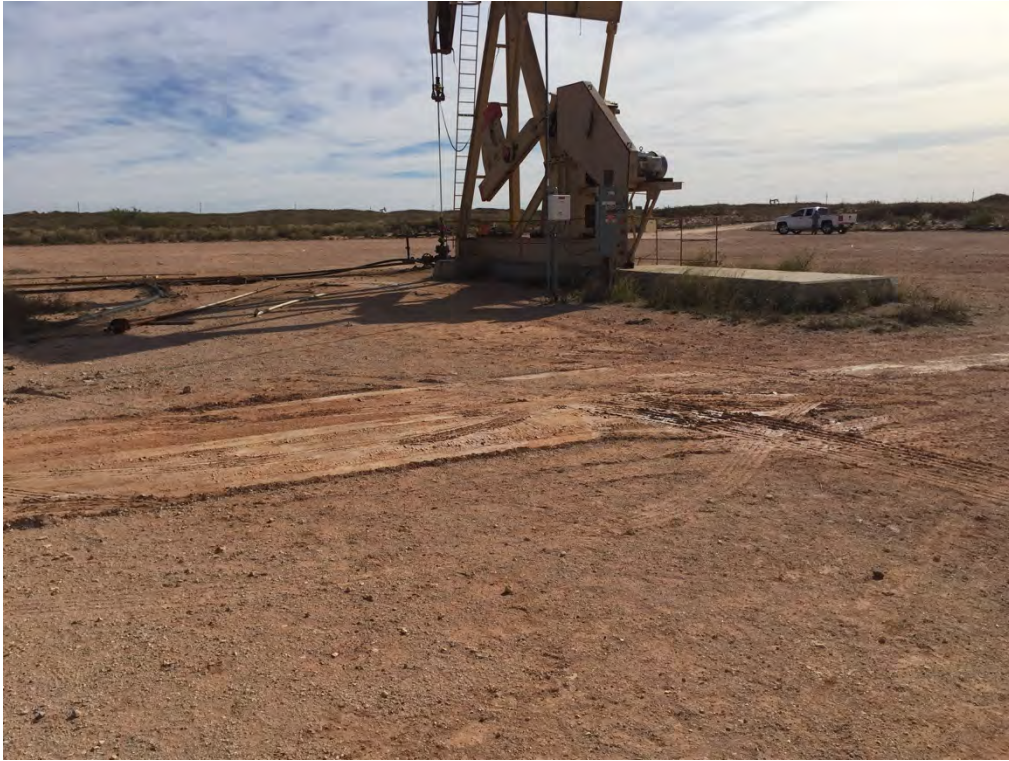
Lost Tank 35 St. 0007 – Release (Looking Southeast)

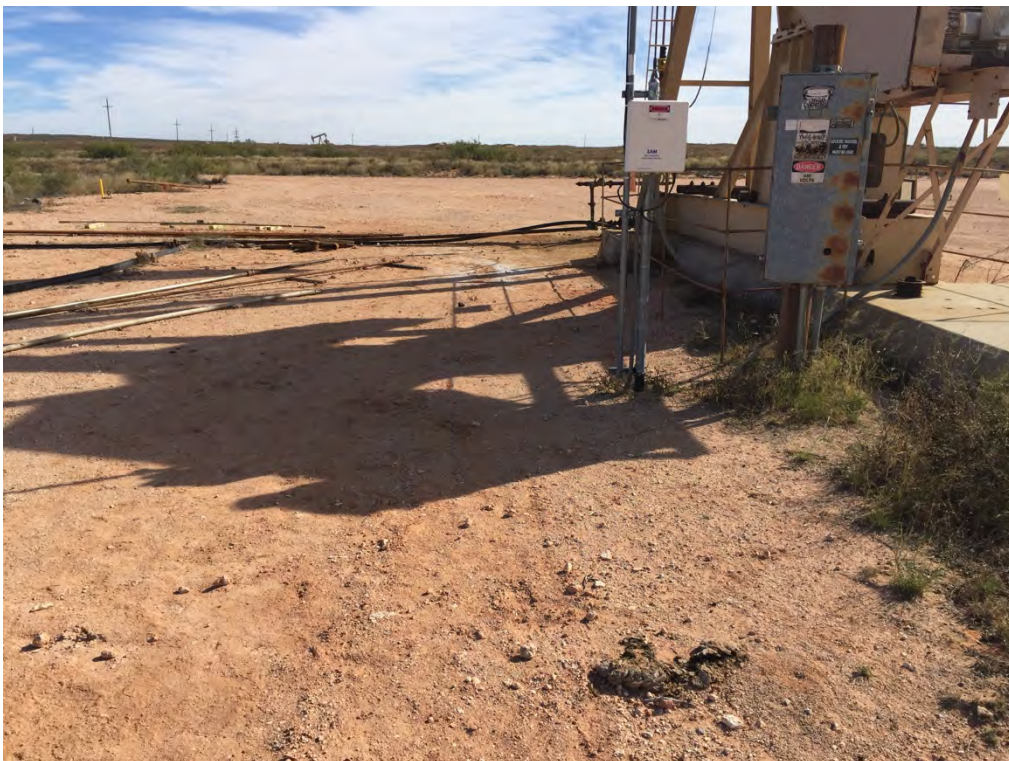
Lost Tank 35 St. 0007 – Release (Looking East)

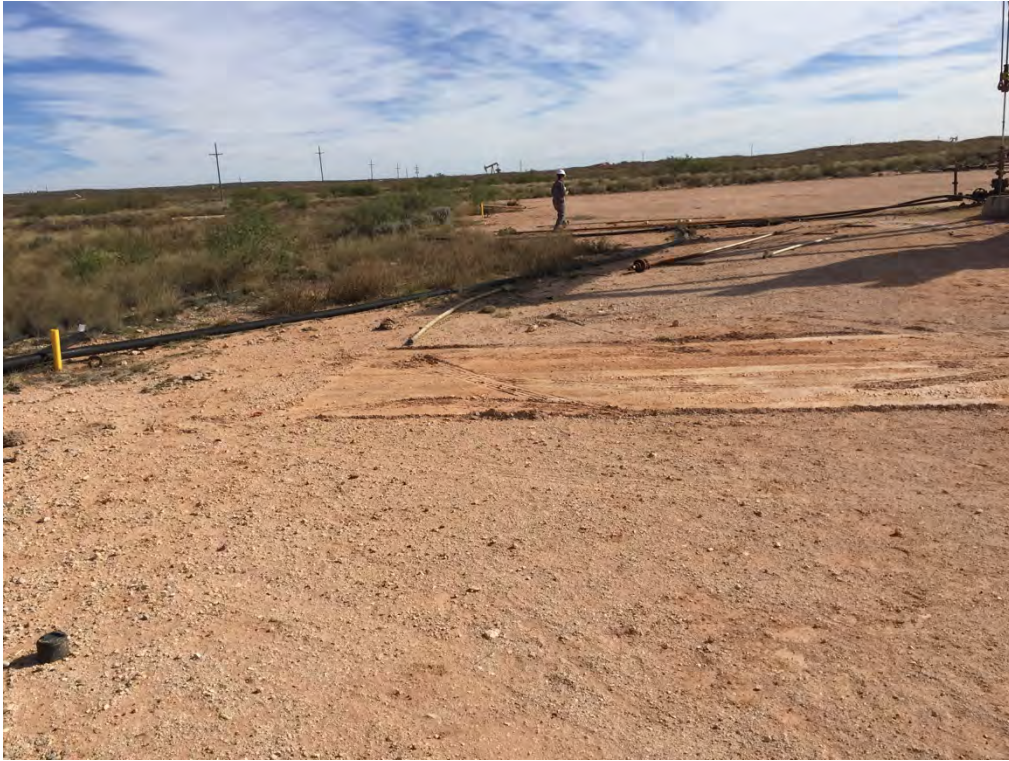
Lost Tank 35 St. 0007 – Release (Looking East-Northeast)

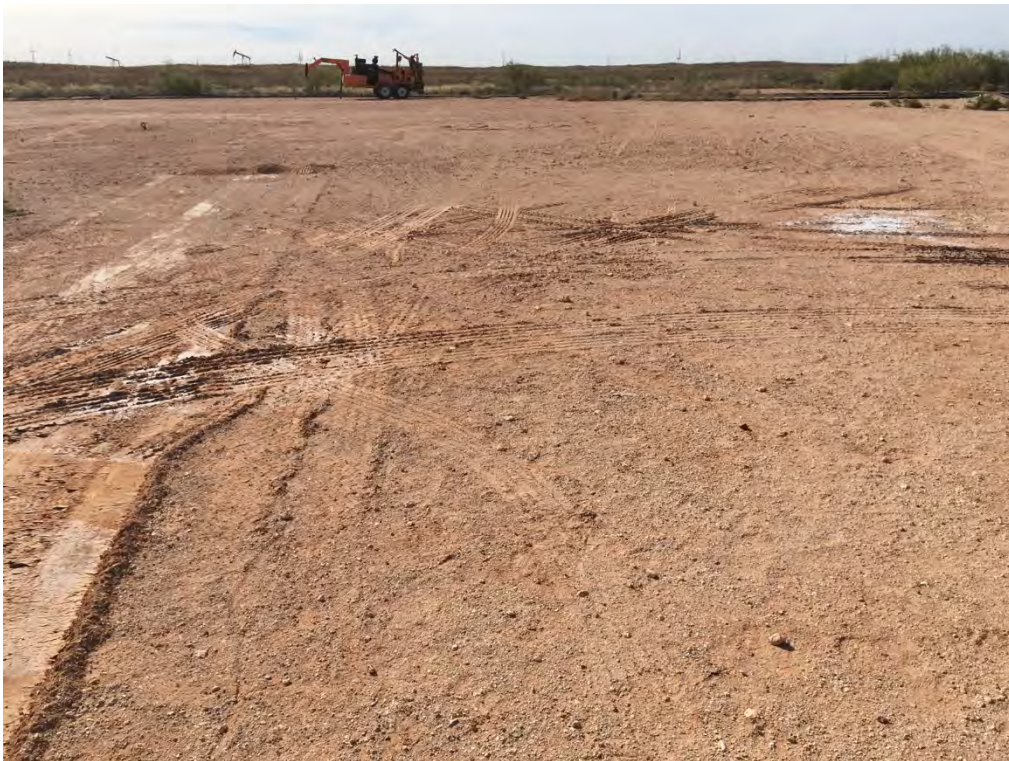
Lost Tank 35 St. 0007 – Release (Looking West)

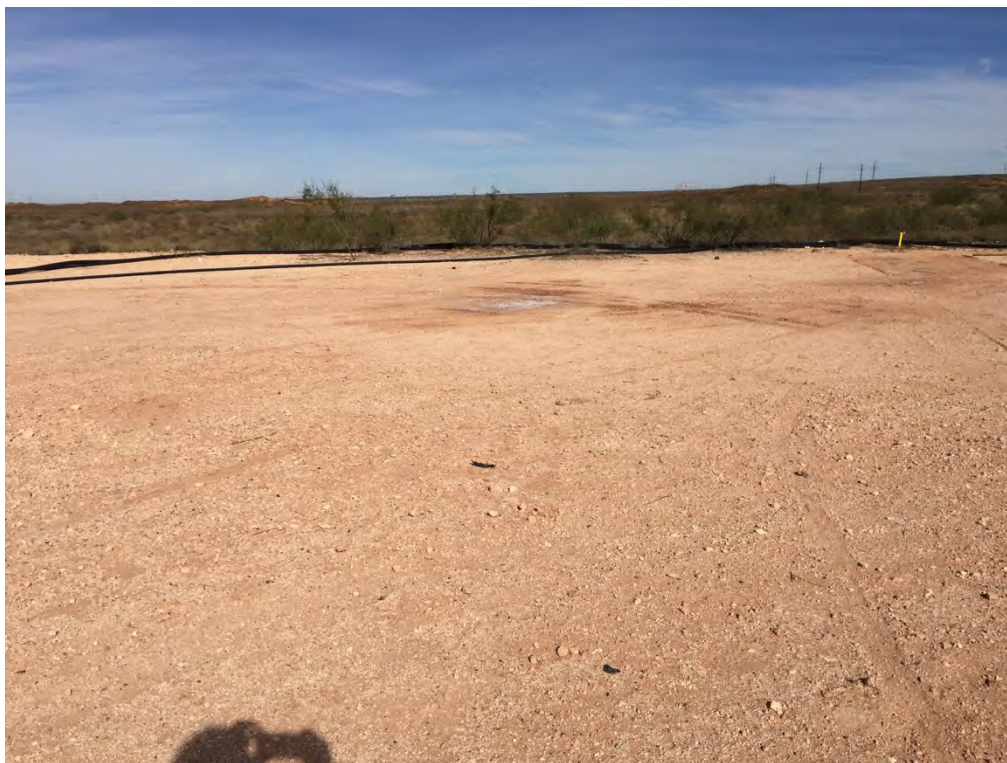
Lost Tank 35 St. 0007 – Release (Looking Northwest)

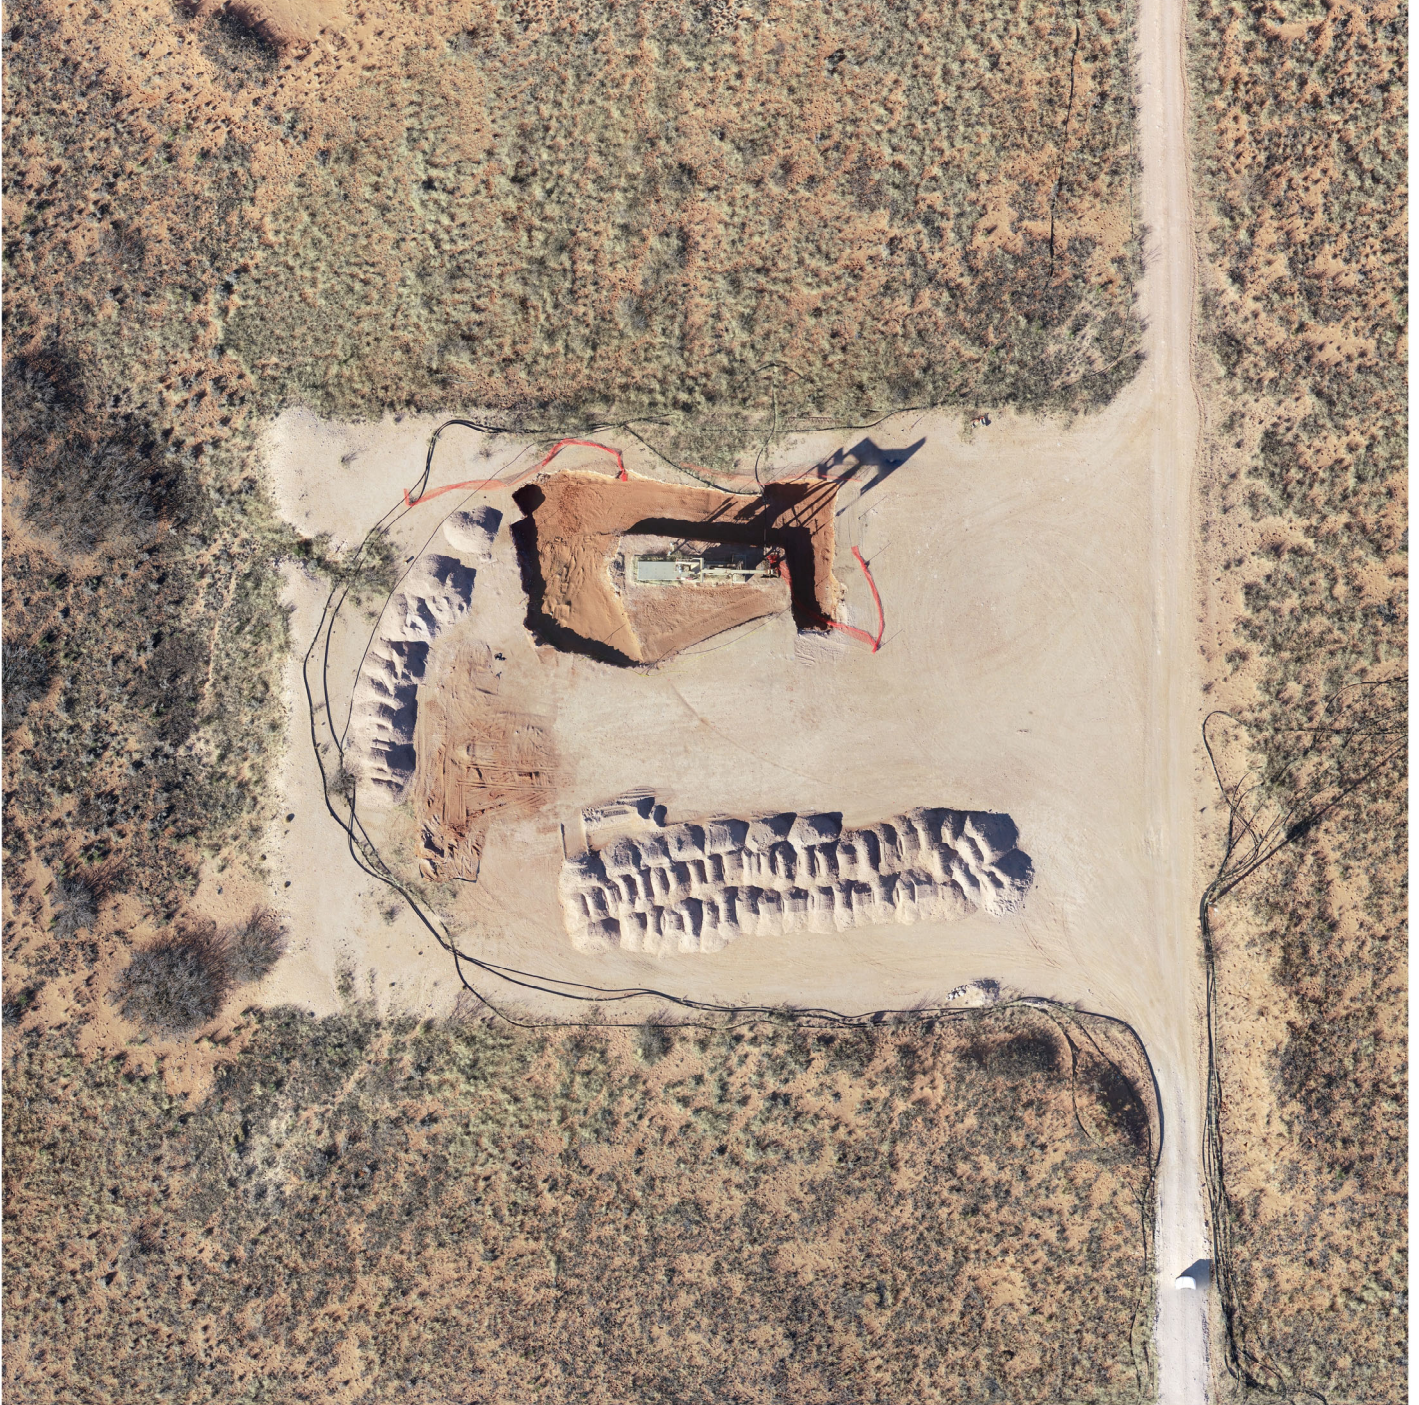
## Previous Excavation
