Release Notification and Corrective Action

Name of Company <u>OXY USA INC. #16696</u>	Contact <u>WADE DITTRICH</u>
Address <u>PO BOX 4294; HOUSTON, TX 77210</u>	Telephone No. <u>575-390-2828</u>
Facility Name <u>PATTON MDPI 18 FEDERAL #5H</u>	Facility Type <u>WELL</u>

On 12/7/2017, OXY USA, Inc. reported a release at the Patton MDP1 18 Federal #005H. The release was caused when a frac tank overflowed. Approximately 6,003 sqft. of the Pad was found to be damp upon initial inspection.

Site Location Map
OXY USA, Inc.
Patton MDP1 18 Federal #005H
32.2241806, -103.8093124
Eddy County, New Mexico
NMOCD Reference # NAB1734834805

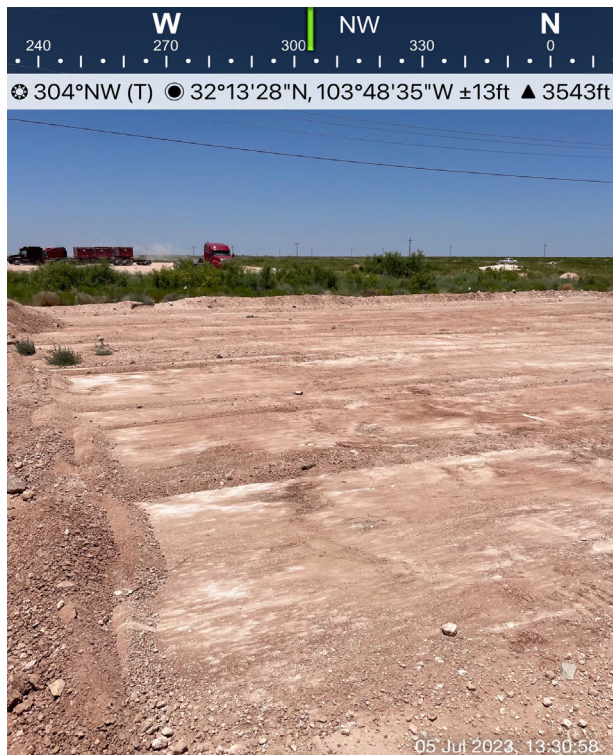
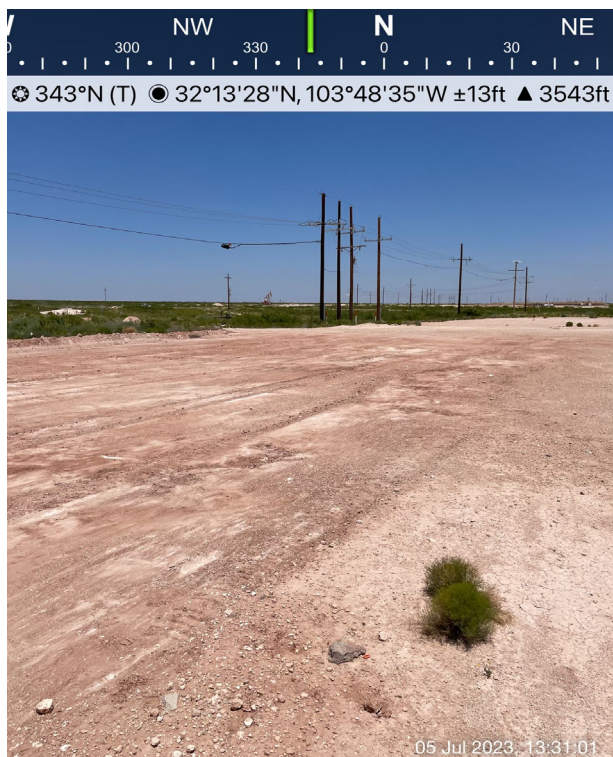
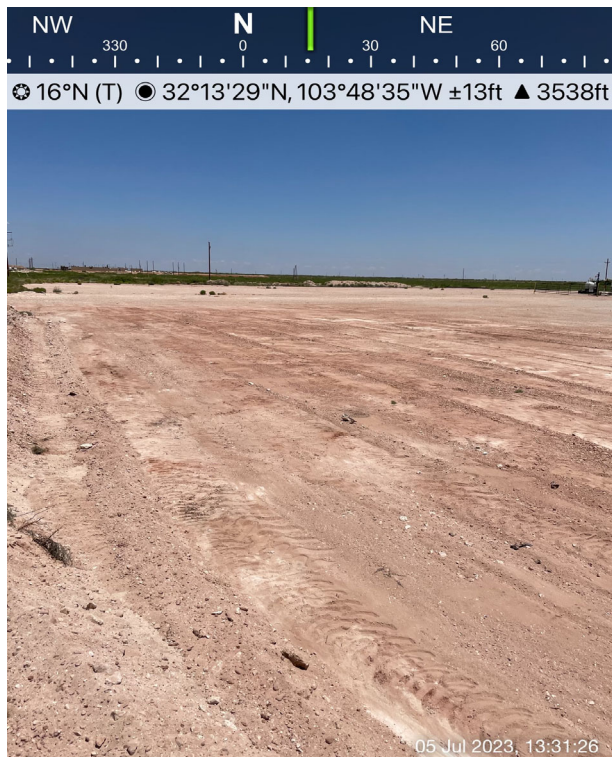
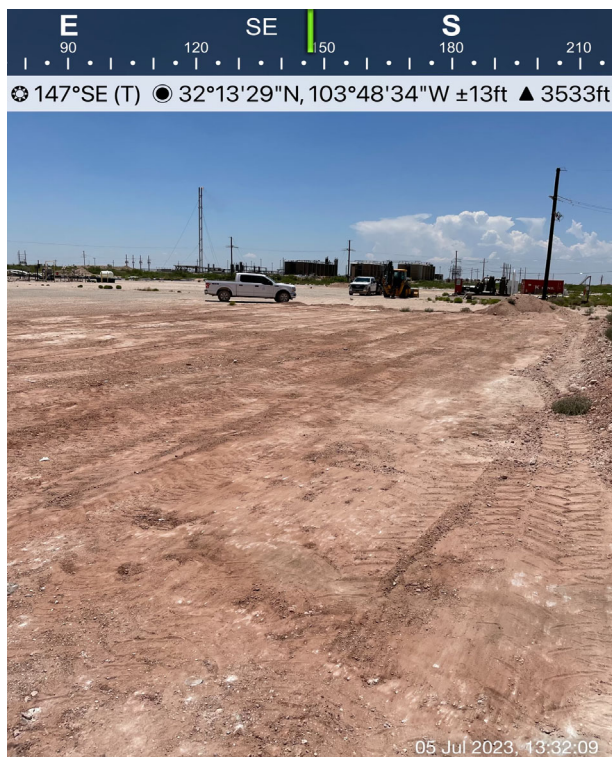
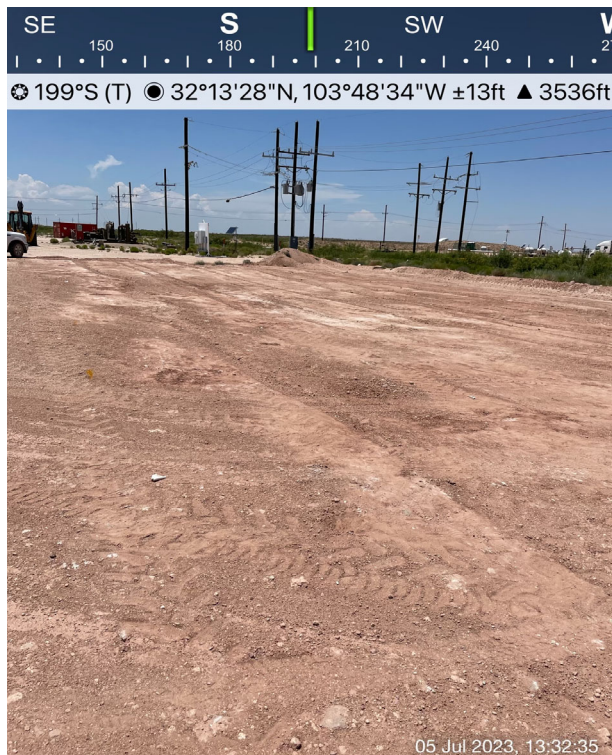
Excavation

Areas affected by the release and the associated remediation activities were restored to a condition that existed before the release to the extent practicable. The affected area was contoured and/or compacted to provide erosion control, stability, and preservation of surface water flow. Affected areas not on production pads and/or lease roads will be reseeded with a prescribed BLM, NMSLO, and/or Private Landowner requested seed mixture during the first favorable growing season following the closure of the site by the applicable regulatory agency.
