**Re: Closure Request
Rojo 18 ELL and Rojo 18/19 & 38/39 Tank Battery
Incident Numbers nAPP2222753156 and nAPP2123047003
Lea County, New Mexico**

BTA Oil Producers, LLC
Closure Request
Rojo 18 ELL and Rojo 18/19 & 38/39 Tank Battery

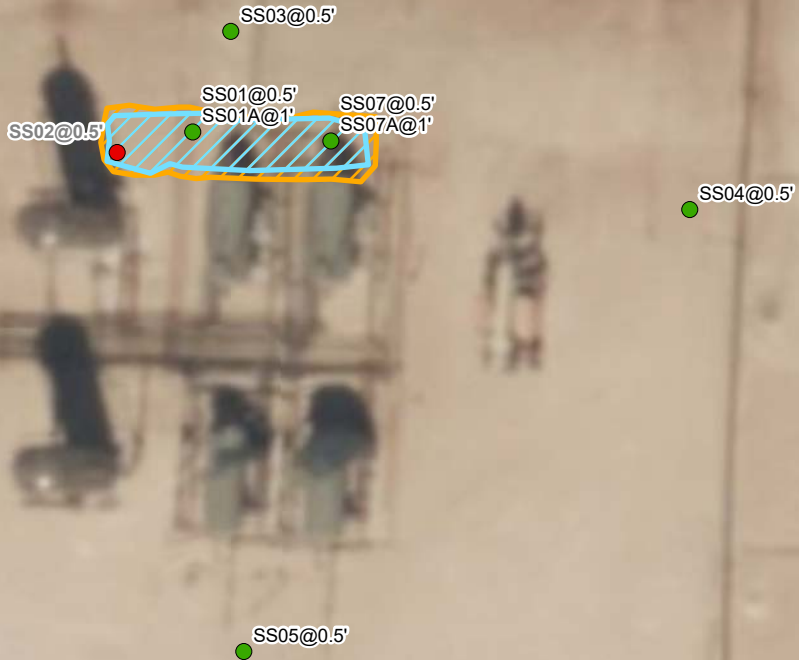
Assessment Soil Sample Locations

strips. The soil sample locations were mapped utilizing a handheld Global Positioning System (GPS) unit and are depicted on Figure 2. Photographic documentation was completed during the Site visit and a photographic log is included in Appendix B.

Laboratory analytical results for delineation soil sample SS02, collected within the release extents, indicated TPH concentrations exceeded the Closure Criteria. Laboratory analytical results for delineation soil samples SS01/SS01A, SS03 through SS06, and SS07/SS07A, indicated all COC concentrations were compliant with the Closure Criteria and successfully defined the lateral and vertical extent of the release to the strictest Table I Closure Criteria. Based on visible staining in the release areas in the vicinity of soil sample SS02 and analytical results, excavation activities appeared to be warranted.

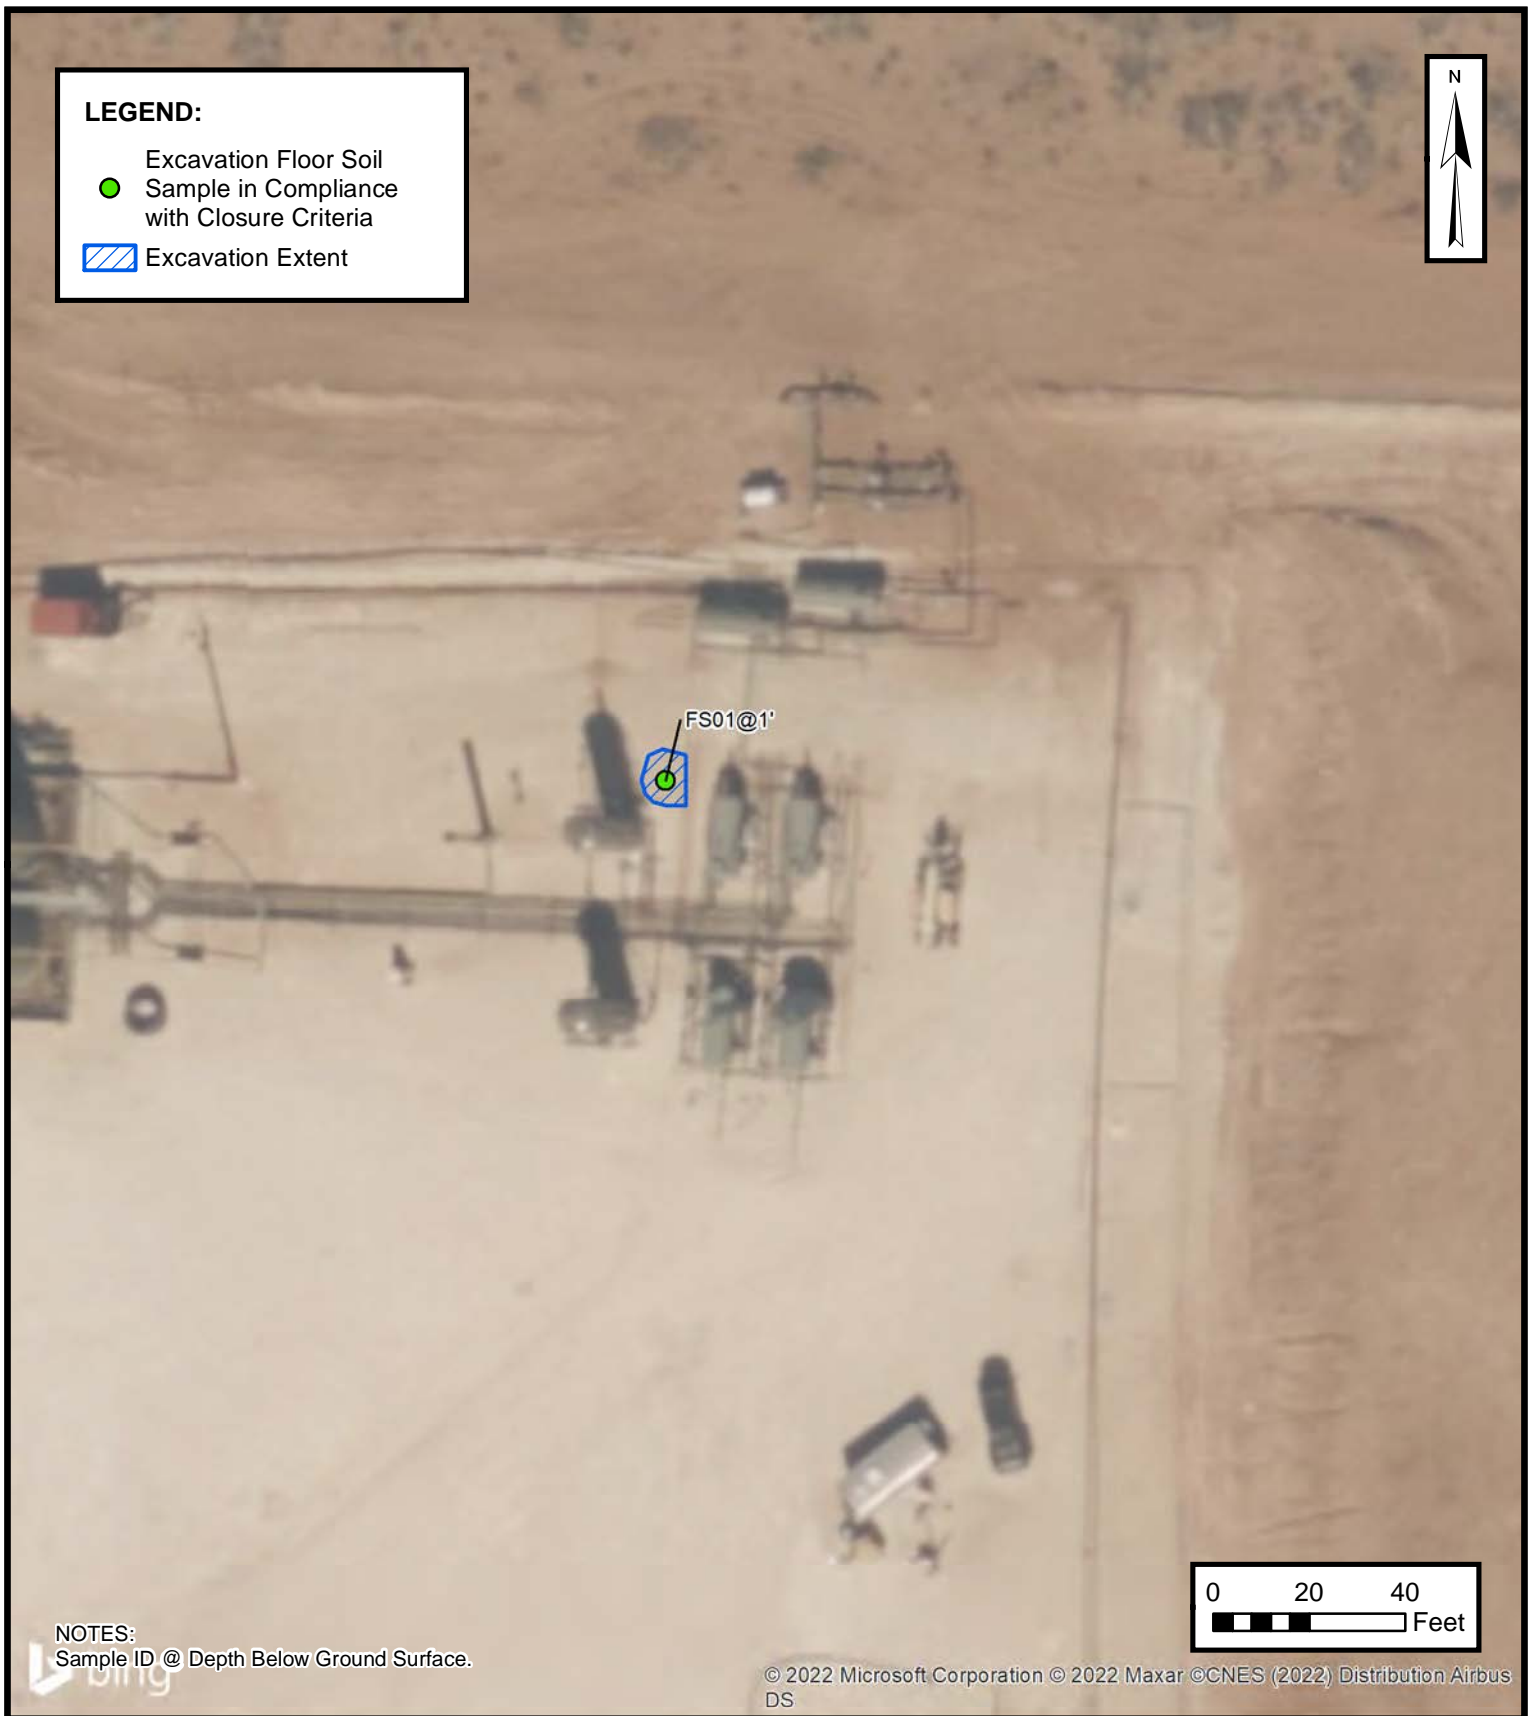
EXCAVATION SOIL SAMPLE LOCATIONS

Following the excavation activities, a 5-point composite sample was collected from the floor of the excavation. The 5-point composite sample was collected by placing five equivalent aliquots of soil into a 1-gallon, resealable plastic bag and homogenizing the samples by thoroughly mixing. Composite soil sample FS01 was collected from the floor of the excavation at a depth of 1-foot bgs. Due to the shallow depth of the excavation, soil from the sidewalls was incorporated into the floor sample. The soil sample was collected, handled, and analyzed following the same procedures as described above. The excavation extent and excavation soil sample locations were mapped utilizing a handheld GPS unit and are depicted on Figure 3. A photographic log of the excavation is included as Appendix B.

Laboratory analytical results for excavation soil sample FS01, collected from the final excavation extent, indicated concentrations of all COCs were compliant with the Site Closure Criteria. The laboratory analytical results are summarized on Table 1 and the complete laboratory analytical reports are included as Appendix C.

The excavation measured approximately 90 square feet in areal extent. A total of approximately 4 cubic yards of impacted soil was removed during the excavation activities. The impacted soil was transported and properly disposed of at the R360 Disposal Facility located in Hobbs, New Mexico. After completion of confirmation sampling, the excavation was secured with fencing.

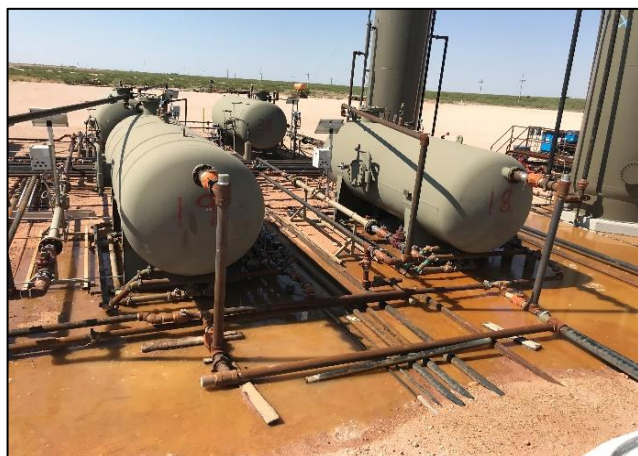
Photograph: 1	Date: 8/14/2022
Description: Soil staining in release footprint	
View: Northwest

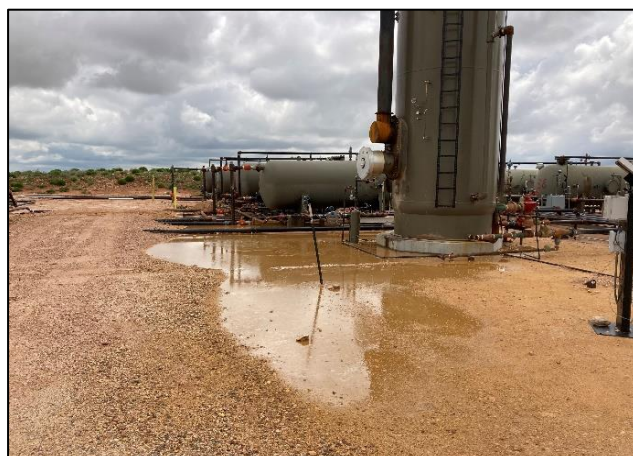
Photograph: 2	Date: 8/17/2022
Description: Soil staining in release footprint	
View: East

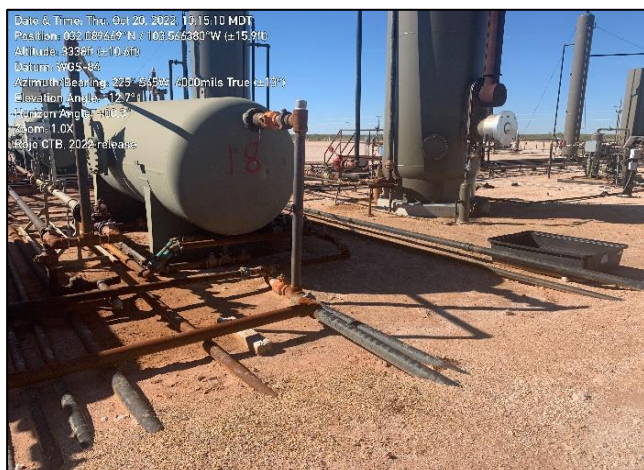
Photograph: 3 Date: 10/20/2022
Description: Initial assessment activities
View: Northwest

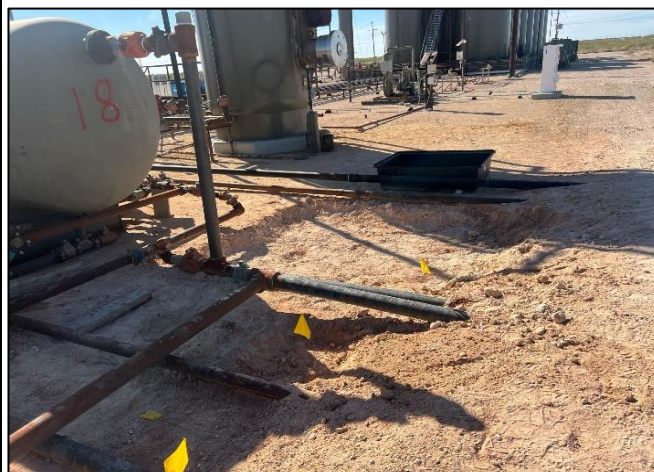
Photograph: 4
Description: Excavation activities
View: Northwest

On April 25, 2023, Ensolum personnel were at the Site to oversee excavation activities. Impacted soil was excavated as indicated by laboratory analytical results for preliminary soil sample SS02. Excavation activities were performed via hand shoveling. To direct excavation activities, soil was screened for VOCs and chloride. The excavation was completed to a depth of 1-foot bgs.

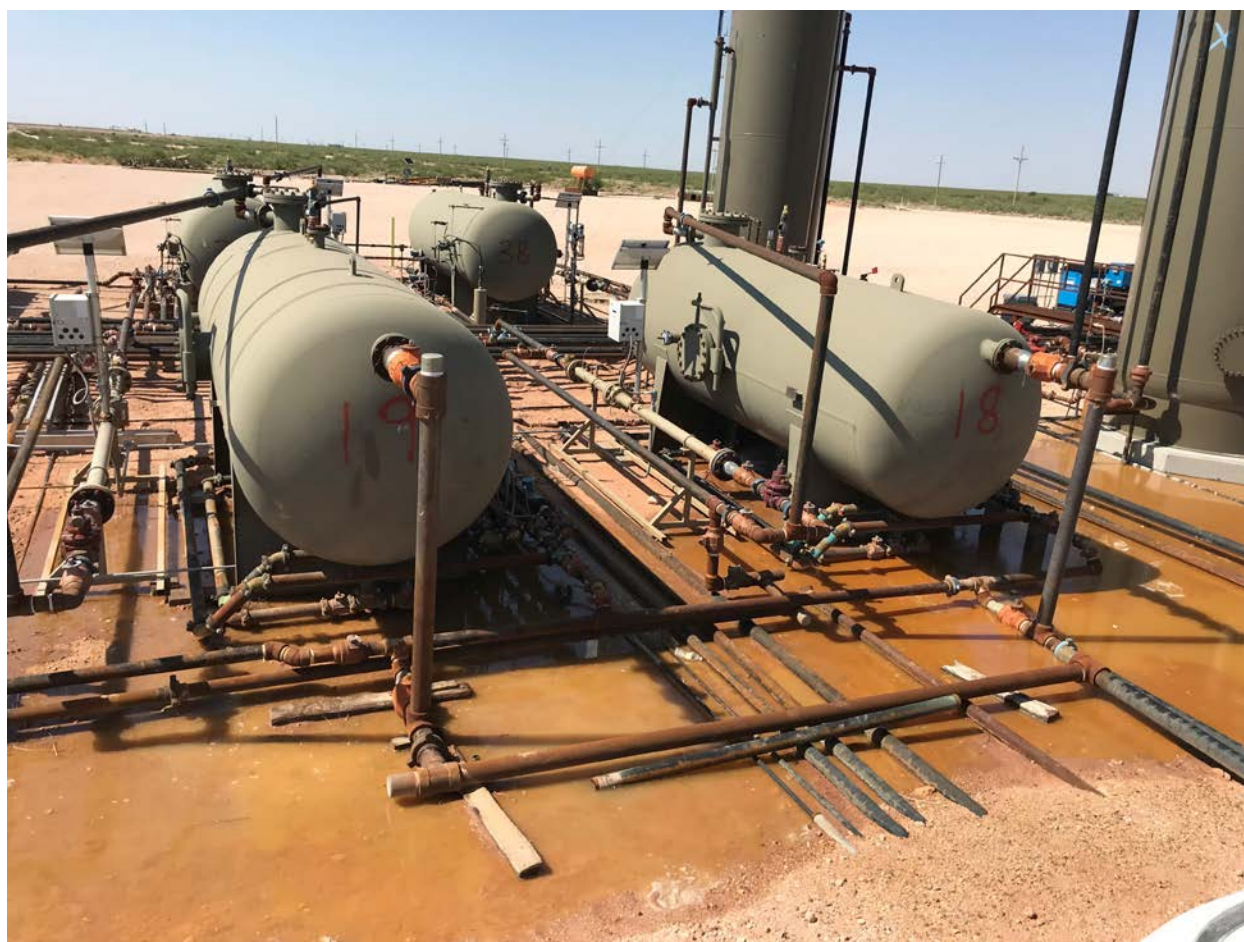
Incident #nAPP2222753156

Fitting Failure. An ell on the bottom of the separator washed out. Produced water released under the vessel into unlined containment area. Recovered 35 BW with vacuum truck. Spill volume calculation is included.

Rojo 18 ELL
8/14/2022
