Re: Site Assessment, Liner Inspection, and Closure Report
Caballo 9 State 1 Battery
API No. N/A
GPS: Latitude 32.321555 Longitude -103.481628
UL -- E, 9, T23S, R34E
Lea County, NM
NMOCD Ref. No. NAPP2312126971

Caballo 9 State 1 Battery| [Devon Energy](#)

**SITE PHOTOGRAPHS
DEVON ENERGY
CABALLO 9 STATE #1**

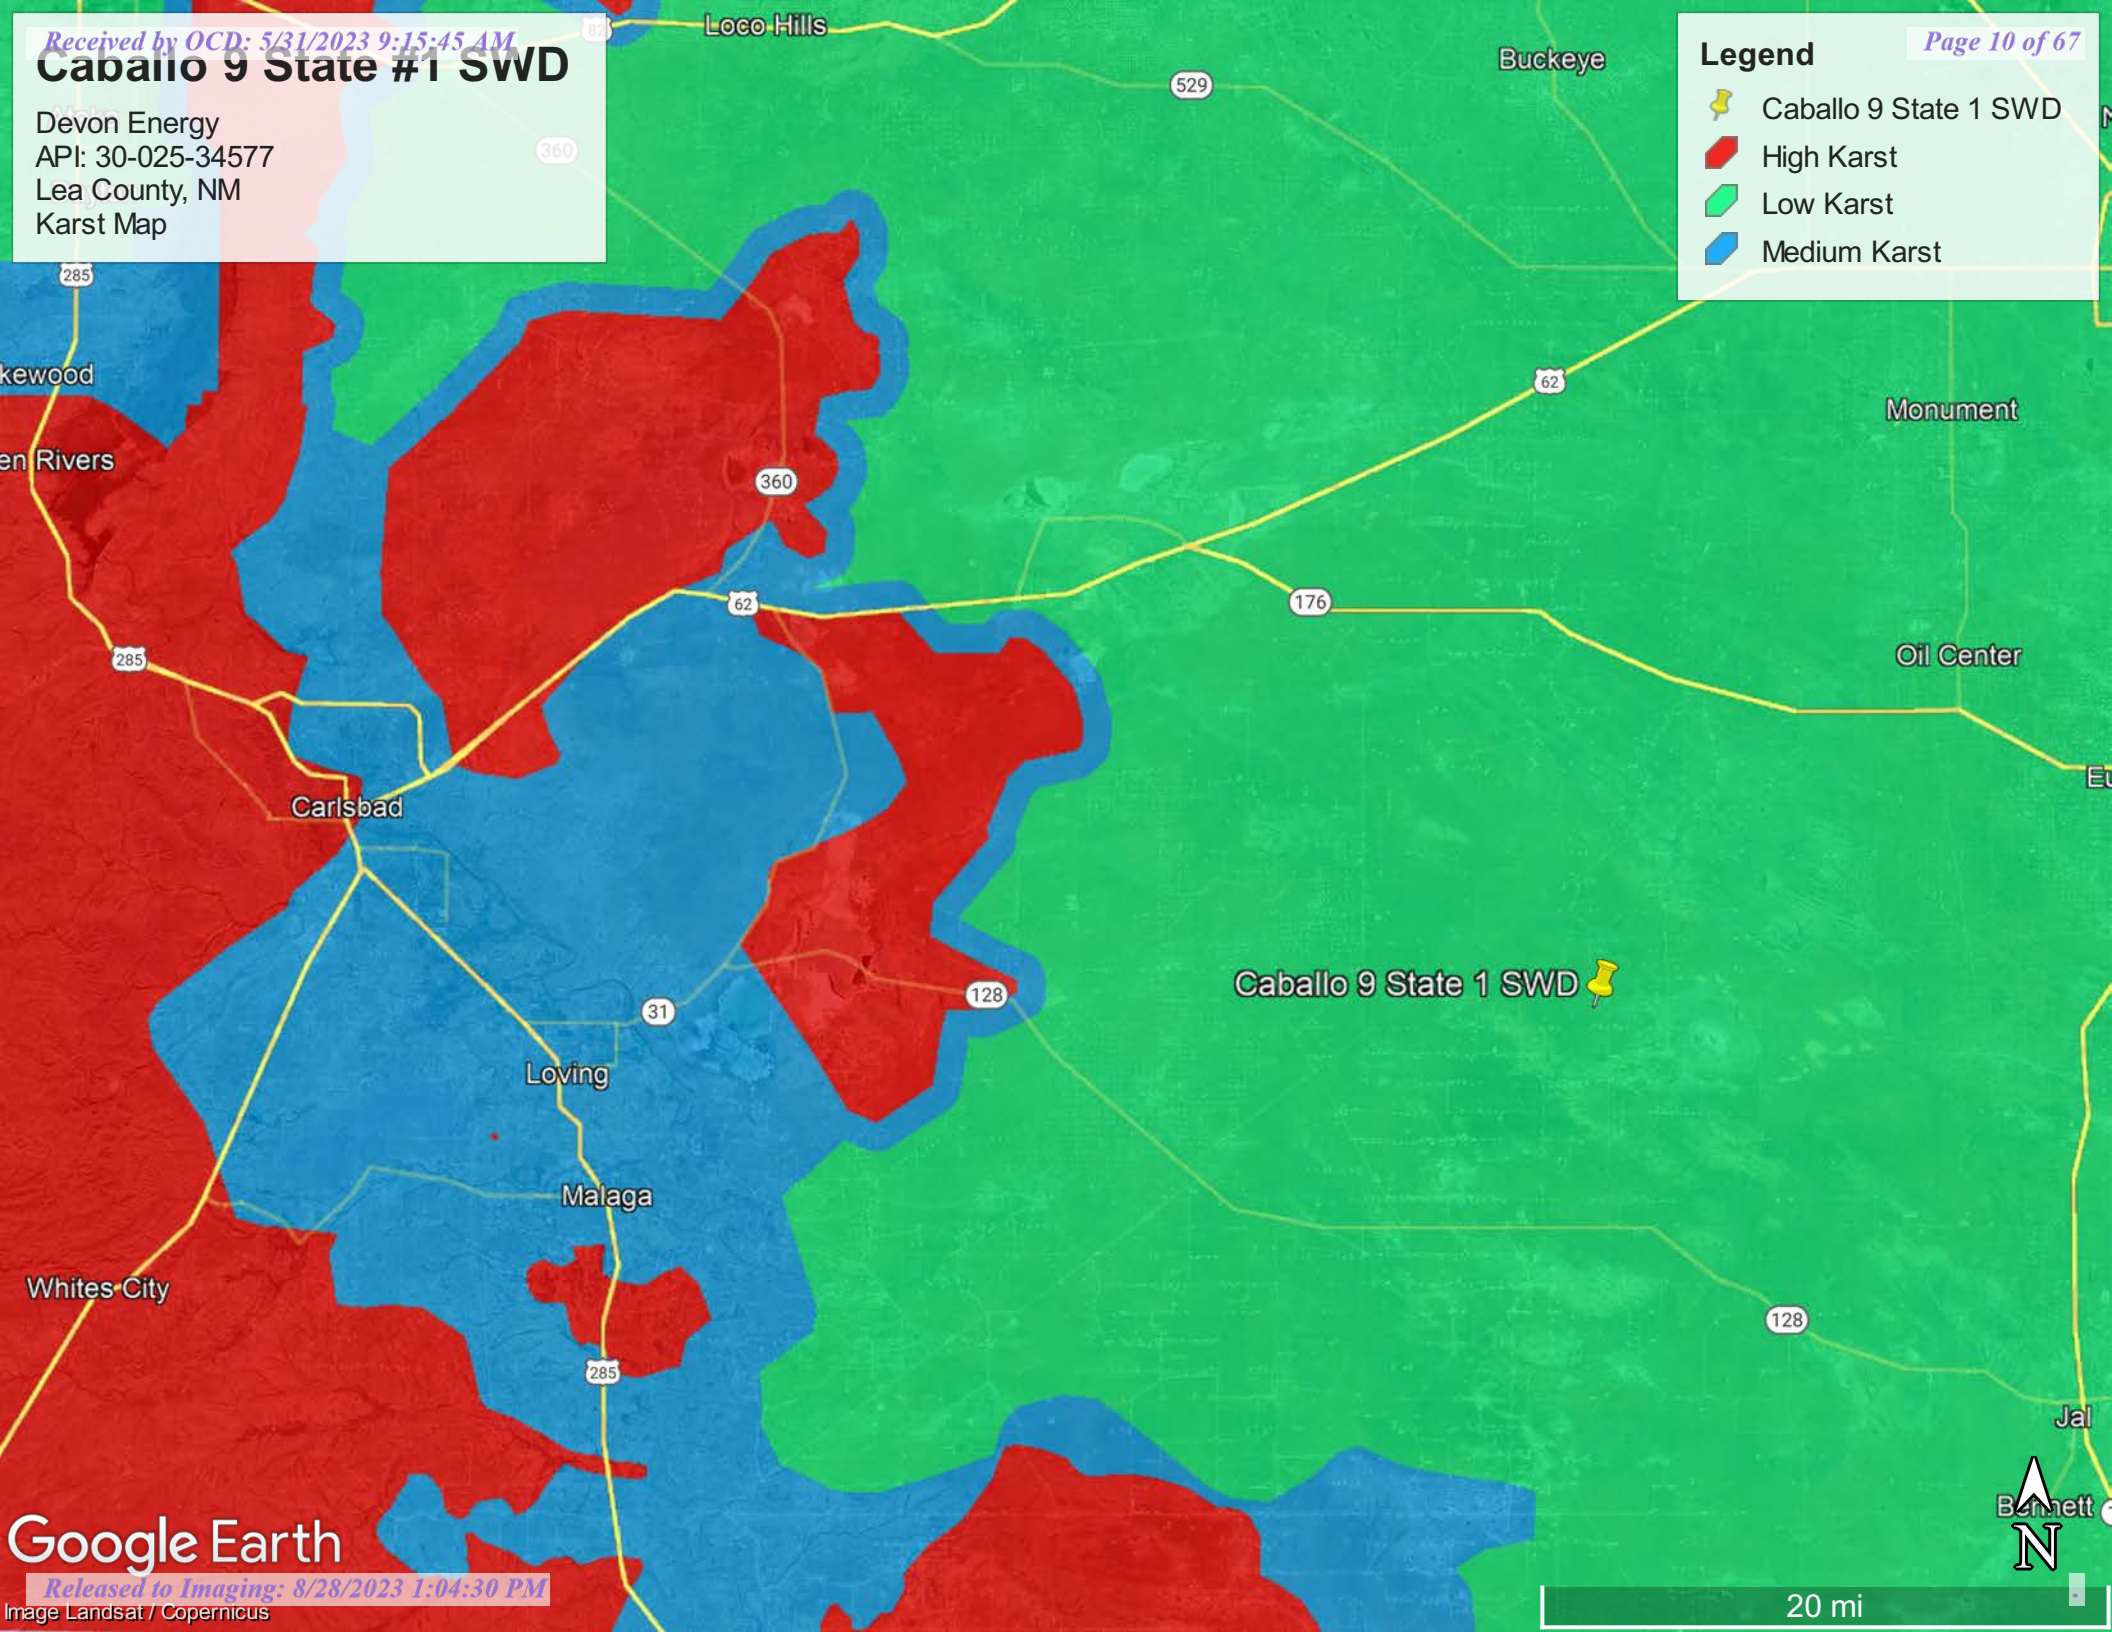
Devon Energy
API: 30-025-34577
Lea County, NM
Karst Map

Per the New Mexico Bureau of Geology and Mineral Resources, the geology is made up of Interlayered eolian sands and piedmont-slope deposits along the eastern flank of the Pecos River valley, primarily between Roswell and Carlsbad. Typically capped by thin eolian deposits. The soil in this area is made up of Pyote and Maljamar fine sands, 0 to 3 percent slopes according to the United States Department of Agriculture Natural Resources Conservation Service soil survey (Appendix B). The drainage class in this area is well drained. There is a low potential for karst geology to be present around the Caballo (Figure 3).

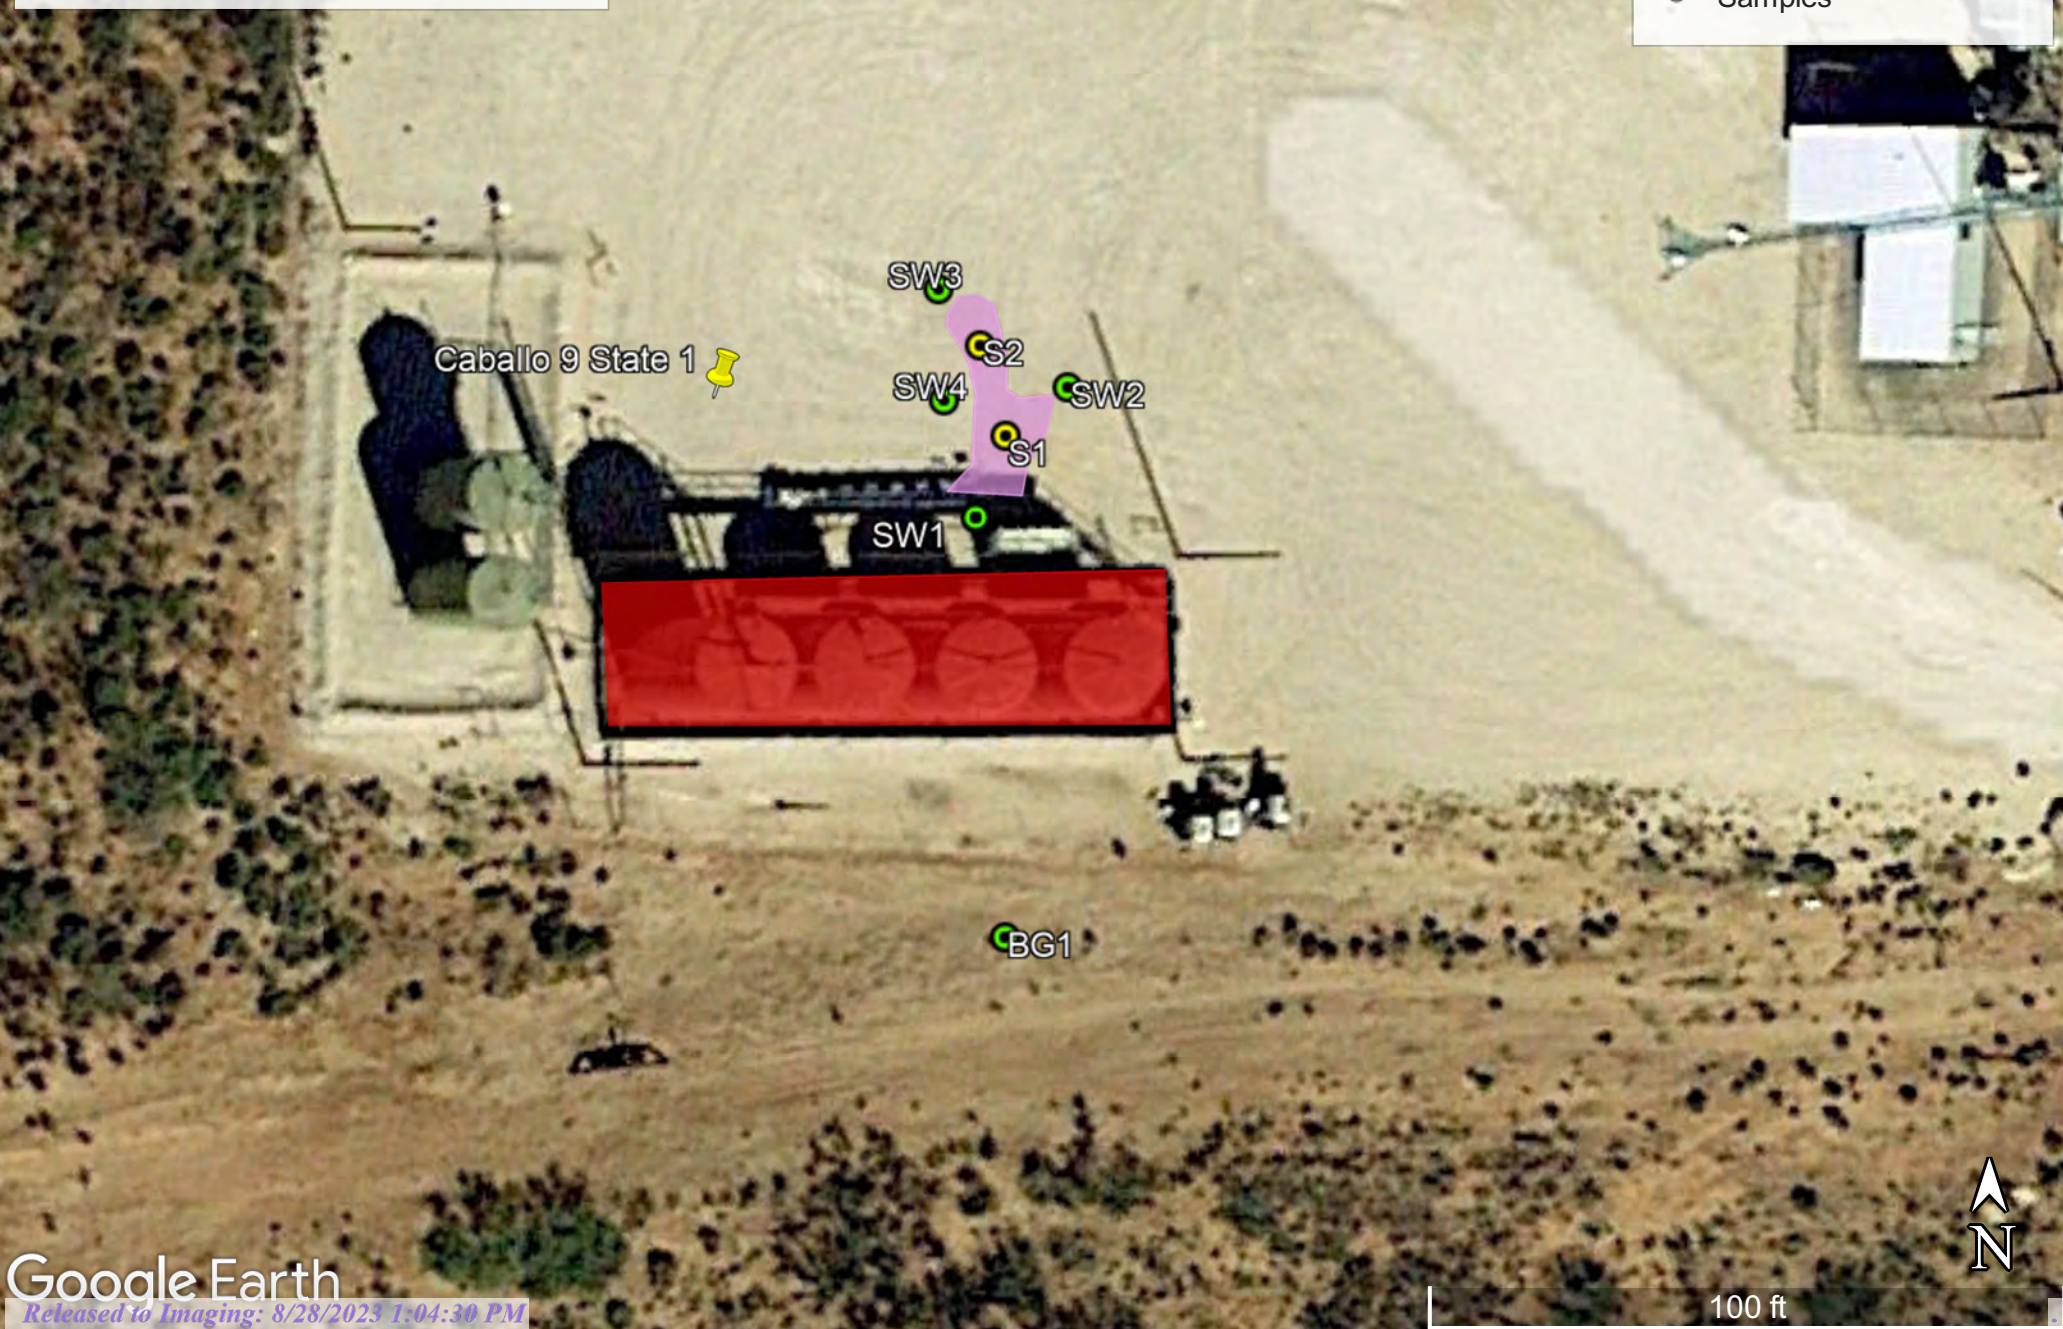
Devon Energy
API: 30-025-34577
Lea County, NM
Site Map

May 4, 2023, Pima mobilized personnel to the site to begin collecting soil samples from spill area. The laboratory results of this sampling event can be found in the following data table. A Site Map can be found in Figure 4.

Caballo spill 269 SQFT
-

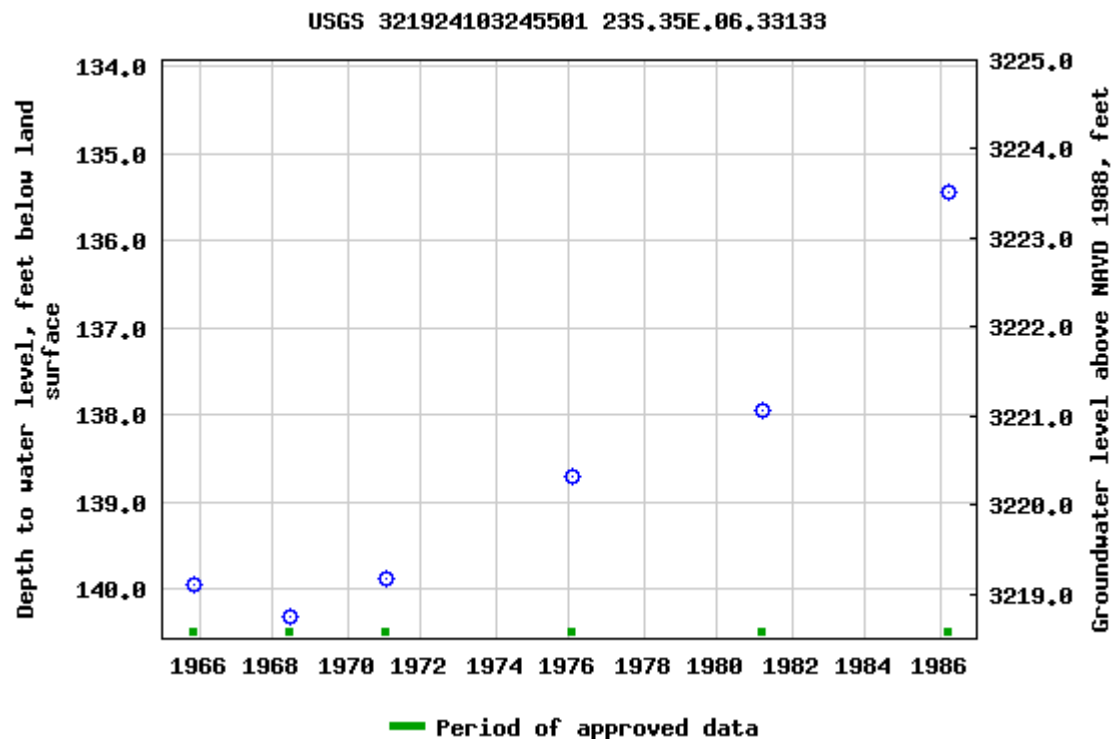
USGS 321924103245501 23S.35E.06.33133

The depth of the well is 200 feet below land surface.

Breaks in the plot represent a gap of at least one year between field measurements.

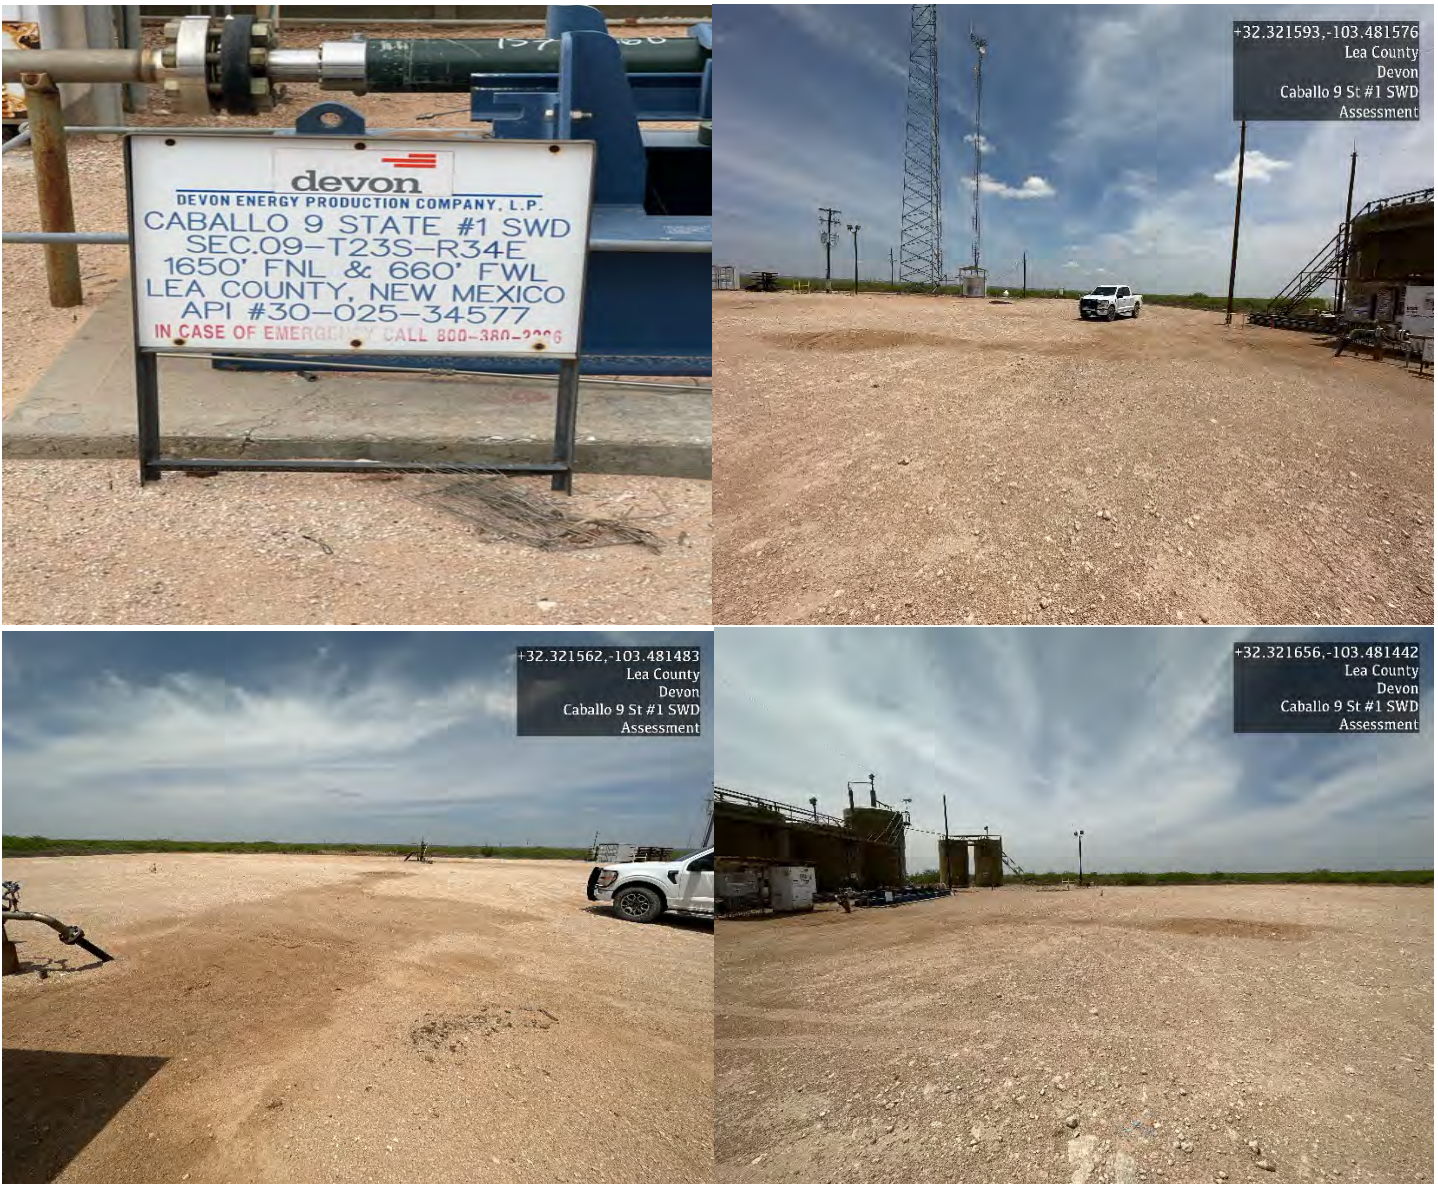
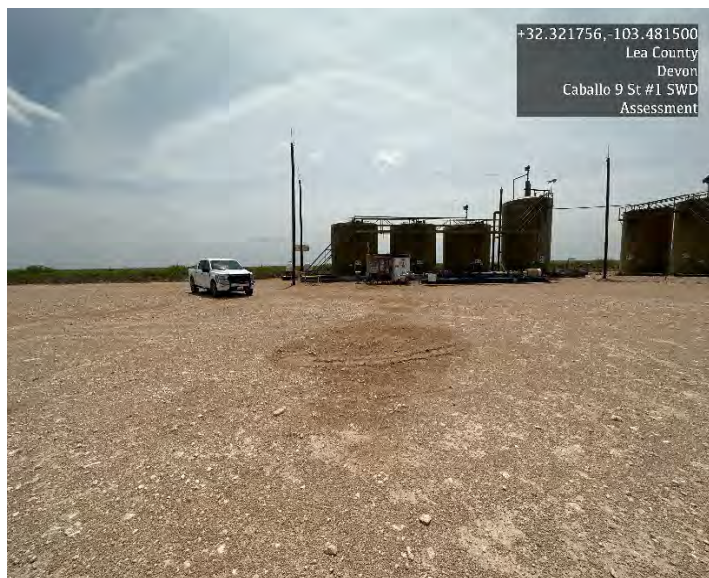
Site Assessment

NAPP2312126971: On May 1, 2023, a valve on water tank developed a leak and sprayed outside the containment onto the pad. The released fluids were calculated to be approximately 16.46 barrels (bbls) of produced water. Vacuum trucks were able to recover approximately 15 bbls fluid from the lined SPCC containment ring. Once fluids were removed, the liner was visually inspected by Devon field staff for any pinholes or punctures.

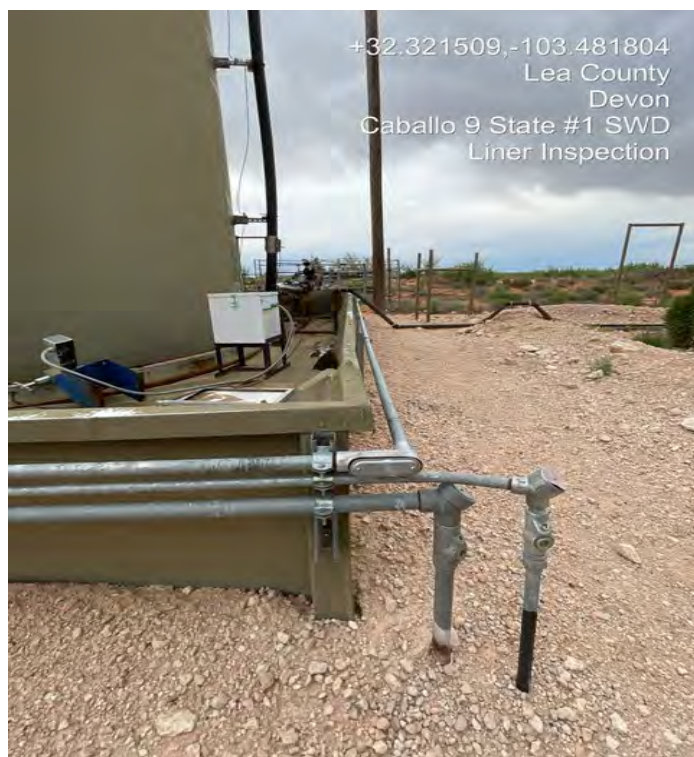
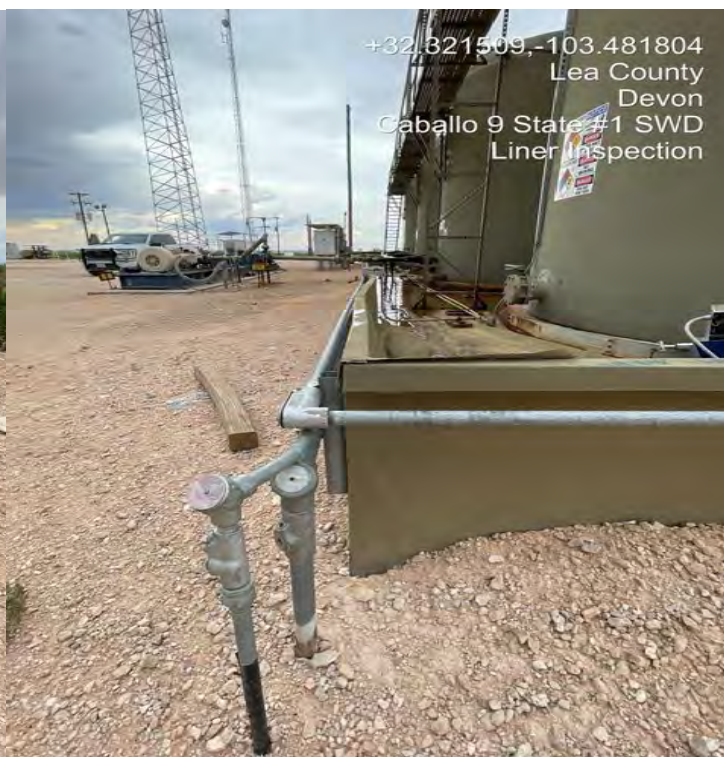
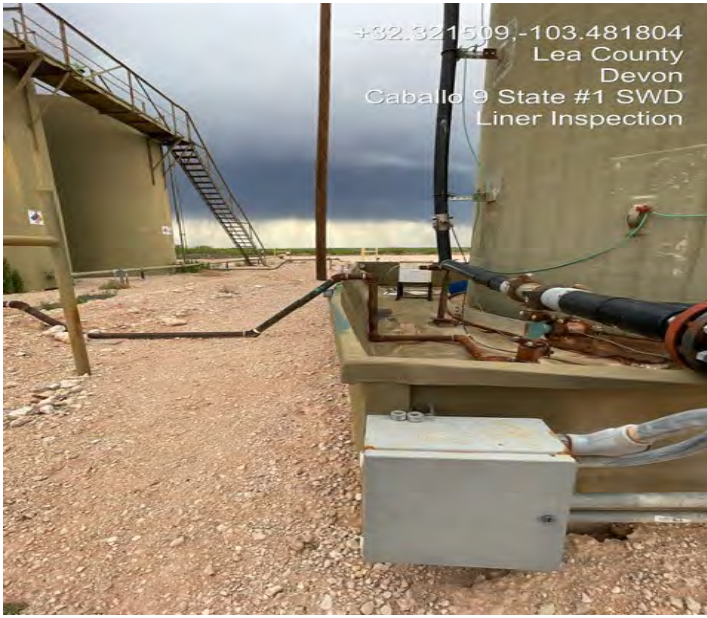
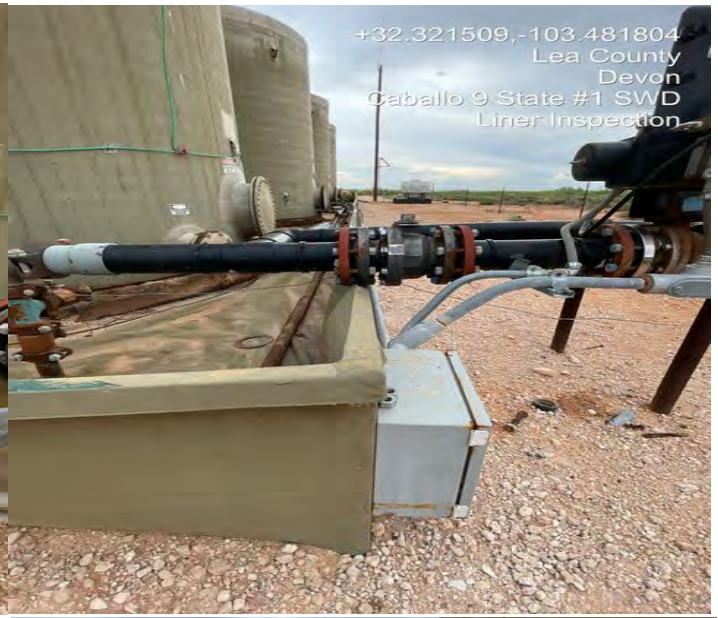
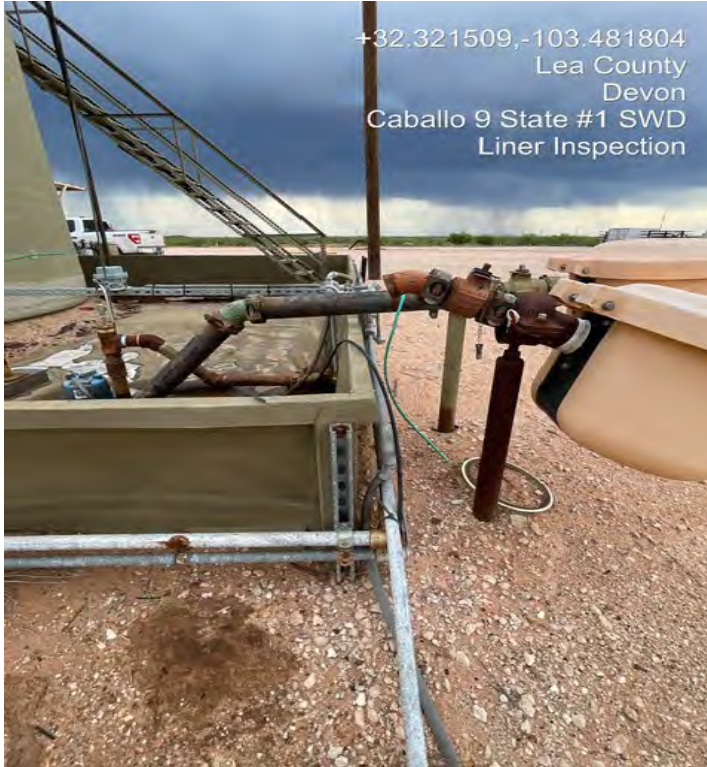
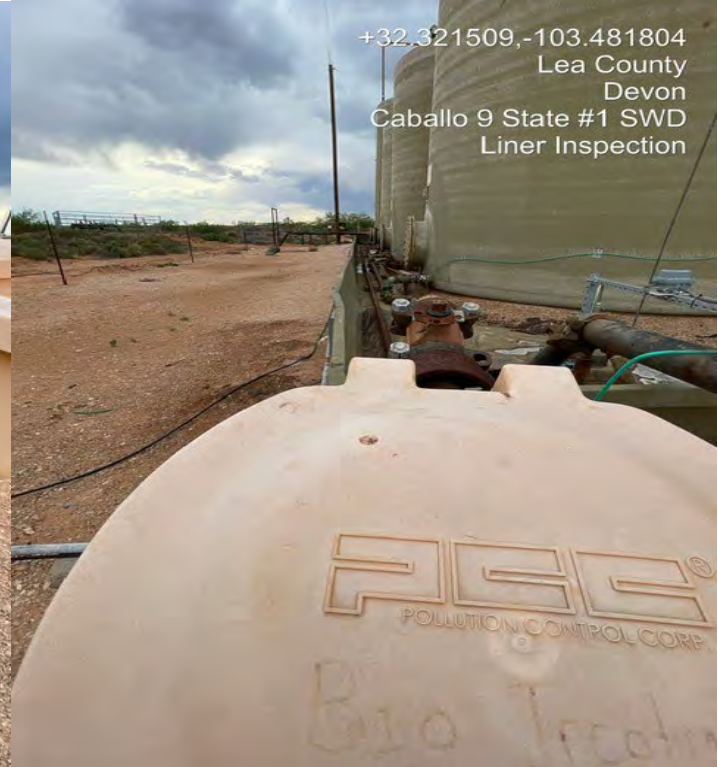
On May 25, 2023, after sending the 48-hour Notification (Appendix C) via email, Pima Environmental conducted a liner inspection at this location. We concluded that this liner and containment maintained its integrity and was able to retain the fluids. The Liner Inspection form and photographic documentation can be found in Appendix D.

Visualization	Yes	No	Comments
Is there a tear in the liner?		X	
Are there holes in the liner?		X	
Is the liner retaining any fluids?		X	
Does the liner have integrity to contain a leak?	X

After careful review, Pima requests that this incident, NAPP2312126971, be closed. Devon has complied with the applicable closure requirements set forth in rule 19.15.19.12 NMAC.
