Release Notification and Corrective Action

Name of Company: RKI Exploration / WPX Energy <i>246289</i>	Contact: James Raley
Address: 5315 Buena Vista Dr.	Telephone No: 575-689-7597
Facility Name: RDX 9 #004	Facility Type: Production

RDX 9 #004

Incident Number: nAB1803254347

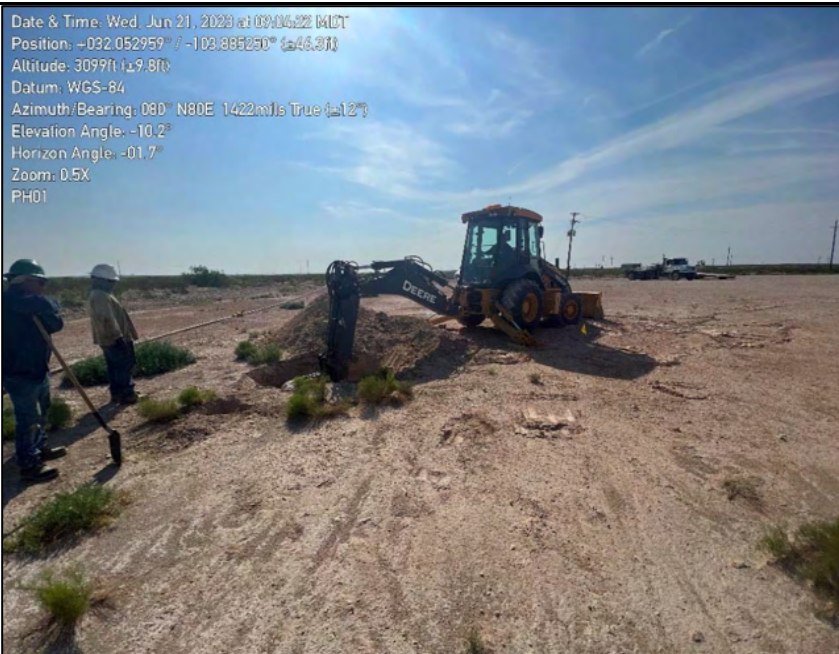
**Photograph 1****Date: 06/21/2023**

Description: Northeastern view of delineation activities, near PH01.

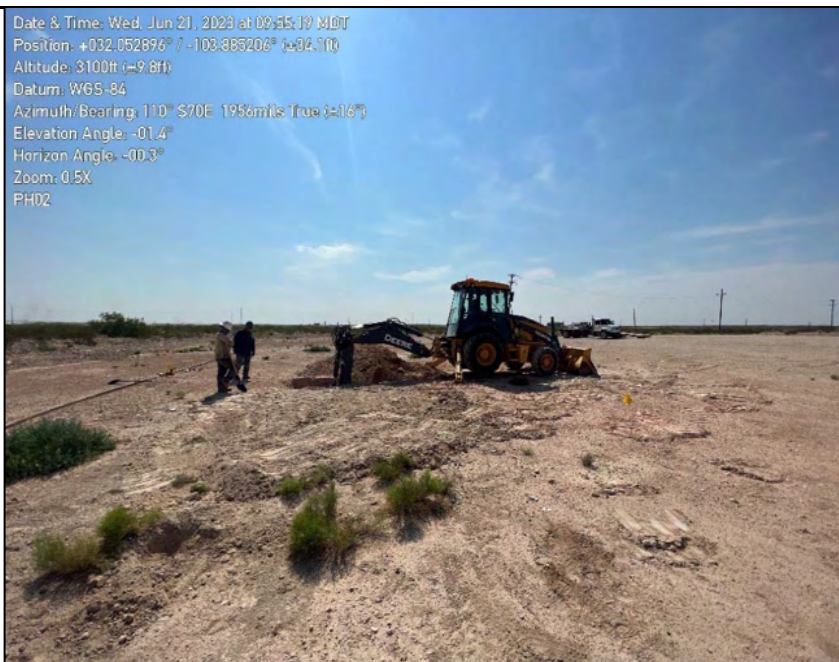
**Photograph 2****Date: 06/21/2023**

Description: Southeastern view of delineation activities, near PH02.

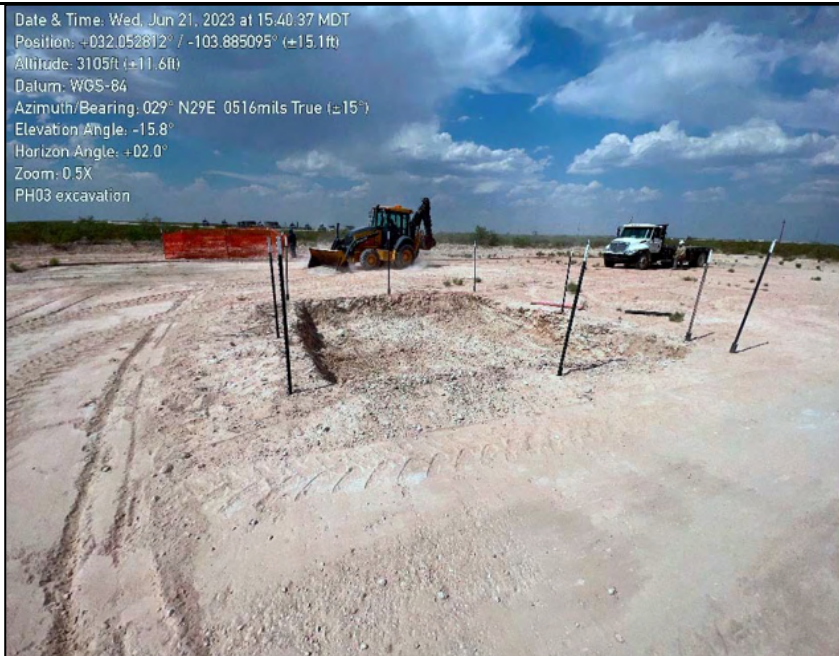
**Photograph 3****Date: 06/21/2023**

Date & Time: Wed, Jun 21, 2023 at 15:40:37 MDT
Position: +032.052812° / -103.885095° (±15.1ft)
Altitude: 3105ft (±11.6ft)
Datum: WGS-84
Azimuth/Bearing: 029° N29E 0516mils True (±15°)
Elevation Angle: -15.8°
Horizon Angle: +02.0°
Zoom: 0.5X
PH03 excavation

Description: Northeastern view of excavation extent, near PH03.

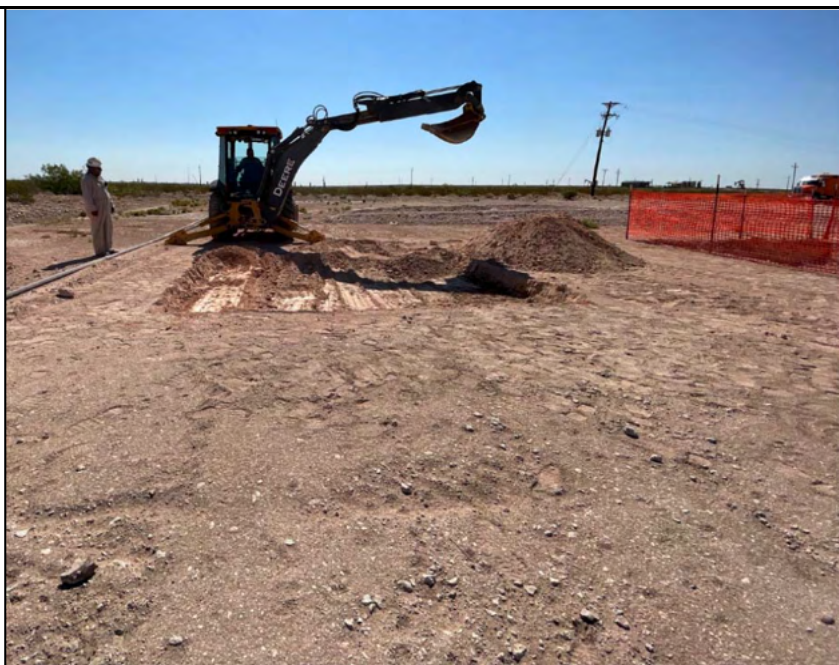
**Photograph 4****Date: 07/24/2023**

Description: Southeastern view during excavation activities, near PH02.

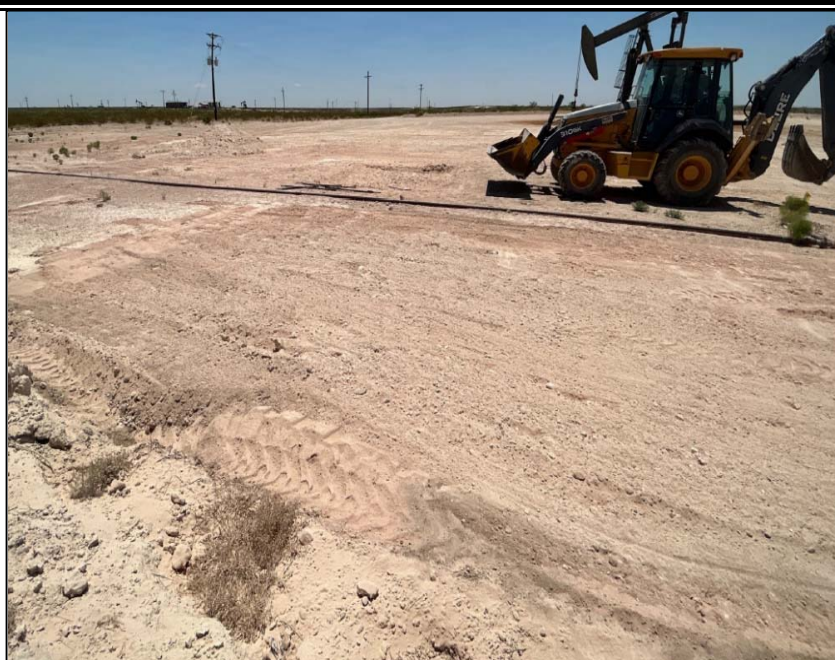
**Photograph 5****Date: 07/24/2023**

Description: Southeastern view of backfill following remediation activities near PH05

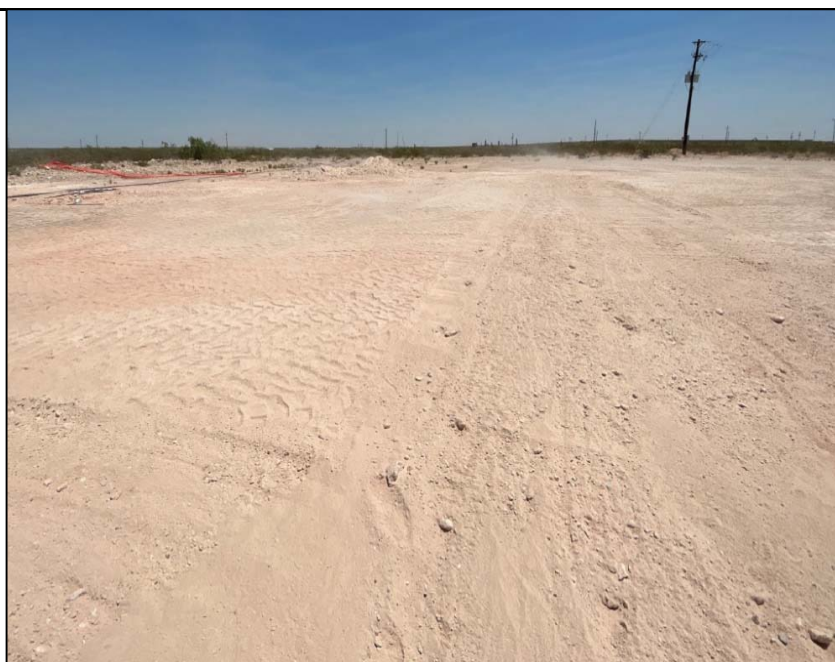
**Photograph 6****Date: 07/24/2023**

Description: Northeastern view of backfill following remediation activities near PH03.
