Release Notification

Site Name: CARRACAS 23A #004	Site Type: WELL
Date Release Discovered: 09/27/2022	API# (if applicable): 30-039-27550

The release occurred on September 27, 2022, during the drilling of a new well, when the cuttings pit became overfilled, and the pit berm collapsed. The overfilling and berm failure resulted in a spill releasing approximately 45 BBL of freshwater and coal cuttings down gradient. The release made its way down gradient of the site for a distance of approximately 890 linear feet. After discovering the spill, MorningStar contacted the NMOCD and Carson National Forest Service, and began initial cleanup of the affected area. Hand crews and a skid-steer were utilized to clean up the soils in the area that had staining and odor within the flow path. Approximately 60 cubic yards of contaminated soil were removed. A Notice of Release (NOR) was filed with the NMOCD when the spill occurred by Samantha Avarello with MorningStar on September 28, 2022. A site inspection was conducted following the initial clean-up efforts for the spill on December 2, 2022, with Mike Howe of MorningStar and Tanner Paulek and Greg Riley of EIS Environmental. During the inspection

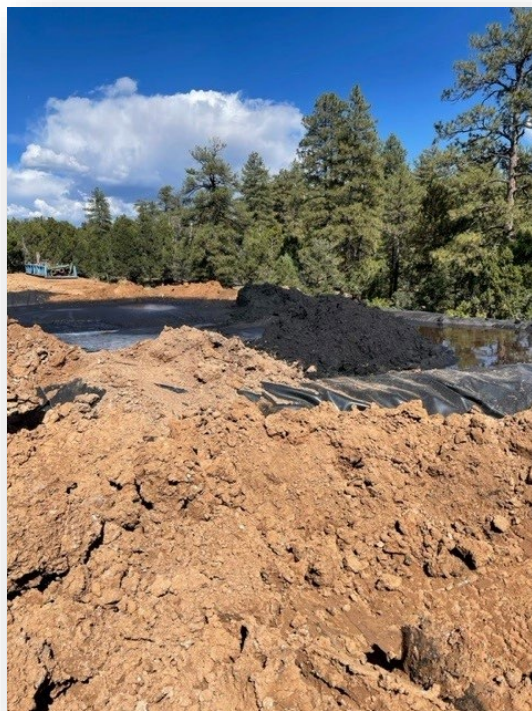
Figure 1. Pit with Produced Water and Coal Cuttings (Sept 27, 2022)

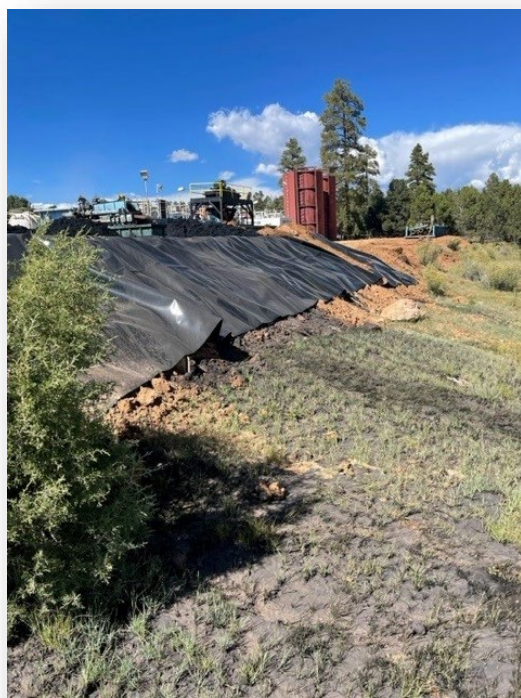
The Rig consultant (Pete McNeil) reported that the drying pad filled with fresh water based drilling fluid mixed with coal cuttings overflowed when ground gave way under the outward containment berm and lost 6" of height.

Figure 2. Point of Spill (Sept 27, 2022)

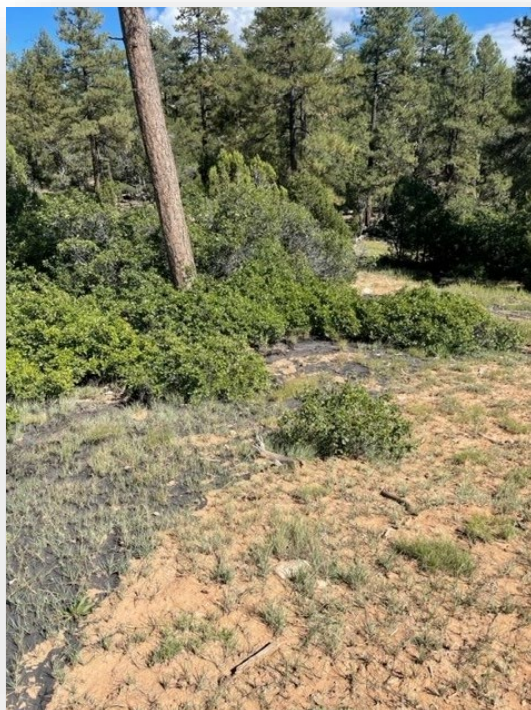
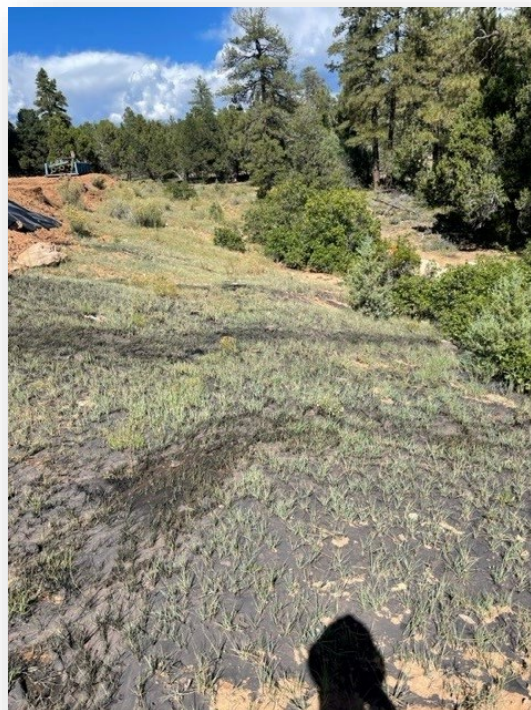
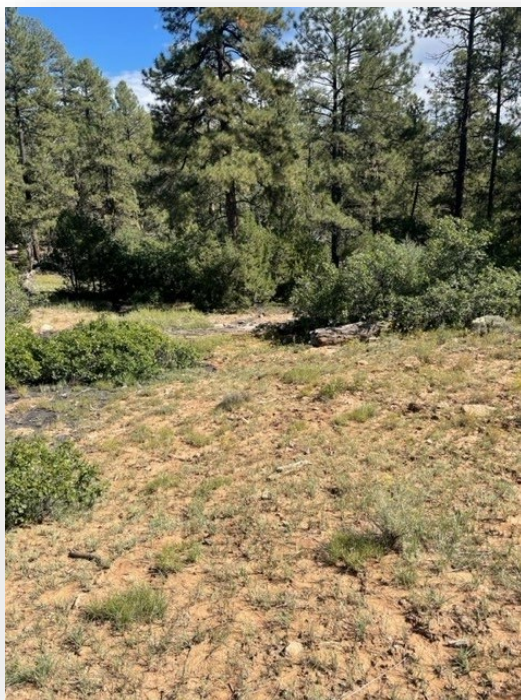
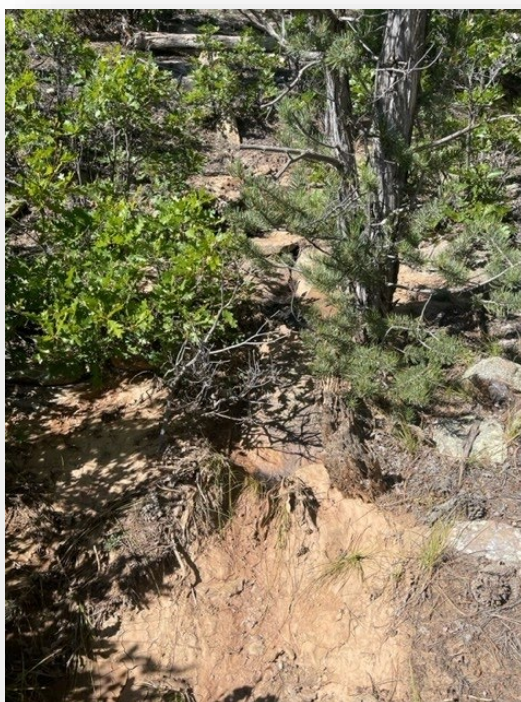
Figure 3. Flow Path of Spill (Sept 27, 2022)

Figure 4. Flow Path of Spill (Sept 27, 2022)

Figure 5. Flow Path of Spill (Sept 27, 2022)

Figure 6. Flow Path of Spill (Sept 27, 2022)

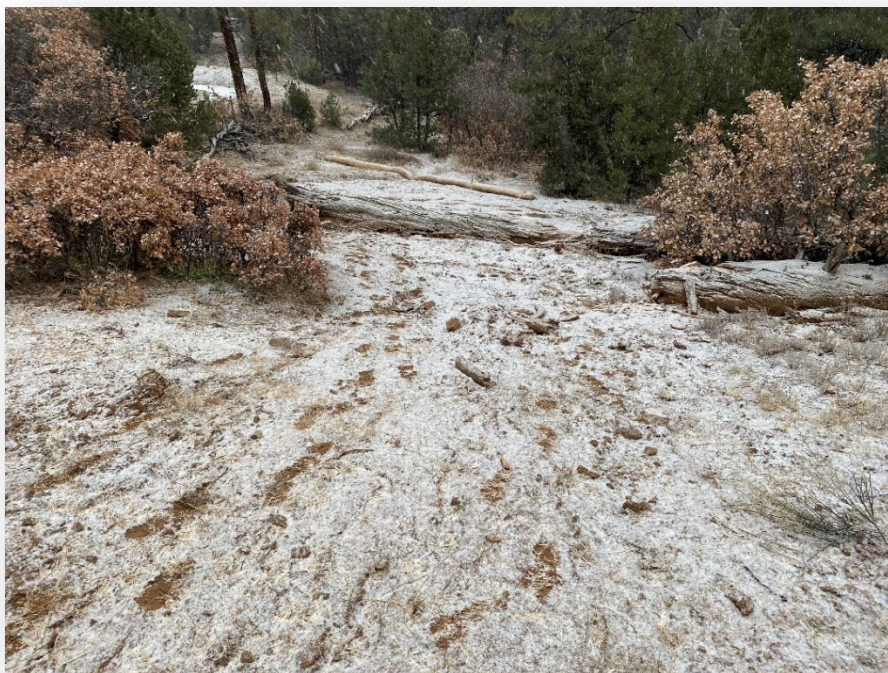
Figure 7. Start of Spill After Cleanup (Dec 2, 2022)

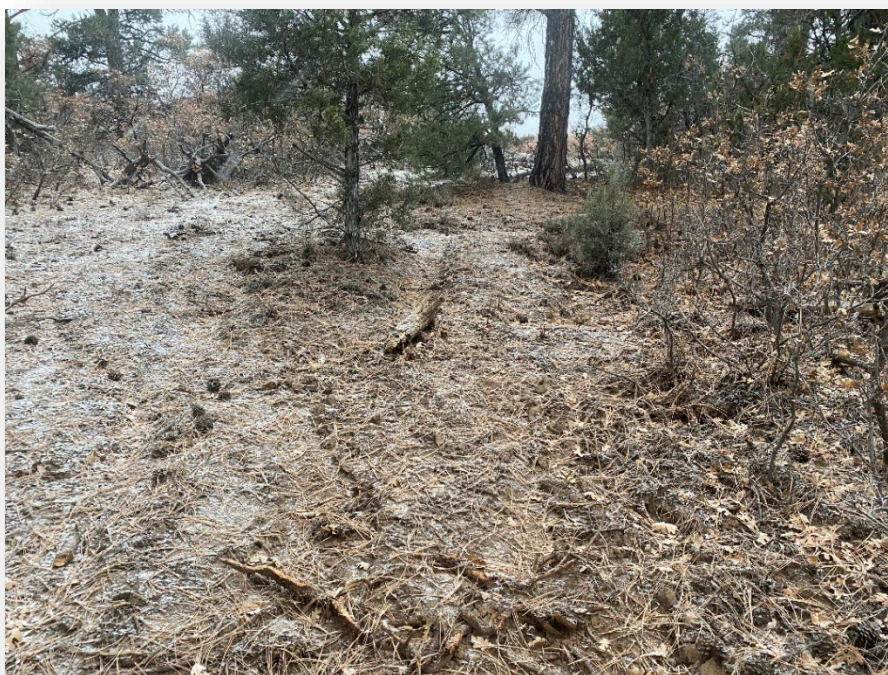
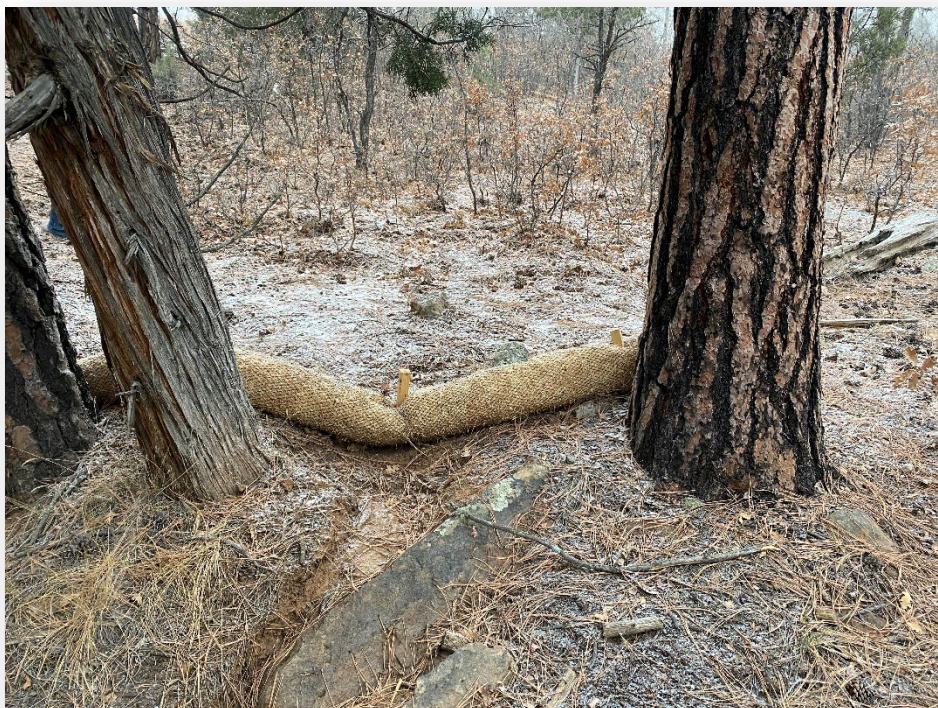
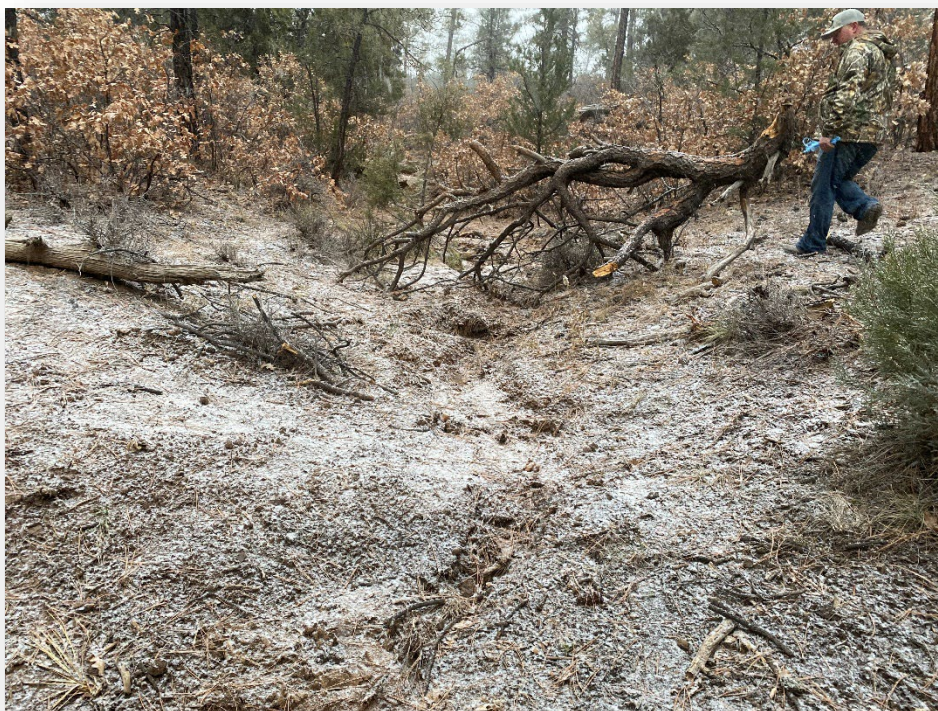
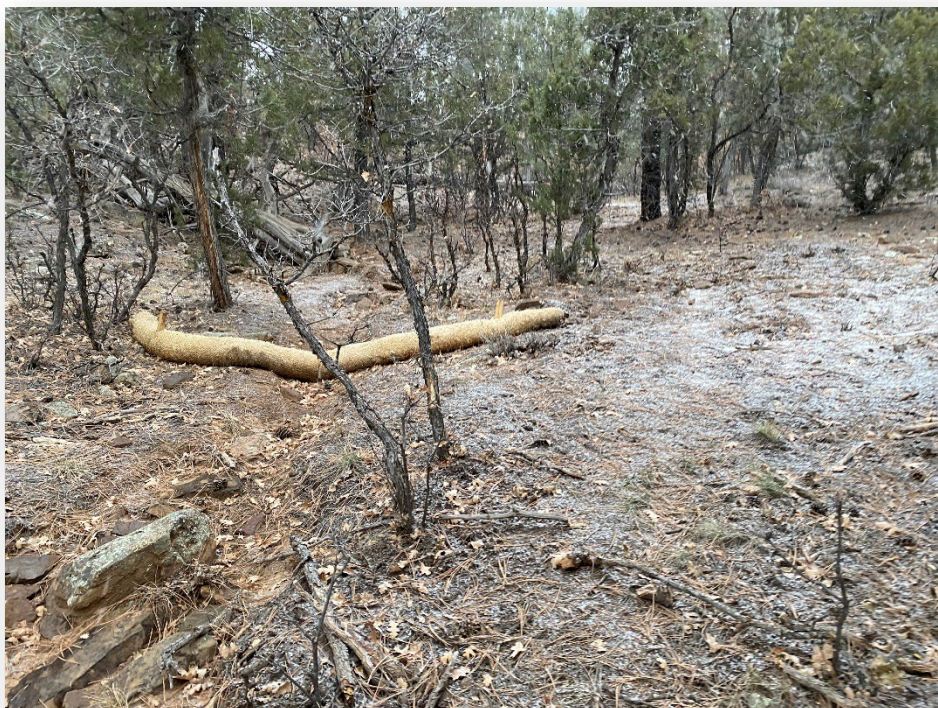
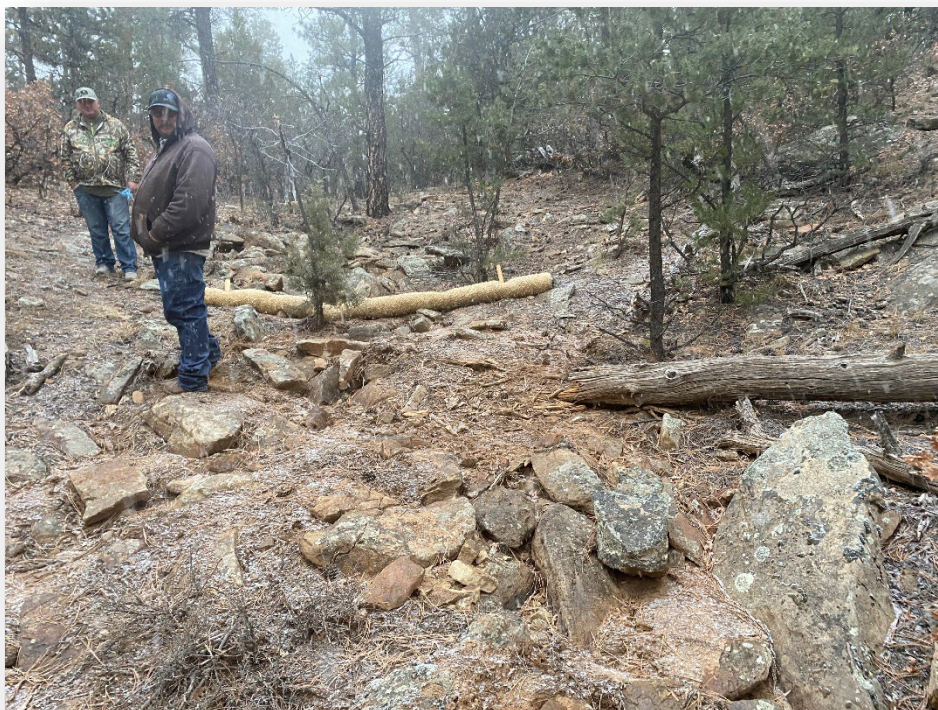
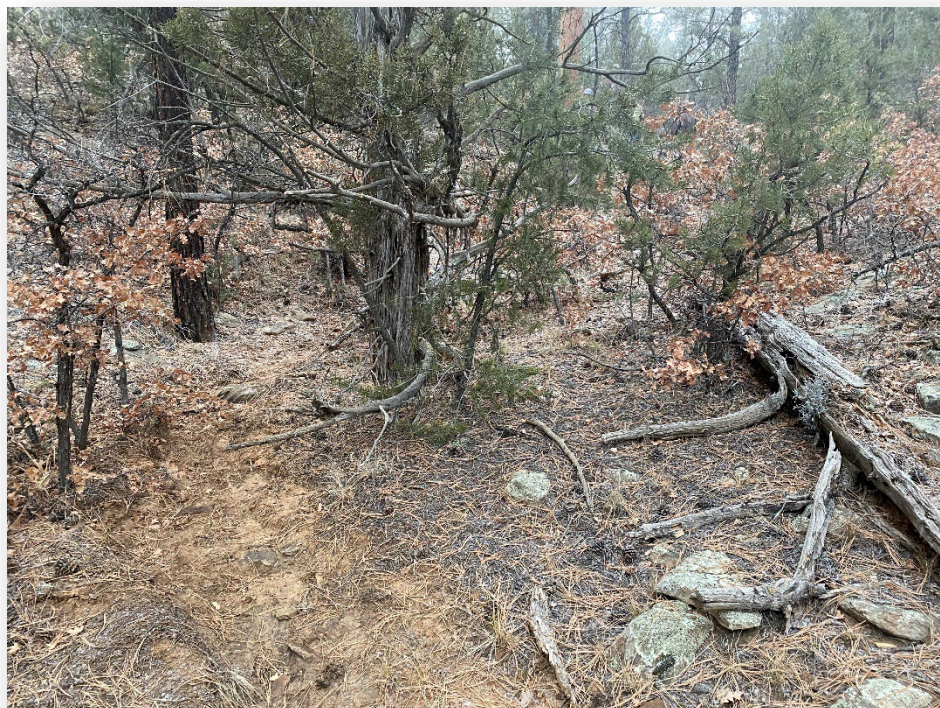
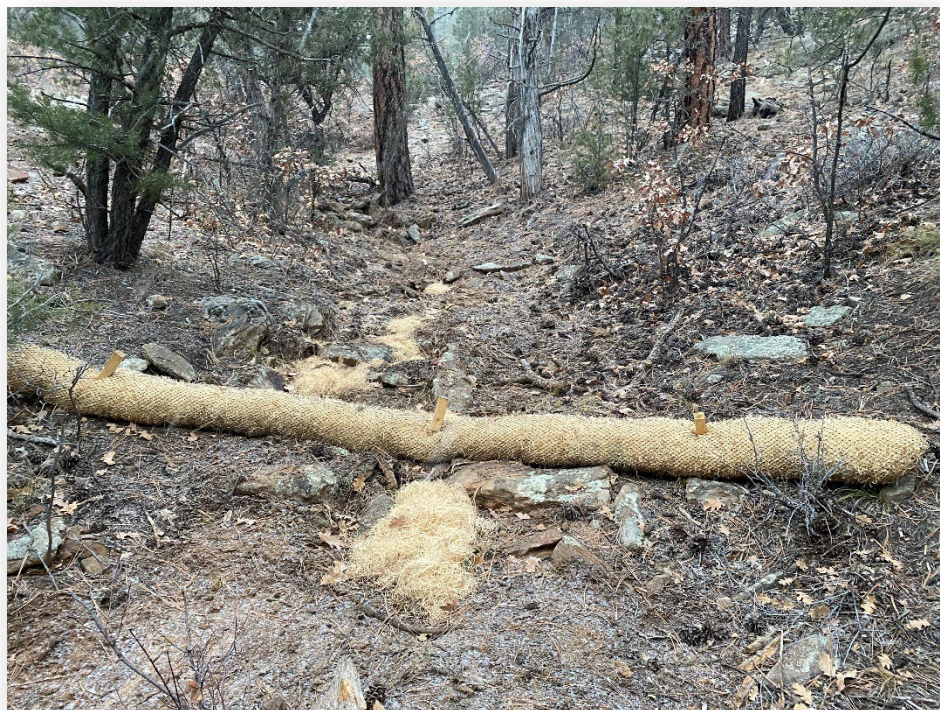
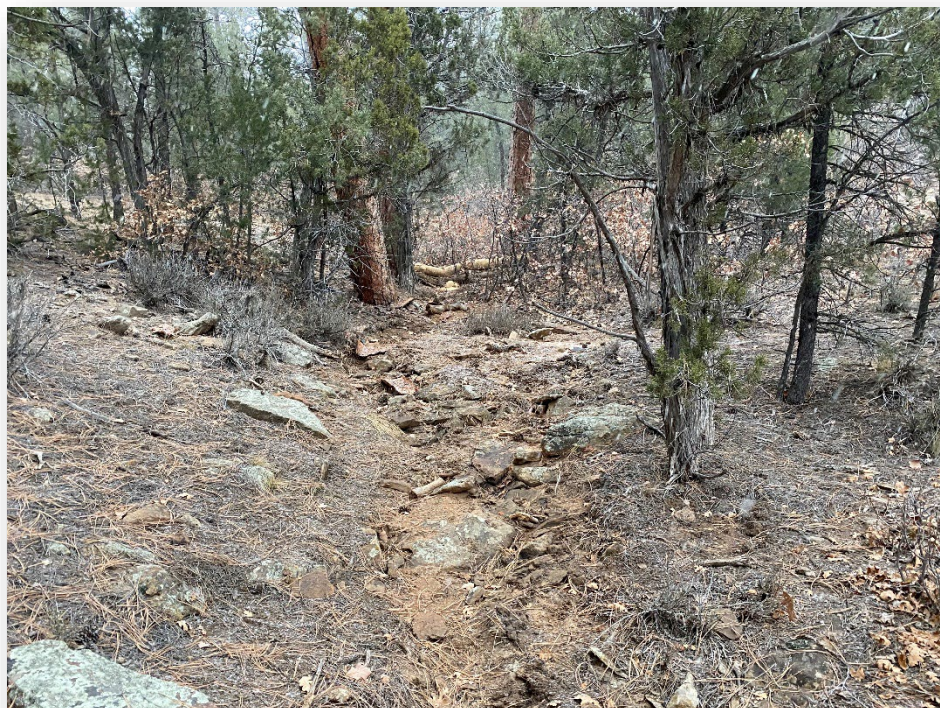
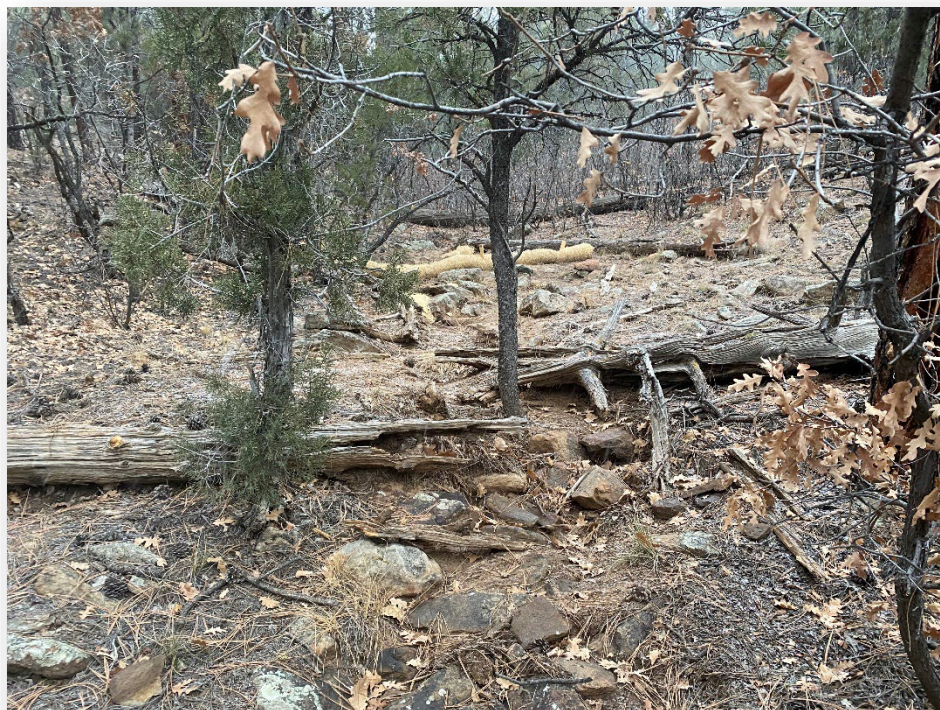
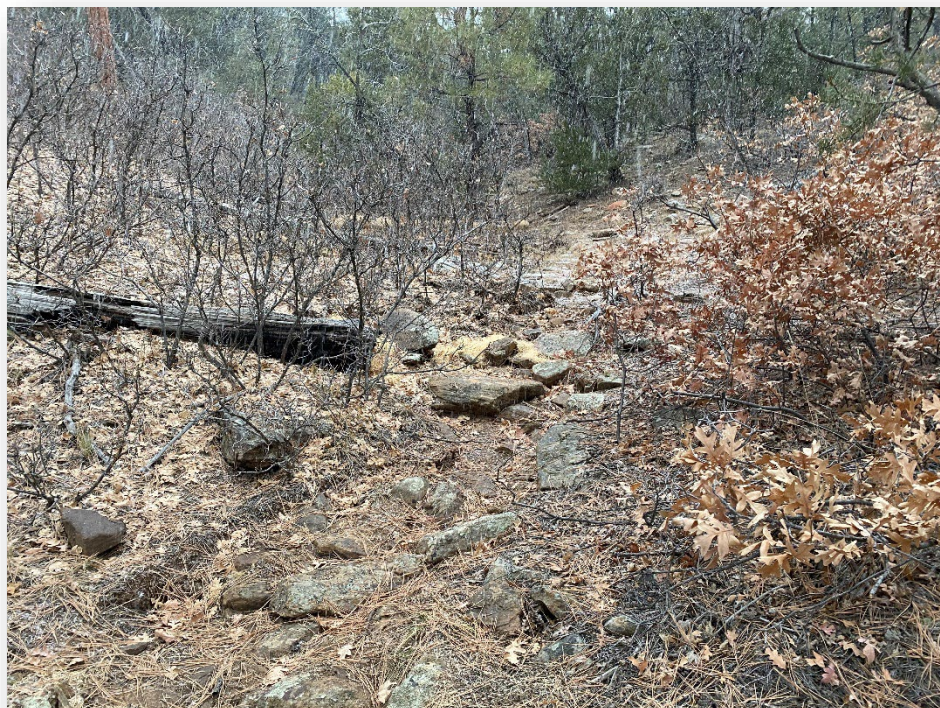
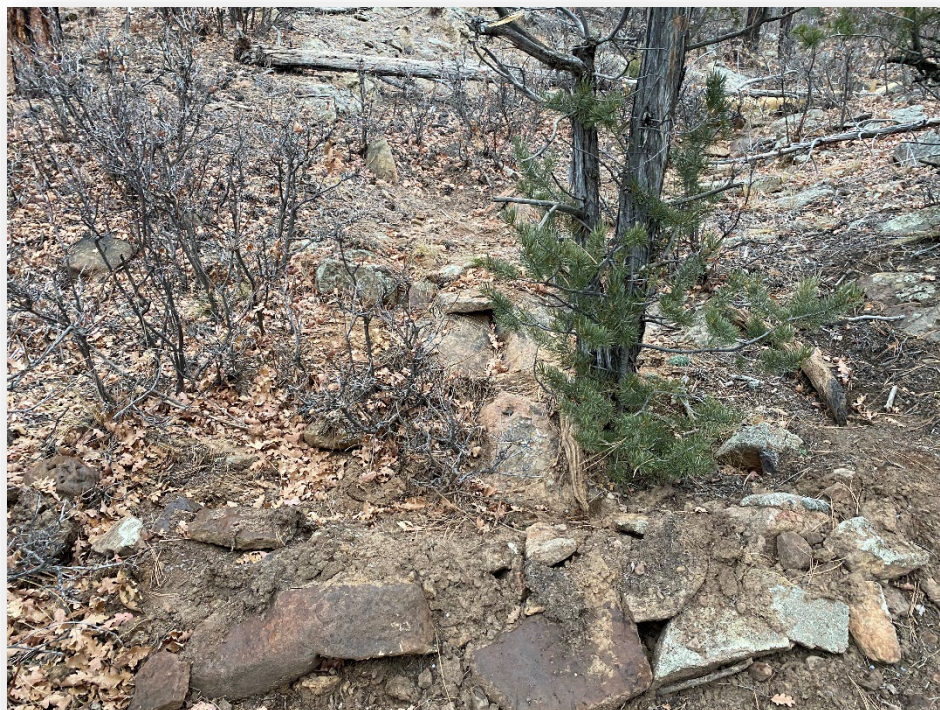
Figure 8. Flow Path After Cleanup (Dec 2, 2022)

Figure 9. Flow Path After Cleanup (Dec 2, 2022)

Figure 10. Flow Path After Cleanup (Dec 2, 2022)

Figure 11. Flow Path After Cleanup (Dec 2, 2022)

Figure 12. Flow Path After Cleanup (Dec 2, 2022)

Figure 13. Flow Path After Cleanup (Dec 2, 2022)

Figure 14. Flow Path After Cleanup (Dec 2, 2022)

Figure 15. Flow Path After Cleanup (Dec 2, 2022)

Figure 16. Flow Path After Cleanup (Dec 2, 2022)

Figure 17. Flow Path After Cleanup (Dec 2, 2022)

Figure 18. Flow Path After Cleanup (Dec 2, 2022)

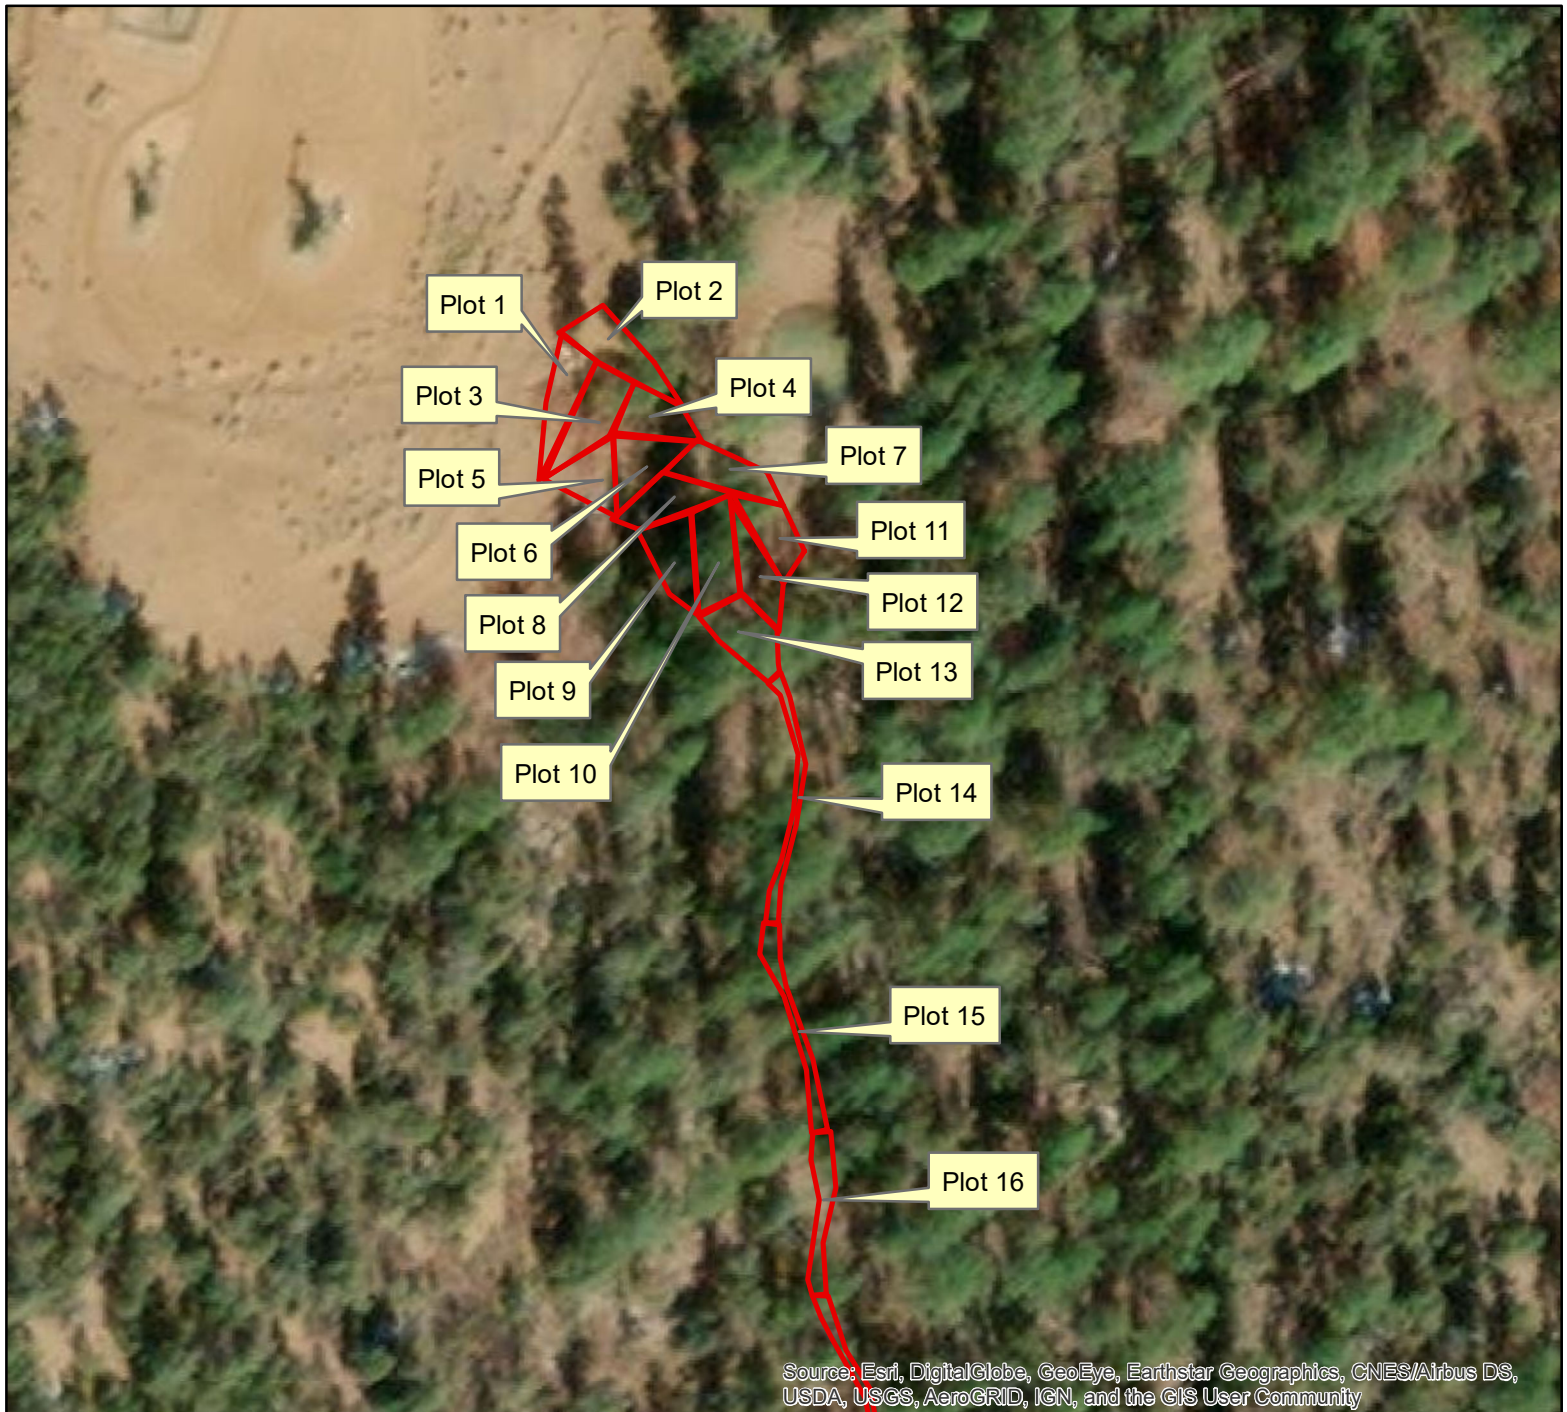
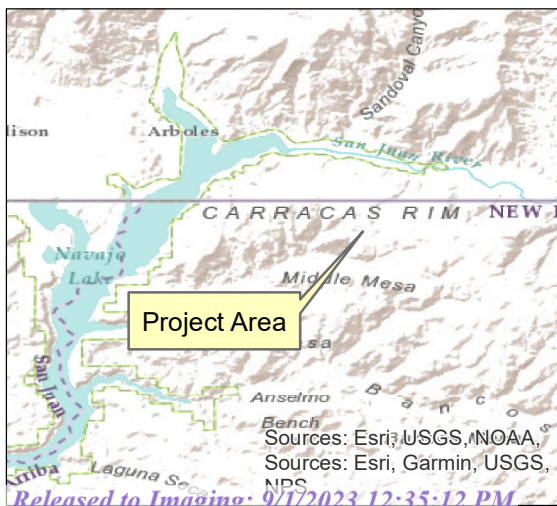
Carracus 23A #004 Soil Sampling Plots

Flow Path with 400 sq. ft Sampling Sections

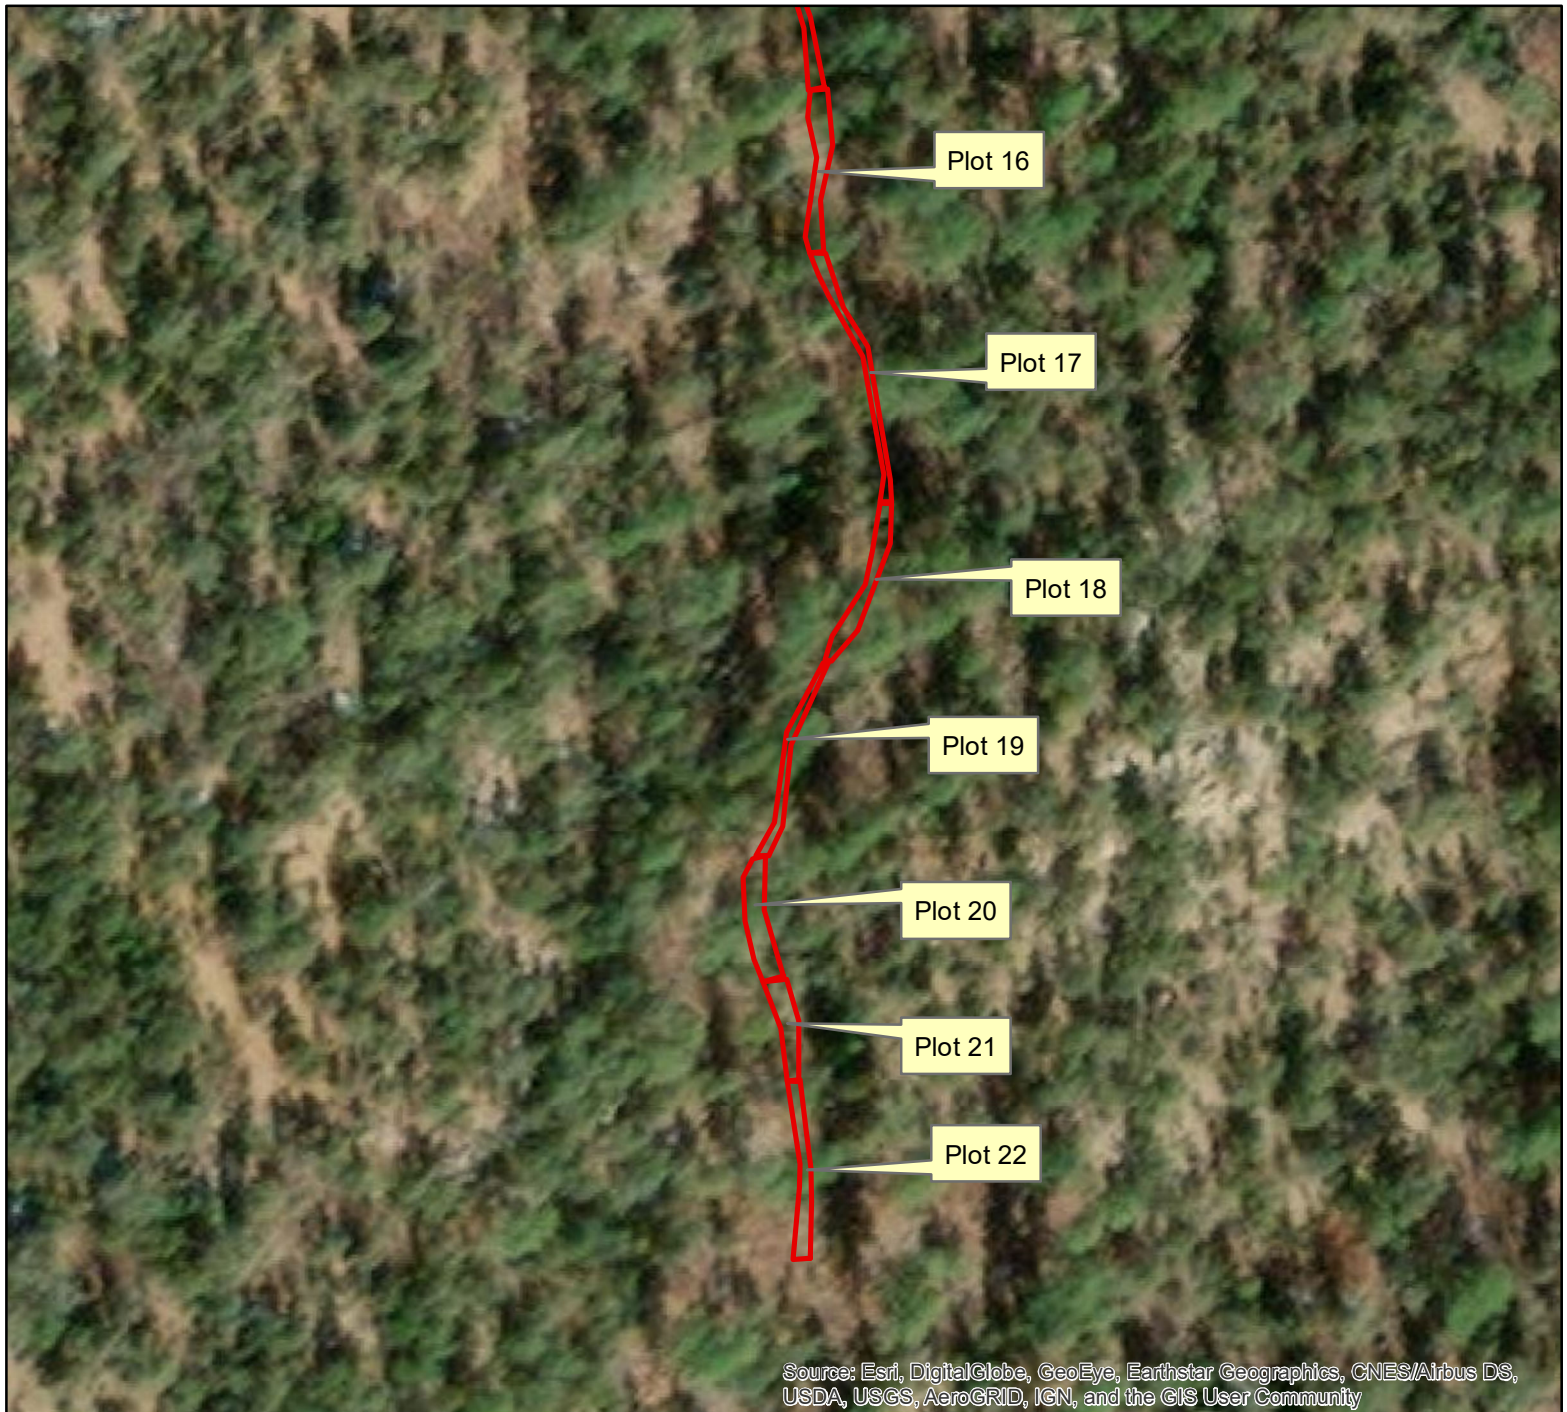
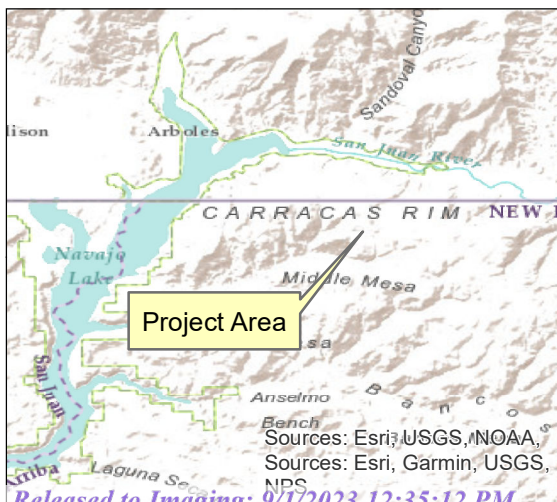
Carracus 23A #004 Soil Sampling Plots

Flow Path with 400 sq. ft. Sampling Sections

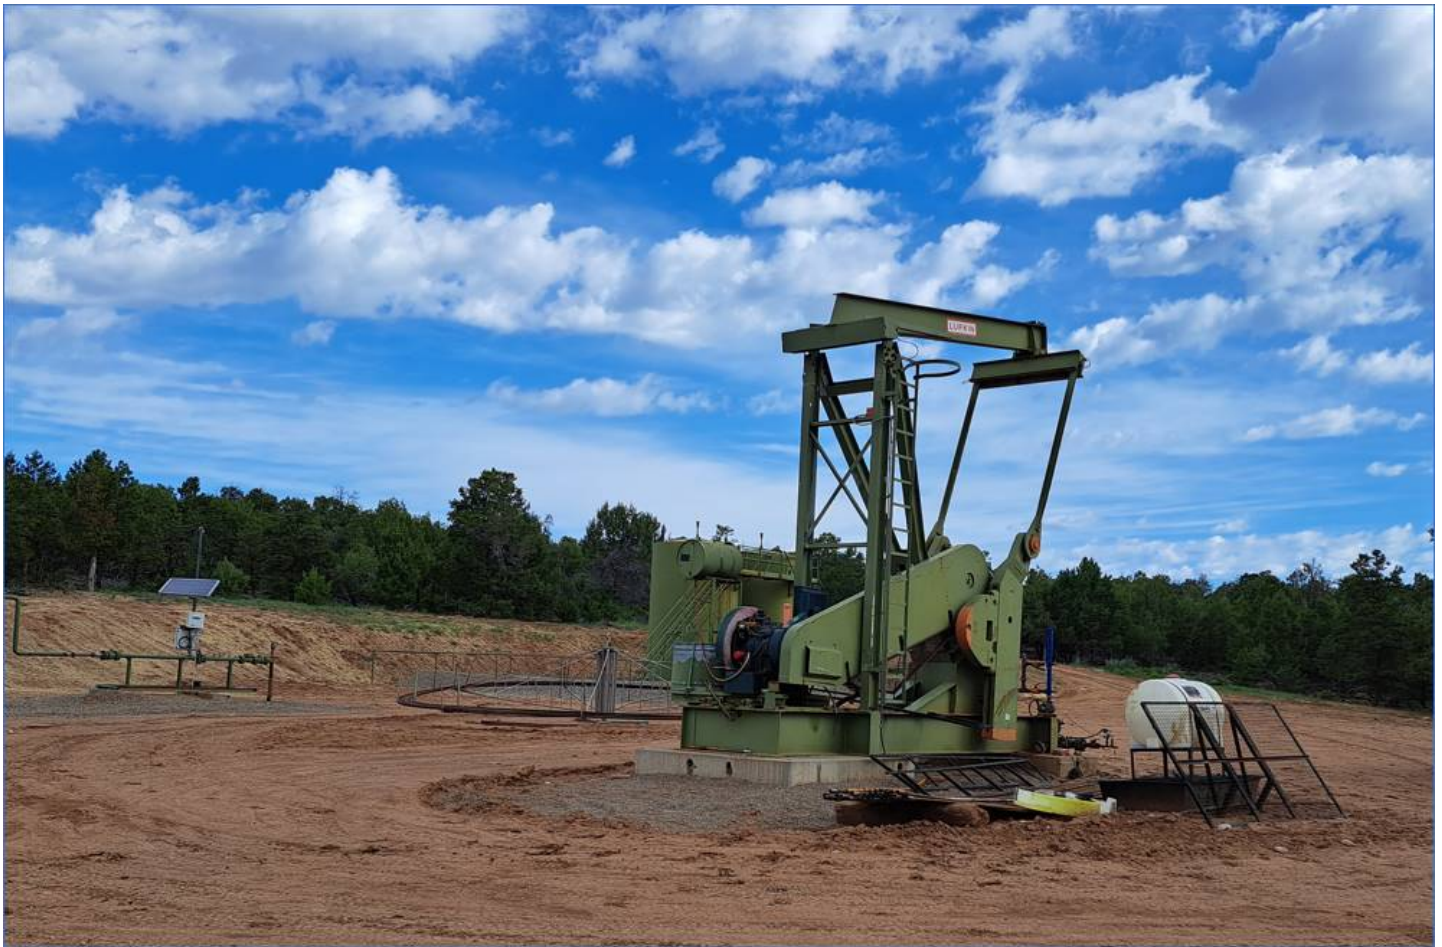
I did a site visit of the Carracas 23 A #4 well location and spill area yesterday. Based on the level of spill mitigation and overall condition of the spill area the Forest Service concurs with your assessment that adding material would be unnecessary.

However, please make sure that all unused equipment is removed from the location. Please see photo below:
