Remediation Summary and Closure Request

Frontier Field Services, LLC Caviness Compressor Station Lea County, New Mexico Unit Letter "D", Section 10, Township 18 South, Range 33 East Latitude 32.766054 North, Longitude 103.655417 West NMOCD Incident # nAPP2301335904

May 2023

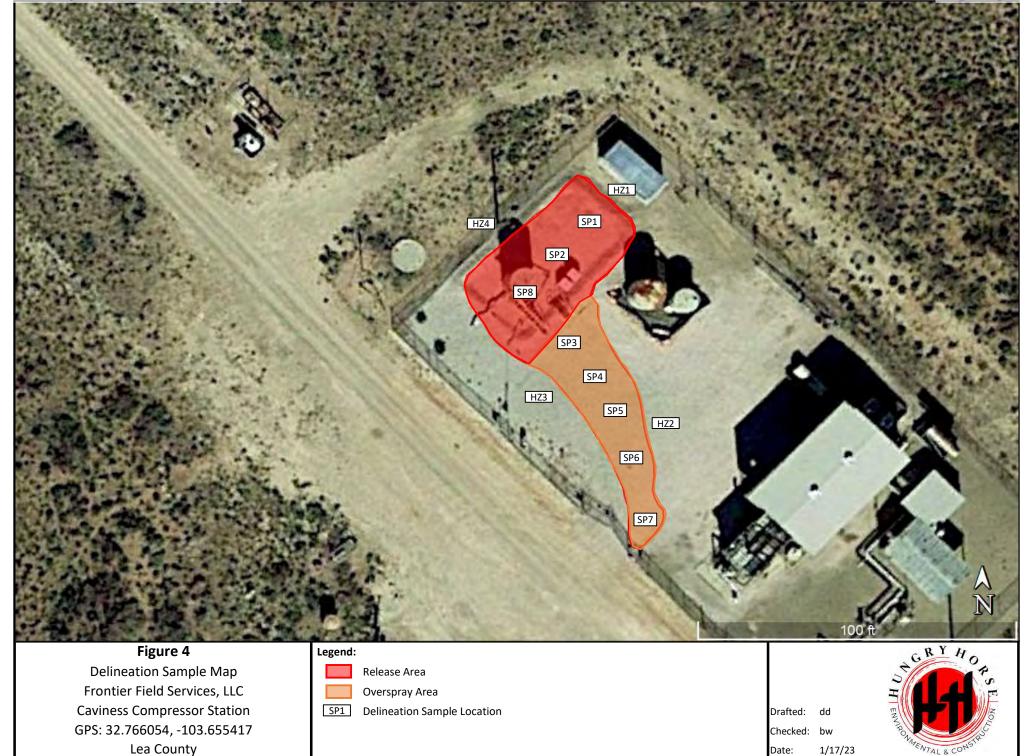
Based on field observations and field test data noted above and provided in Attachment V, sixteen representative soil samples were selected for laboratory analysis. Delineation soil samples SP1 through SP7, HZ1 through HZ4, were submitted to the laboratory for analysis of BTEX, TPH, and chloride. Laboratory analytical results indicated contaminant concentrations were below the NMOCD Closure Criteria in each of the submitted samples, with the exception of SP2 at Surface and one-foot bgs and SP3 at Surface, which exhibited TPH and/or chloride concentrations in excess of the NMOCD Closure Criteria.

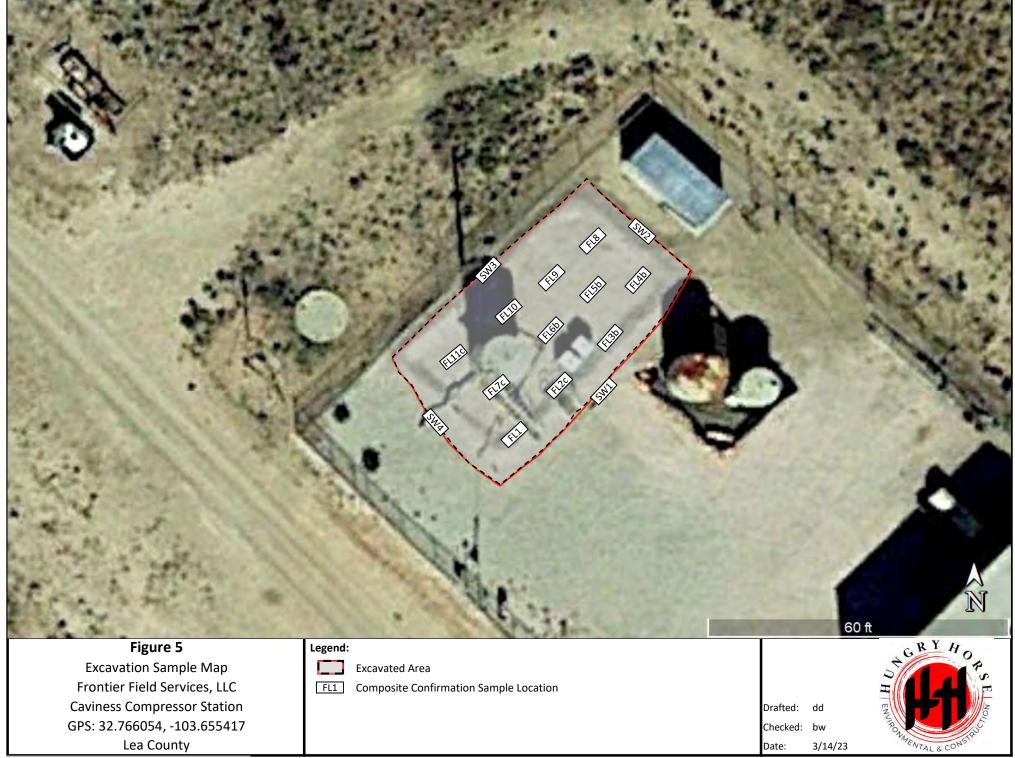
On January 25, 2023, the overspray area was scraped to approximately three inches bgs, removing the stained gravel. A small stockpile of gravel that had been removed from within the containment area and temporarily stockpiled on site, atop plastic, was also removed. Contaminated gravel and caliche were transported to an NMOCD approved disposal facility. The area characterized by sample location SP3 was also sampled, with soil sample SP3 at three inches, submitted to the laboratory for analysis of BTEX, TPH, and chloride. Laboratory analytical results indicated contaminant concentrations were below the NMOCD Closure Criteria for the submitted sample.
